# Heavy Jagdpanzer

Development • Production • Operations

Walter J. Spielberger, Hilary L. Doyle & Thomas L. Jentz

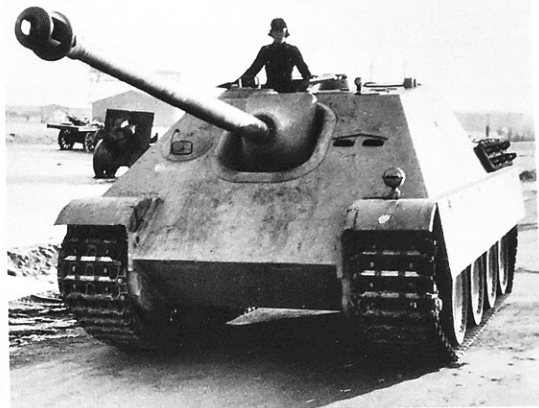
The first *Jagdpanther* (chassis no. V 101) was accepted by the Army Ordnance Office in October 1943. The cylindrical holder for the barrel cleaning rods on the left side is still lacking. The driver had two sight openings to use. In the sidewalls of the fighting compartment were machine-pistol loopholes. The original Type Kfg 64/660/130 still had no grippers.

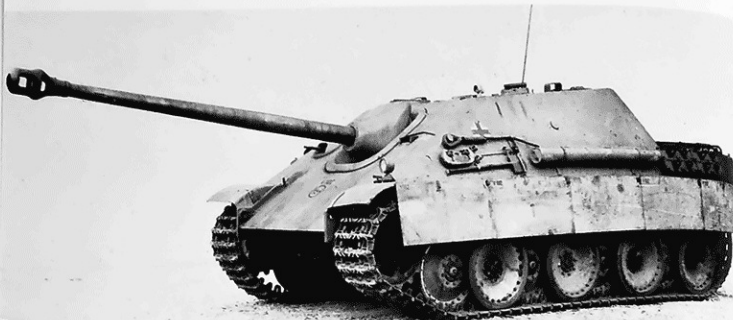
The second prototype (chassis no. V 102) was accepted by the Army Weapons Office in November 1943 and tested thoroughly by Verskraft, in Kummersdorf.

The five "pistol ports" in the side and rear walls were present only in the two prototypes (chassis no. V 101 and V 102). They were dropped when series production began (from no. 300001 on). These

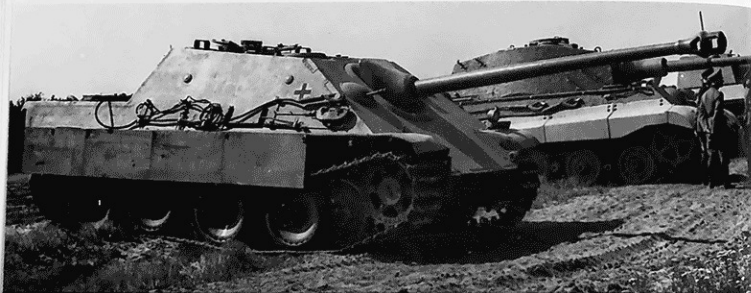
The second prototype was shown to Hitler on December 16, 1943. The two machine-pistol ports can be seen on the right wall of the fighting compartment. They allowed use of MP for close range defense, and for observation. In the background is a Tiger H 2 tank.

openings weakened the side armor plate, and were also made unnecessary by the installation of the "close combat weapon." Because of delivery difficulties, this weapon could not be built into most of the *Jagdpanthers* that were finished before June 1944.

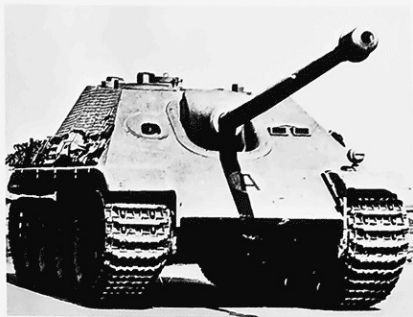
One of the first series-produced *Jagdpanthers*, of which MIAG produced five in January 1944. The driver's view was assured by two periscopes. The MP ports on the sidewalls were eliminated. This vehicle was sent to a Fueroerjäger replacement unit for training. Series production began with chassis no. 300001.

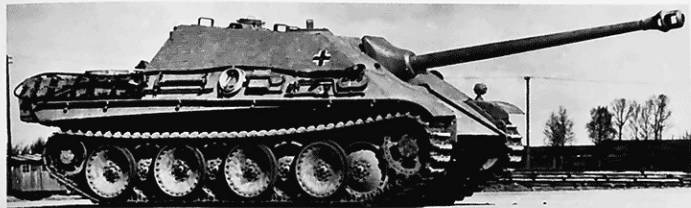
The MG ports could be eliminated because a close-combat weapon mount was provided in the roof, but the gun was not ready for the first series vehicles. The opening in the roof was temporarily closed by a circular plate.

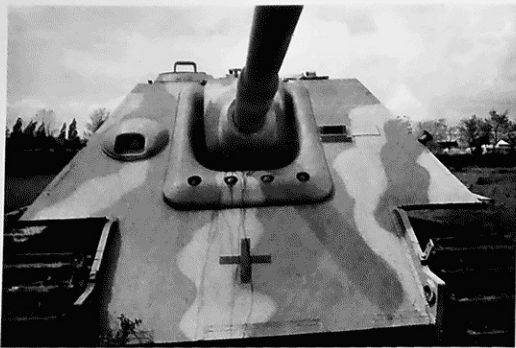
In February 1944 production the left periscope for the driver was eliminated. The opening was covered by a welded on rectangular plate.

The left periscope for the driver was eliminated. The opening was welded shut with a rectangular piece of steel plate. The towing coupling attached to the middle of the rear plate was welded to the round servicing hatch. For recovery, towing rods could now be used, much improving control over the defective vehicle. With the towing cables used before, the towing of the *Jagdpanzer* was hard to control and brake. To make room for the new towing coupling, the winch—which had been mounted horizontally over the servicing hatch until then—was located vertically between the exhaust pipes.

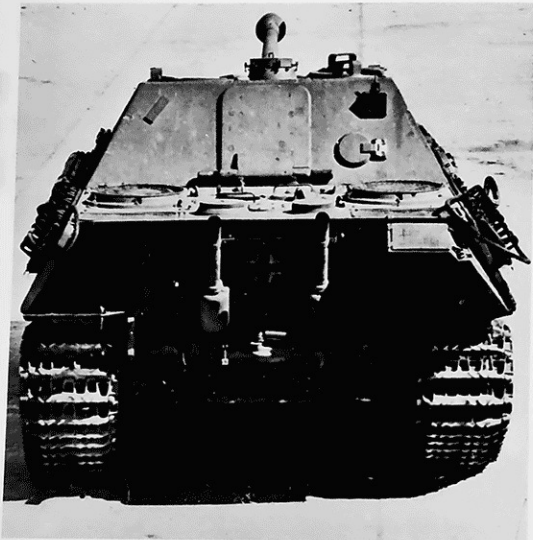
The towing shackle attached to the center of the rear plate was formerly welded to the round servicing hatch. In recovery, towing rods could now be used. To make place for the new towing coupling the winch, formerly mounted horizontally, had to be placed vertically between the exhaust mufflers. The vehicle shown is a command tank, with a mount for a star antenna on the upper right part of the rear wall.

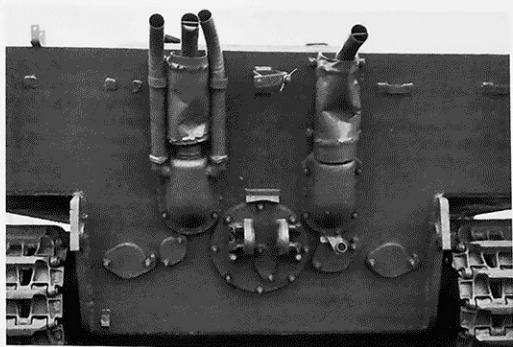
Attachments for the vertically placed winch.

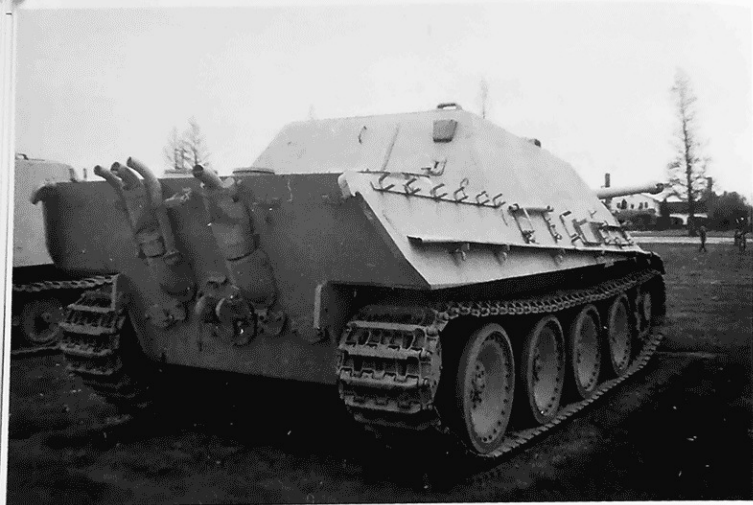
As of May 1944 two pipes were attached, one on each side of the exhaust pipe. They served to cool the exhaust temperature, and were also used to remove dust and smoke from the steering and wheel brakes.

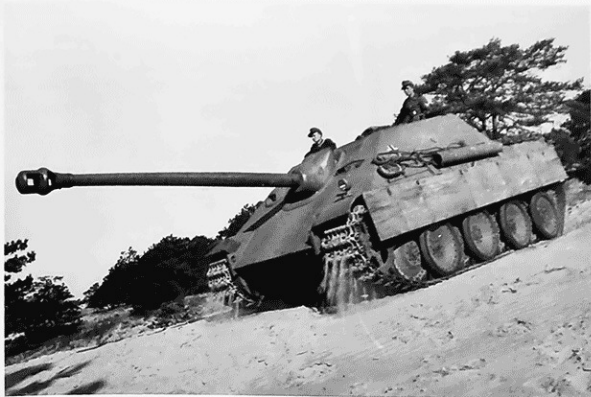
After the early Jagdpanthers had been equipped with a single-piece barrel for the 8.8 cm Pak 43/3, a version of this weapon with a two-piece barrel was used as of May 1944. All the supplies were used up, so that by the end of October 1944, Jagdpanthers with the one-piece barrel were still delivered. The one-piece barrel is shown above, the two-piece type below. (BA, BA)

In the armament, a two-piece barrel replaced the one-piece barrel of the 8.8 cm Antitank Cannon 43/3. Both weapons had the same designation. This considerably simplified construction, since the shorter pieces of the separated version were easier to produce.

One-piece barrel	Two-piece barrel
Cannon balanced by a lead counterweight.	Cannon balanced by a strong spring.
Breech spring was serviced on right side.	Breech
Muzzle brake 60 kg, recoil brake 1.1 liter.	Spring serviced on left side.
	Muzzle brake
	35 kg,* recoil brake 6 liters.

It was shown that changes were made in production only when all existing parts were used up—as long as the weapons had first been delivered to the Army Weapons Office for shooting in. Thus, it happened that some *Jagdpanthers* still received the one-piece cannon at the end of October 1944.

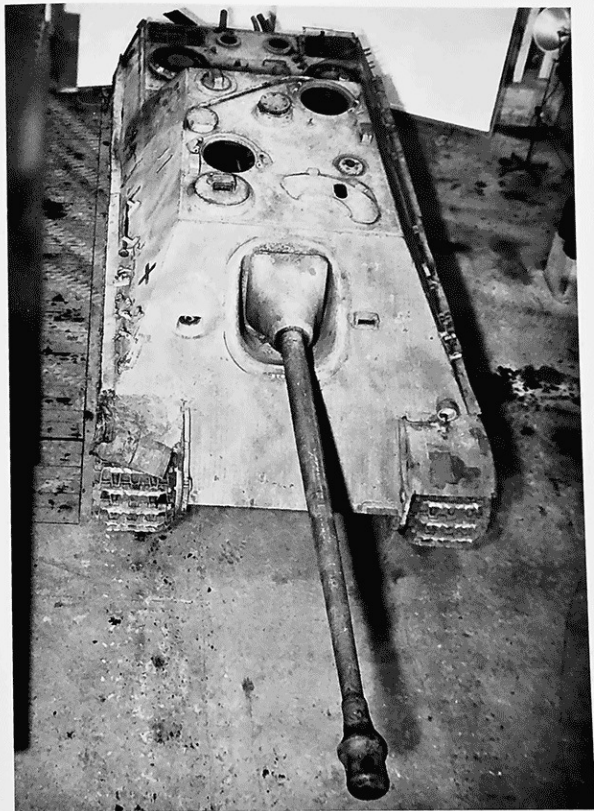
In September 1944 the manufacturers were instructed not to use Zimmerit protective coatings any more.

On September 9, 1944, the OKH advised the manufacturers to stop using "Zimmerit" protective coatings against hollow charges,

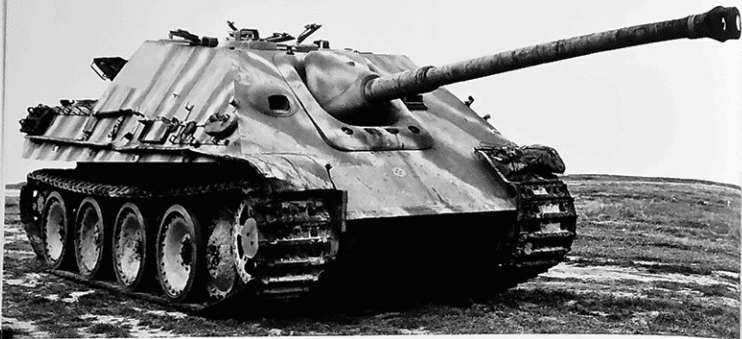
The collar of cast steel that covered the weapon opening was originally welded. As of October 1944 it was held by four screws, above and below. Some Jagdpanthers with the welded collar were still delivered until November. The Jagdpanther delivered by the MNH firm in December 1944 (chassis no. 303018) was captured by the Americans in the 1944 Ardennes offensive, and sent to the USA (Aberdeen Proving Grounds). The vehicle still had the old leading wheels.

A thickened inner weapon mount increased protection. The stronger cast piece was likewise held on by four screws above and below.

The leading wheels did not clean themselves of snow and ice well, and tracks were thrown. New leading wheels with a bigger diameter were developed; they are easy to recognize by their doubly ribbed spokes. With a shortage of parts and available spare parts to be used up, the manufacturers were still installing original leading wheels in new Jagdpanthers in February 1945.

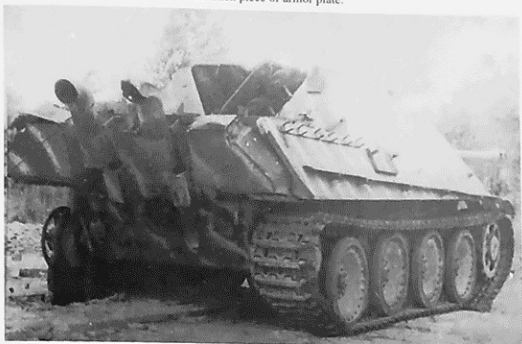
This vehicle (chassis no. 303018) built by MNH was one of about ten pieces that had an additional smoke escape right over the breech of the gun.

On a limited number of Jagdpanthers (ten confirmed) made in November and December 1944, the smoke escape ventilator was moved forward on the roof, directly over the weapon mount. In all other Jagdpanthers built before and afterward, this ventilator was on the right side of the roof directly behind the commander's hatch.

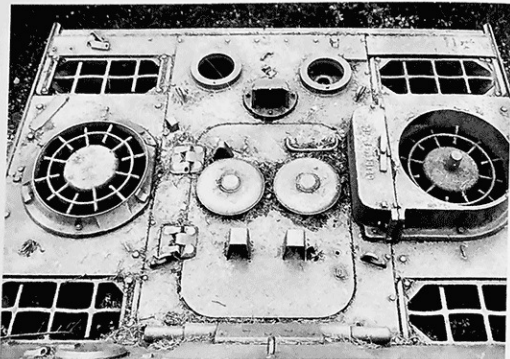
In December 1944 new fighting compartment heating was introduced. In the process, a raised ventilator cover was placed over the left engine cooling duct, which brought warmed air that had blown over the motor through a shaft into the fighting compartment and to the driver.

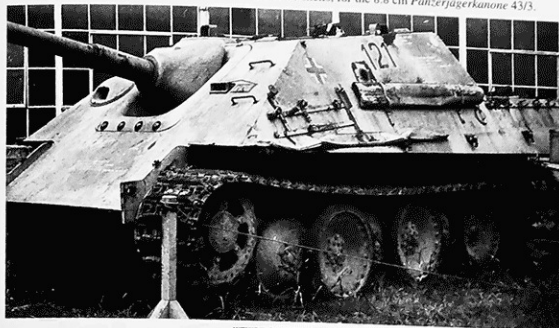
This *Jagdpanther* was captured by the Americans and sent to the USA. The second driver's vision opening is closed, and the vehicle had the two-part barrel and screwed-on gun-mount collar, but no Zimmerit coating. Note the handholds welded onto the driver's side, making getting in and out easier for the crew.

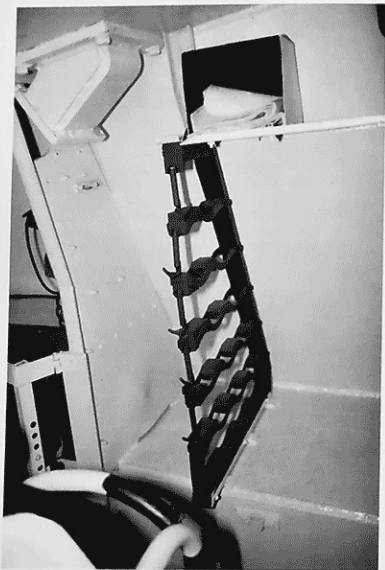
The rear body wall with the square entrance-exit hatch. To the left is a round port for throwing out used cartridges.

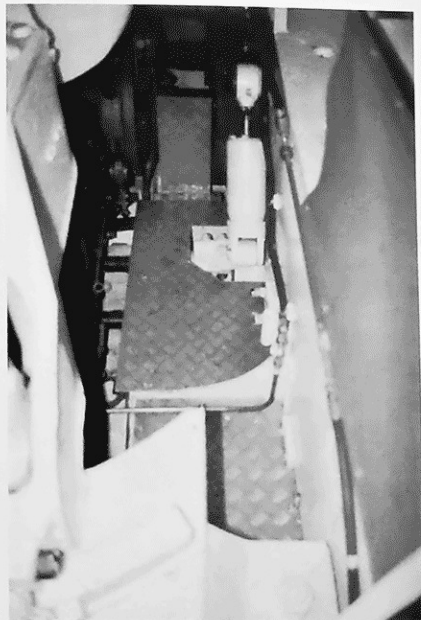
Ammunition storage at the left rear.

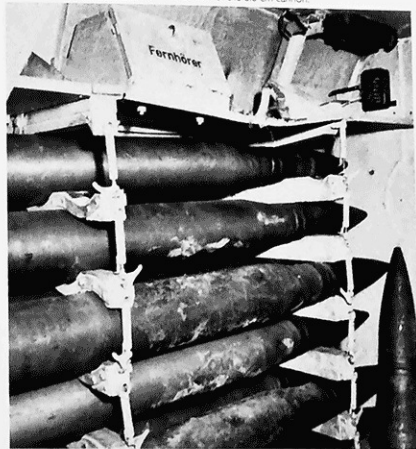
Stowed ammunition, at left in front of the commander.

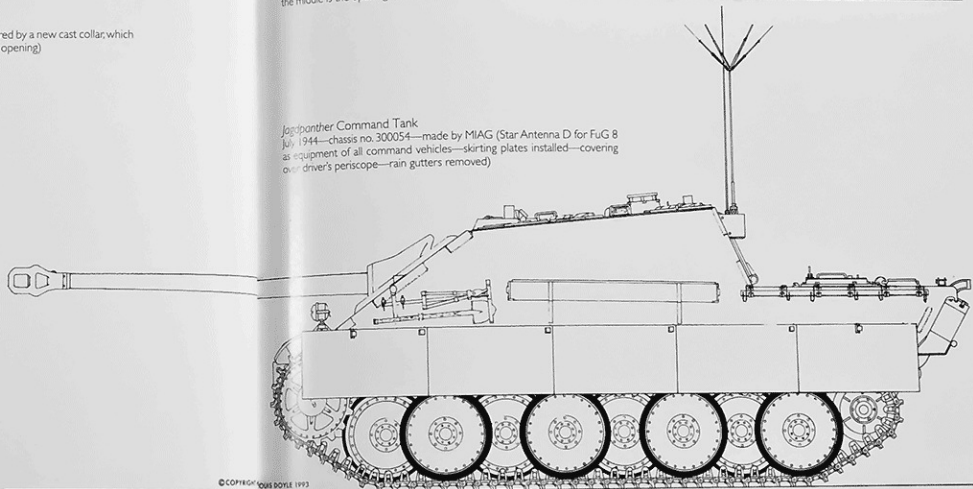
July 1944—chassis no. 300054—made by MIAG (Star Antenna D for FuG 8 as equipment of all command vehicles—skirting plates installed—covering over driver's periscope—rain gutters removed)

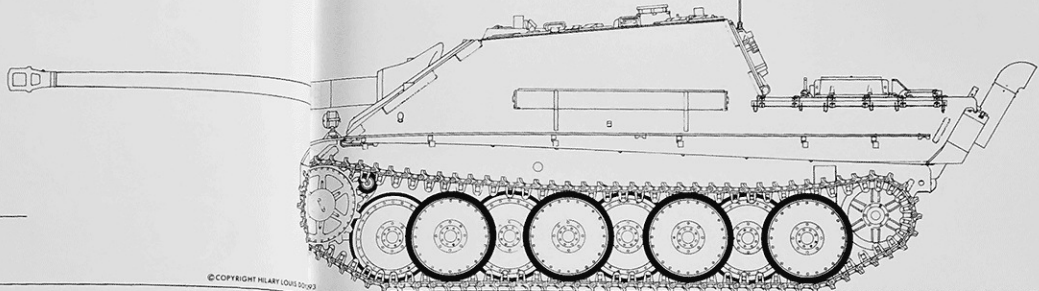
May 1945—Chassis no. 393101—MNH production (two-piece barrel of the 8.8 cm Stuk 43/3, introduced on a few vehicles as of May 1944, on all as of November 1944—lightweight muzzle brake—new leading wheels (660 mm diameter)—87 links per track on some vehicles as of October 1944—rear shock absorbers dropped as of October 1944—fighting compartment heating duct from the left hot air escape—Flame-extinguisher exhaust as of December 1944—the last vehicles produced had tools and equipment that were formerly attached to the side of the vehicle moved back to behind the engine compartment (including 50 mm diameter towrope). These changes were also made to older vehicles by their crews.

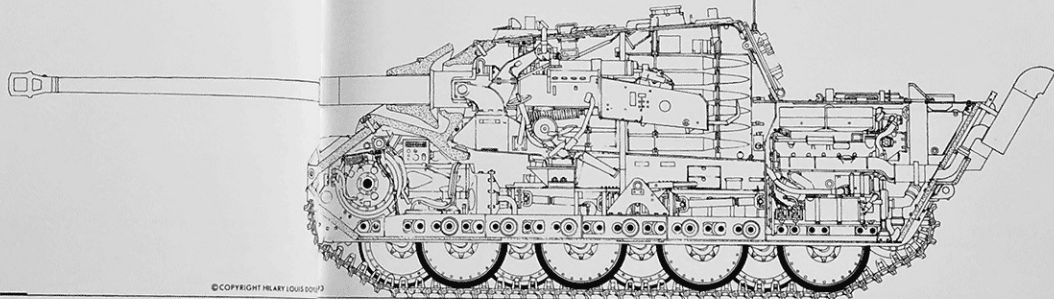
Side view: (Ready for action: Two-part gun barrel—counterweight on the recoil brake replaced by equalizing spring under the cannon—lengthened recoil protection—Z-14 targeting device installed—improved fresh air ducting through ventilator and forward on the right side of the vehicle—changed location of radio sets—Air escape for the HL 230 P 30 motor in the middle of the engine cover.)

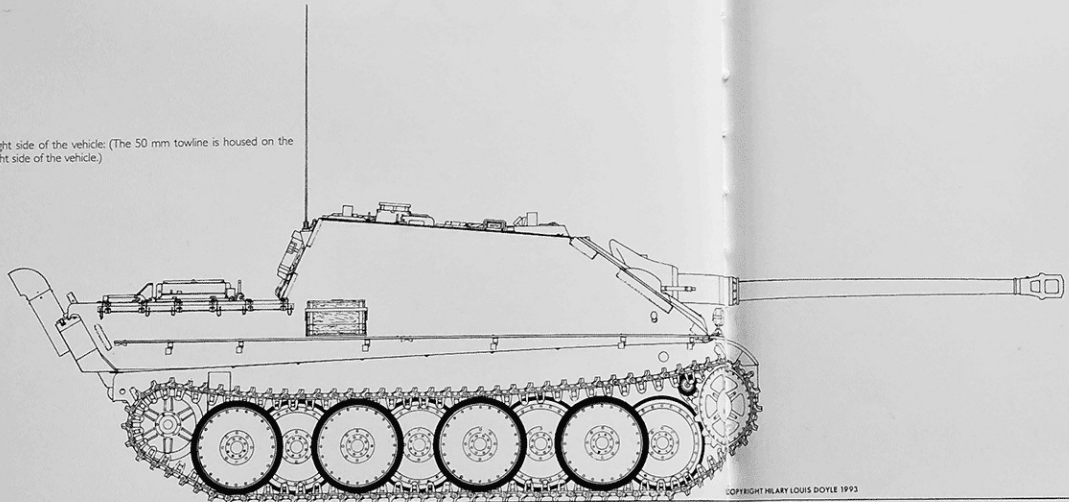
Right side of the vehicle: (The 50 mm towline is housed on the right side of the vehicle.)

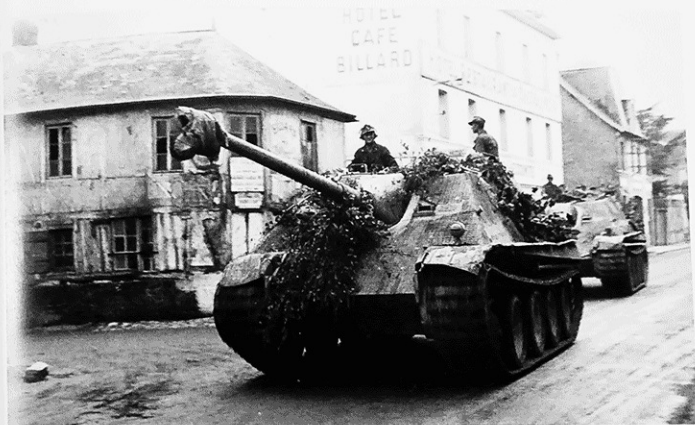
The *Jagdpanther* in action in France, 1944. The small ball mantlet and the left opening for the driver's periscope, now welded shut, can be seen clearly. (BA)

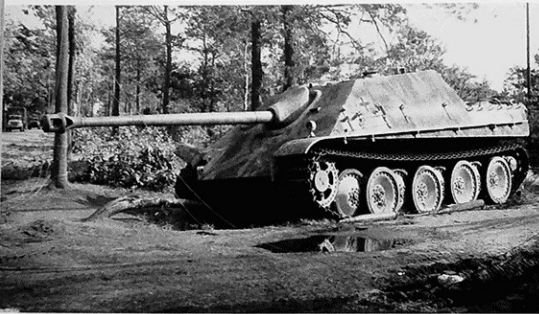
The Command Jagdpanzer, chassis no. 300054, was finished by MIAG in July 1944 and assigned to the staff of Heavy Panzerjäger Abteilung 559. Four 75 or 76 mm KE shells penetrated the rearward right side and caused a small fire in the engine compartment. The vehicle was recovered and shipped to England, where it is still on display at the Imperial War Museum.

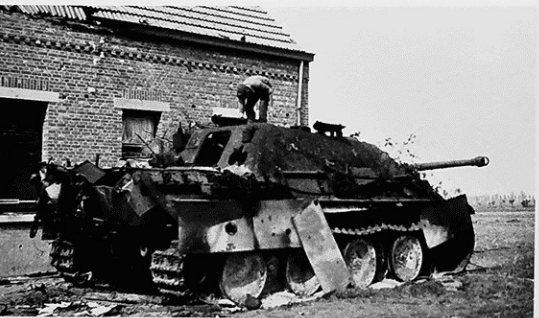
The Heavy Panzerjäger Abteilung 559 had little luck with its Command Jagdpanzers. The second one was lost on September 13, 1944, in the vicinity of the Albert Canal. Fire from an M4 Sherman tank broke through its right side at the level of the engine compartment, and the vehicle burned out.

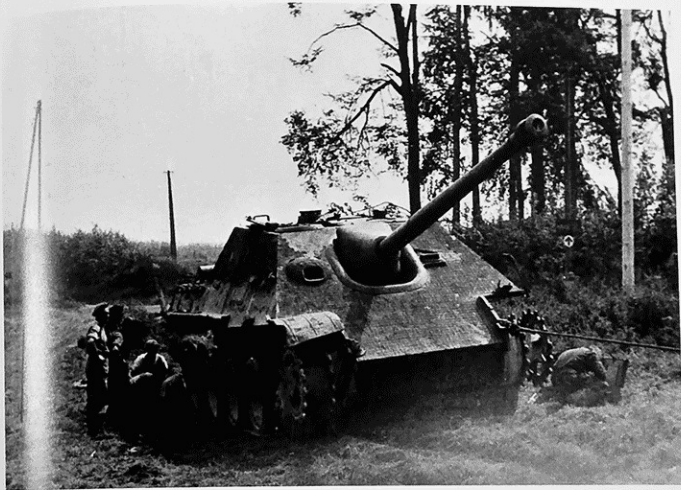
In major action, engineers of the British Army recovered this Jagdpanzer, chassis no. 300027, in mid-August 1944. The vehicle, built by MIAG, was assigned to the 3<sup>rd</sup> Company of Heavy Panzerjäger Abteilung 654 in April 1944. The vehicle was thoroughly examined in Britain.

To bring Heavy *Panzerjäger* *Abteilung* 654 back to full strength, it was assigned 16 "fresh" *Jagdpanthers*. On July 31, 1944, eight *Jagdpanthers* left the Army Equipment Office by rail. The last eight followed on August 14, 1944. The 1<sup>st</sup> Company of the 654<sup>th</sup> *Abteilung* was declared ready for action on 10 August, although at that point (and only very briefly) it had only eight *Jagdpanzer* available. One *Jagdpanzer* (tactical no. 314) of the 3<sup>rd</sup> Company was captured by the British in mid August 1944. One battalion of the 43<sup>rd</sup> British Division recovered this vehicle. A six-pound antitank shell had hit the intermediate gears. A PIAT hollow charge shell had penetrated the right side of the body but did no

fatal damage. The roof had also been penetrated, probably by an explosive artillery shell. To take the vehicle to Britain for examination it had to be recovered first. The attempt to load the *Jagdpanther* onto a Diamond T low loader with a winch line failed. The *Jagdpanzer* hit a ditch with its nose, flung the low loader trailer high into the air, and destroyed the winch of a Scammell towing vehicle which tried to hold the whole aggregation together. The Royal Engineers of the 43<sup>rd</sup> Division made 1000-Franc bets that the *Jagdpanther* weighed more than the official 46 tons. In the delaying combat on the invasion front, in breaking out of the pocket at Falaise and southwest of the Seine, the *Abteilung* lost 17 *Jagdpanthers* in August. With their remaining 23 *Jagdpanthers*, they finally withdrew behind the Seine. Most of their vehicles urgently needed repairs. The order to return to Germany came on September 9, 1944. *Abteilung* 654 moved to the Bavarian troop training camp at Grafenwöhr for refreshment.

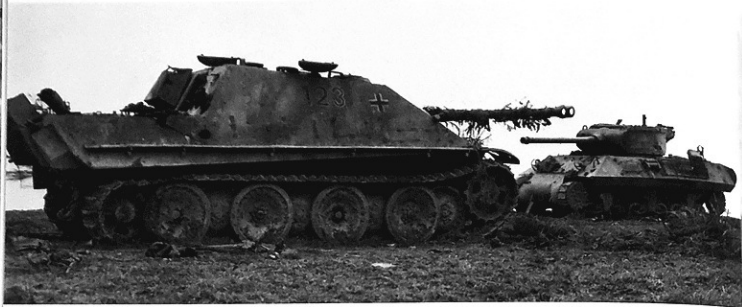
This *Jagdpanther* was put out of action by two KE hits in the engine compartment. In the right background is a Type M36 American tank, also shot down. This picture was taken on March 17, 1945. Until February 1945 the *Jagdpanthers* received a third equipment container, which was mounted on the left side of the engine compartment cover. The new leading wheels with doubled ribbing were produced sporadically from October 1944 on.

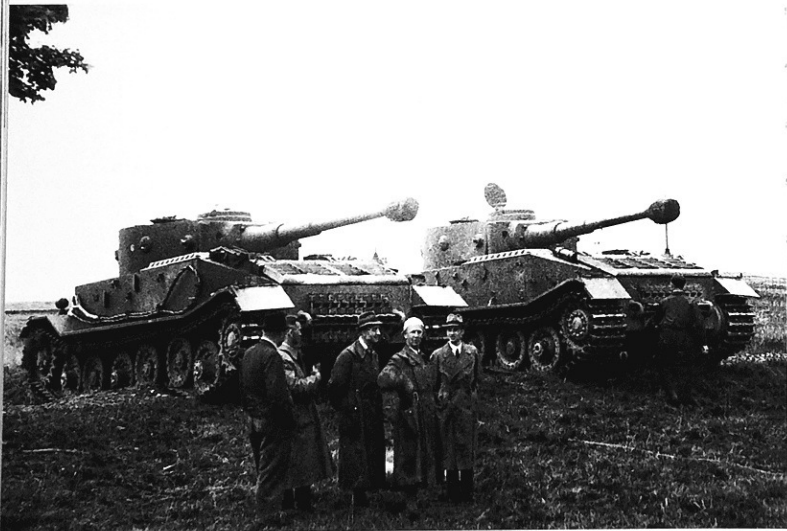
Tiger Tank, Porsche VK 4501 (P) version.

Basic motor and gearbox problems of the Porsche vehicles could not be cured in the short times that were available. In August 1942 the Steyr-Daimler-Puch firm, Werk Nibelungen GmbH, in St. Valentin halted the already begun production of the VK 4501 (P). Krupp, on the other hand, had already fulfilled its contract for 100 armored bodies for this vehicle.

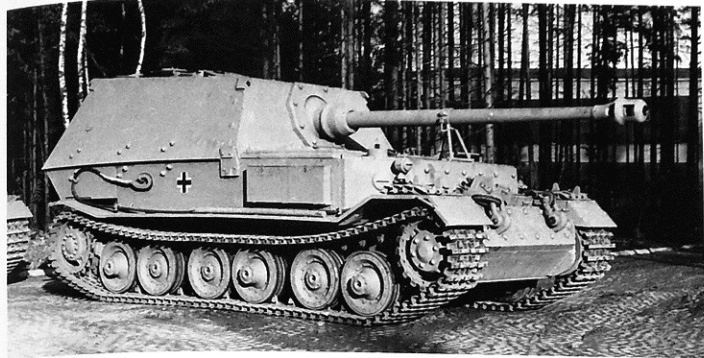
The finished product in its full size. The Ferdinand was presented as ready for acceptance by the Army Ordnance Office. The official paint was dark yellow, with the national emblem on either side.

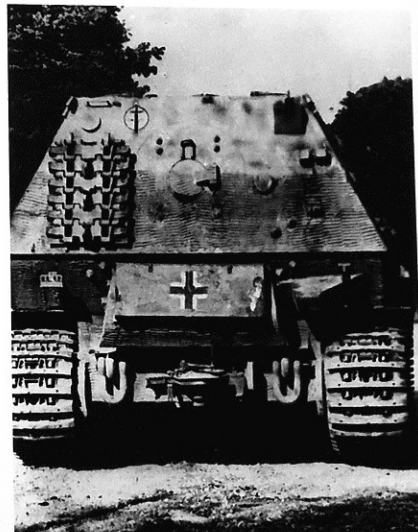
Getting into and out of the fighting compartment was done via two hatches in the roof, plus a big round opening in the rear body plate. The vehicle shown here is a command tank, recognizable by the antenna mount at the upper right of the rear body plate.

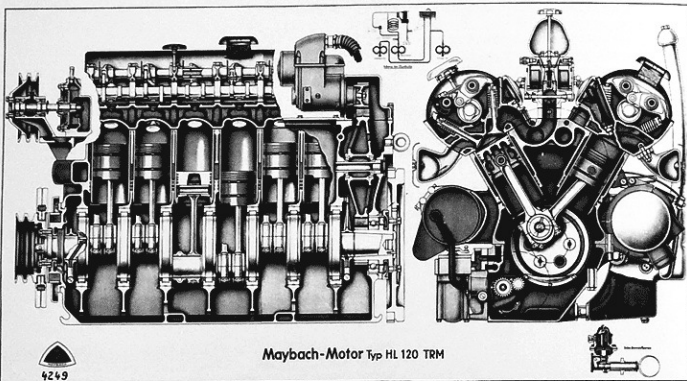
Two of these Maybach HL 120 TRM gasoline engines replaced the originally planned air-cooled 10-cylinder gasoline motors, made by the Porsche firm, in series production.

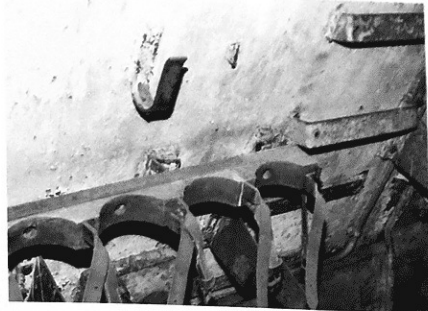
Racks for six shells on the right side of the fighting compartment.

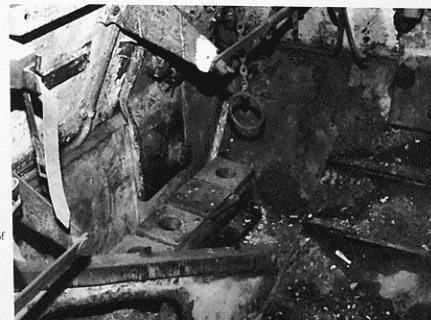
Nine racks for ammunition were located at the right rear. Part of the rack is missing.

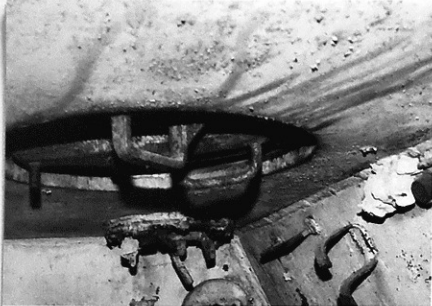
The loader's entry-exit hatch was at the left rear of the roof. Behind it, in the far corner of the fighting compartment, was the periscope mount.

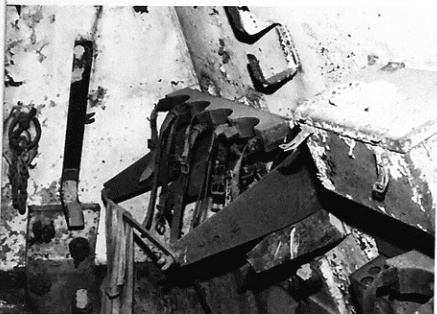
Nine more shells were stowed at the left rear. A machine-pistol port can be seen on the rear wall.

The secondary armament consisted of one MG 34 (with 600 rounds) carried loose, and two MP 38/40 (with 384 rounds). The crew could fire these automatic weapons either through the open ports, or through pistol openings on each side of the body—or the two openings on the rear wall.

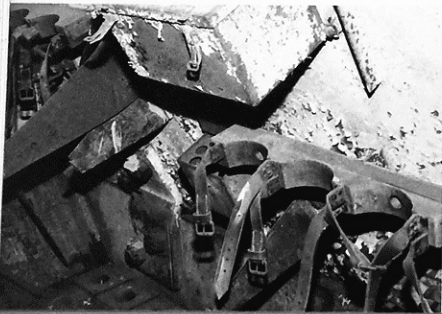
The left body side, with ammunition racks (the shells stood on end in the racks with the igniters downward. A rack for nine more shells can be seen at the far left.

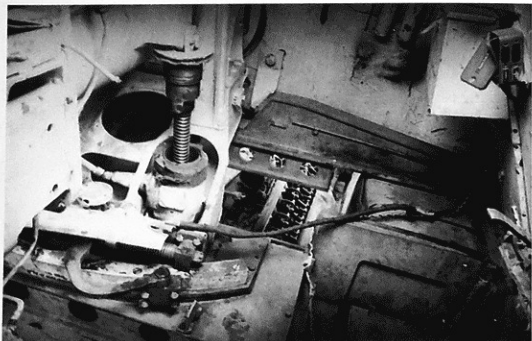
A look at the right side of the fighting compartment. Floor plates for the fighting compartment and the engine cover are missing.

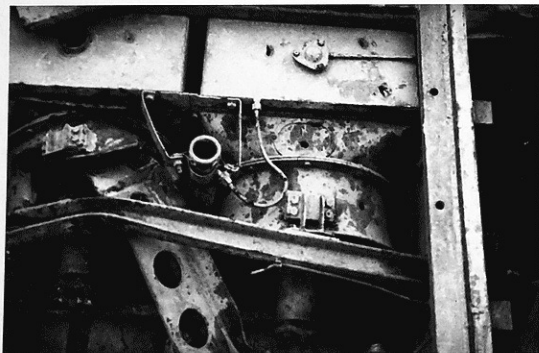
Details of the damaged cooling system space.

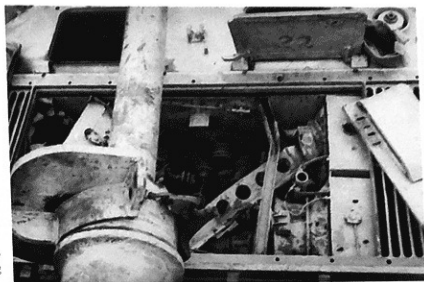
This Ferdinand, chassis no. 150022, was destroyed and captured by the Red Army. A look into the generator room with the cooling system before the fighting compartment.

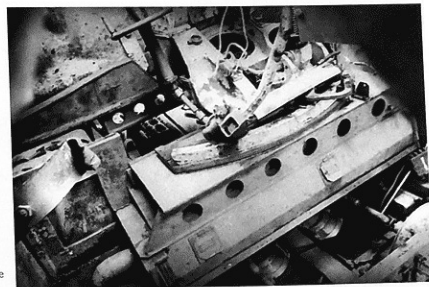
Part of the fighting compartment. The flooring is missing. One of the two small ventilators is visible; it cooled the electric motors.

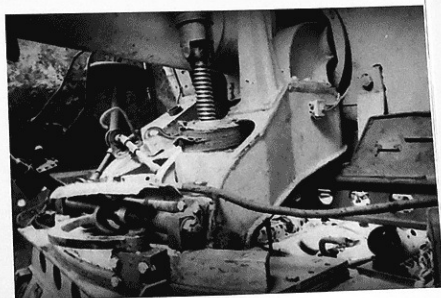
A look at the weapon mount from the right side.

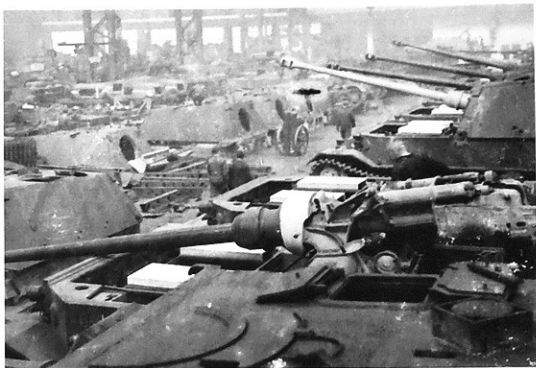
This picture from above shows the rectangular hatch for the commander. The rear lid had to be opened all the way when the commander wanted to use his shear scope. The nearest vehicle affords a rare view of details of weapon installation.

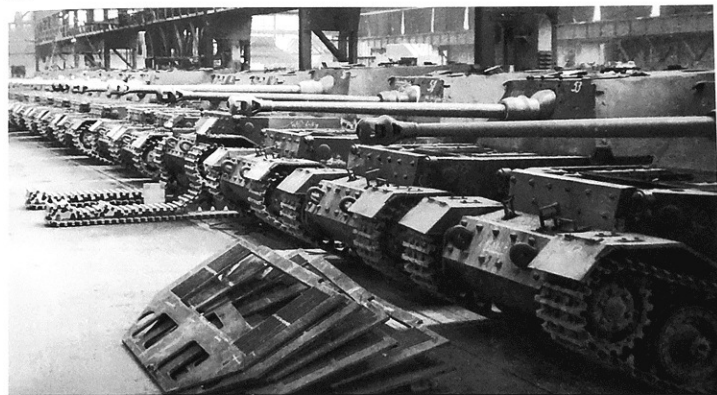
Almost finished Ferdinands. The covering of the driver's space must be attached. Chassis no. 150027 is first in line at right.

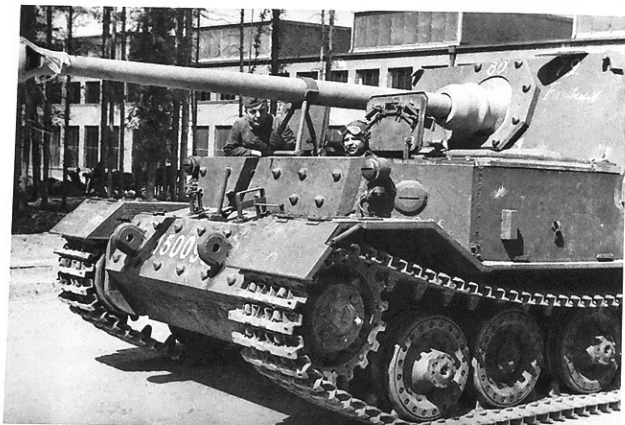
Ferdinand (chassis no. 150096) is seen after being accepted by inspectors of the Army Weapons Office. The word "Fähig" ("ready to drive") has been written on the body plate with chalk.

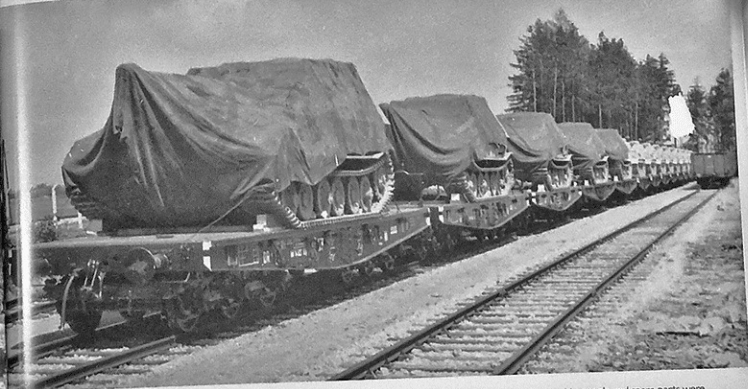
Loaded on SSyms railroad cars of the German Reichsbahn, the Ferdinands first went to the Heereszeugamt, where ammunition, tools, and spare parts were added. The radios were built in and the vehicles desensitized. The last Ferdinands to be ready for action reached the troops in June 1943.

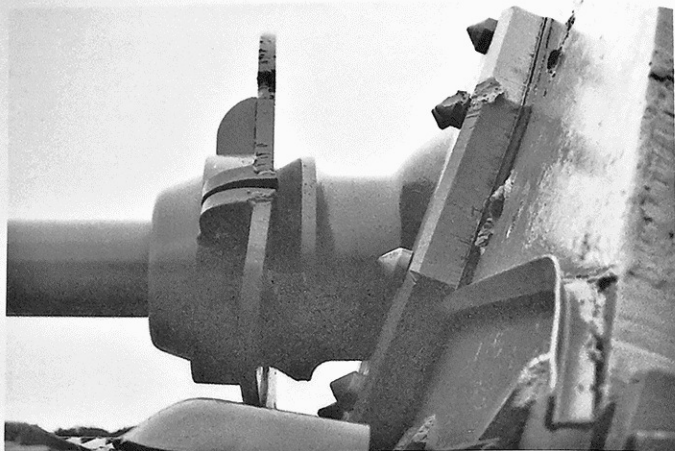
The Ferdinands left the factory with unprotected ball mantlets. Krupp of Essen sent the additional armor to the troops by rail on May 13, 1943. The troops mounted them themselves before going into action.

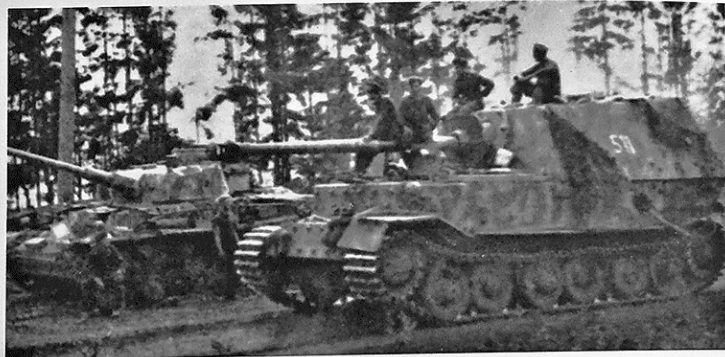
Ferdinand 511 of Heavy Panzerjäger Abteilung 654 stands next to a Panzer IV, Type G tank. The difference in size can be seen.

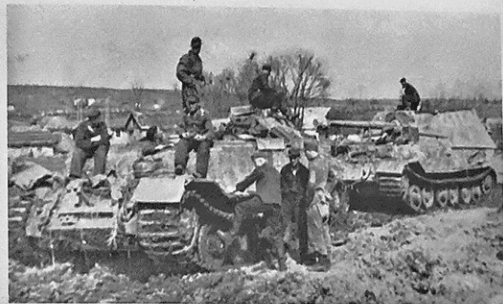
A rare picture of a Recovery Ferdinand in action.

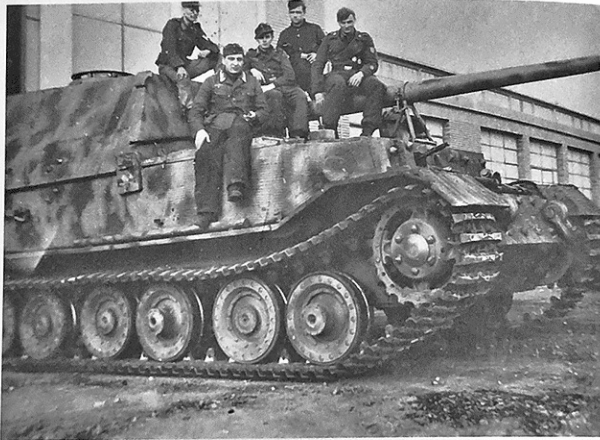
A vehicle of the I/653, with the new commander's cupola easy to see, stands before the workshop in Rome in March 1944.

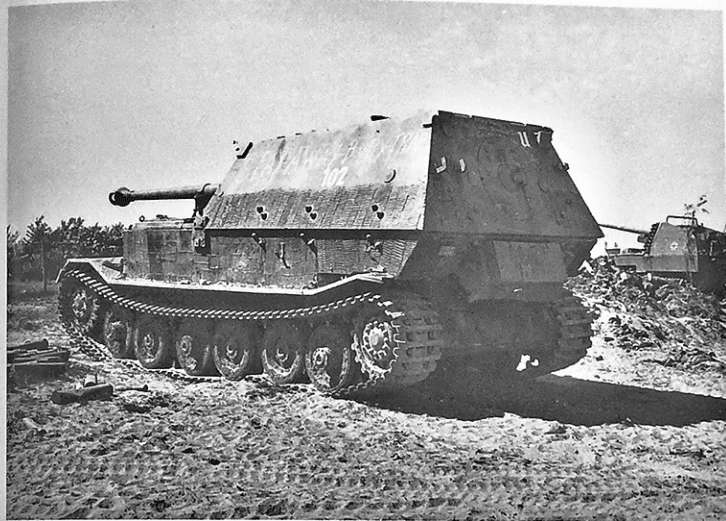
An *Elefant* with tactical number 102 (chassis no. 150040) was captured by the U.S. Army in Italy and shipped to Aberdeen, Maryland, for examination.

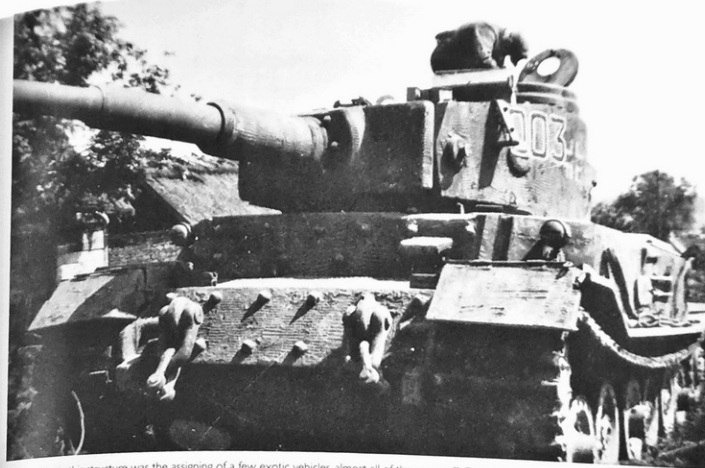
Noteworthy in this structure was the assigning of a few exotic vehicles, almost all of them one-offs. These vehicles were to be found in the Abteilung Staff, Gruppe Führer. This Tiger (P) (VK 4501(P)) was used as a command tank, its commander being Captain Hanns Wegelin. The tactical number was 003. The picture shows the front of the Tiger reinforced with added armor plates.

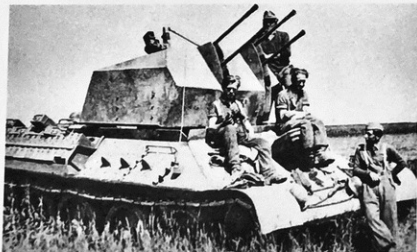
The unusual equipment included a 2 cm Flak quad on the chassis of a Russian T 34.

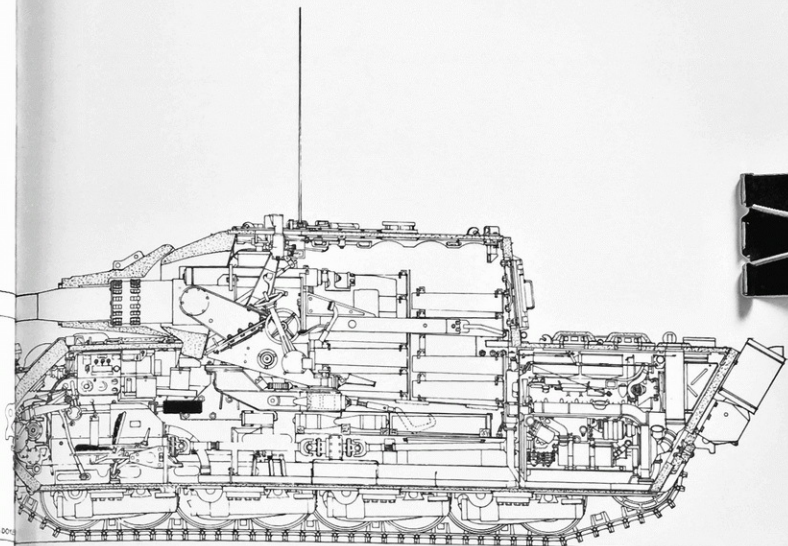
Cutaway side view: (Ready for action: longitudinal torsion-bar suspension of the road wheels—separated ammunition stored on the fighting compartment walls and under the floor in the rear part of the fighting compartment, as well as under the gun mount—Maybach HL 230 P 45 motor—Driver's seat height adjustable)

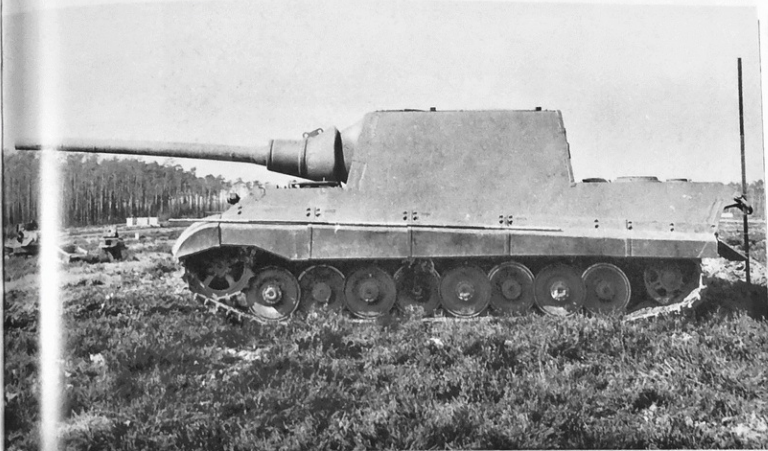
The first two *Jagdtiger* were finished in February 1944. The first vehicle (chassis no. 305001) was built with the Porsche running gear of eight road wheels (700 mm diameter) on each side.

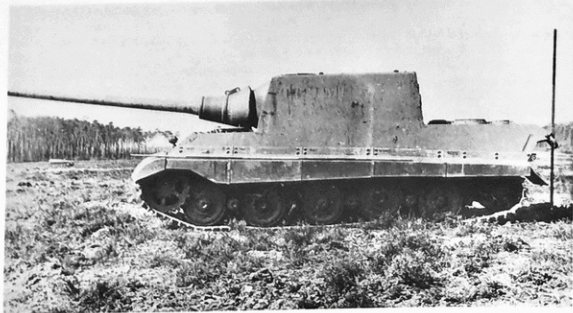
The second vehicle, which was produced at the same time (chassis no. 305002) had the Henschel running gear with nine road wheels (600 mm diameter) on each side.

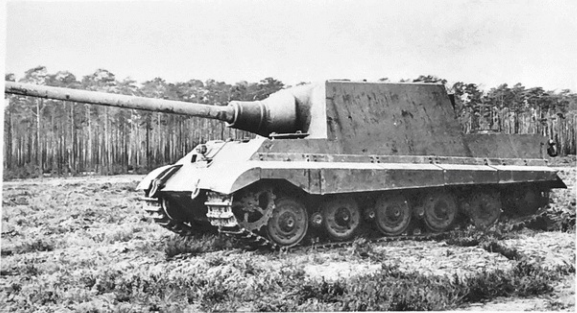
Both vehicles were tested thoroughly by the Army Ordnance Office, beginning on May 5, 1944. The Porsche running gear could not provide the required performance. Both vehicles were just painted. Zimmer was not yet applied. The racks for tools and equipment were also missing.

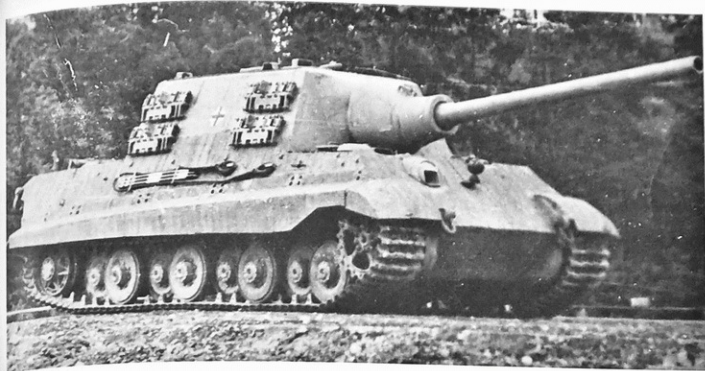
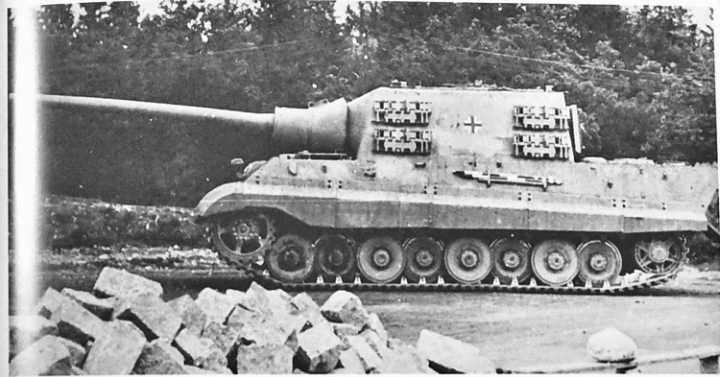
In the course of these tests, the *Jagdtriger* (chassis no. 305003) with Porsche running gear was fitted with Type Kps 64/640/130 tracks from the Eifelort. They did not help. The pictures show both sides, fully equipped, with spare track links on the sides of the fighting compartment. This vehicle was turned over to the Panzertruppen School in Mieland. It was the school's first *Jagdtriger*.

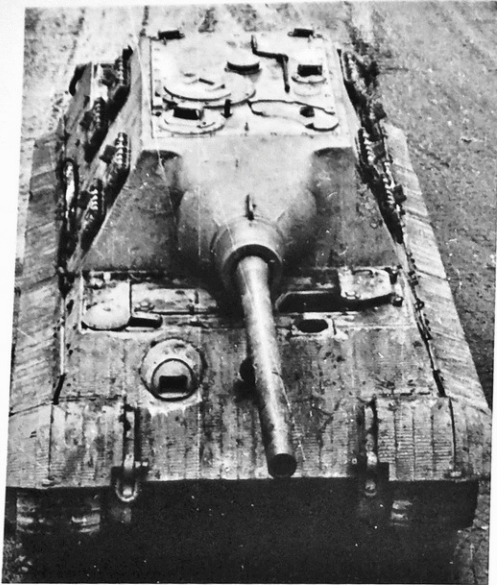
A front view of the vehicle, seen from above. The driver's hatch is open. The paint is dark yellow, with RAL shade 7028. The "Zimmerit" coating was applied only as high up as a man could reach.

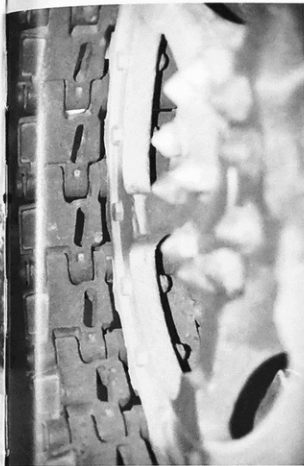
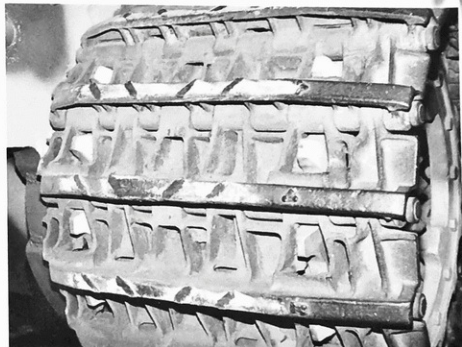
These two pictures show details of the new tracks (Type Kf 73/880/152) that were to be introduced toward the war's end for the Tiger II and *Jagdiger*. For these tracks, the old drive wheels with 18 teeth had to be used.

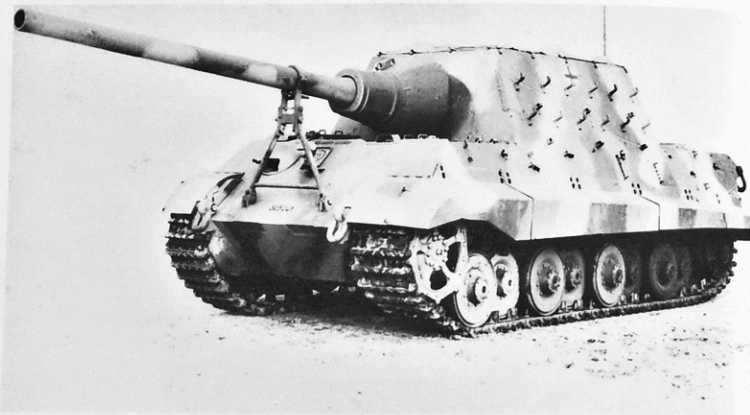
The first Jagdtiger with Porsche running gear (chassis no. 305001) was reequipped by Verskraft in Kummersdorf. Now twelve hooks for spare track links are welded onto each side of the fighting compartment. A barrel brace for the cannon was mounted on the upper bow plate.

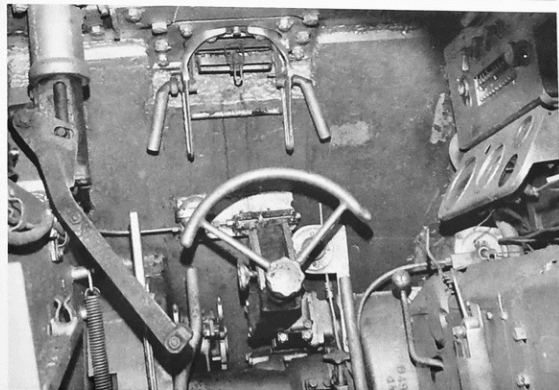
The other position by the driver was to be found behind the steering wheel, right in the driver's field of vision. It consisted of an indicator and a bell, to make the driver aware that the commander wanted to communicate with him.

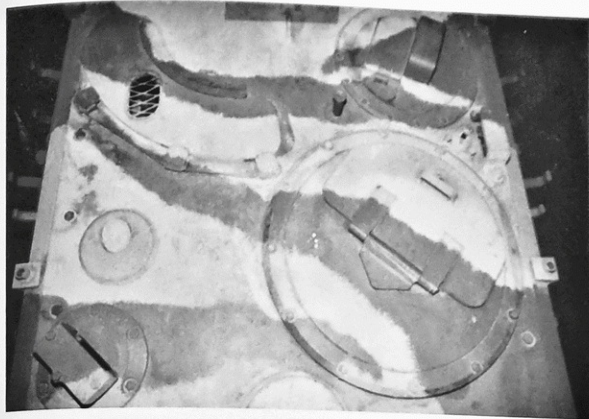
The roof of the *Jagdtiger* fighting compartment. The bolt in front of the commander's hatch is an attachment for the planned range finder.

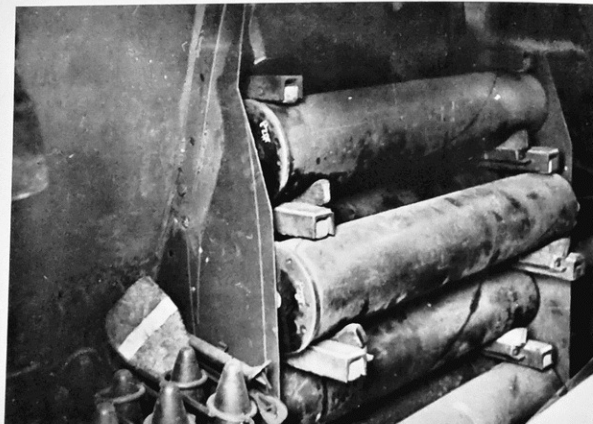
Storage of the separated ammunition, cartridges lying, shells standing (chassis no. 305058).

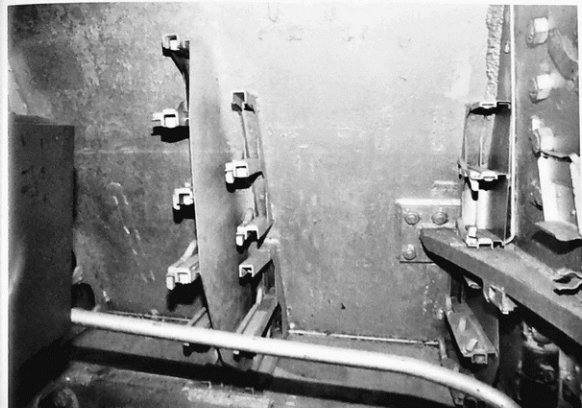
Left rear: Rack for six cartridges. Traces of welding on the sidewall indicate the position in the prototype.

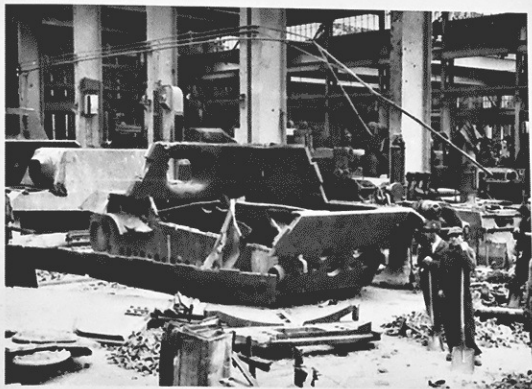
The Nibelungenwerk was hit by 143-ton explosive bombs during an Allied air raid on 10/16/1944. The considerable damage to the heavily armored *Jagdtiger* bodies came as a surprise.

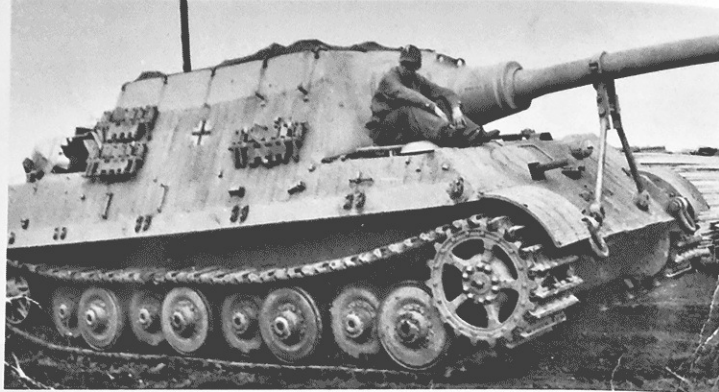
Jagdtiger with Porsche running gear (chassis no. 305009) and loading tracks.

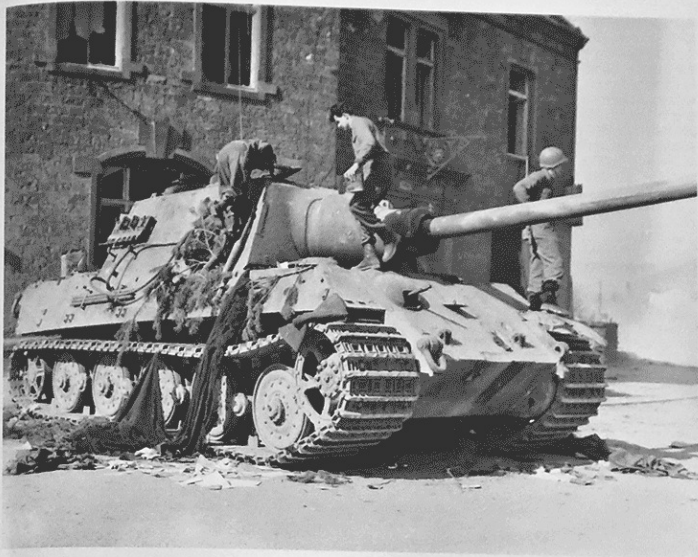
*Jagdtiger* (chassis no. 305020), finished in October 1944, was assigned to PzJgAbt. 653. Its tactical number was 31. The vehicle took several hits, but they did not penetrate. One shot hit the rear's head mantlet, another the front corner of the hull side plate. This damage blocked the left reduction gear (see small picture). The vehicle turned with its side to the enemy, and the crew left it without destroying it.

This Jagdtiger (chassis no. 305020) was shipped to the USA for examination, and was taken by rail to the Aberdeen Proving Ground in Maryland. Since the left drive wheel was jammed, it was removed along with the track. The chassis number was on the upper bow plate in black numbers 9.5 cm high. The tactical number 331 and the German cross, in black with white borders, were painted on both sides of the fighting compartment.

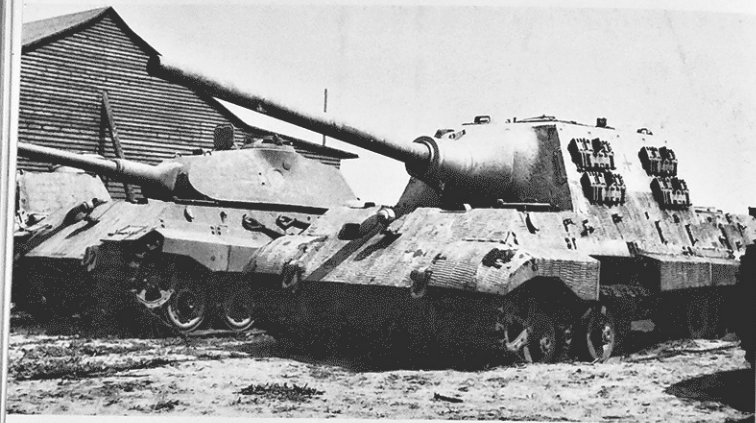
The *Jagdiger* (chassis no. 305004) was also sent to the proving grounds of the Army Ordnance Office, and was captured by British troops at a training camp. It was sent to Bovington, where it is still to be seen in the museum. The barrel brace was not yet installed, and the third wheel track of the Porsche running gear is missing. It broke off during driving tests. Next to it is a Tiger tank, Type B, with the early turret.
