# Heavy Jagdpanzer

Development • Production • Operations

Walter J. Spielberger, Hilary L. Doyle & Thomas L. Jentz

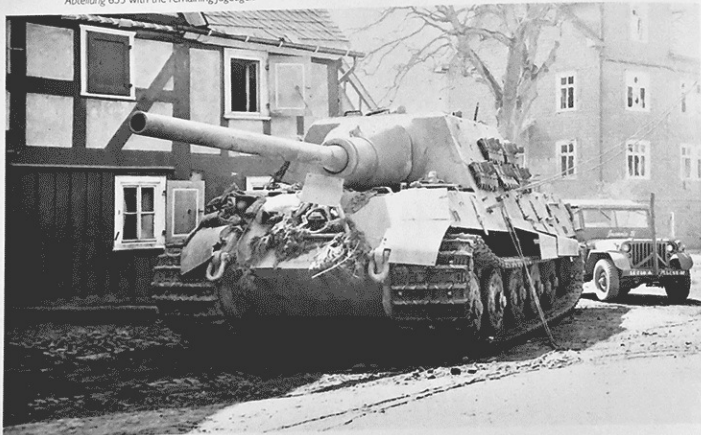
This Jagdtiger (chassis no. 3050580) was finished in January 1945, and sent to Heavy Panzerjäger Abteilung 653 in March 1945. Captured by the US Army in Germany, the vehicle shows the six sets of spare track links attached at the factory since December 1944. The driver's and radoman's hatches each had two handholds.

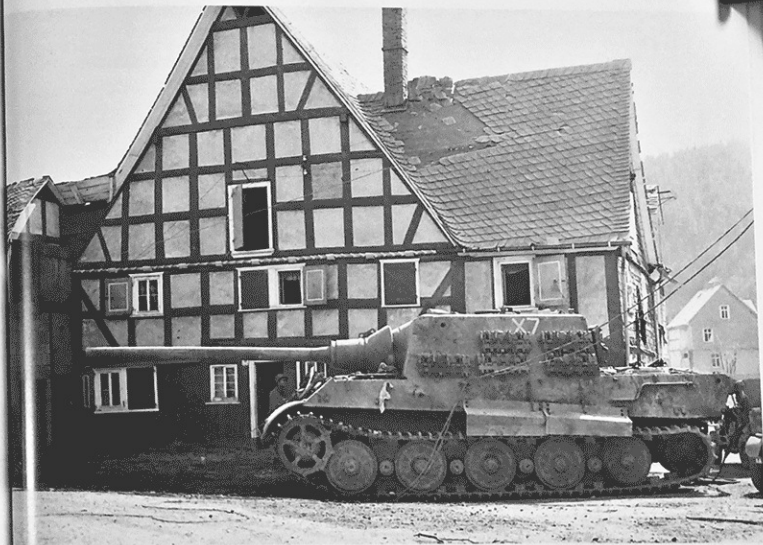
Further improvements to all *Jagdtiger* made since December 1944 were carried out by attaching a covering plate for the deep-fording air intake, and omitting the winch and ground plates.

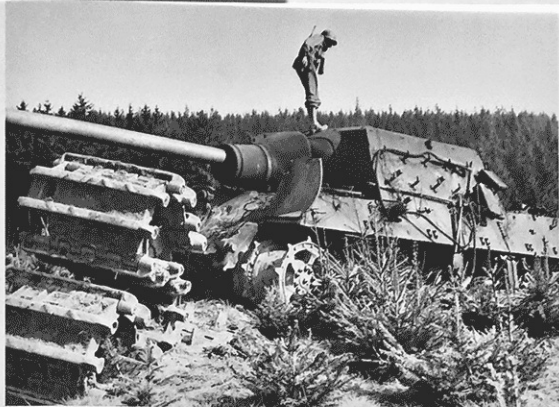
One of the last Jagdtiger, made in February or March 1945 and turned over to s.Pz.Jg.Abt. 512. The vehicle has the four "mushrooms" for attaching the two-ton crane. The vehicle was hit several times by KE shells, or the tracks were damaged and finally blown up by the crew.

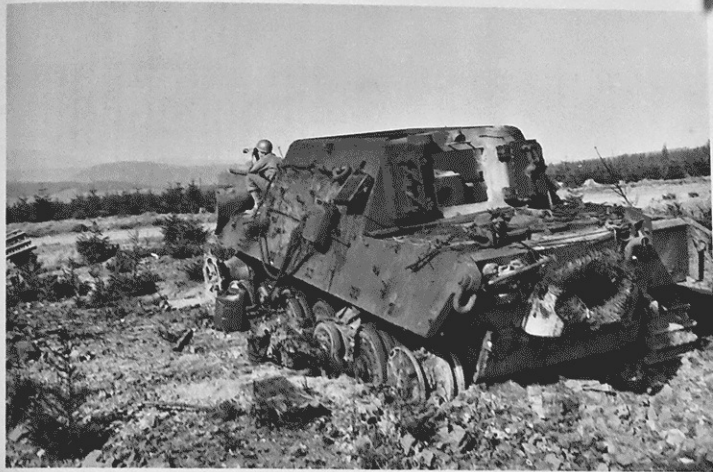
This picture, taken on 4/16/1945, seems to attest to the rumor that track supplies were not assured. The Type Cg 24/660/300 tracks of this vehicle were loading tracks for railroad transport; they were not to be used offroad. The ground pressure was much too high.

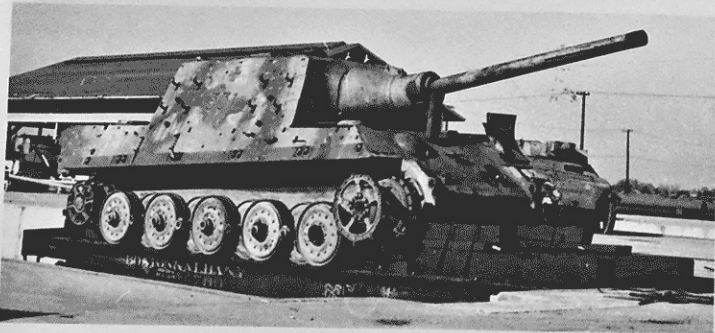
This Jagdtiger (chassis no. 305020) was shipped to the USA for examination, and was taken by rail to the Aberdeen Proving Ground in Maryland. Since the left drive wheel was jammed, it was removed along with the track. The chassis number was on the upper bow plate in black numbers 9.5 cm high. The tactical number 331 and the German cross, in black with white borders, were painted on both sides of the fighting compartment.
