TIGER TANK

Panzerkampfwagen VI Tiger I Ausf. E (SdKfz 181)

Owners' Workshop Manual

An insight into the history, development, production and role of the most feared battle tank of the Second World War

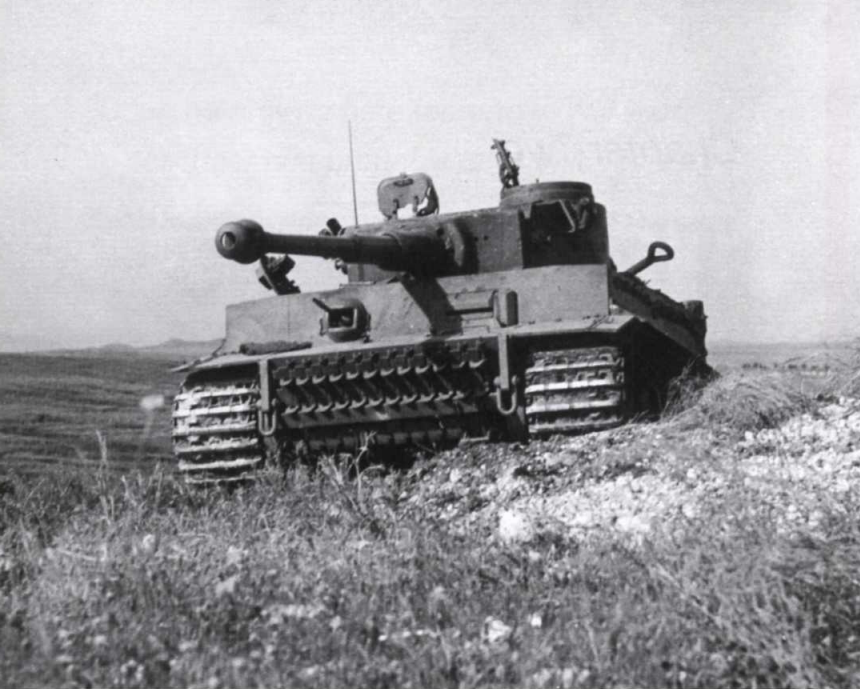
LEFT This photograph of Tiger 131 was taken on 22 April while shells landed nearby; the photographer is sheltering in a vacated German foxhole. Damage to the loader's hatch can be clearly seen and the towing cable appears to be loosened – perhaps ready for use. Note the absence of material on the front glacis plate. No one has yet started to remove items from the interior.

The early photographs also clearly show the cracked loader's hatch, which was subsequently replaced. To be damaged in such a manner the hatch would have had to be open. Could this impact have also caused injury to a crew member?

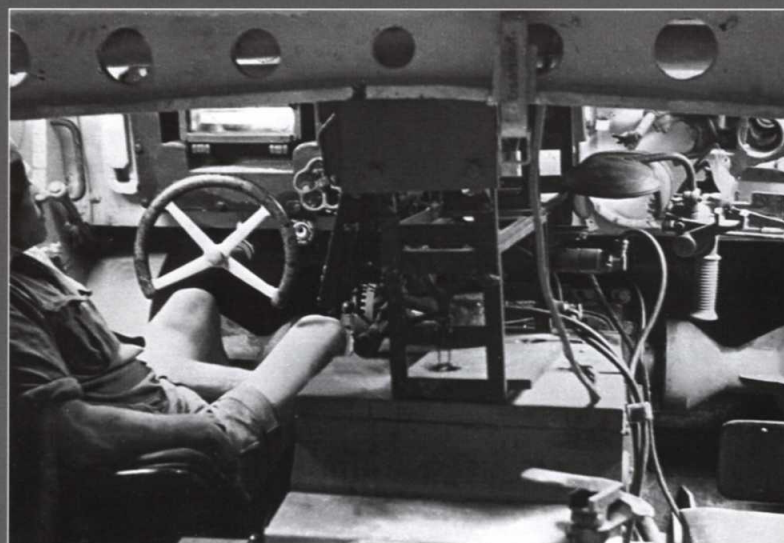
BELOW The smashed radios have been removed from the shelves in the centre between the driver's and bow machine gunner/radio operator's positions.

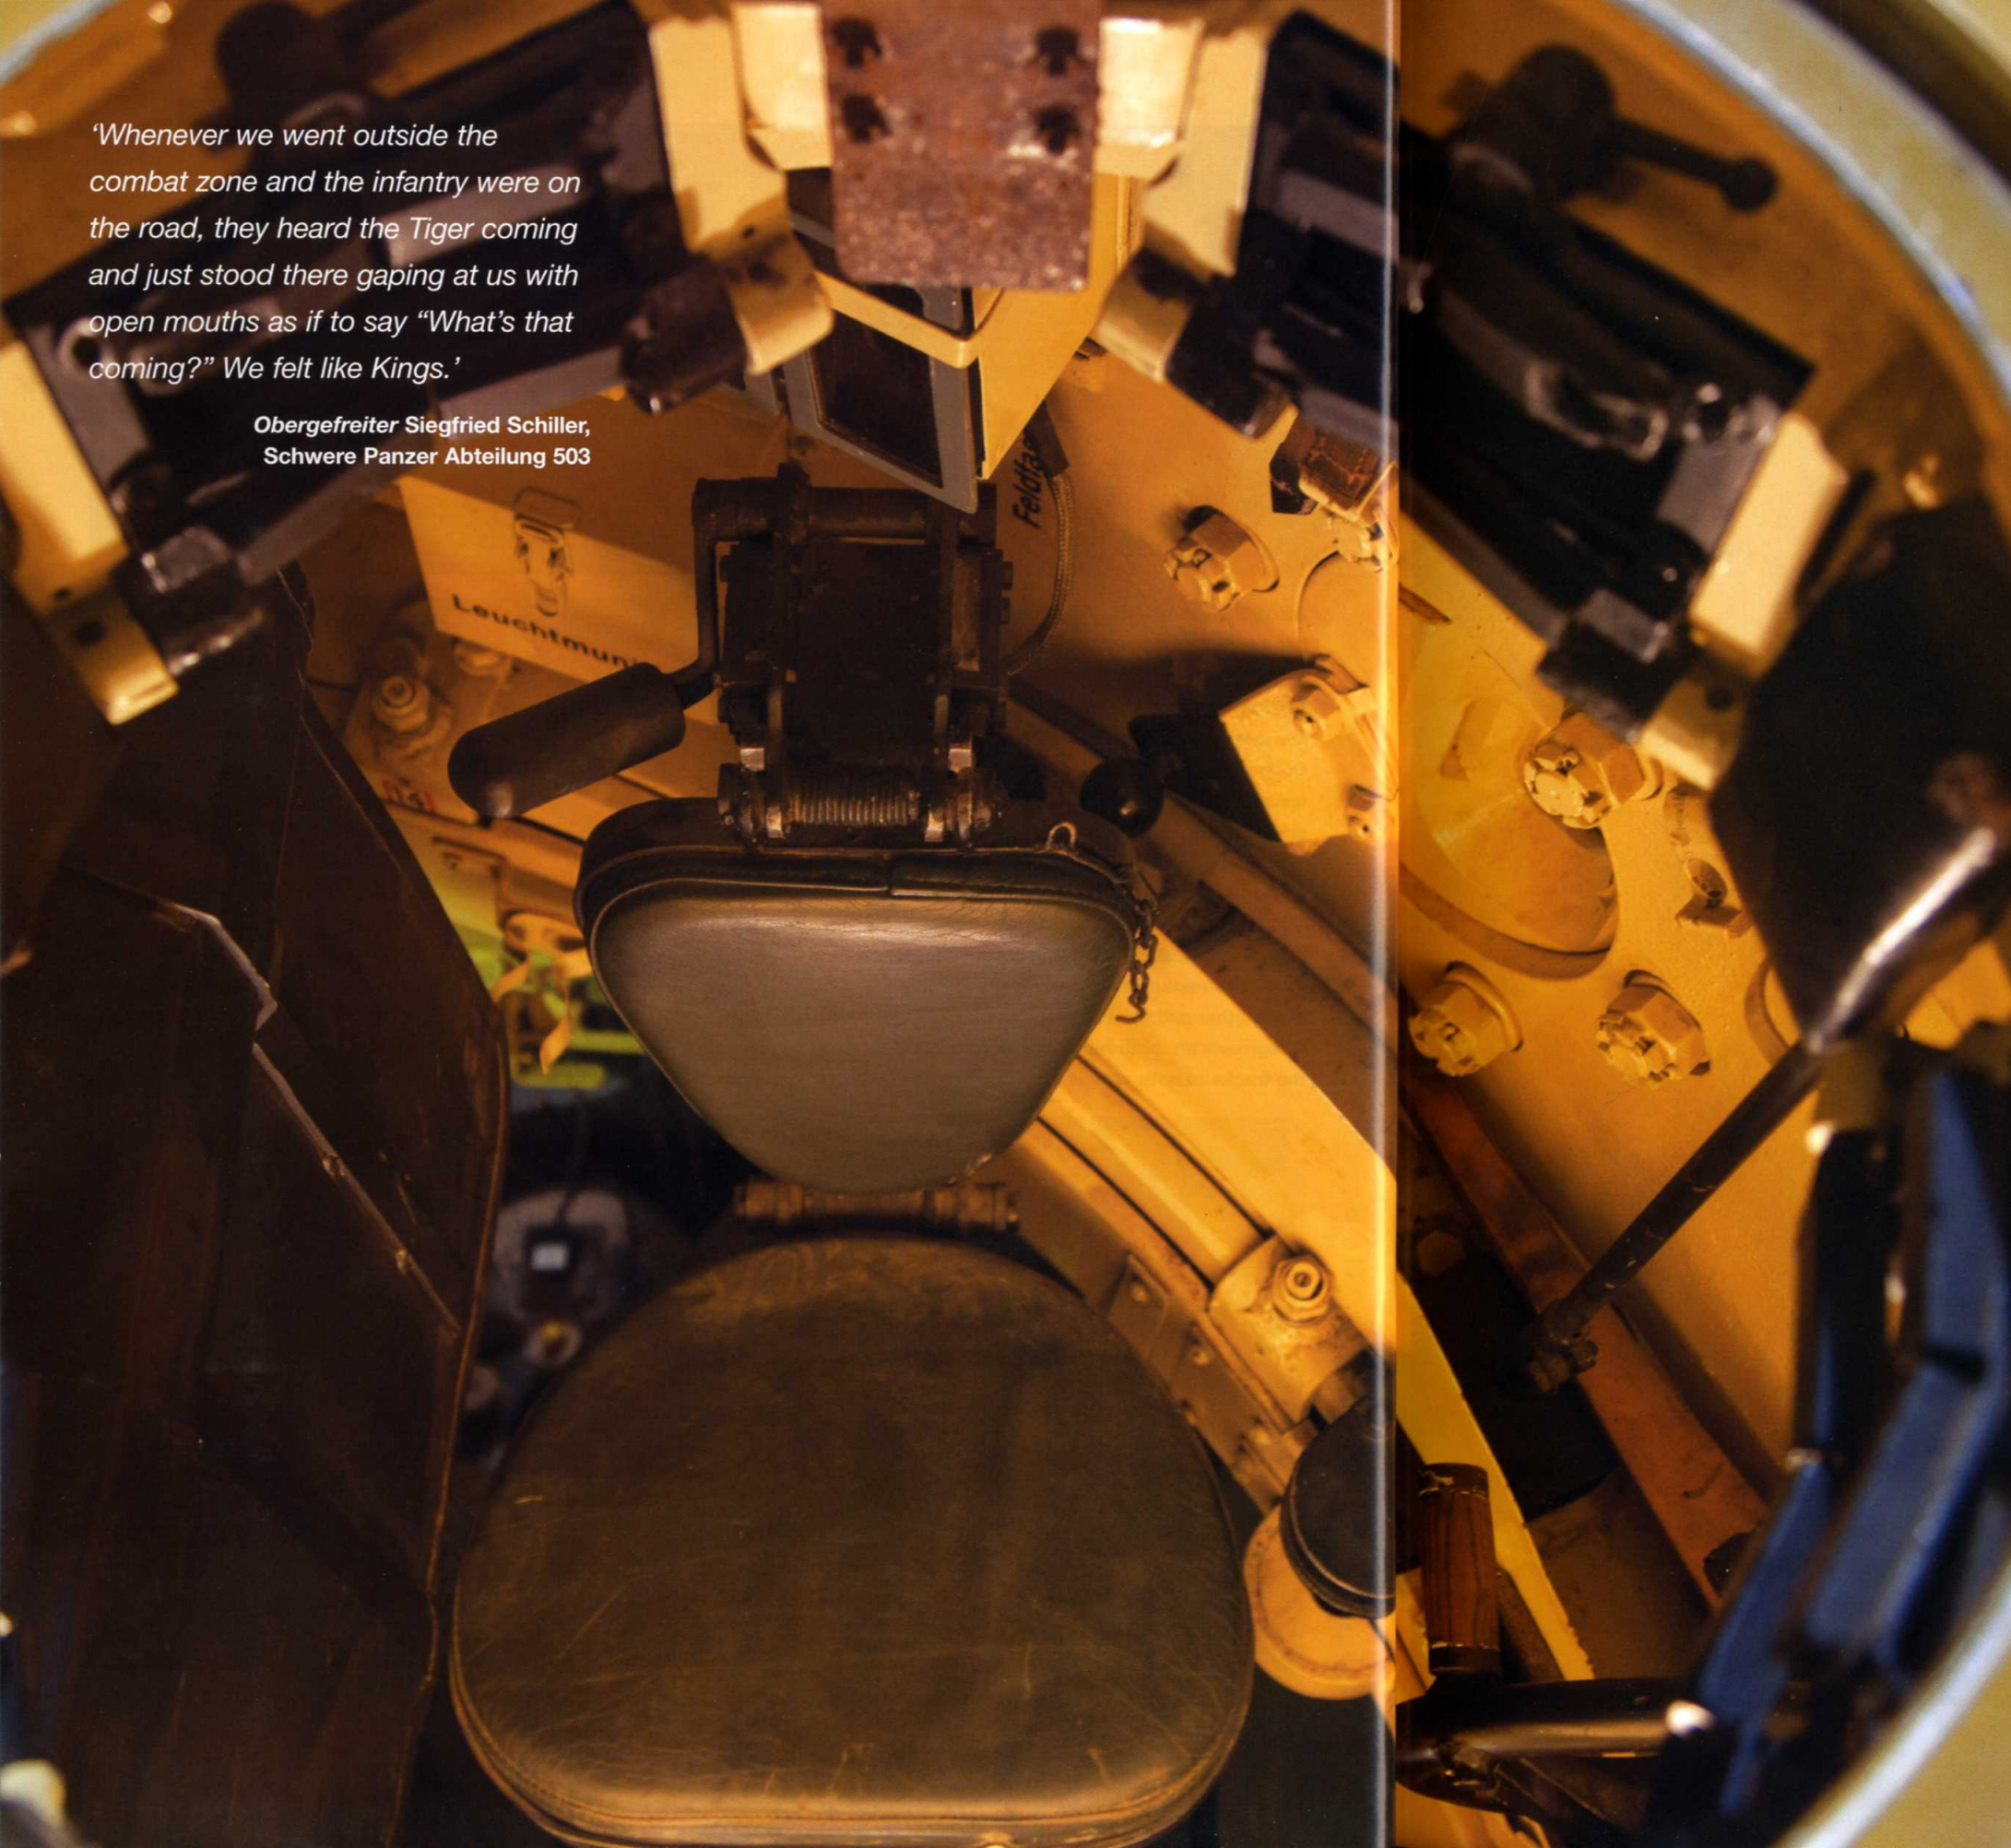
A detailed photograph showing the interior of a Tiger tank's commander's position. The view is from above, looking down into the cupola. A large, dark, leather-upholstered seat is the central focus. The surrounding area is filled with complex mechanical components, including levers, bolts, and metal plates. A yellow metal plate with the word 'Leuchtmun' is visible. The lighting is warm and focused, highlighting the textures of the metal and leather.

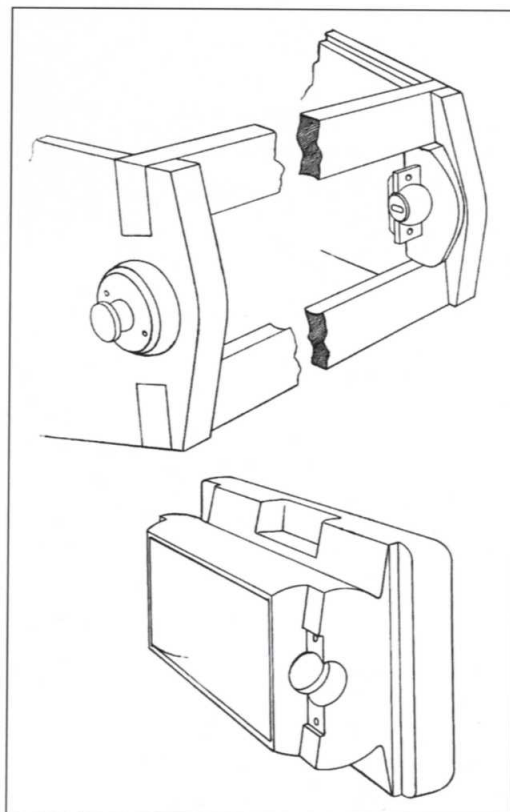
RIGHT Diagram from a British intelligence report showing the arrangement of the turret front, the trunnions and the external armoured mantlet.

FAR RIGHT The cut-out section in the lower right corner of the mantlet indicates this turret is one of the 90 used that had originally been intended to fit the VK 45.01 (P).

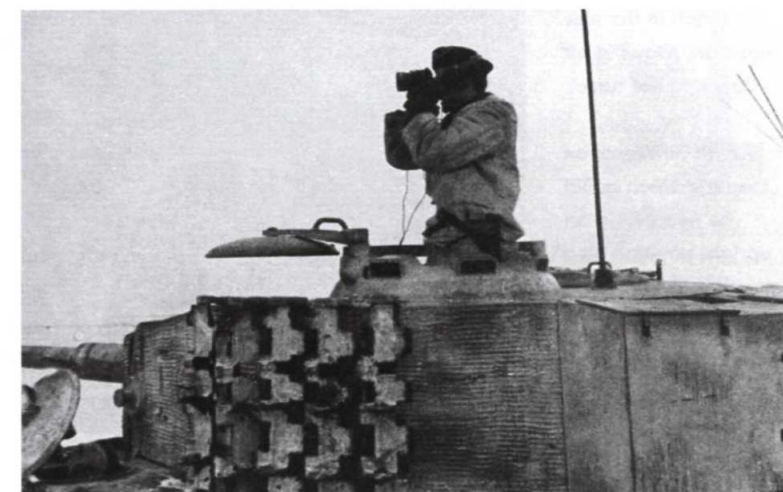
ABOVE The later-version cupola with its sideways-turning hatch.

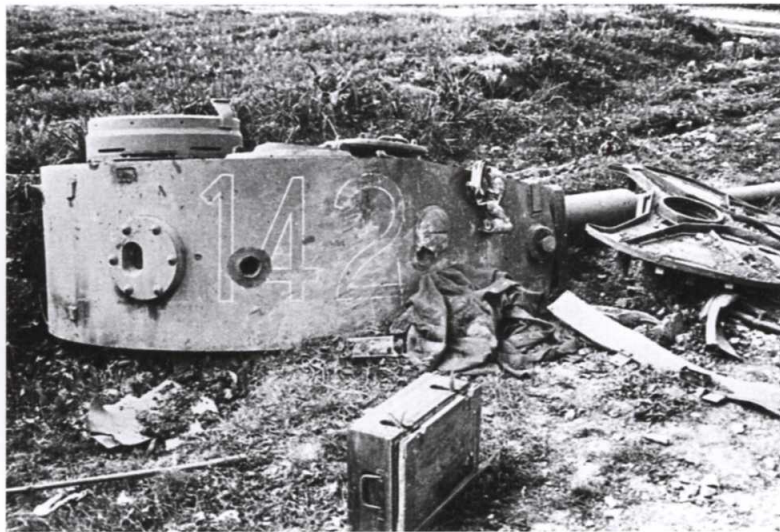
ABOVE The MP port on the rear turret. To the right can be seen a penetration.

apart for evaluation and over years of study, with people crawling on it and now running, the padlock has remained steadfastly in place. The bin also shows evidence of battle damage.

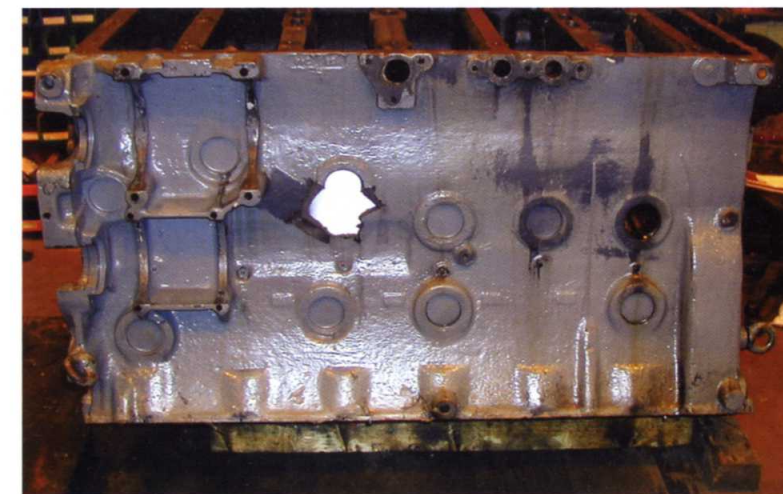
ABOVE The block after the engine failure. The white card indicates where the hole was punched through the casing.

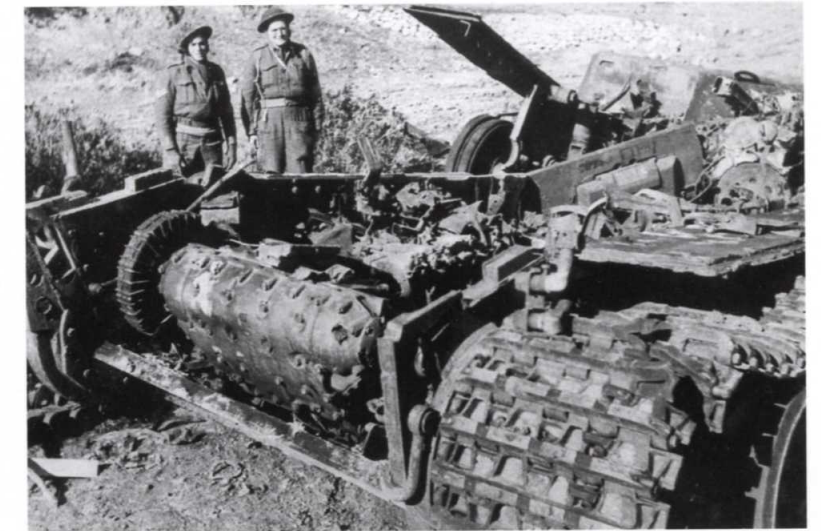
ABOVE LEFT The transmission once removed.

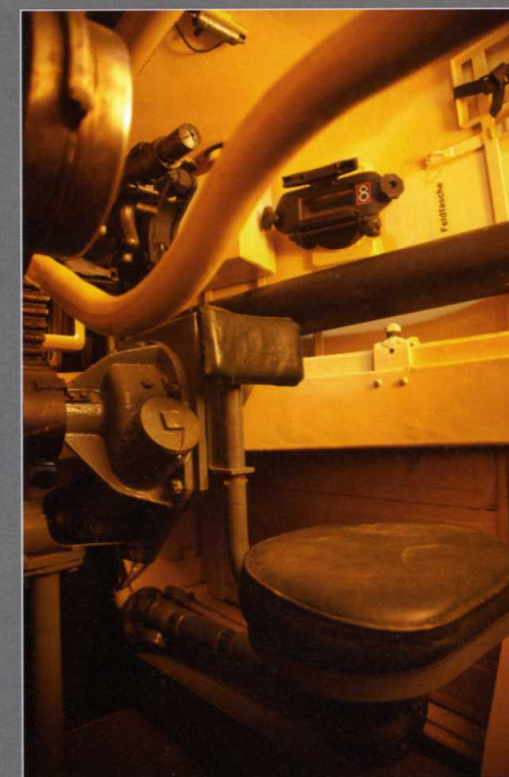
ABOVE The loader's seat faced backwards in the turret and could be lifted and pivoted out of the way when in action.

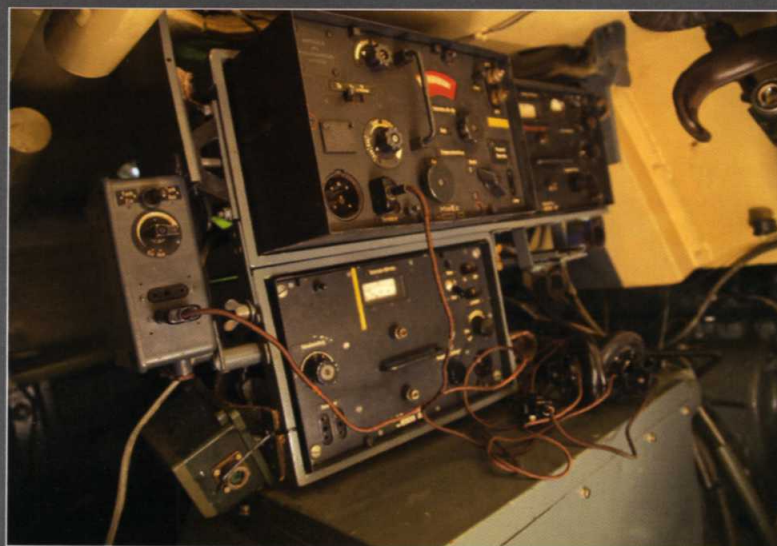
ABOVE The radios installed to the left of the bow machine-gunner's position.

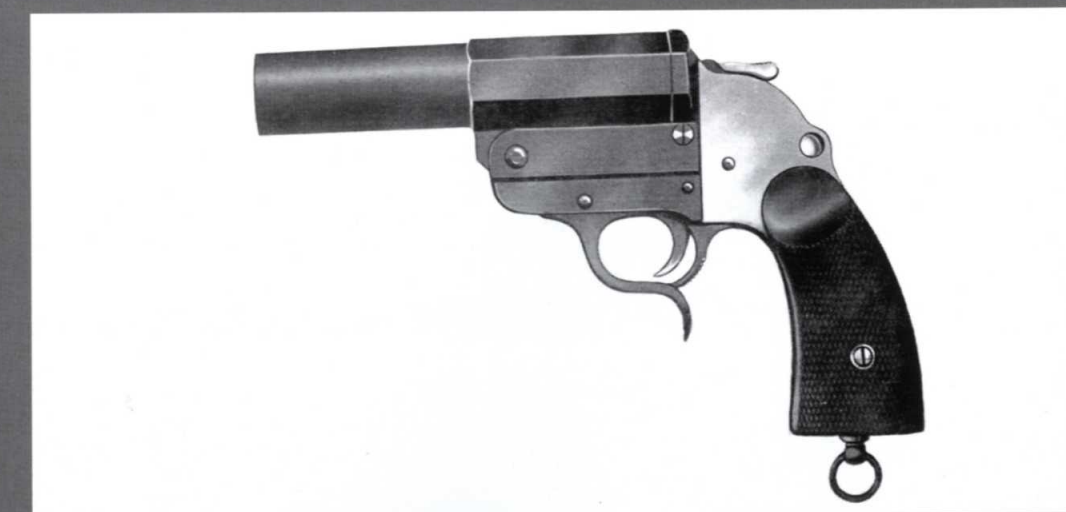
LEFT The *Leuchtpistole* or 2.7cm flare pistol. Firing a single cartridge it was mainly for communications, but it could also be used for launching grenades.

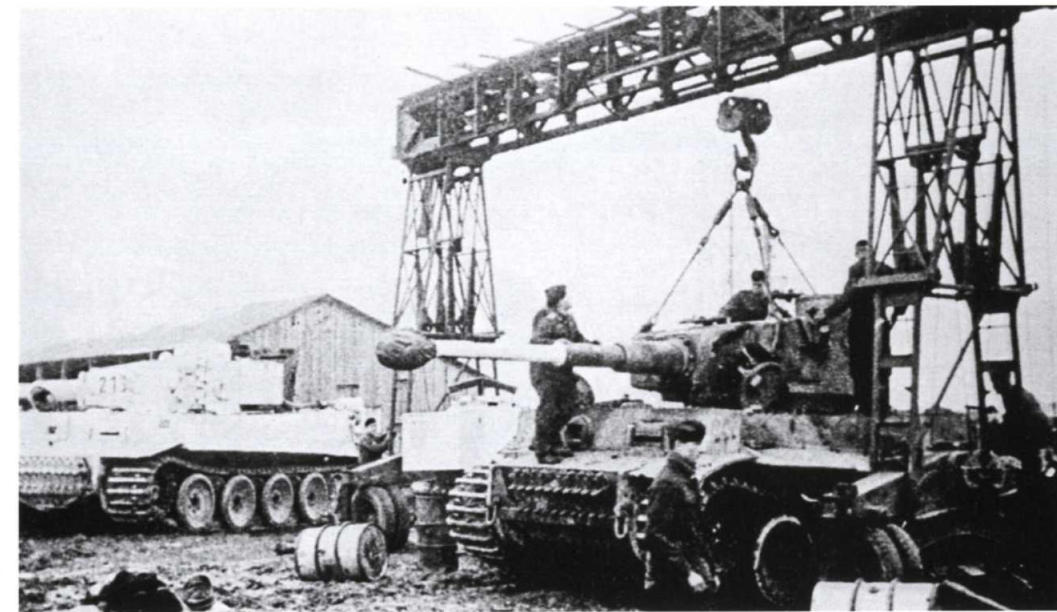
LEFT The Fries-Kran was so named after the makers, J.S. Fries und Sohn. Used by the workshop maintenance crew, a generator was attached to the gantry to power the lifting capacity of 15 tons. Angled metal bars were fixed to the three turret lugs to clear the lifting chains from the turret edges and, when clear, turrets were often rested on extemporised stands made from fuel drums.

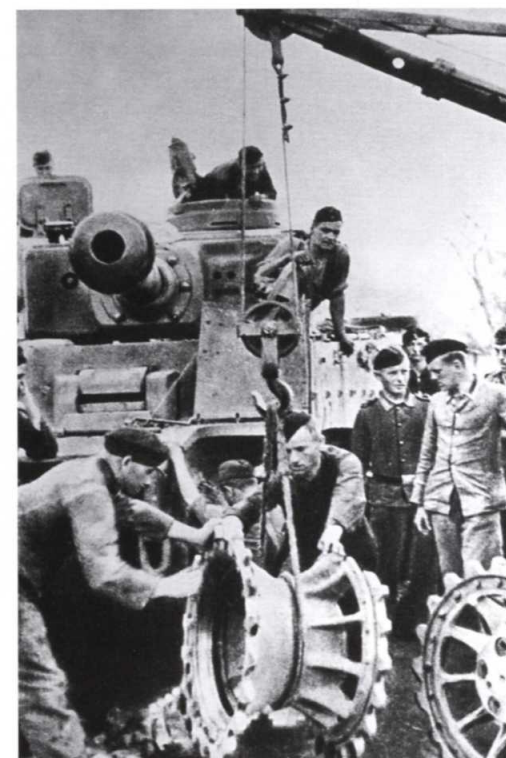
ABOVE Removing a broken drive sprocket with the use of a crane on a recovery vehicle.
