FERDINAND AND ELEFANT TANK DESTROYER

OSPREY
PUBLISHING

Thomas Anderson

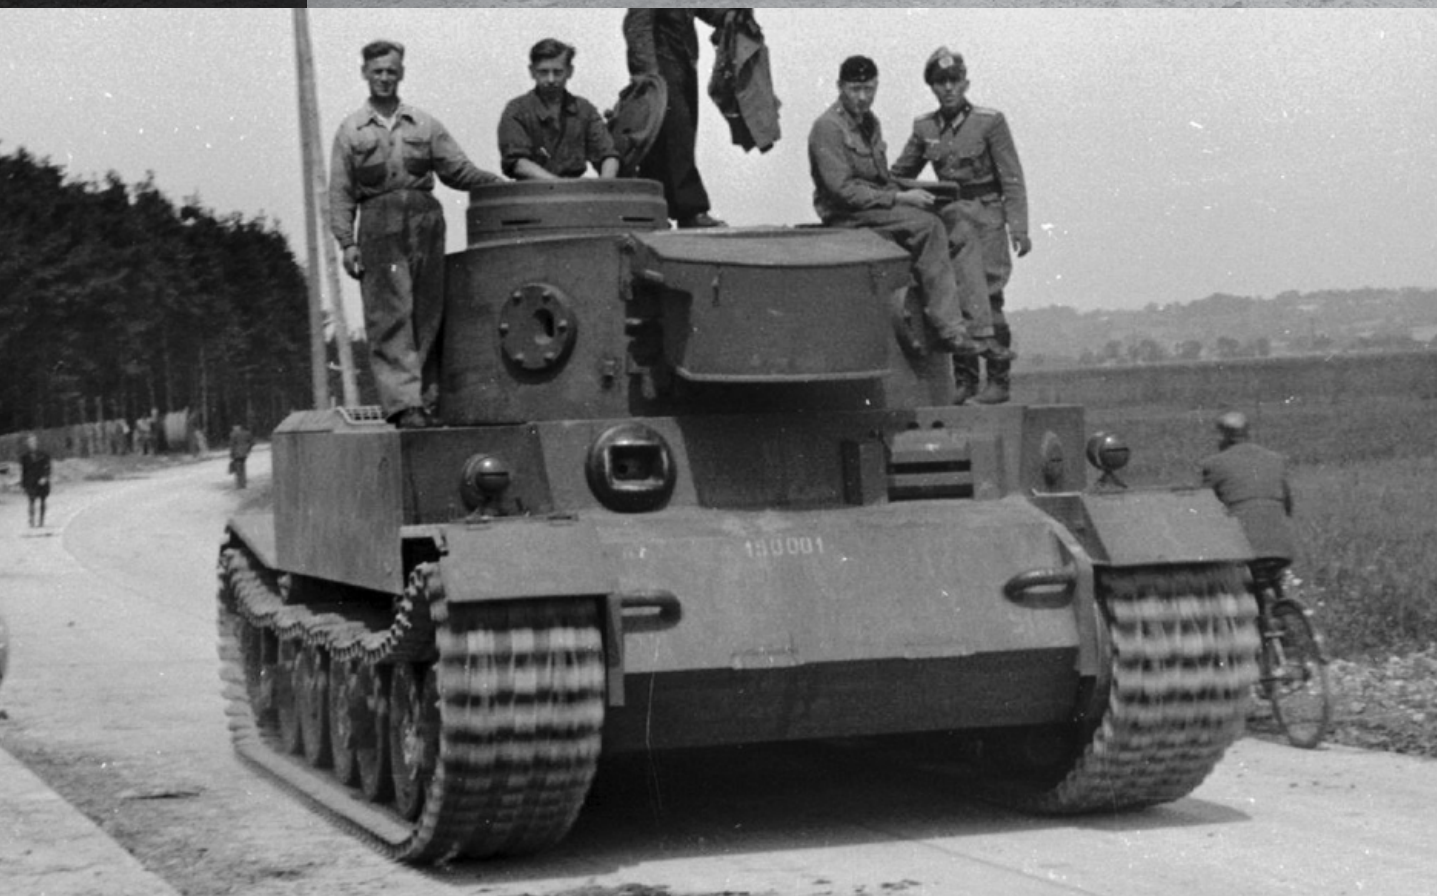
Porsche No.150001 on trials: Despite the vehicle's number, this was not the first of the type to be completed. A PzKpfw IV-type *Gepäckkasten* (stowage bin) is fitted on the rear of the turret. (Historyfacts)

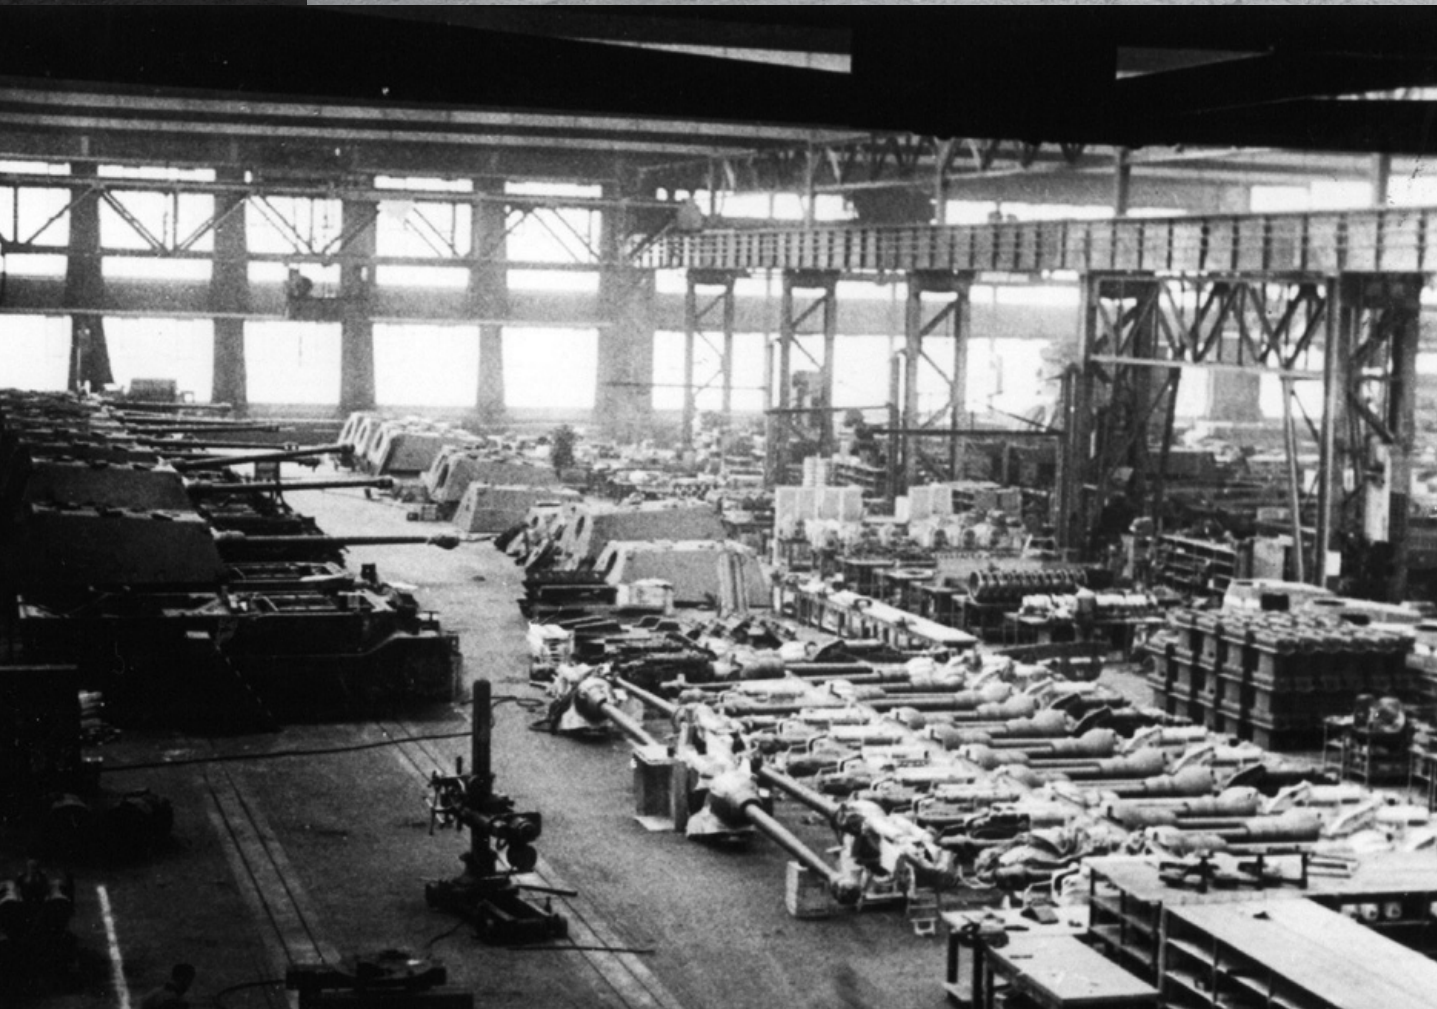
The production line for the *schwerer Panzerjäger Ferdinand* at the Nibelungwerke; a number of 8.8cm *Panzerabwehrkanonen 43/2* (8.8cm PaK 43/2) and fighting compartments are ready for fitting on the hulls. (Historyfacts)

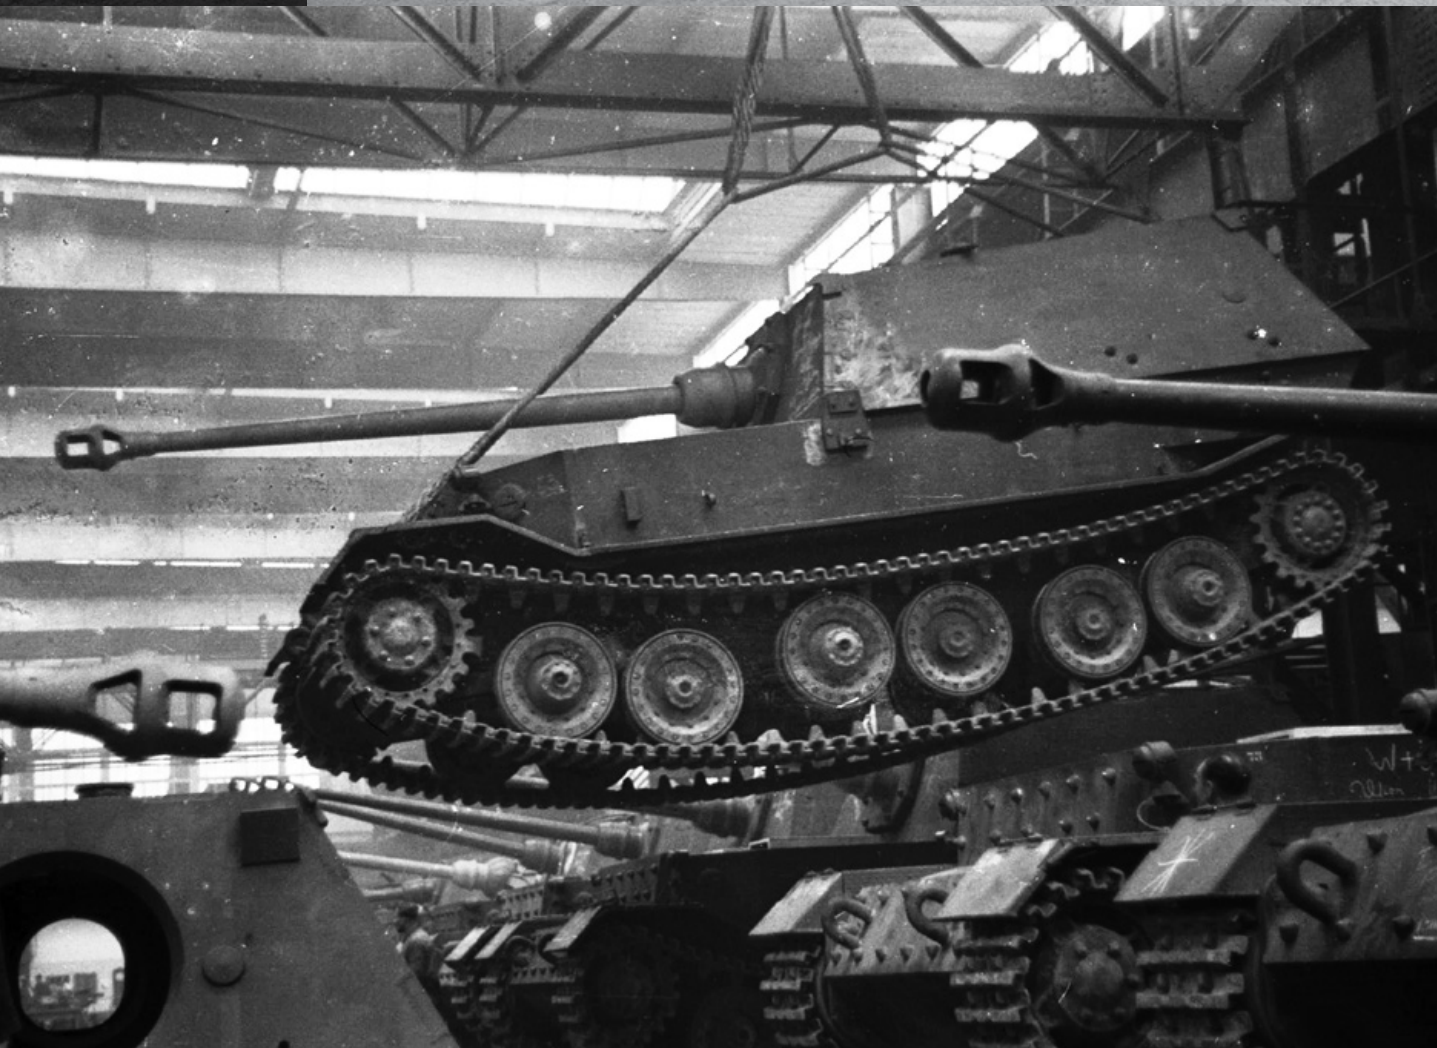
The heavy gantry crane in the assembly hall at the Nibelungenwerke transports a Ferdinand to the next work station. Note that the tracks are different to those on the Porsche Typ 101, having guide horns at every second link. (Historyfacts)

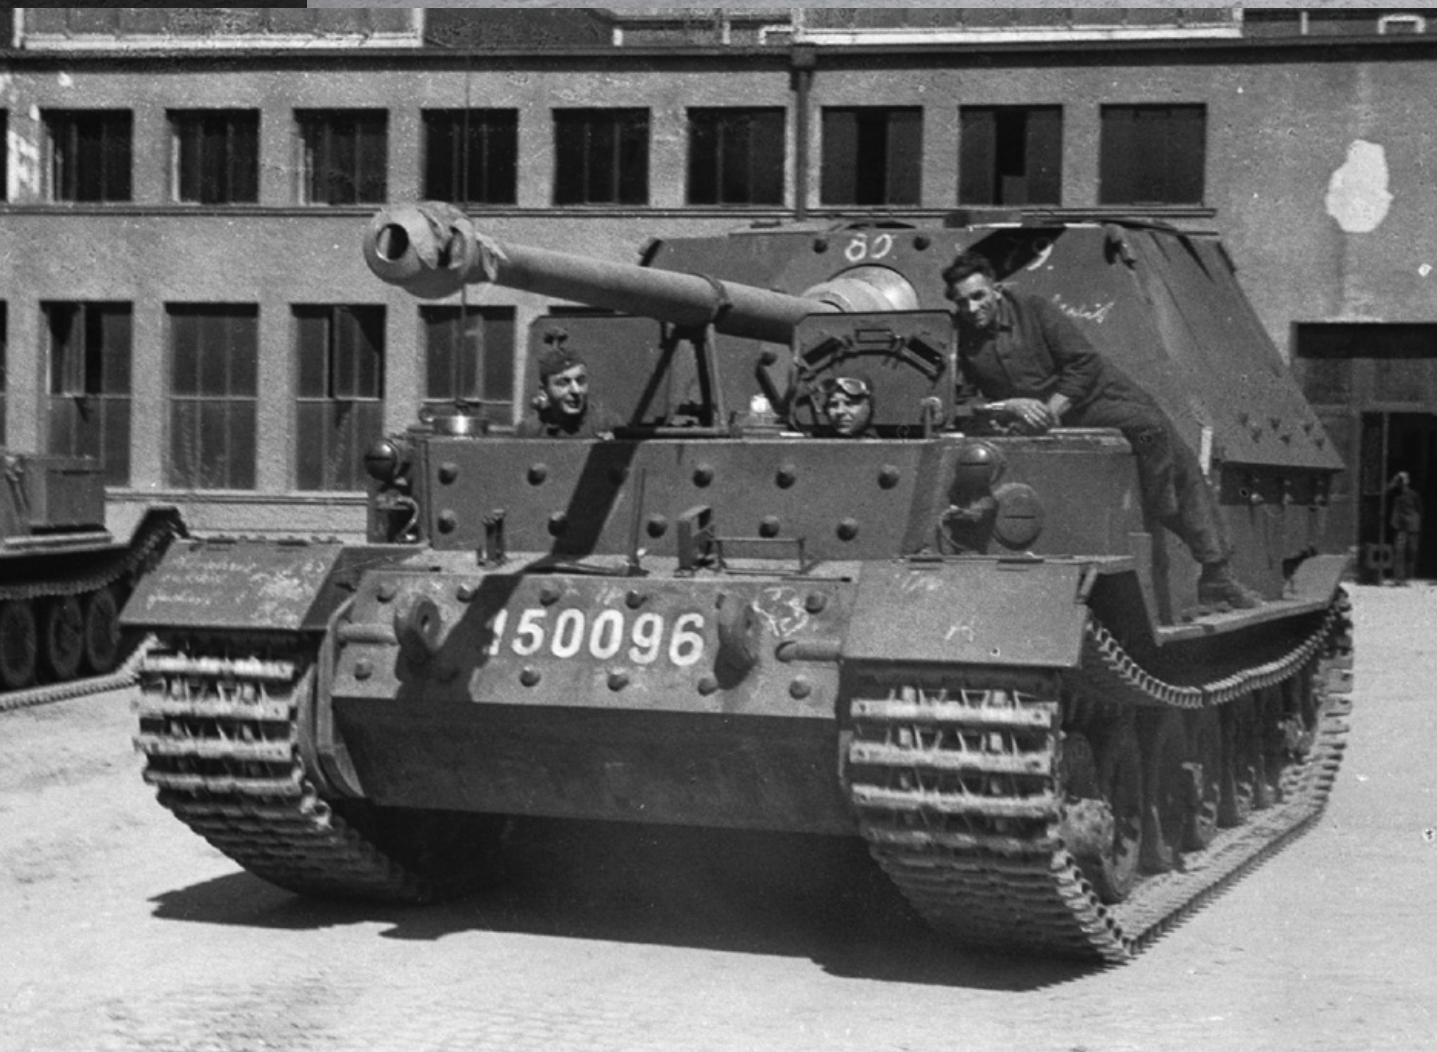
A completed Ferdinand parked outside the production hall, prior to being taken on running trials. The vehicle is unpainted, but will soon receive the standard dark yellow base colour. Note that the armoured deflector shield for the gun mounting is not yet fitted. This vital piece of armour was retrofitted before the beginning of the Kursk campaign. (Historyfacts)

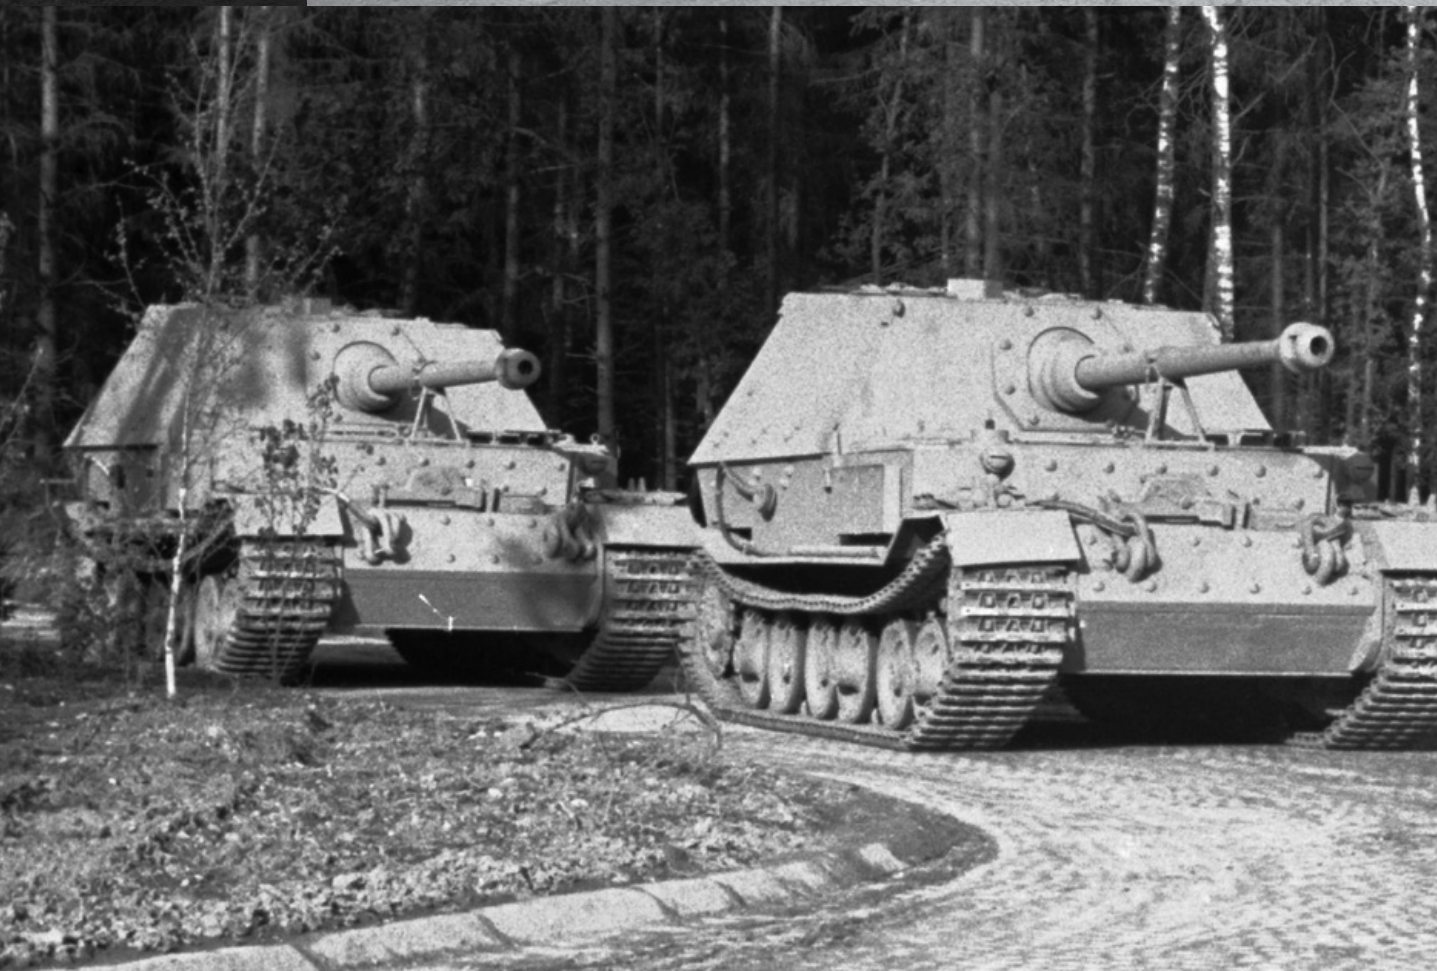
Three new Ferdinands, painted and fully equipped awaiting final approval and acceptance by the *Heereswaffenamt*. (Historyfacts)

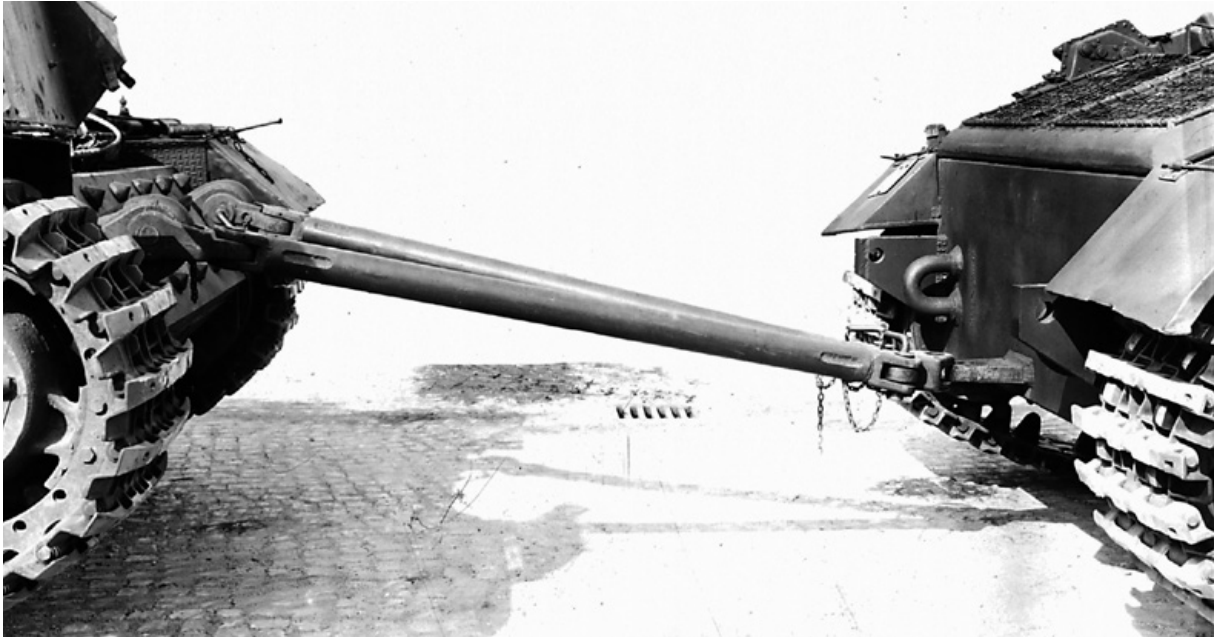
Rigid tow bars could be fitted to the front towing brackets on the Ferdinand, but there were no brackets at the rear of the vehicle. Here a Ferdinand is coupled to a Porsche Typ 101. (BAMA)

- The towing hooks used at present do not fit on the available towing bars
- We suggest the addition of a horizontal central towing hook with adequate linkage for the towing bar on the Tiger (H).

Apparently this problem was examined, and a replacement coupling was produced. There is, however no photographic evidence that these were actually used on the Ferdinand.

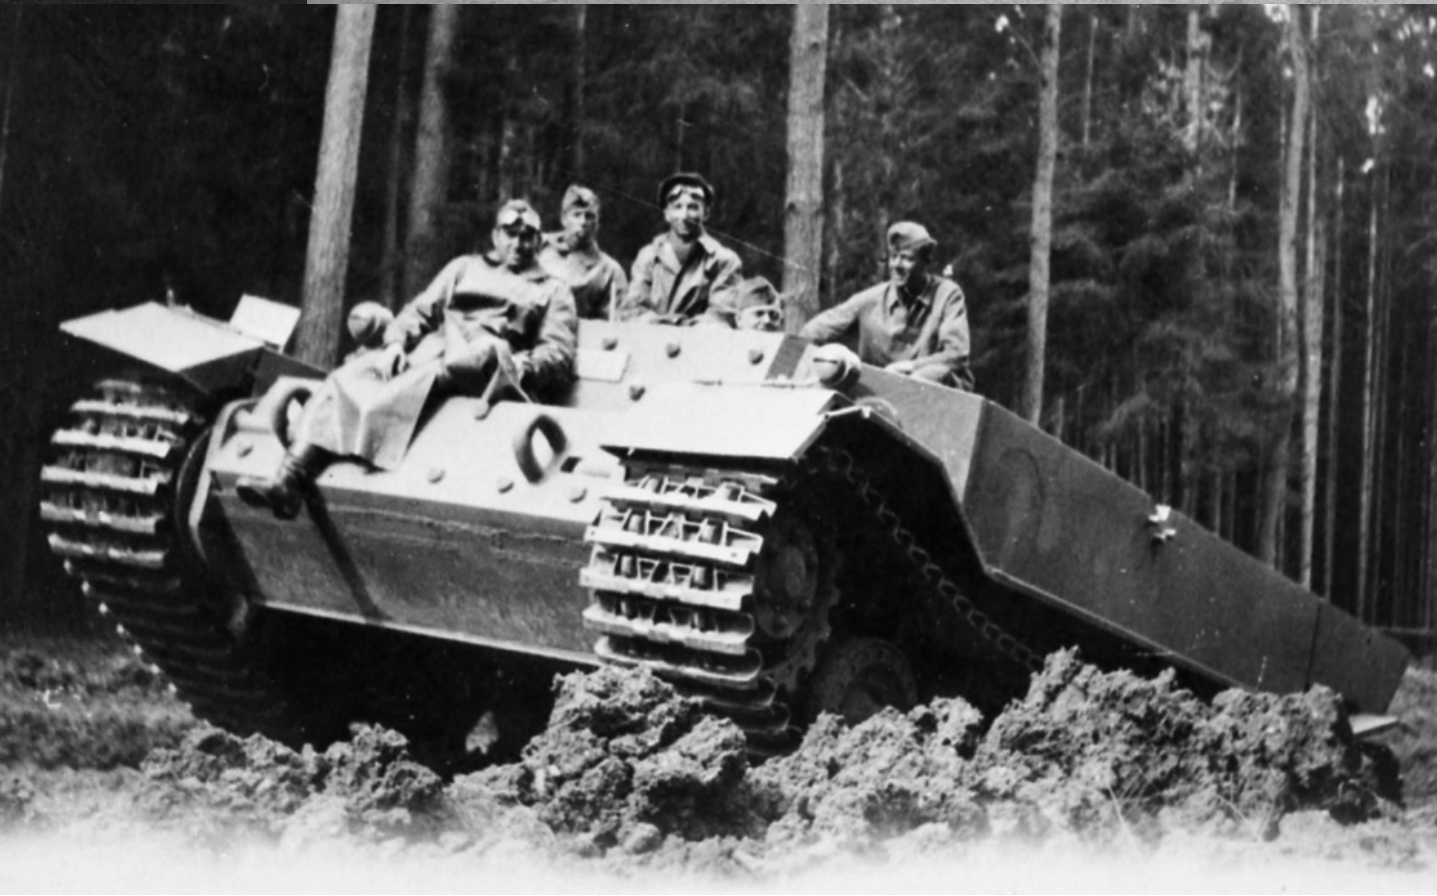
The original layout of the engine and cooling system gratings proved to be ill-fated. Splinters from artillery shells and close combat weapons could enter the engine compartment. (BAMA)

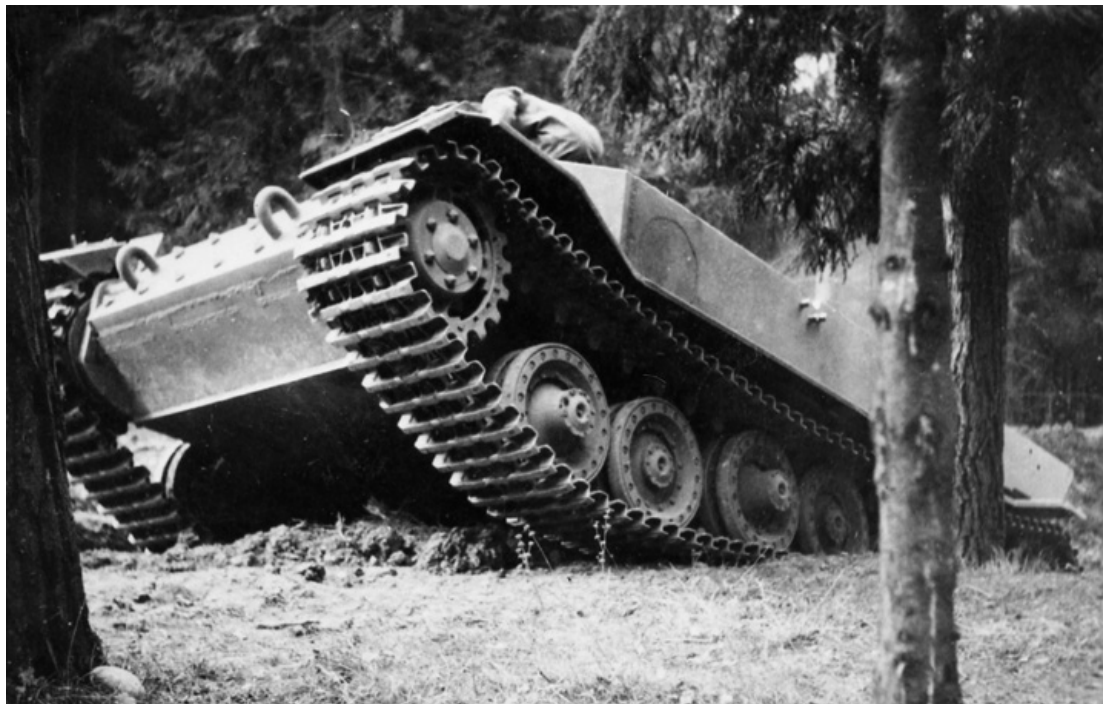
The prototype chassis for the Ferdinand on trials at St. Valentin: The vehicle had a good 'climbing' ability very useful for crossing enemy defences and heavily cratered ground. (Münch)

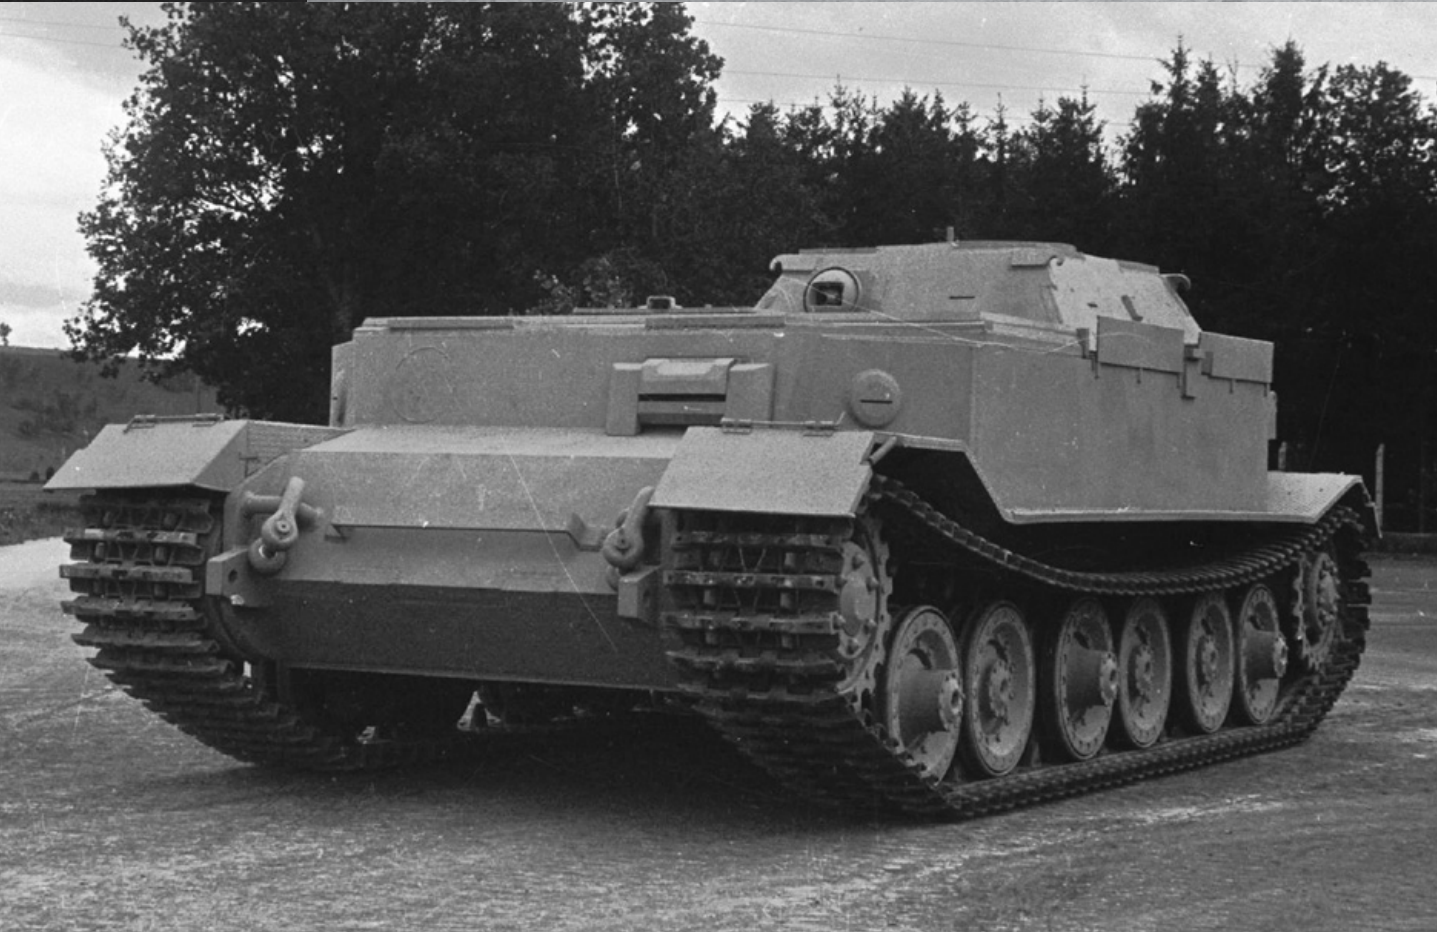
A total of three Bergepanzer Ferdinands were produced at the Nibelungenwerke in summer 1943. A hull-machine gun was not fitted, the opening being plated over. For close defence, a ball-mounted 7.92mm *Maschinengewehr 34* (MG 34) was fitted in the small armoured superstructure. No extra armour was added to the basic VK 45.01(P) chassis. (Historyfacts)

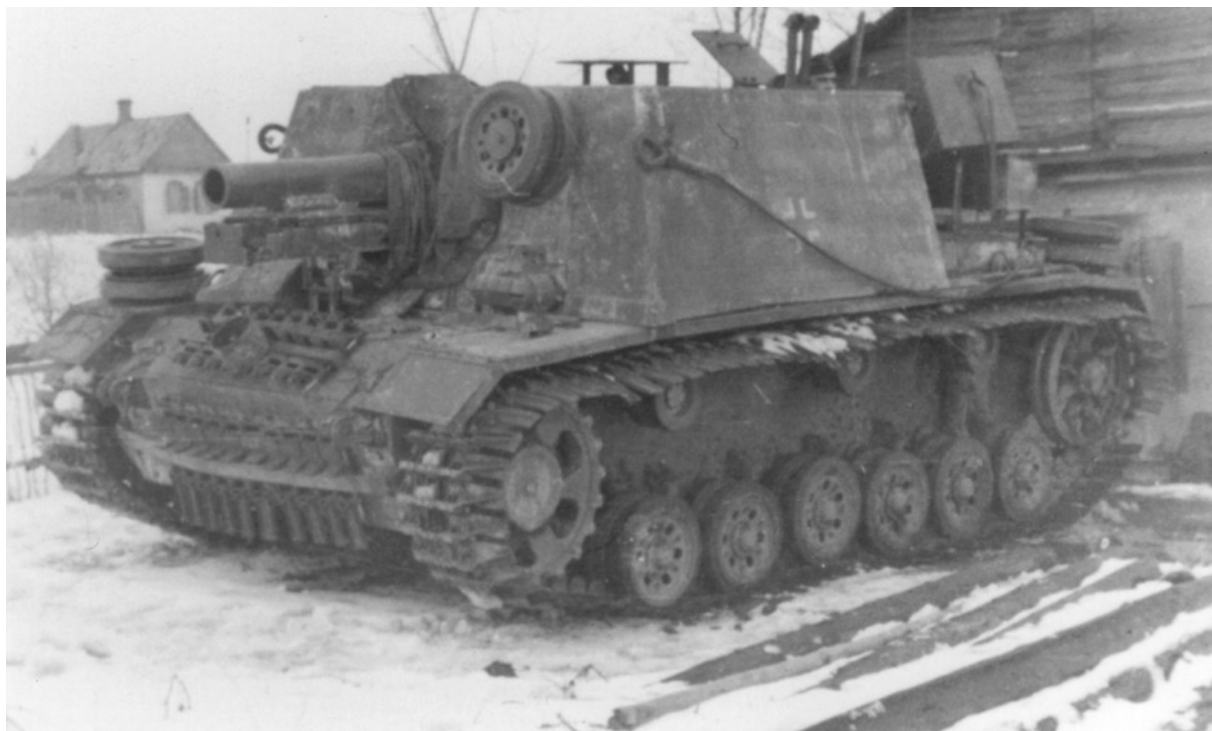
A 15cm *Sturmpanzer-Abteilung* 216 (15cm sIG33/1) fitted with standard-type winter tracks. Track links have been fitted to the front of the vehicle as added armour protection; a number of spare road wheels are also carried. Note the commander's Scherenfernrohr (scissors periscope) on the rear of the superstructure. (Anderson)

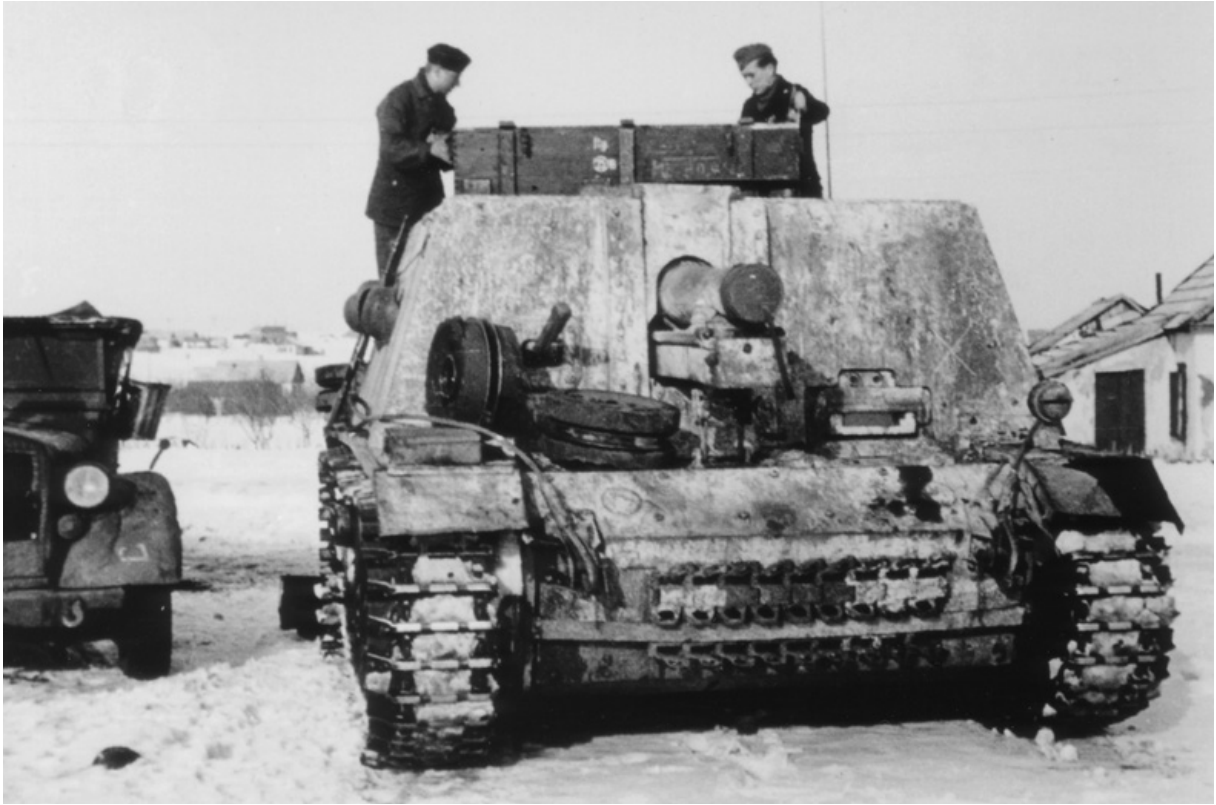
The first batch of 12 *Sturminfanteriegeschütze* were issued to *Sturmartillerie* units. This vehicle, carefully whitewashed seems to be outfitted for the next combat by its crew. Wide winter tracks were fitted to improve mobility in mud or snow. However, the width of these *Winterketten* seem to have been reduced. (Regenberg)

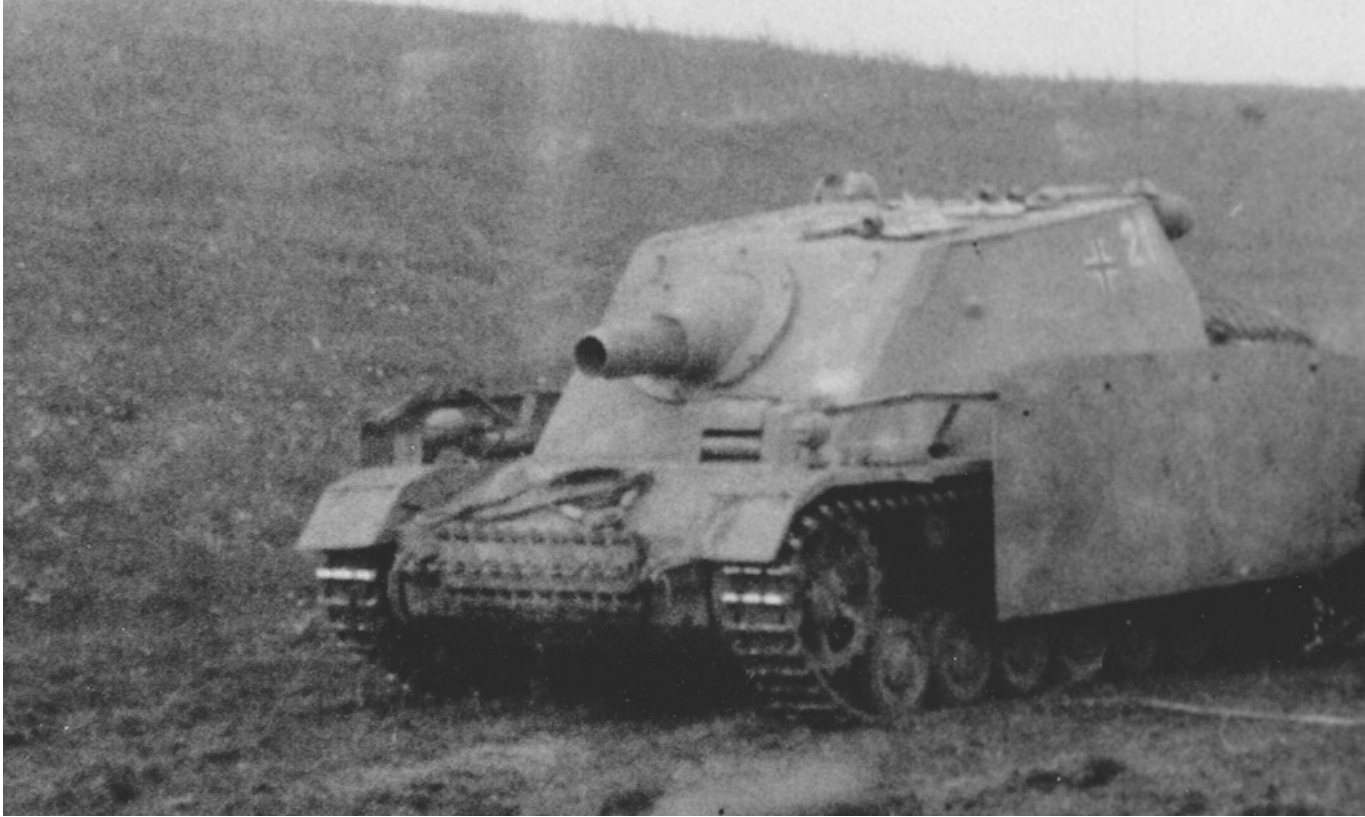
were used, one set of photographs is known which shows PzKpfw IV Ausf D hull, chassis No. 80655.

The turret was removed and the turret ring was covered by a circular plate, one half being divided in two opening lids. The complete cover plate was rotatable, the lids allowed access to the interior and the some 70 rounds of stowed 15cm ammunition.

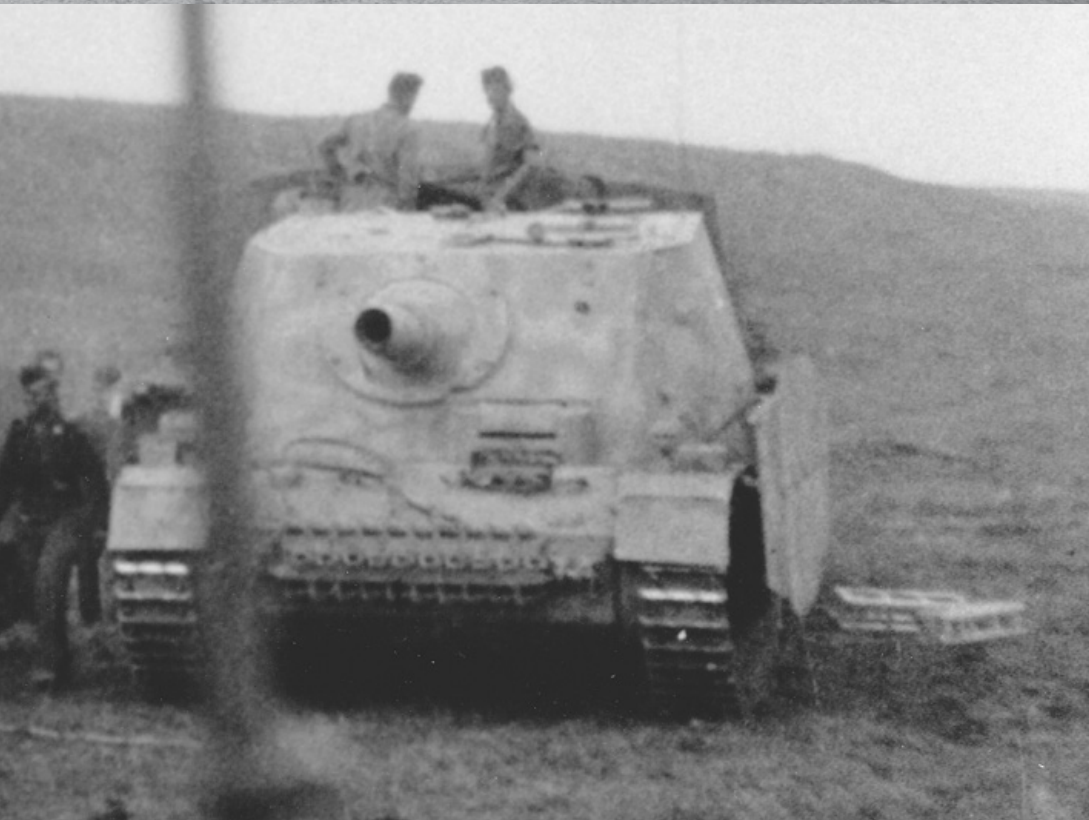
A *Sturmpanzer* of StuPzKp 216. This vehicle was built on the chassis of a refurbished PzKpfw IV Ausf E hull, as evident by the bolted-on armor plate. (Jaugitz)

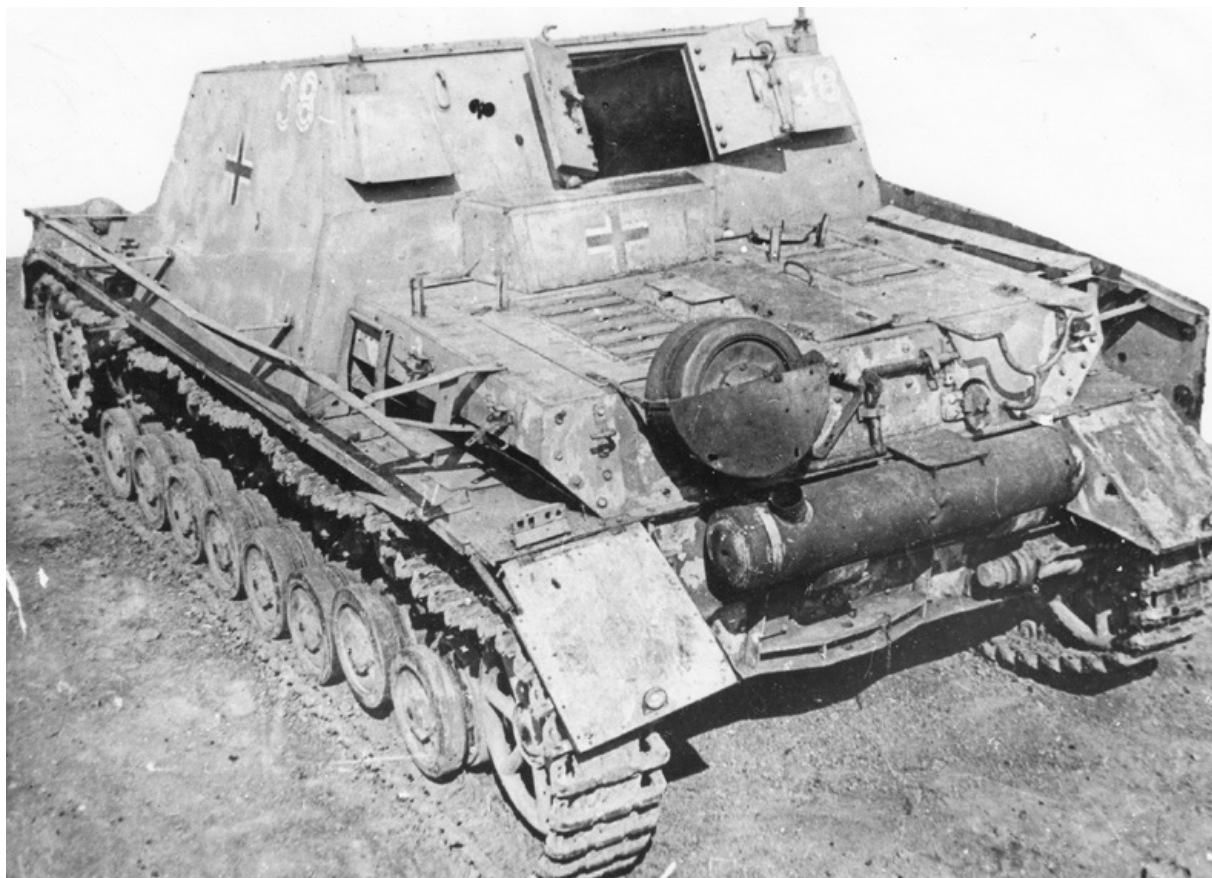
Sturmpanzer '38' was captured intact, and is now on display in the Russian tank school Kubinka. The rear view is interesting. Again based on a PzKpfw IV Ausf E, the tank shows the early wide exhaust muffler. The split rear doors are open, flanked by the big armored air inlets and the antennae. (Netrebenko)

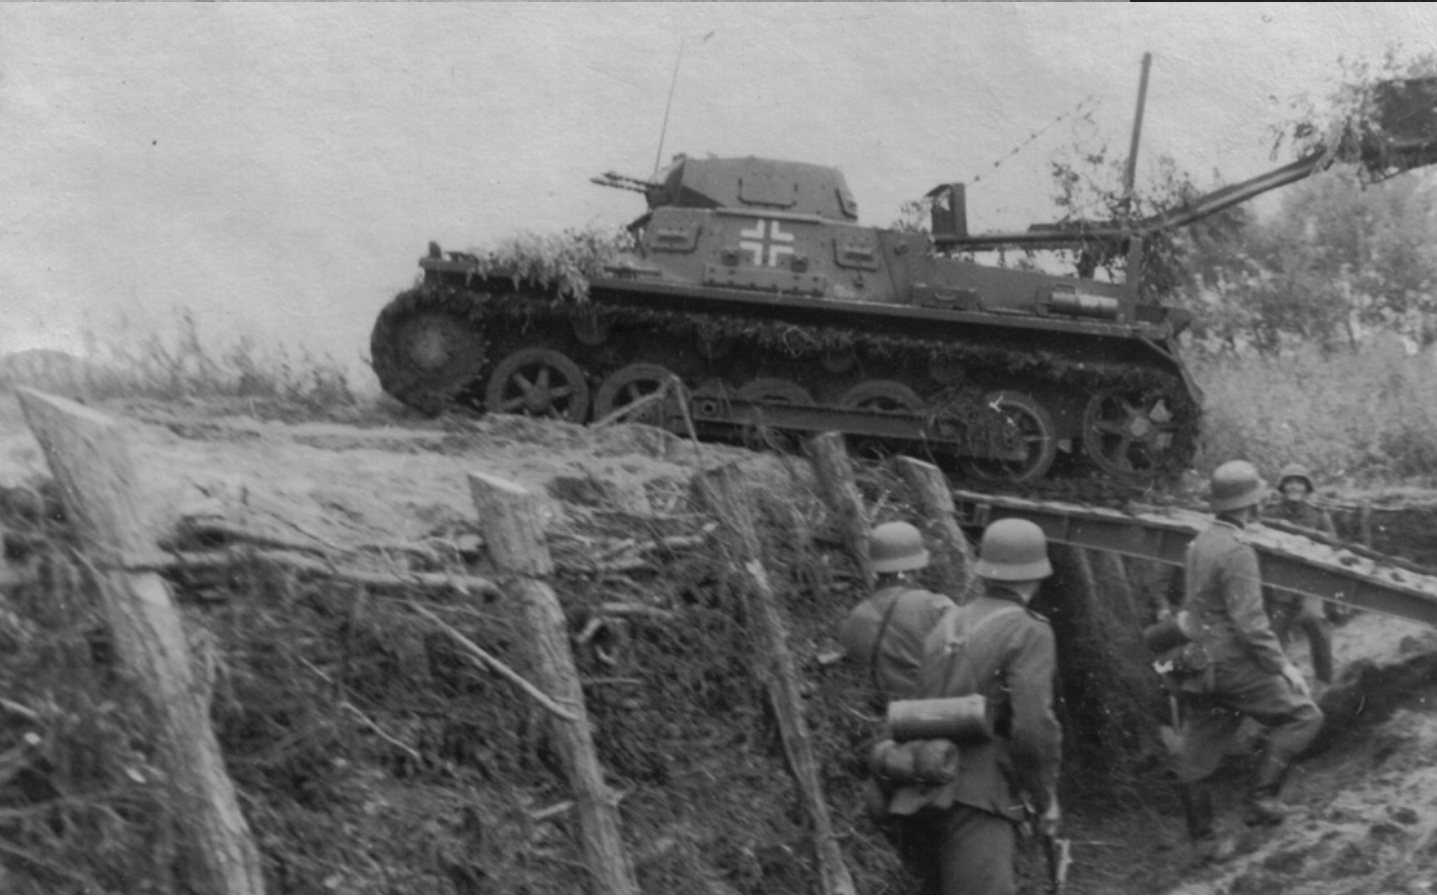
**Above:**

A PzKpfw I Ausf B mit *Abwurfvorrichtung* passes through the lines of German forward infantry before crossing a small bridge placed by pioneer units. When used responsibly, the type had a certain combat value. (Anderson)

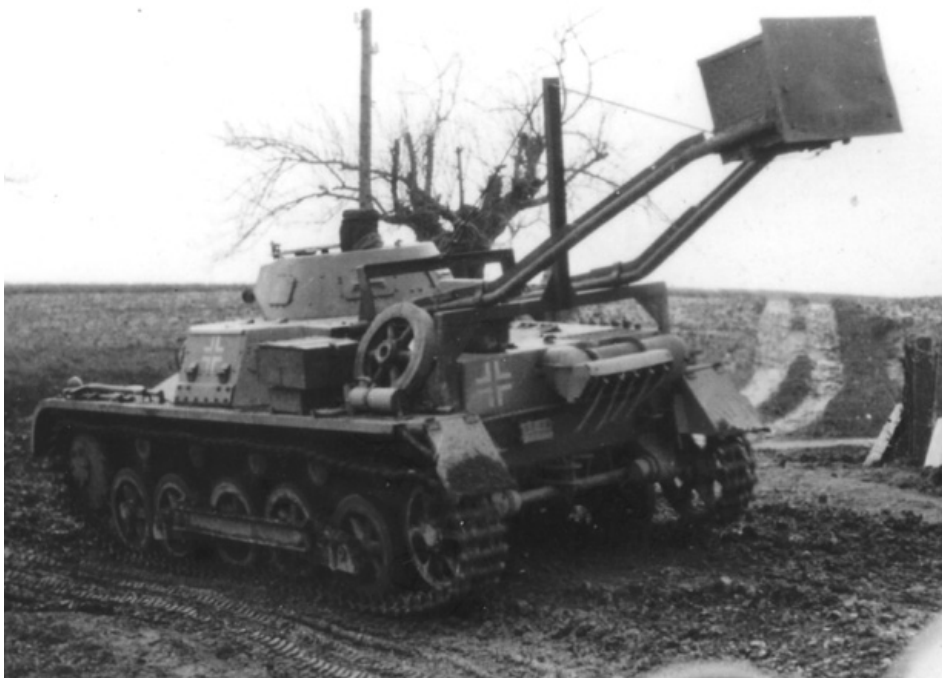
**Left:**

A PzKpfw I Ausf B of 1.PzDiv fitted with an *Abwurfvorrichtung*. The armoured shield to the rear of the box is visible. The fabrication of the outriggers was not standardized, and differed from unit to unit. (Wilhelm)

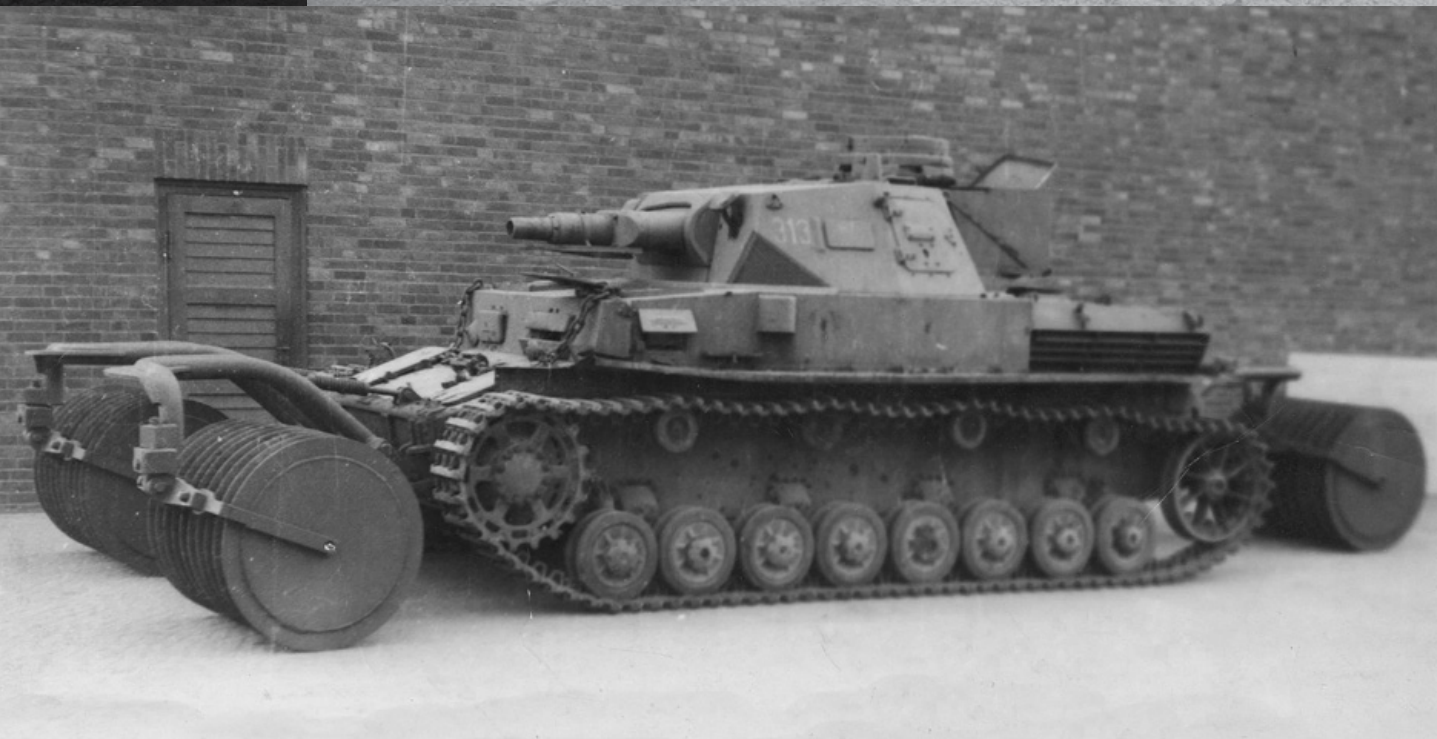
A PzKpfw IV Ausf C fitted with mine-clearance rollers for testing purposes. To the knowledge of the author this idea was not followed up, but there were some conversions carried out on the frontline. (BAMA)

However, for the sake of completeness, the author has to note that there was similar research being undertaken in the Reich. An experimental mine roller was fitted to a PzKpfw IV Ausf C. To the knowledge of the author, this development was not continued with and only one prototype was built and tested. Possibly the automotive performance of the PzKpfw IV was too poor to move the triple set of rollers through rough terrain. Towards end of the war the HWA reported on a PzKpfw V Panther which was fitted with flails. Unlike the Allies equipment, which relied on flails driven by external engines, the flails on German-designed mine clearers were driven by chains connected to the drive sprocket on the tank. A test report revealed the vulnerability of this type of device, as when the drive chains were attached steering the tank was impossible. It is questionable that this development would have been successful.

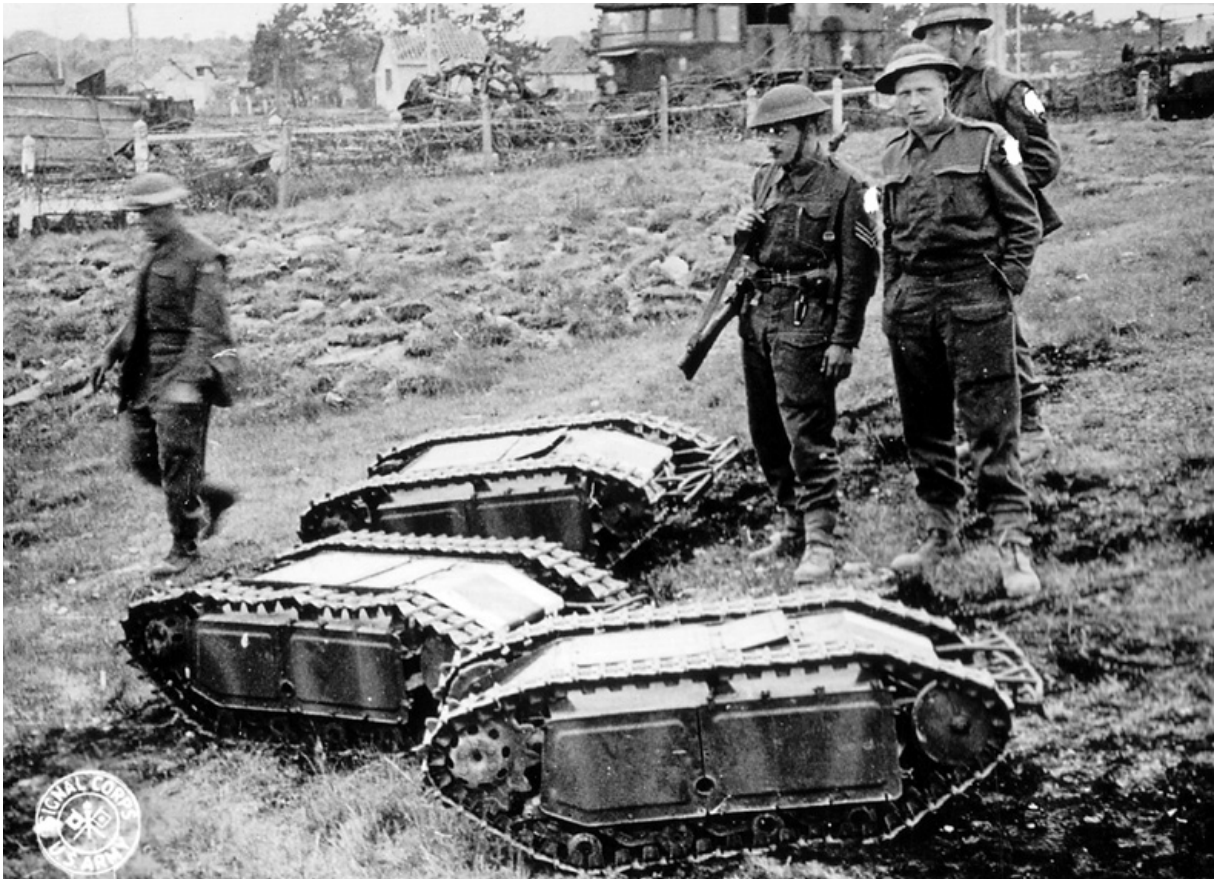
Above:
Members of a British Army bomb-disposal team inspect three Goliaths abandoned after the fighting in the Nettuno area of Italy.
(US Signal Corps)

Righte:
The interior of a petrol-engined Goliath (SdKfz 302). The explosive charge has been removed from the front compartment.

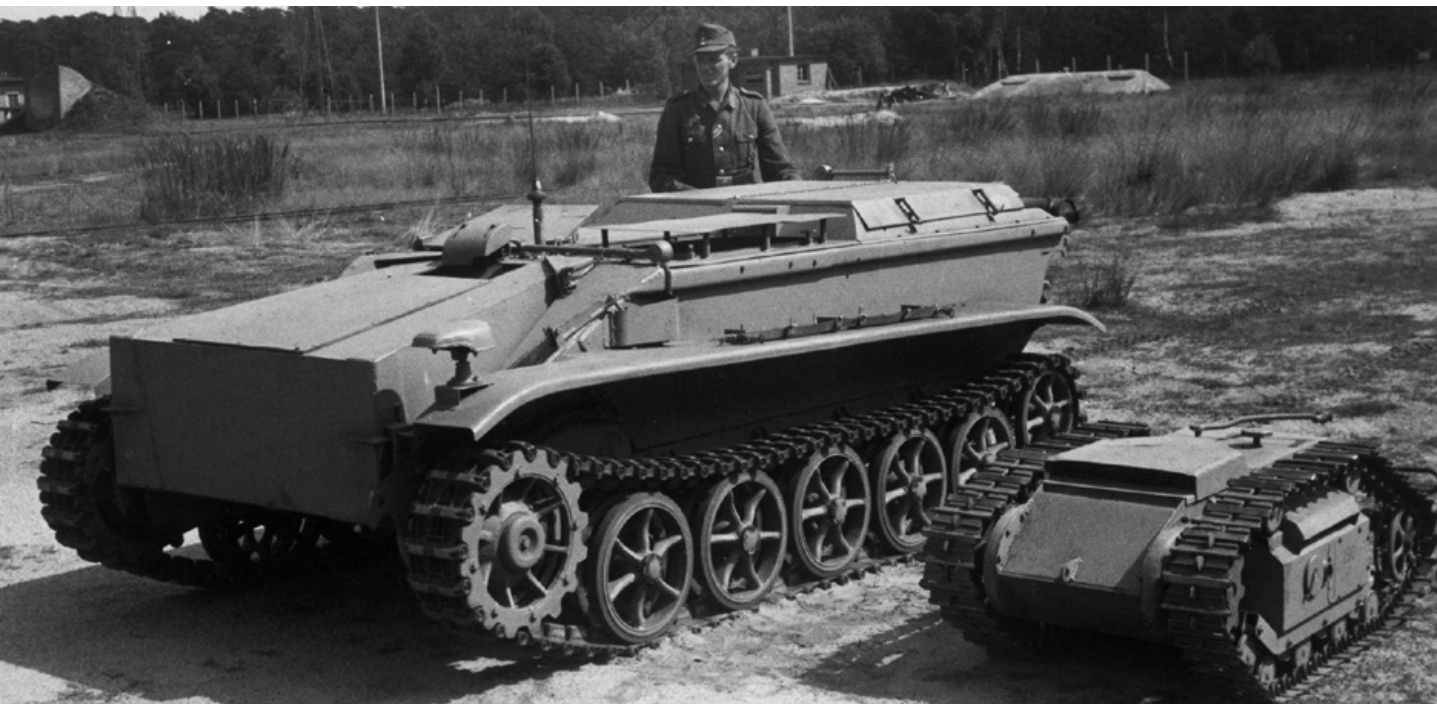
A Borgward B IV Ausf B with a Goliath alongside at a demonstration of armoured vehicles arranged for Hitler and senior army officials. The Borgward has been fitted with later type unlubricated tracks. (bpk images)
