FERDINAND AND ELEFANT TANK DESTROYER

OSPREY
PUBLISHING

Thomas Anderson

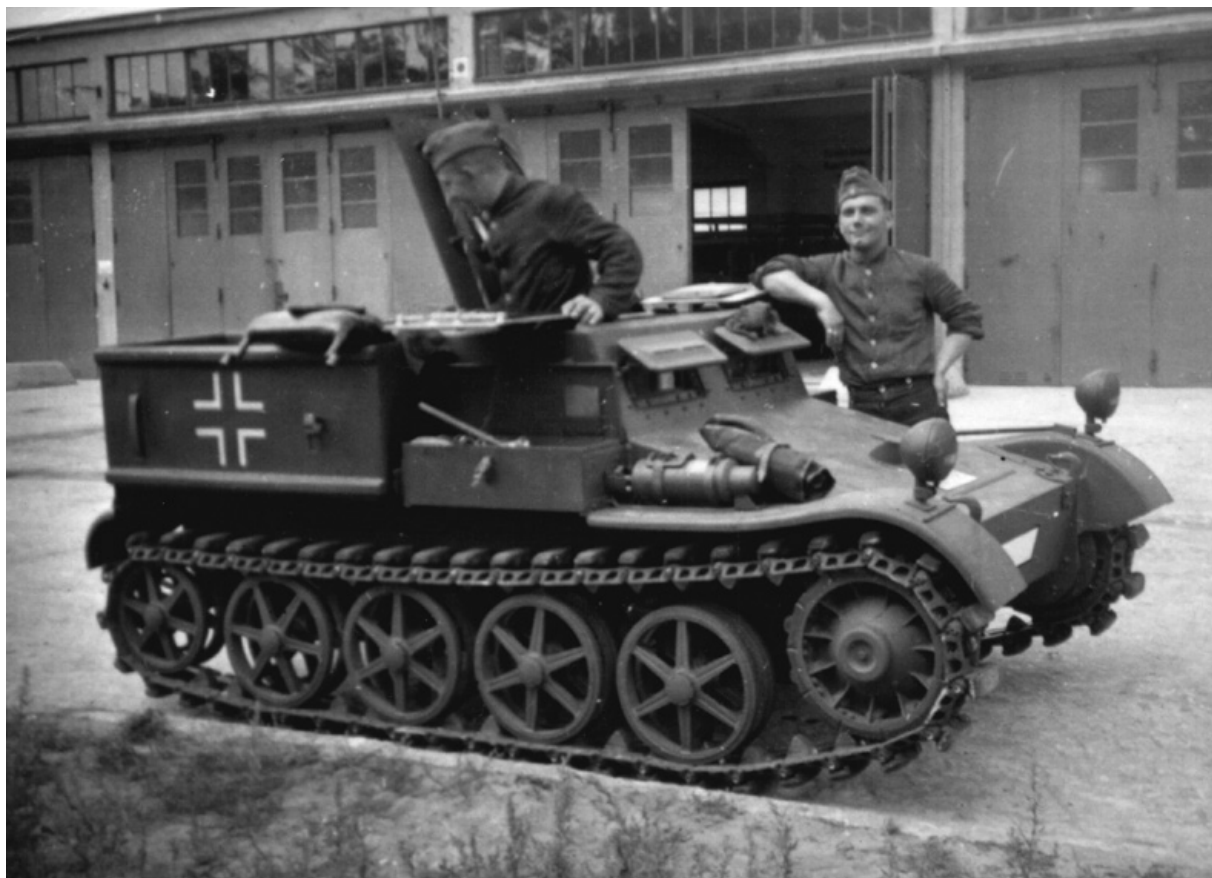
The Borgward VK 302 was developed as an armoured ammunition carrier. The vehicle was rear engine and fitted with the same type of tracks (with rubber pads and greased links) as those used on German halftracks. (Anderson)

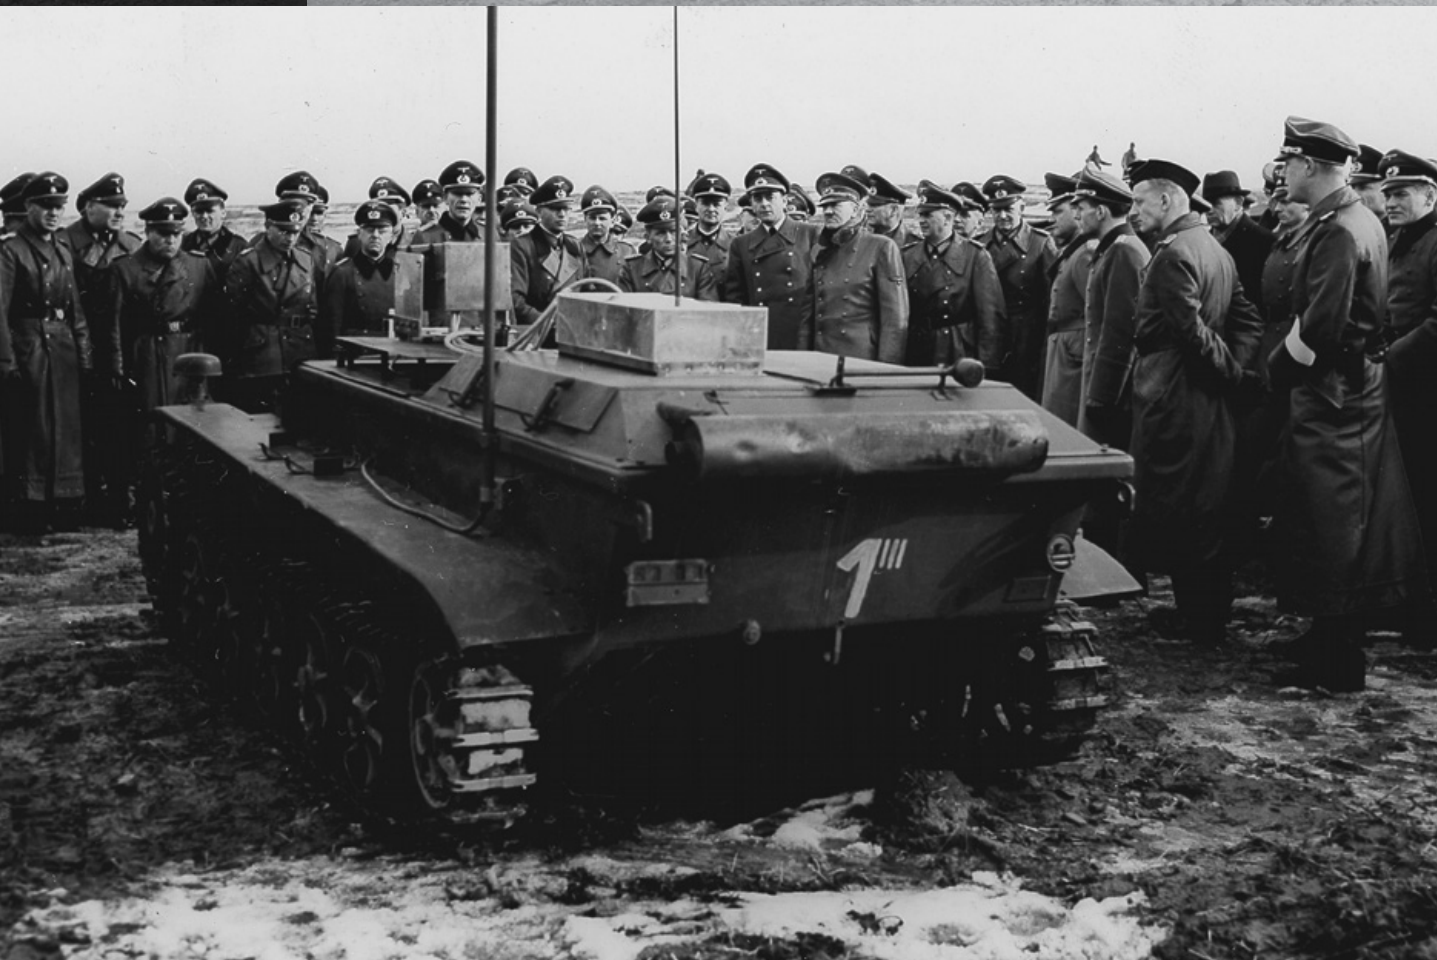
A B IV Ausf B, being examined by Hitler. The vehicle is fitted with a small television camera which allowed the controller to guide it to the target without having a 'direct' view. (bpk images)

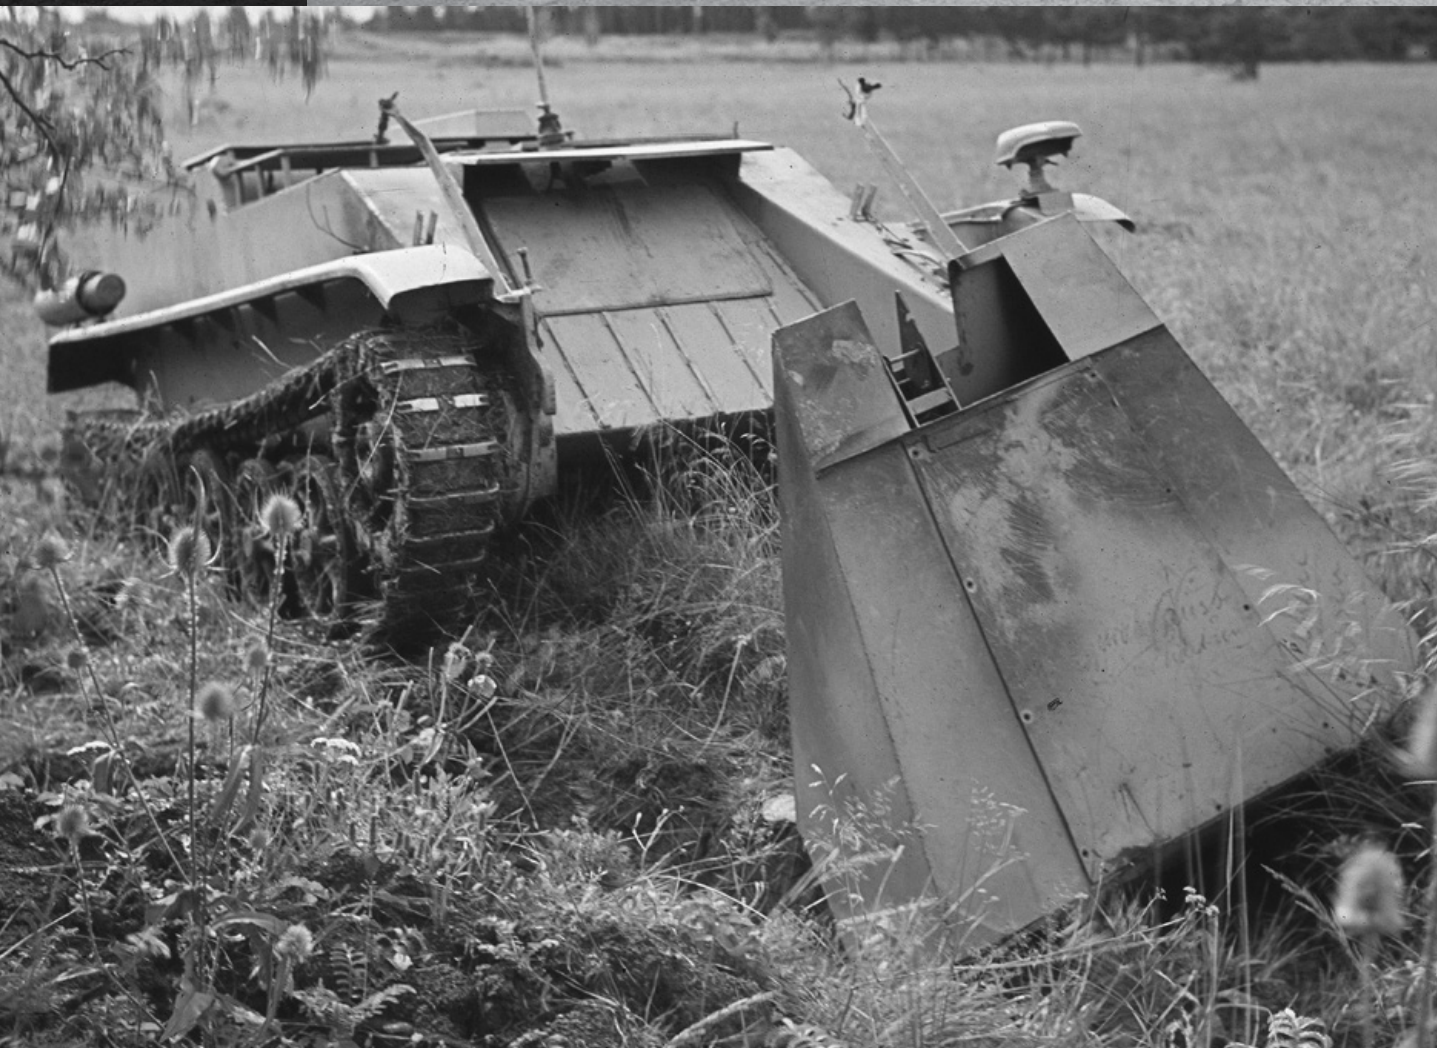
**Above:**

After reaching the target, the 450kg charge would be released from the B IV by remote control and slide gently to the ground. The vehicle would be guided back to German lines. (bpk Images)

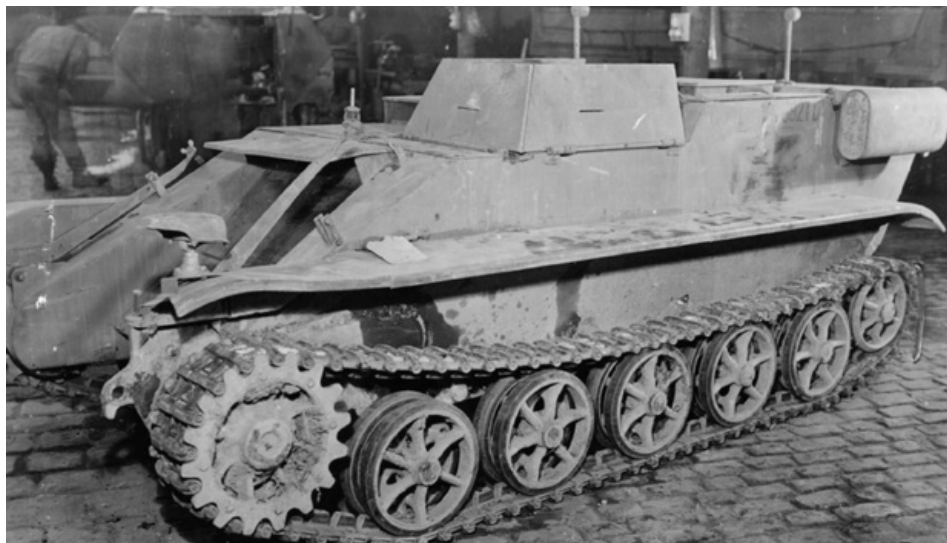
Right:

A B IV Ausf C captured by US troops in 1944. The container for the explosive charge has been removed: Note the release arms. The driver for the Ausf C was repositioned to the left-hand side of the vehicle. (NARA)

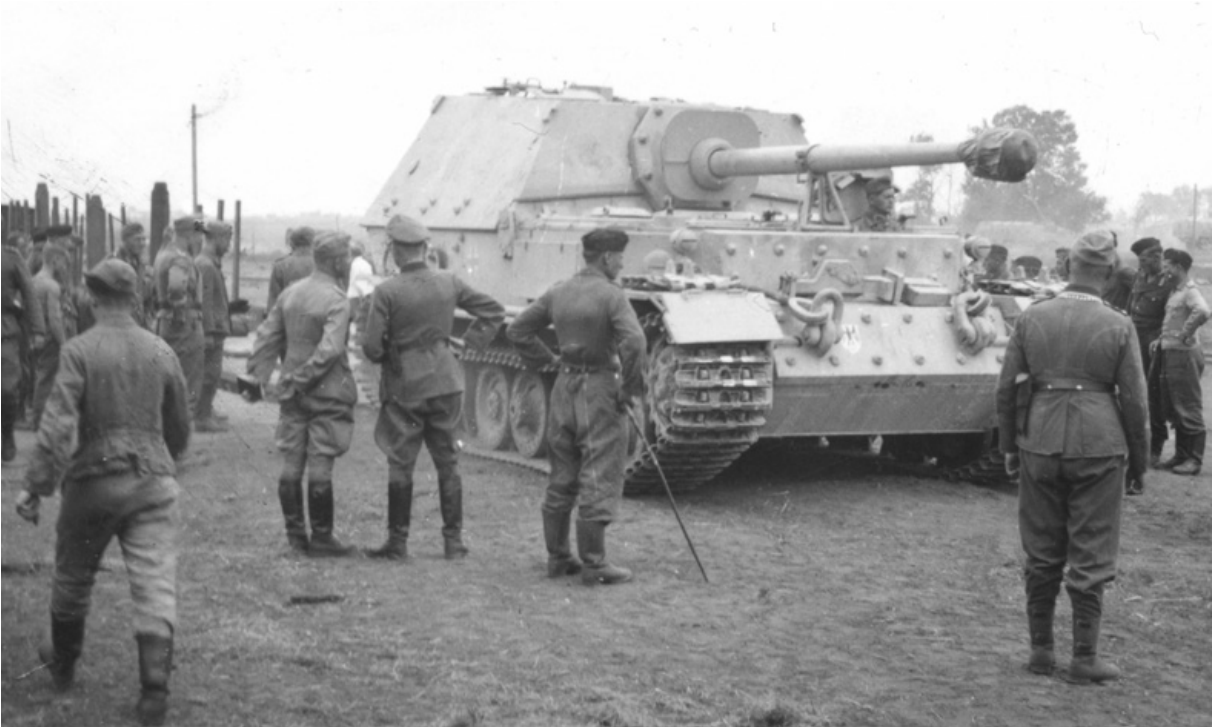
A vehicle from sPzJgAbt 653 carrying the insignia of StuGAbt 197; the lead unit. Rain drains have been fitted in front of the ball-mounting deflector plate to prevent water entering the engine compartment. (Anderson)

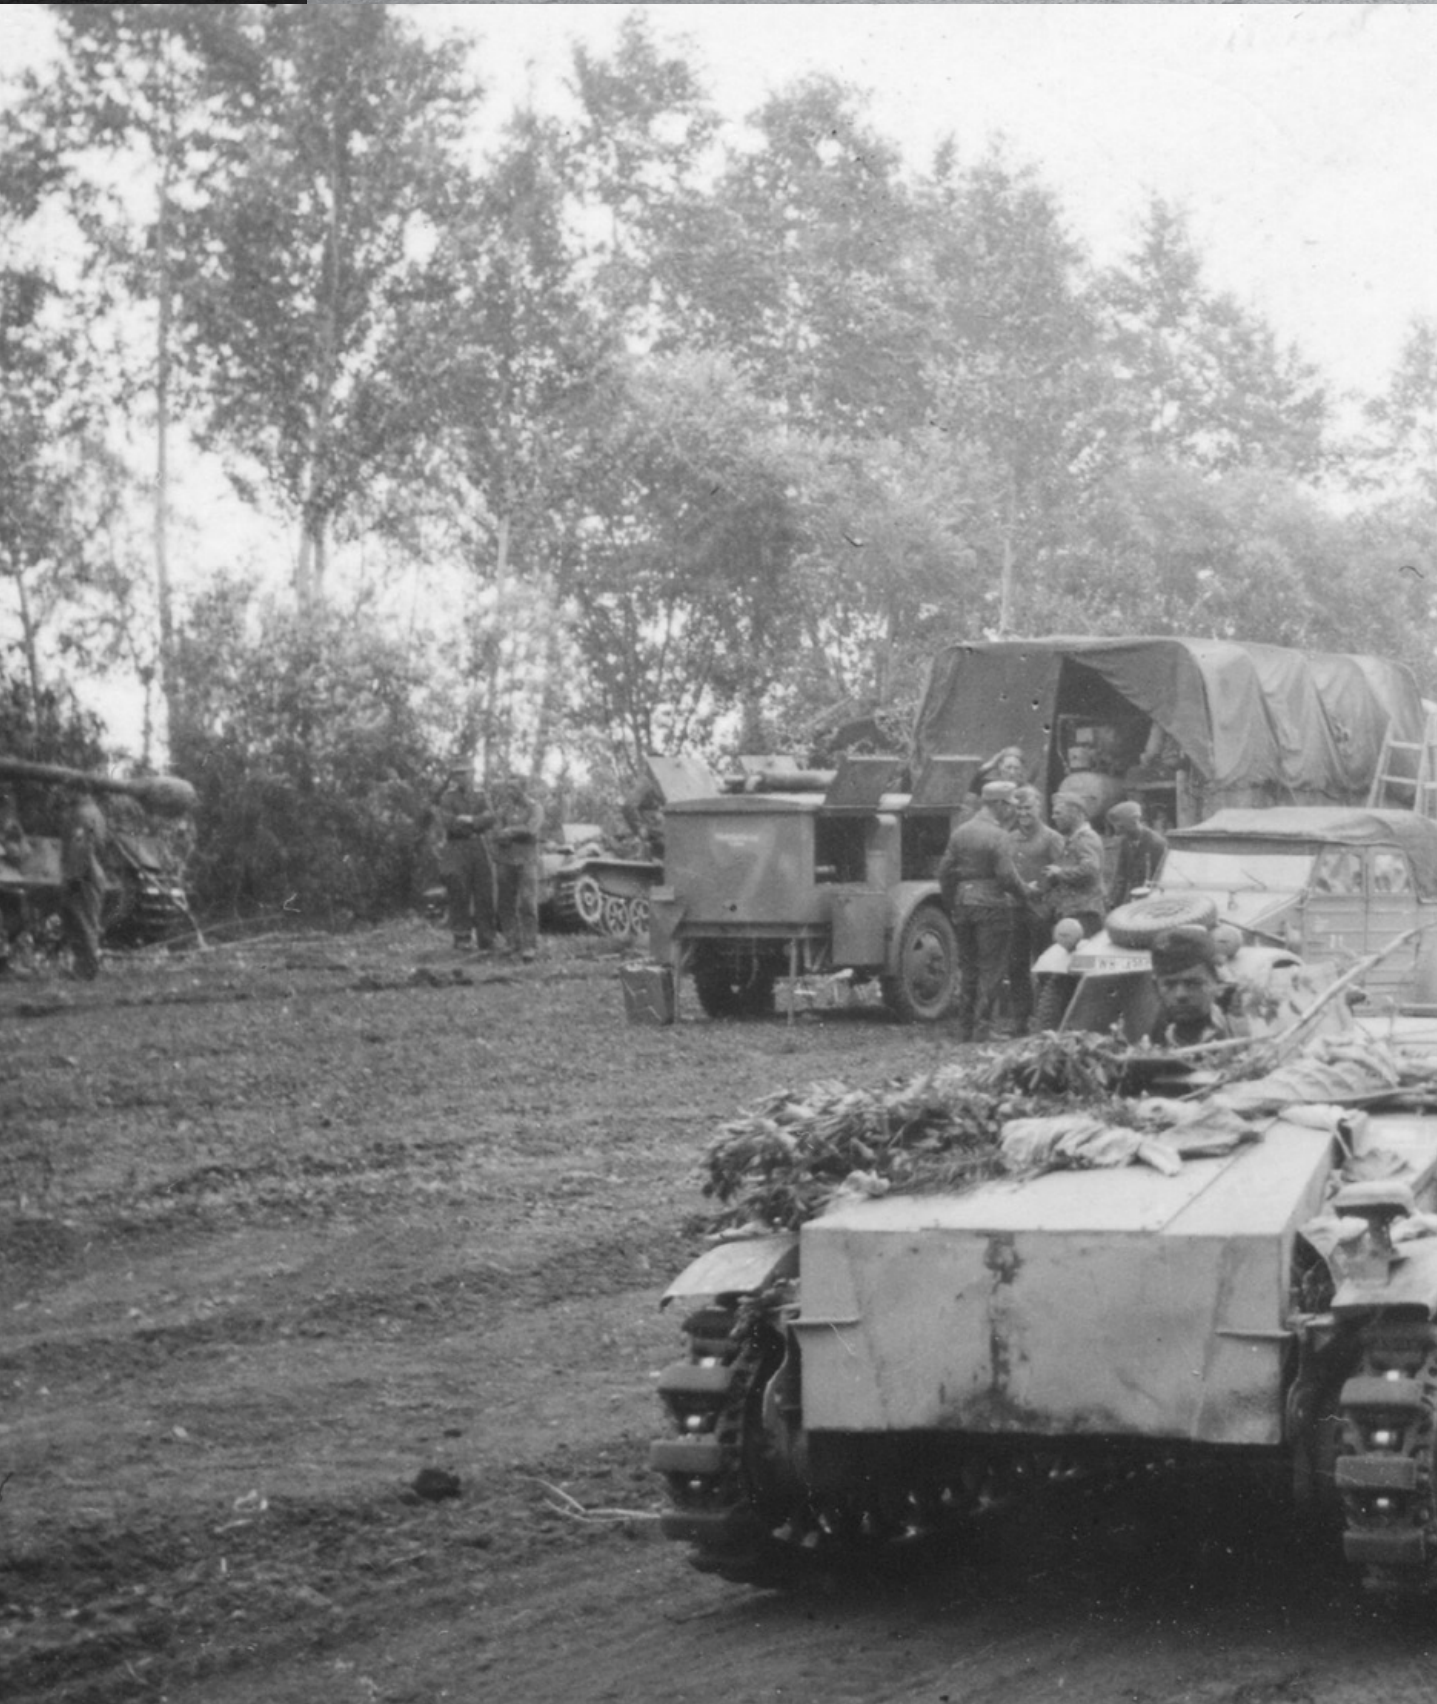
Supplies of fuel and ammunition are delivered from a Büssing-NAG truck. The operational range of the Ferdinand was severely restricted by the excessive fuel consumption of the Maybach HL-120 engines. (Münch)

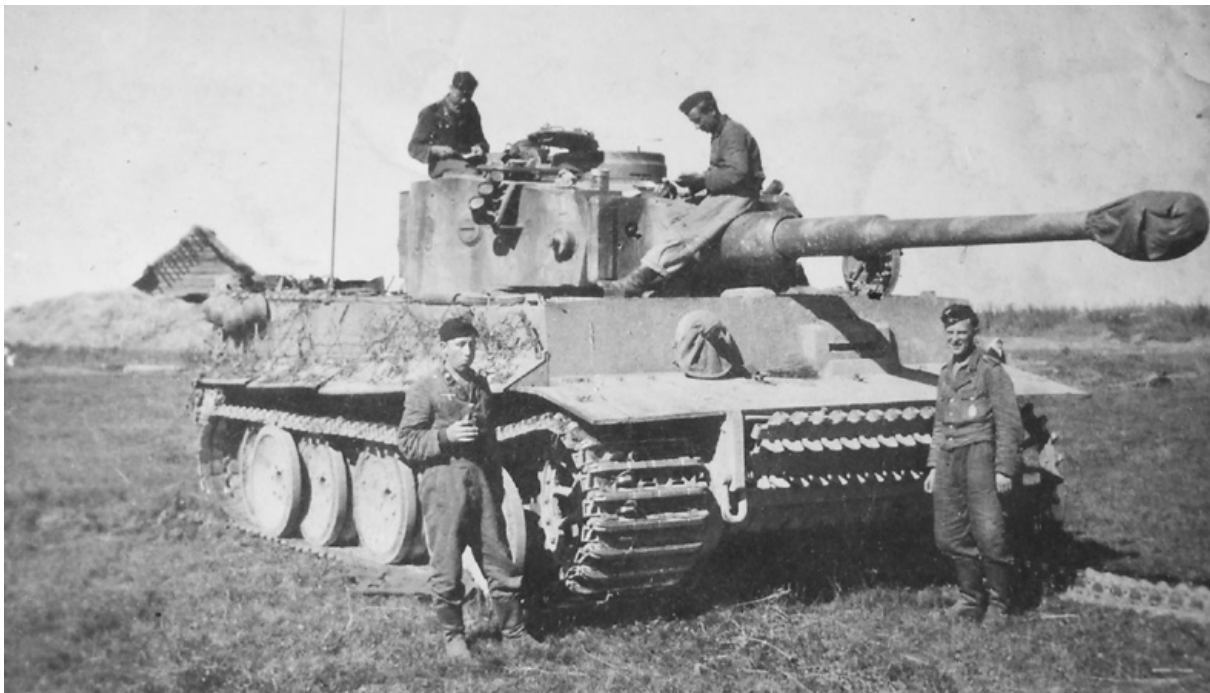
Tigers were normally loaded on rail with narrow transport tracks. This tank of sPzAbt 505 has still the wide combat tracks fitted, which considerably exceeded the loading gauge. (Anderson)

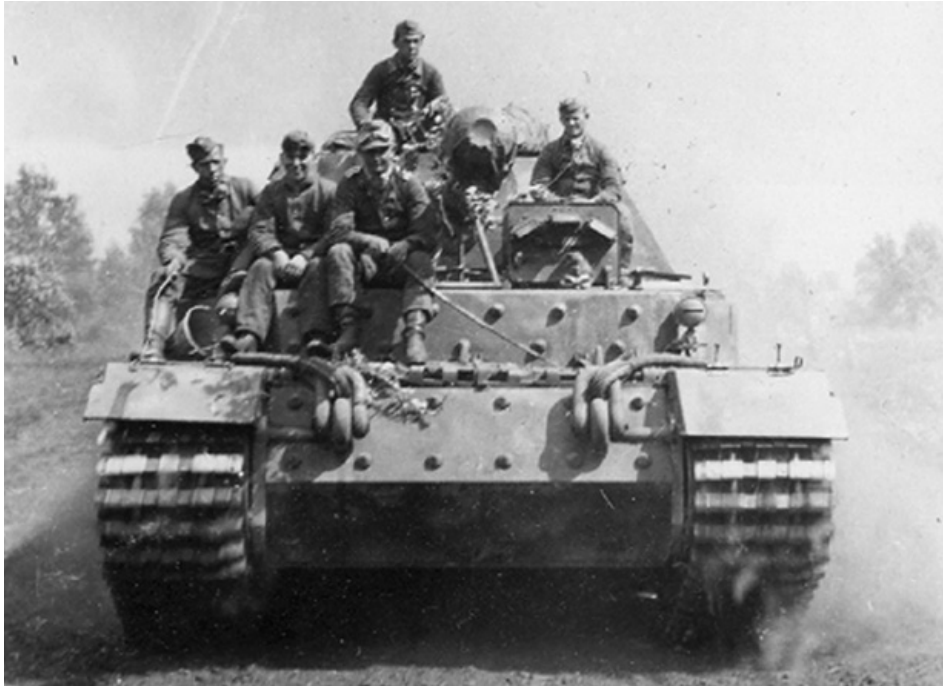
A Ferdinand being driven at speed, after the attack on the Kursk salient, kicking-up a large cloud of dust. Note the periscopes on the hatch above the driver's head. The muzzle brake has been covered to protect the gun barrel against the ingress of dust. (Hoppe)

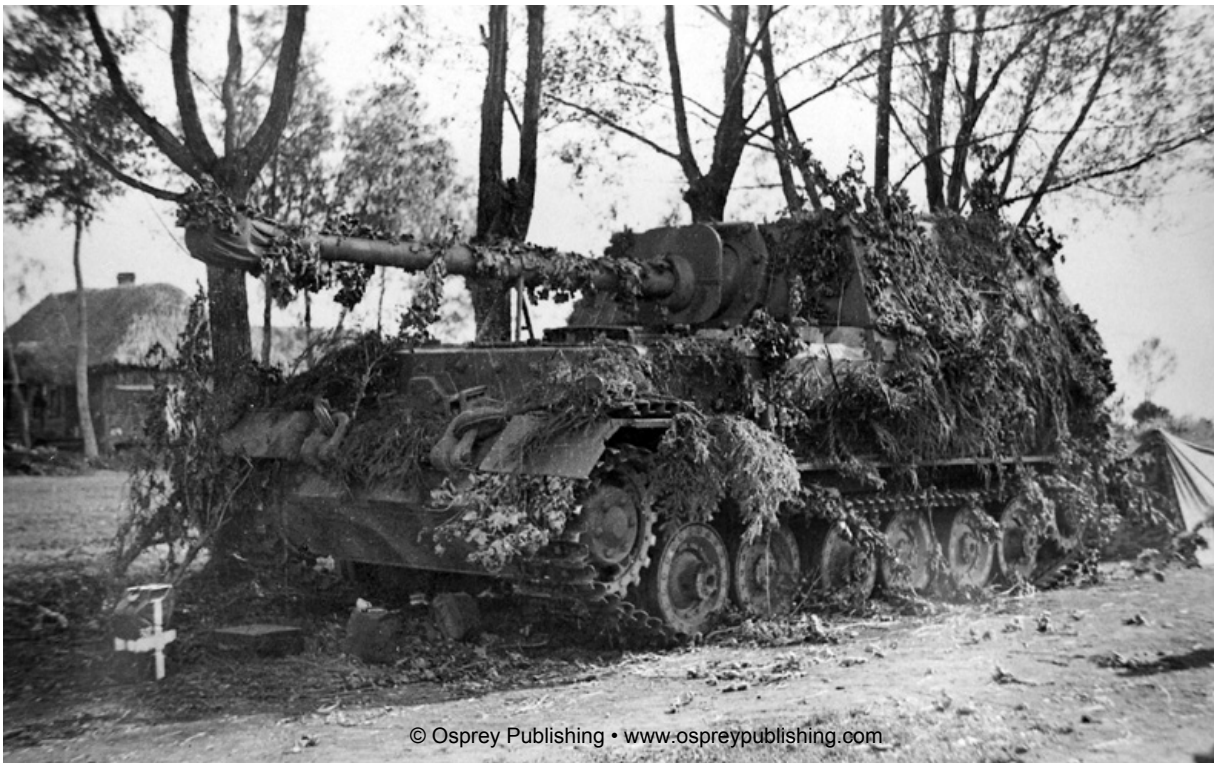
The crew of this Ferdinand from sPzJgAbt 653 has camouflaged their vehicle by covering it with foliage. It appears that a purpose-made tarpaulin has been placed over the grilles on the engine compartment to prevent water entering. (Münch)

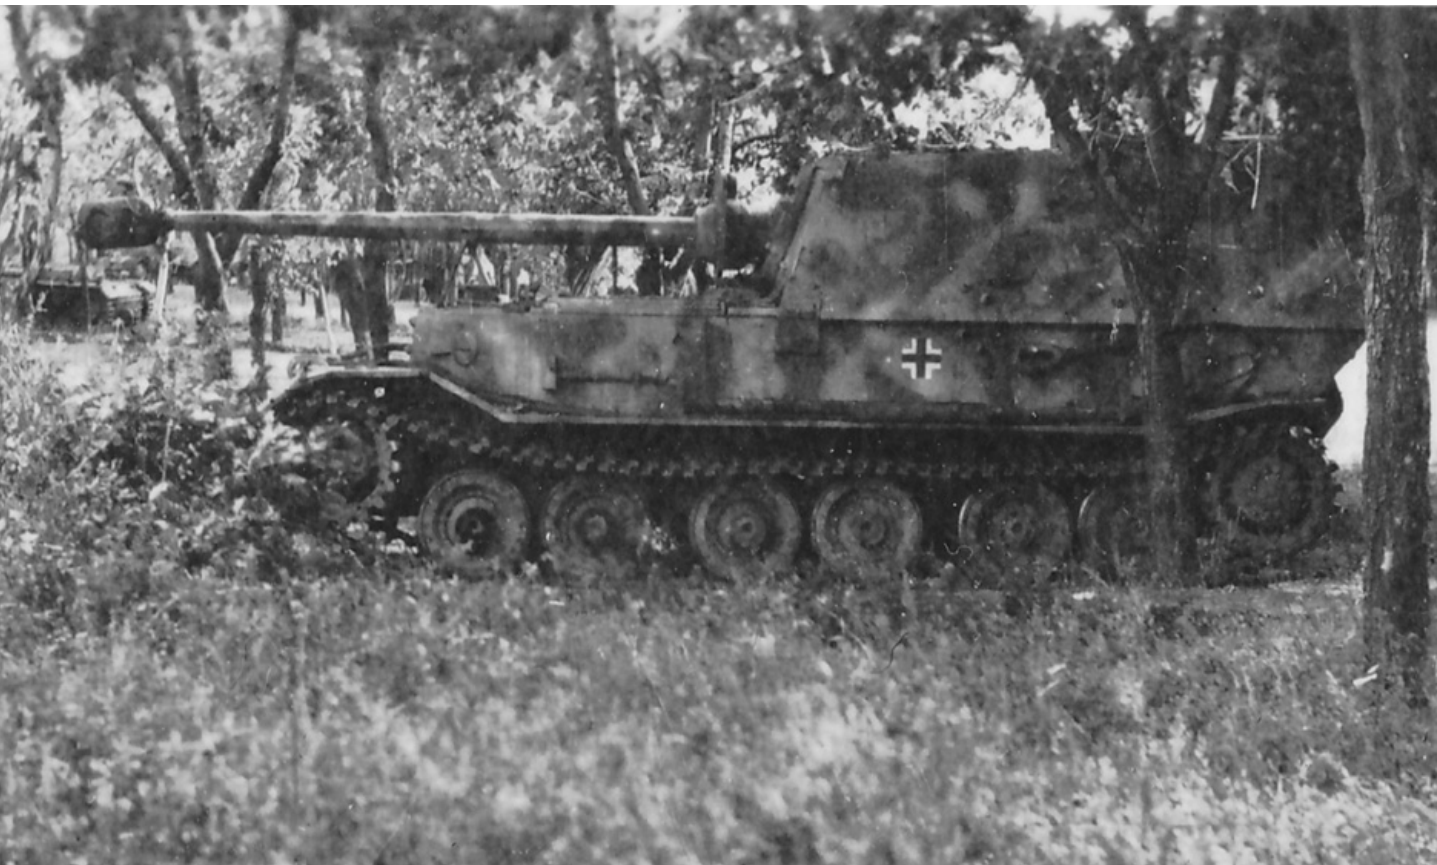
A tri-tone camouflage was used on some Ferdinands of sPzJgAbt 653. Unlike sPzJgAbt 654 its tactical numbers were stenciled in black outlined, which were very difficult to recognize. (Anderson)

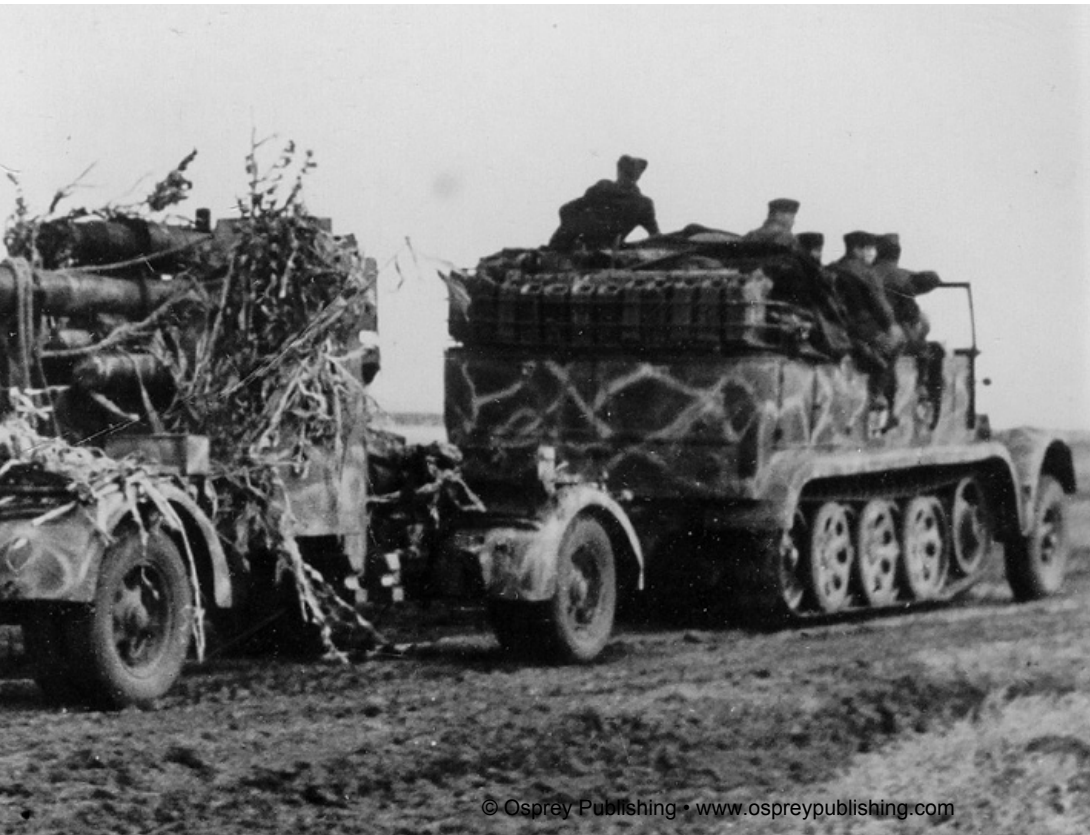
An 8.8cm *Fliegerabwehrkanone 36* (8.8cm FlaK 36) towed by an SdKfz 7 half-track vehicle passes engineers working to repair a Ferdinand. (PK photo)

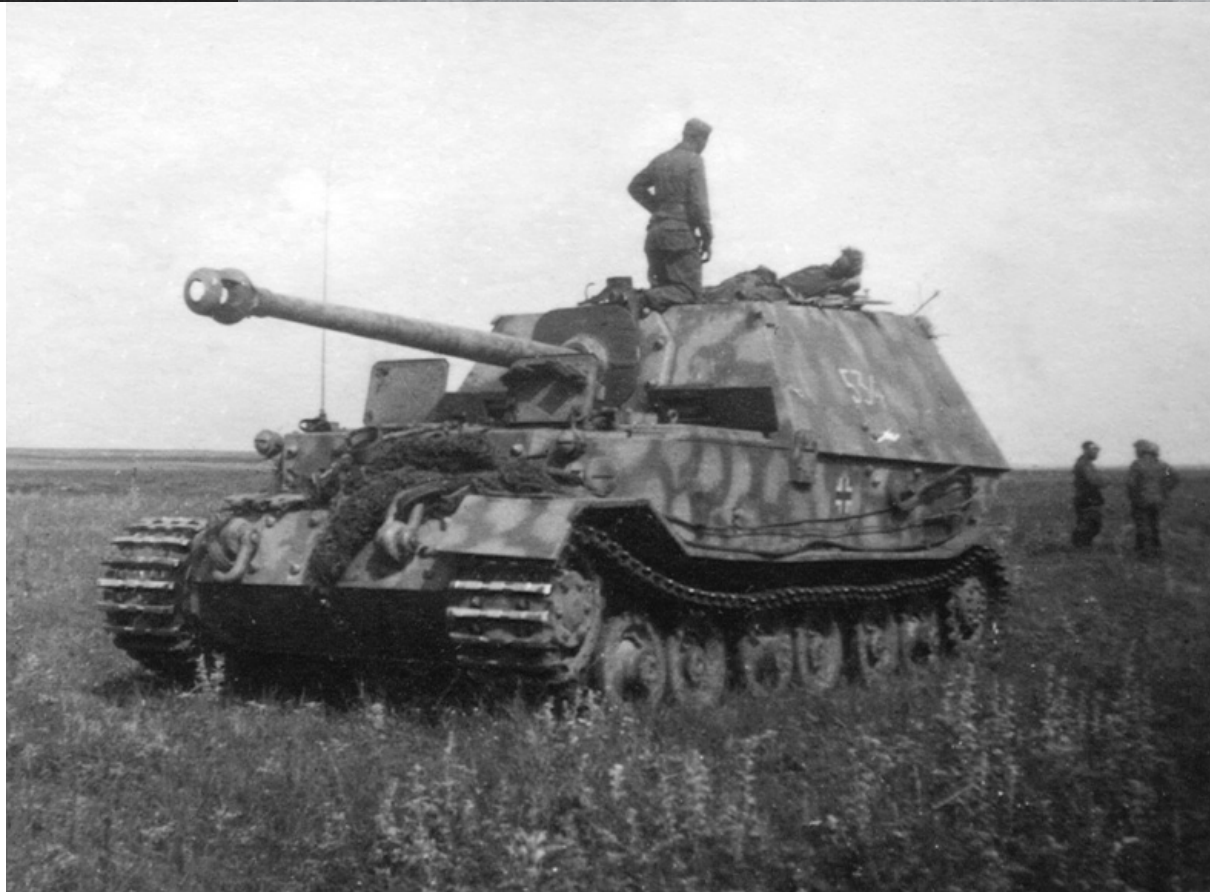
Ferdinand, tactical number 534, from sPzJgAbt 654 on the Ukrainian steppe; the small engine access hatches in front of the superstructure have been opened to allow more air into the compartment. The deflector plate in front of the ball mount was fitted on all Ferdinands shortly before the Kursk campaign. (Anderson)

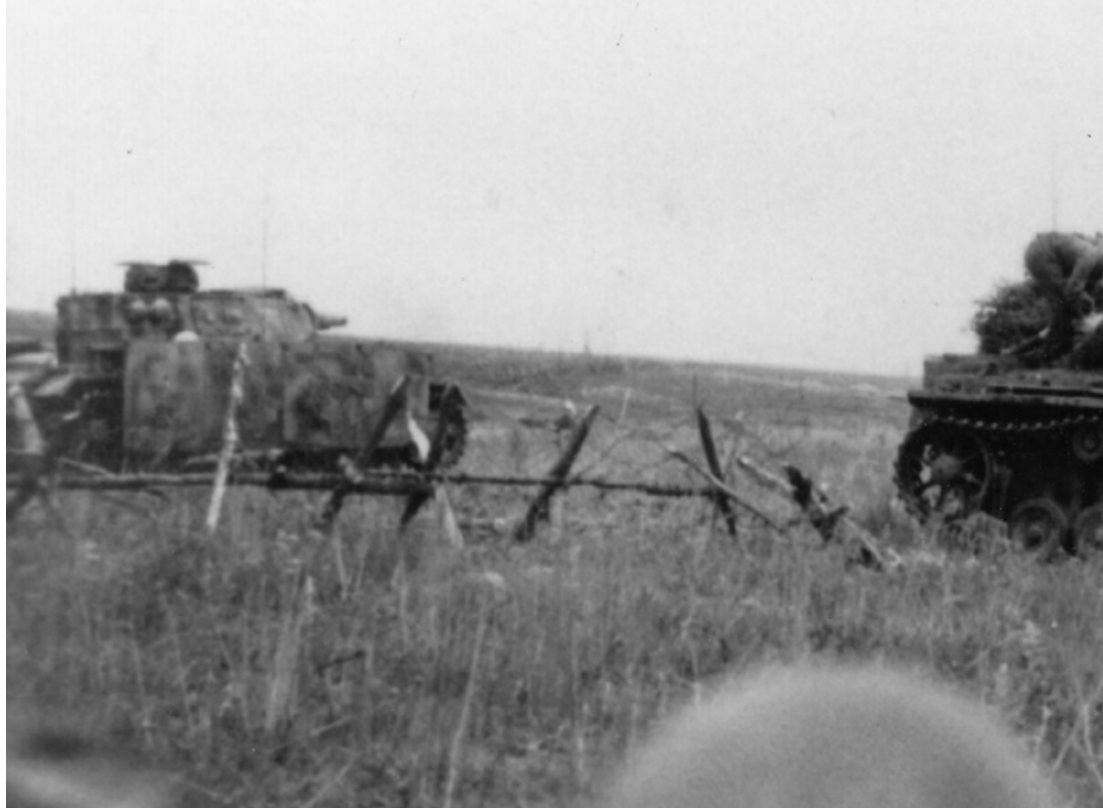
A Ferdinand of sPzJgRgt 656 and one of the PzKpfw III *Begleitpanzer* attached to 12.Pz Div being prepared for combat. The PzKpfw III was attached to provide close-support fire for the Ferdinand and *Sturmpanzer*. At left is a *Leitpanzer* III (7.5cm L/24) of PzKp 313 (Fkl). (Wilhelm)

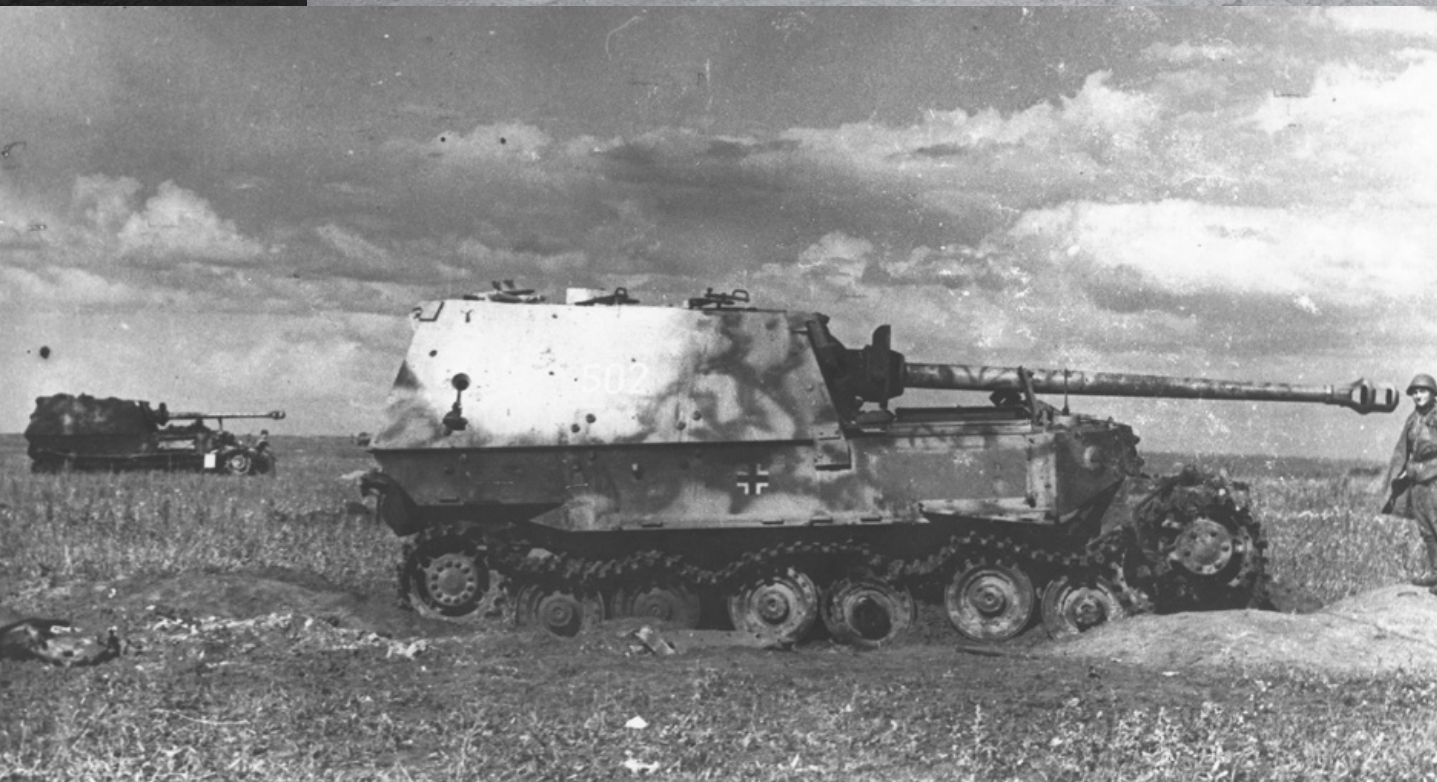
Two knocked-out Ferdinands from sPzJgAbt 654 being inspected by Soviet infantry. Both have received multiple hits which have removed almost all external fittings. (Netrebenko)

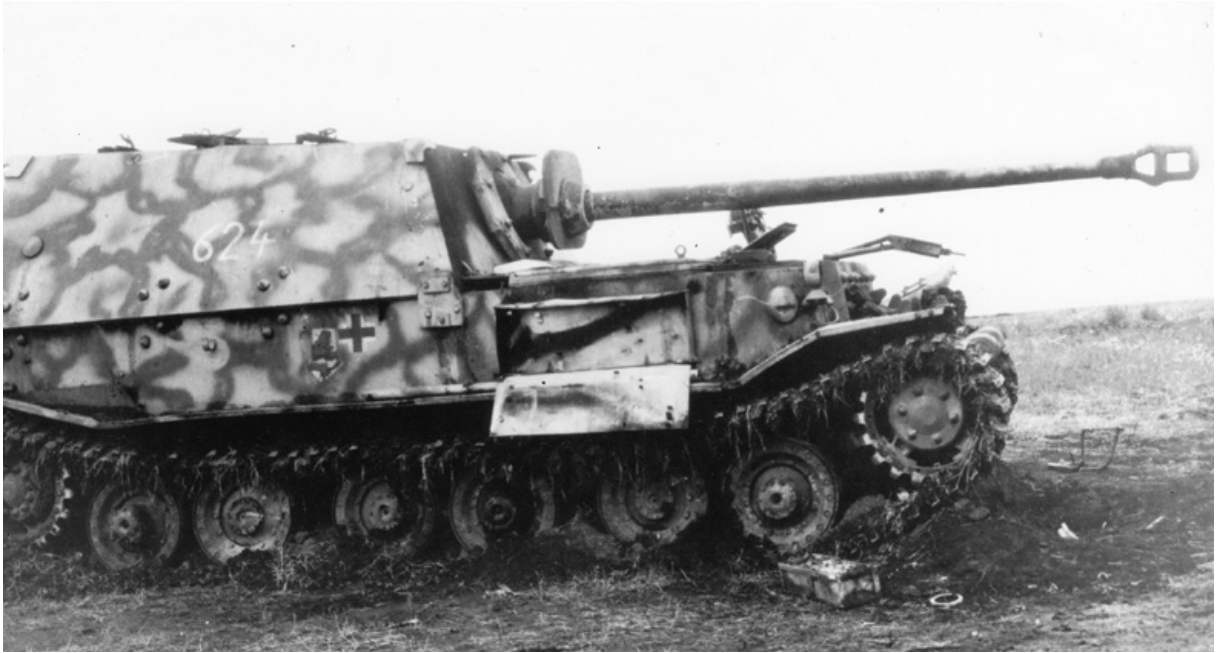
Ferdinand, tactical number 623, from sPzJgAbt 654 has been abandoned intact. Recovery teams, often under heavy enemy fire, retrieved many damaged vehicles which, where possible, were repaired and returned to the frontline. The vehicle is painted in sPzJgAbt 654 typical 'spider's web' camouflage scheme. (Netrebenko)

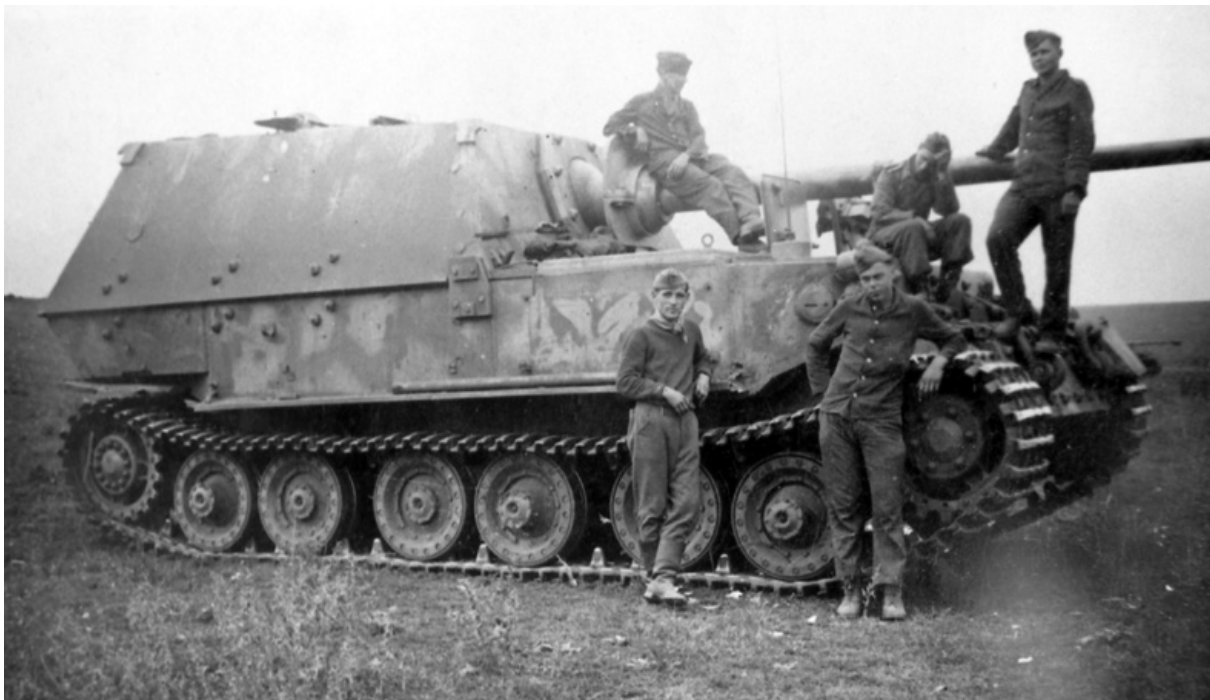
Exhausted men on top of their exhausted *sPanzerjäger*. The track guards are badly damaged. A hit from a small caliber gun has left a notch at the superstructure's front plate, wiping off parts of the rain drain (Münch)

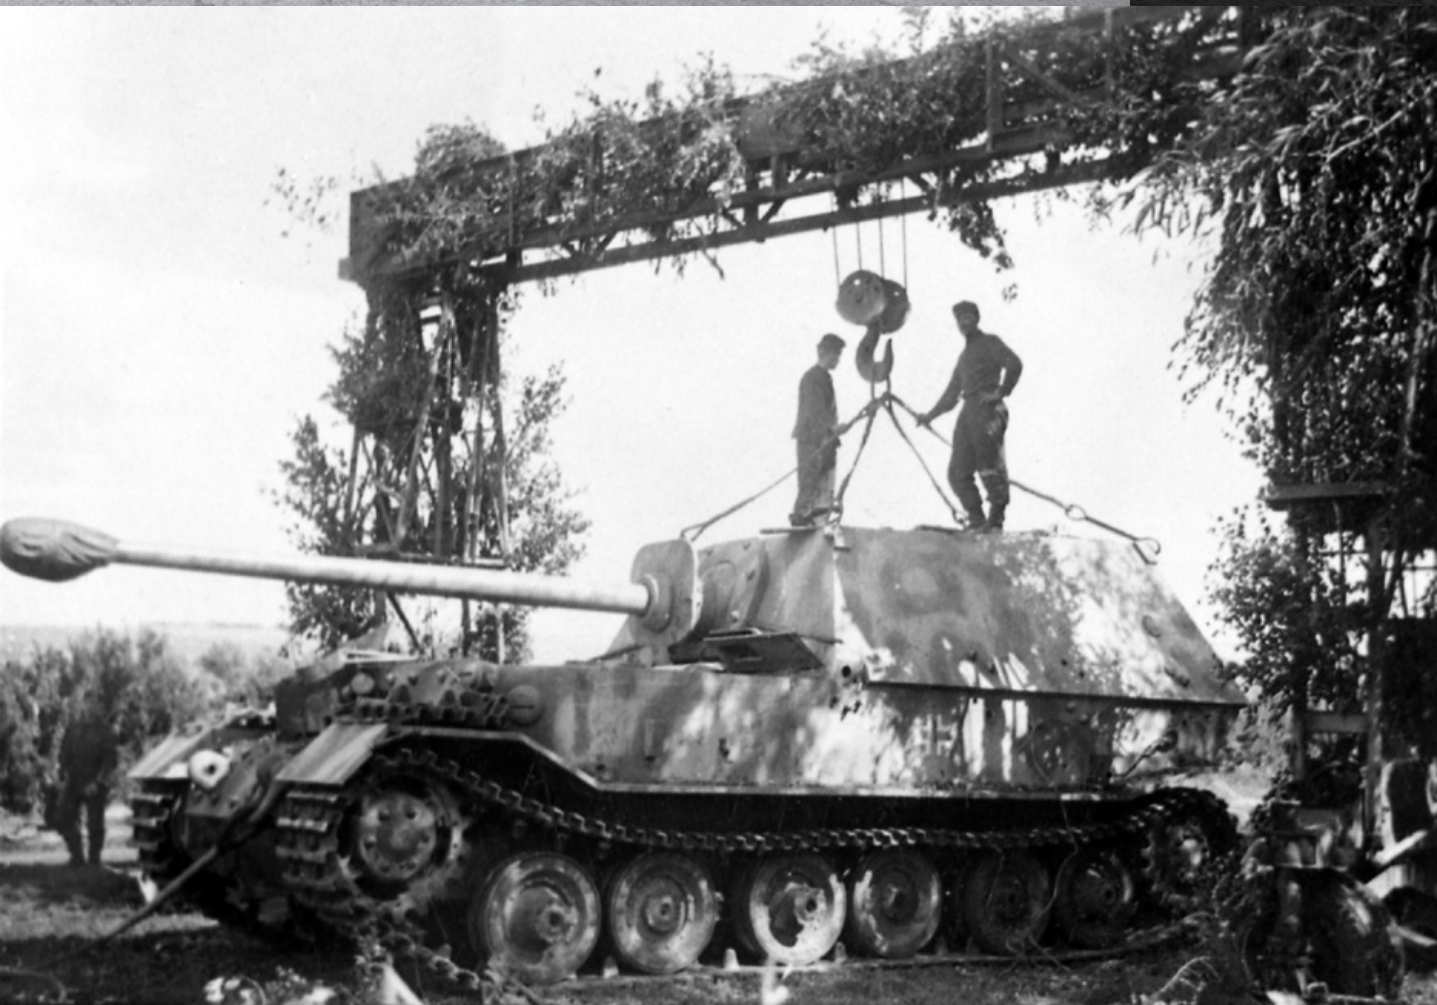
The maintenance of the *sPanzerjäger* was hindered by the vehicle's general layout. The engines were installed under very cramped conditions, partly covered by the overstrained cooling system. Here the engine cover plate is being removed by Kfz 100 with a 3t rotary crane. (Anderson)

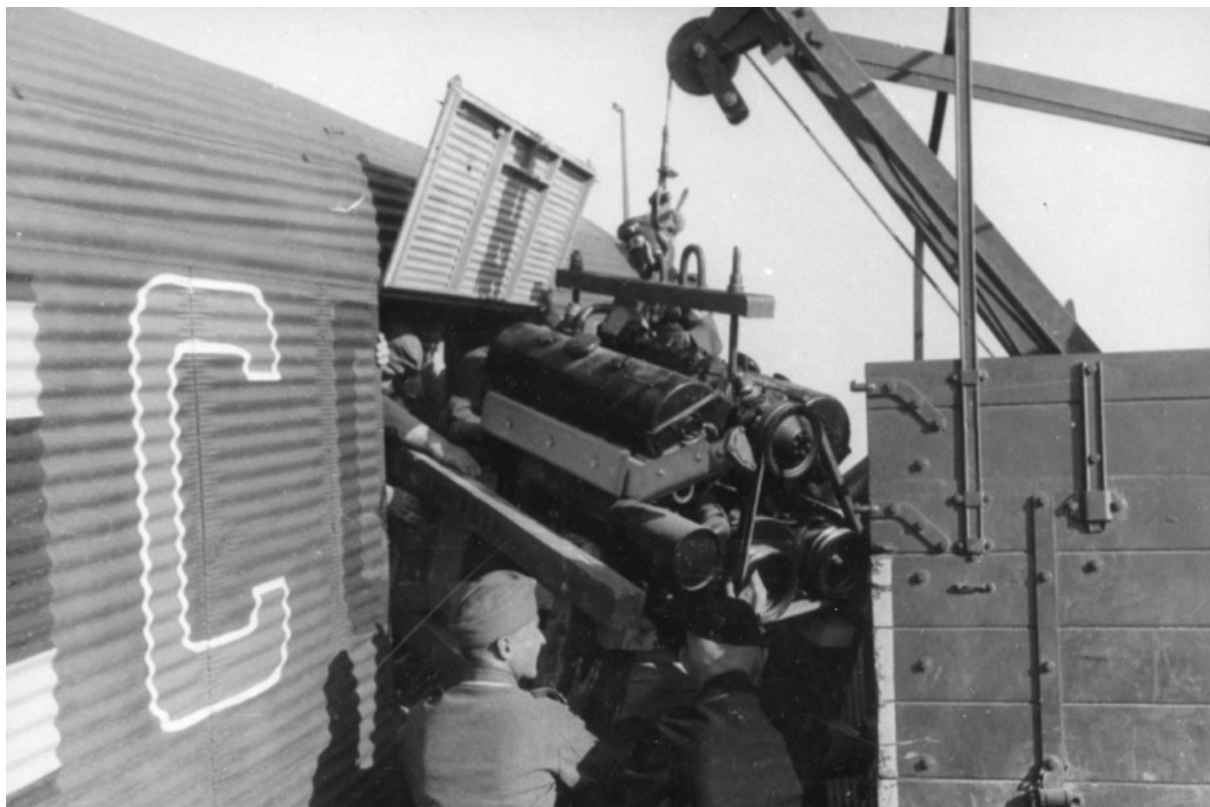
Spare engines were in short supply at all time. Due to the engine compartment’s cramped conditions, the Maybach HL 120 had a service life of 800km at maximum. To keep the valuable vehicles running, the engines were delivered to the unit via air transport, if necessary and possible. (Anderson)

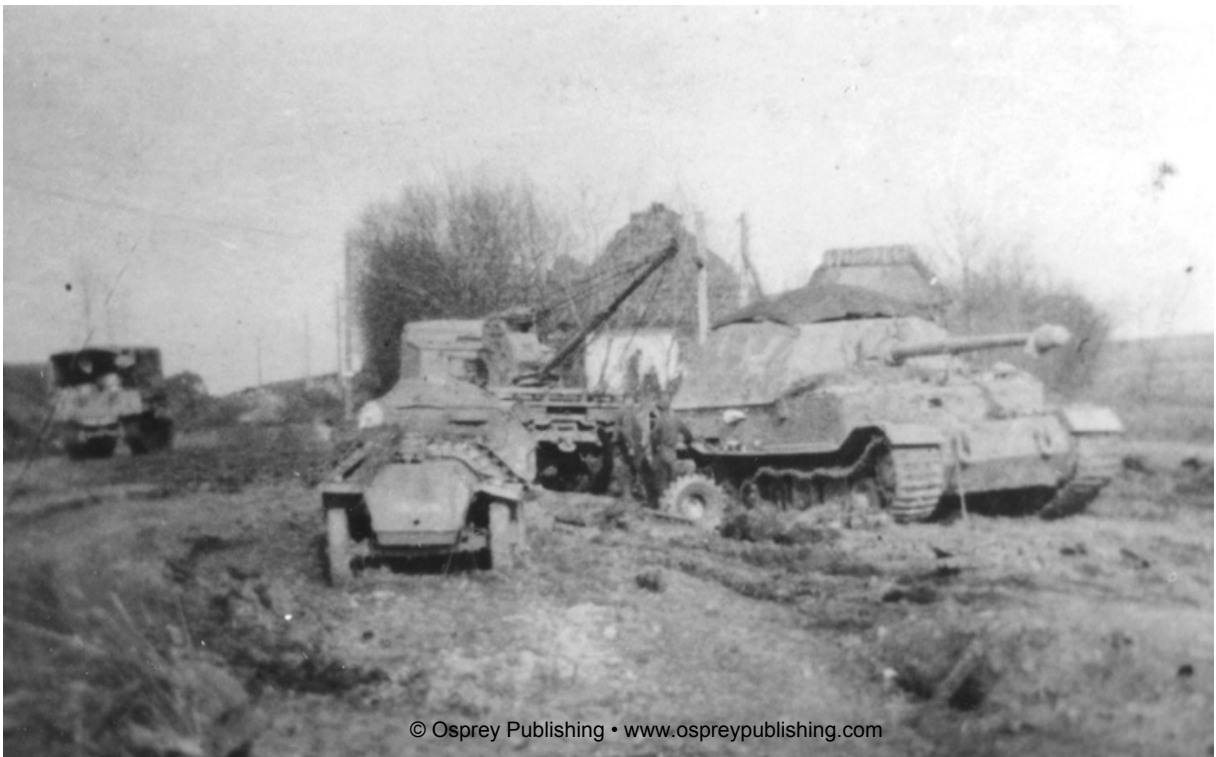
The Kfz 100, a 4,5t truck with 3t rotary crane was of vital importance for the workshop and repair sections. Here the final drive is being repaired, the drive sprocket has been already removed. In the foreground a SdKfz 251/8 is visible. The regiment had only one m SPW as an armored ambulance (SdKfz 251/8) in its inventory, so it was possibly used for purposes other than intended. (Anderson)

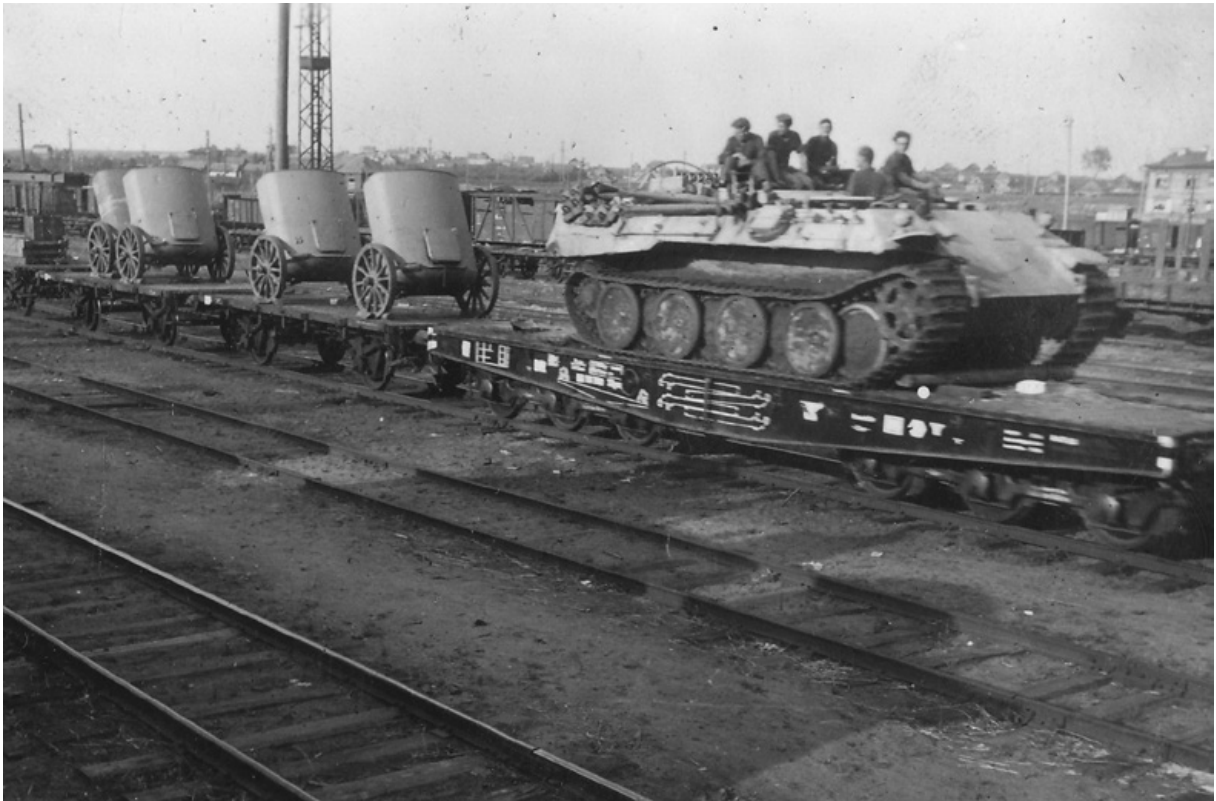
The regiment was authorized with heavy recovery equipment. Two *Bergepanther* recovery tanks were allocated to the unit by July and three *Bergepanzer Tiger (P)* by October. Here one of the *Bergepanther* is visible, these vehicles were of the early production, lacking the valuable winch. The purpose of the 'chariots' loaded behind the tank is unknown. (Anderson)
