FERDINAND AND ELEFANT TANK DESTROYER

OSPREY
PUBLISHING

Thomas Anderson

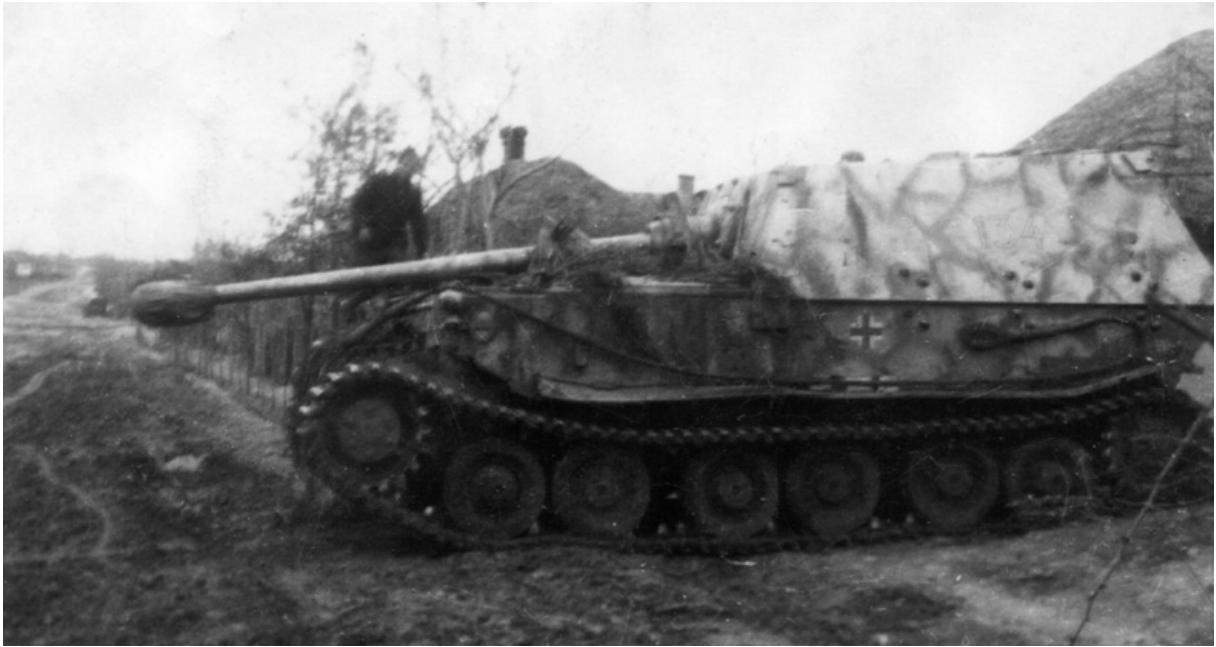
Waiting in the cover of some peasants' huts, this Ferdinand (tactical no. 134) shows the damage of the last fighting. Except for the towing ropes no further tools are visible. (Anderson)

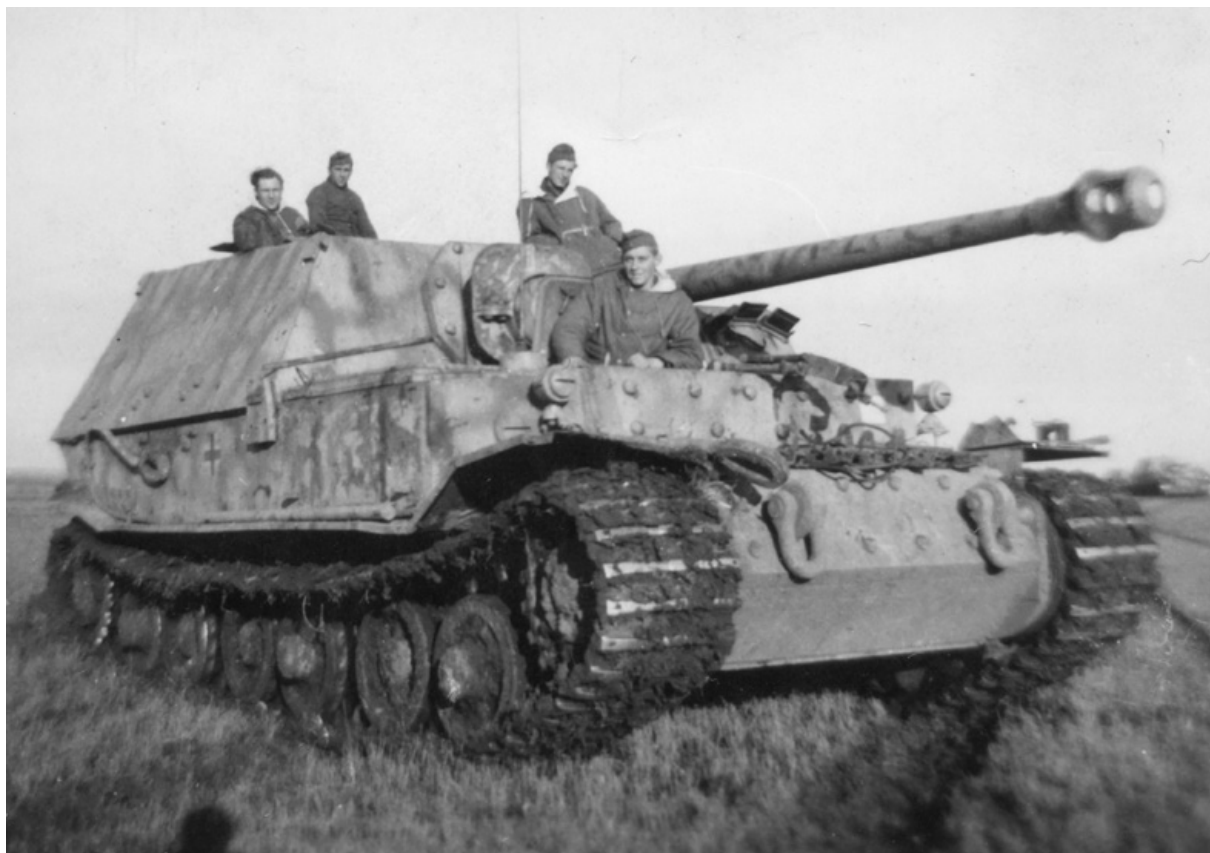
A good portrait of the *sPanzerjäger Ferdinand*. Instead of the jack, spare track links are carried on the glacis plate. Many parts, which have been altered, replaced or refitted after delivery (gun deflector shield, the gun barrel, the area behind the removed tool box) seem to show an improvised coat of color.

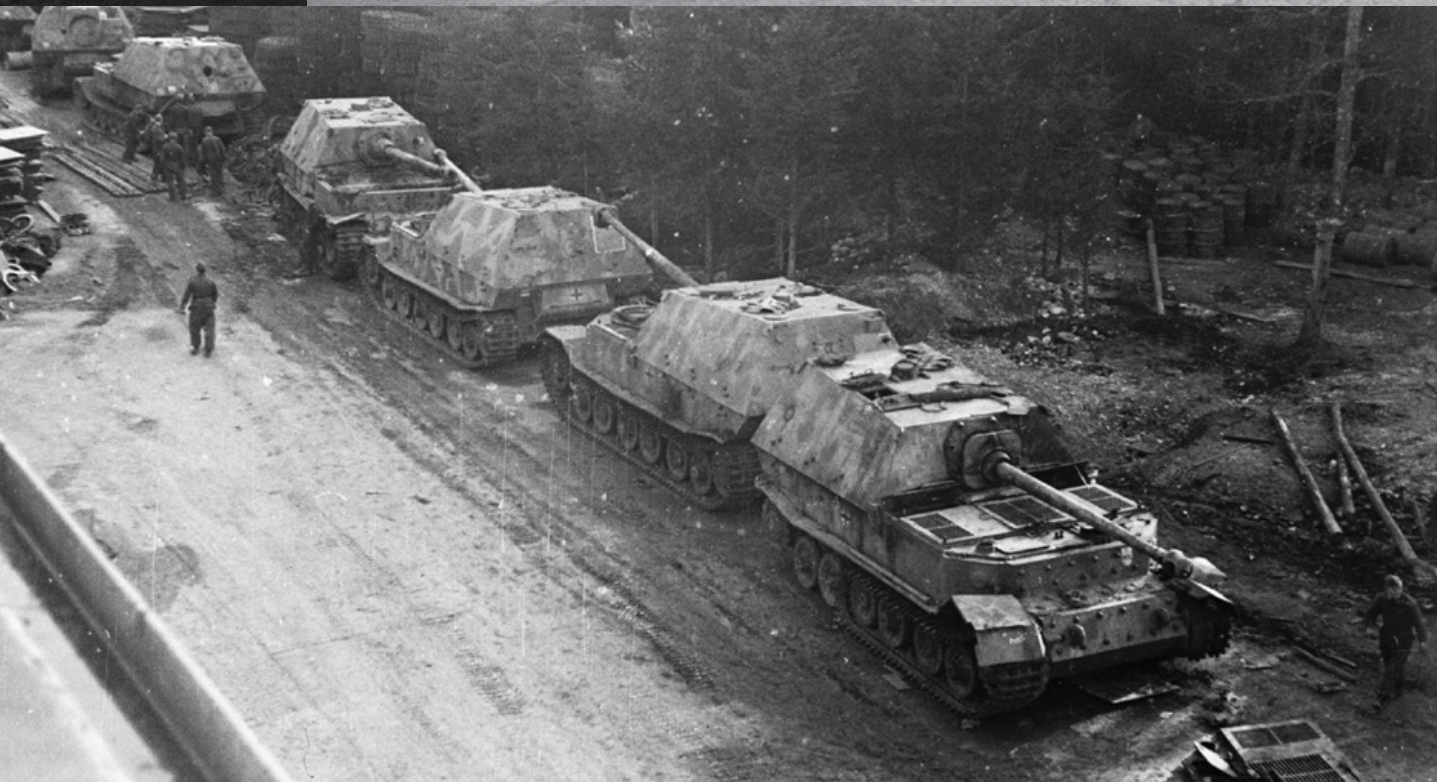
A line of battle-worn Ferdinands awaiting refurbishment parked in the grounds around the Nibelungenwerke. The crews of the vehicles and unit engineers were enlisted to assist in the refurbishment programme. (Historyfacts)

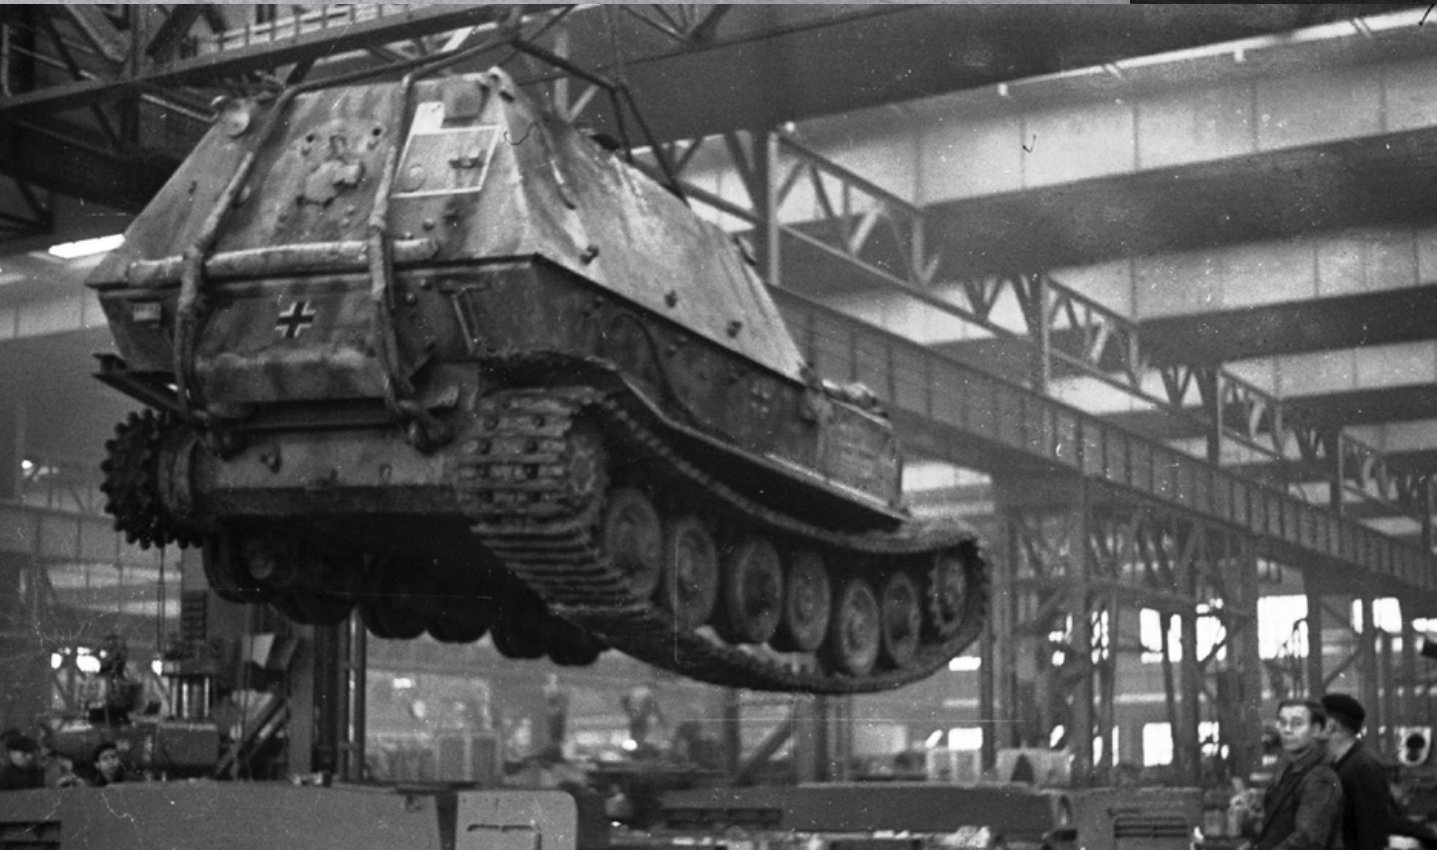
A Ferdinand being craned (note the special lifting cradle) to a position on the repair line. The track guards are badly damaged, and one track is missing. The tank is being lifted over the PzKpfw IV production line. (Historyfacts)

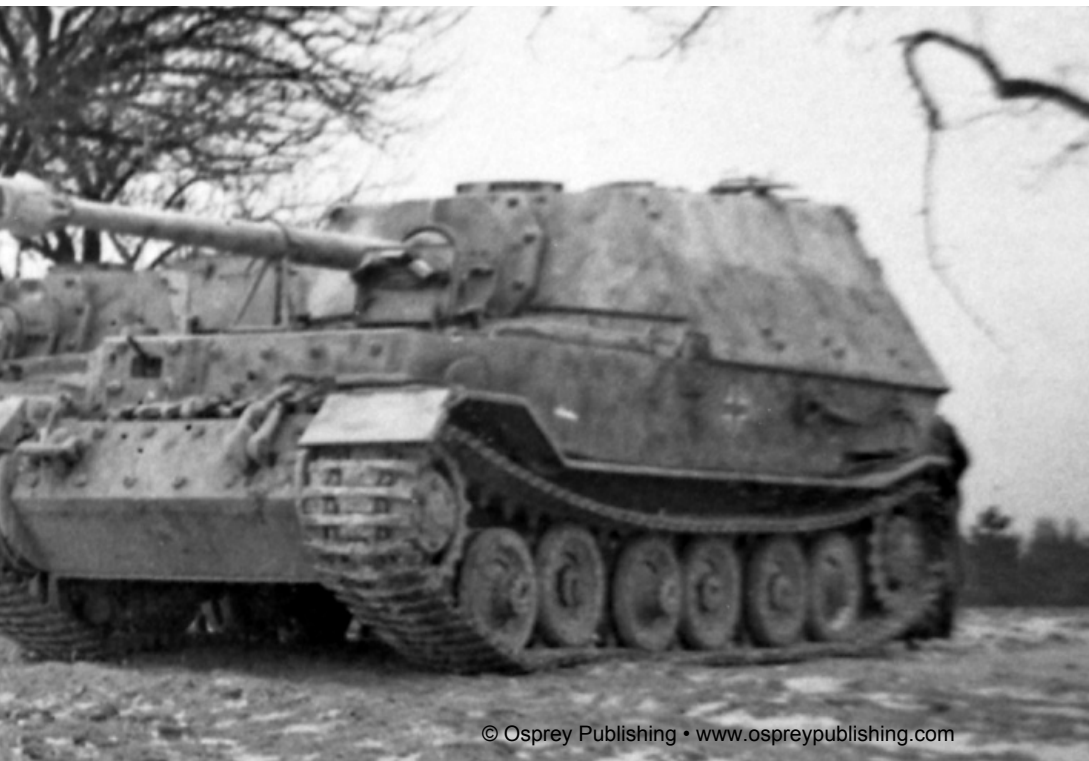
After completion, the Ferdinands, now renamed *Elefant*, were parked on a field near the Nibelungenwerke. Note the vehicles now have a self-defence *Maschinengewehr* 34 (MG 34) and are coated with *Zimmerit* anti-magnetic mine paste. (Historyfacts)

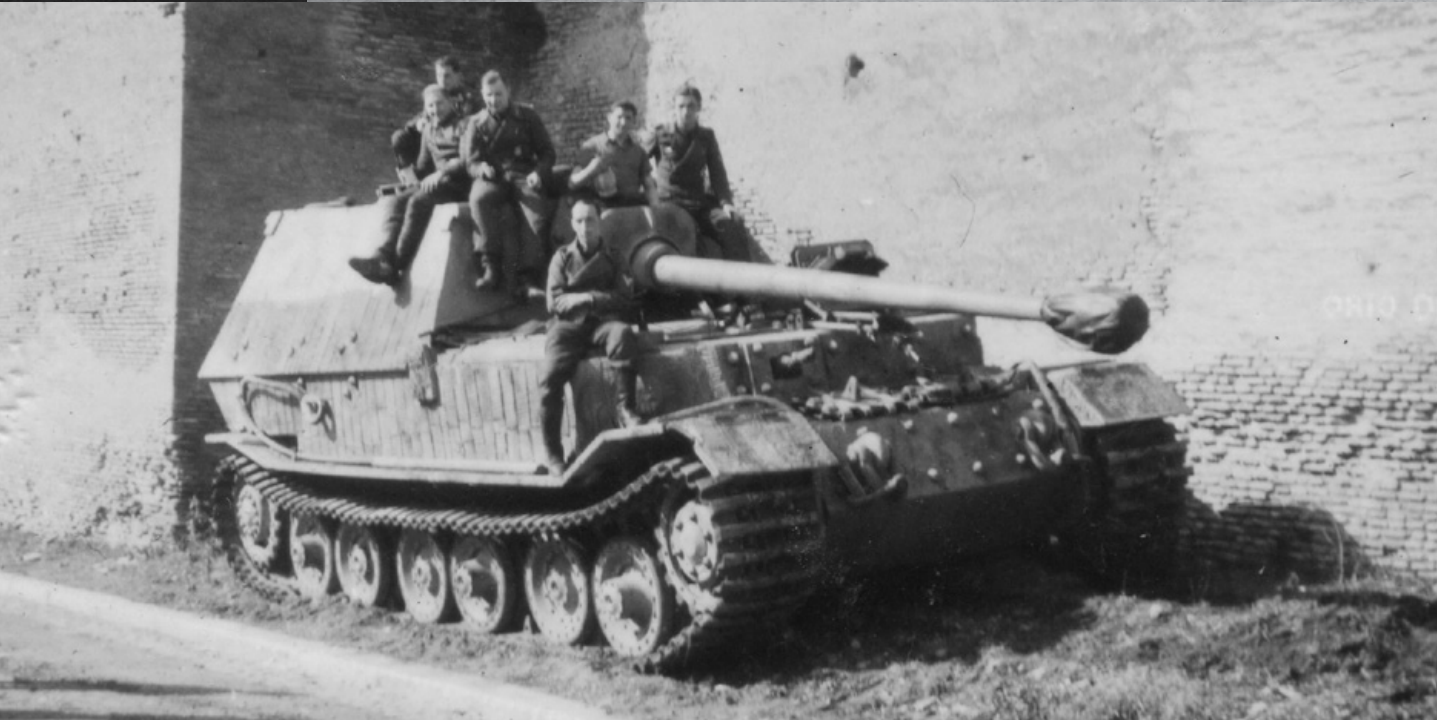
A Ferdinand parked alongside a wall on the outskirts of the eternal city, Rome. The gun barrel is not in the travel rest. (Anderson)

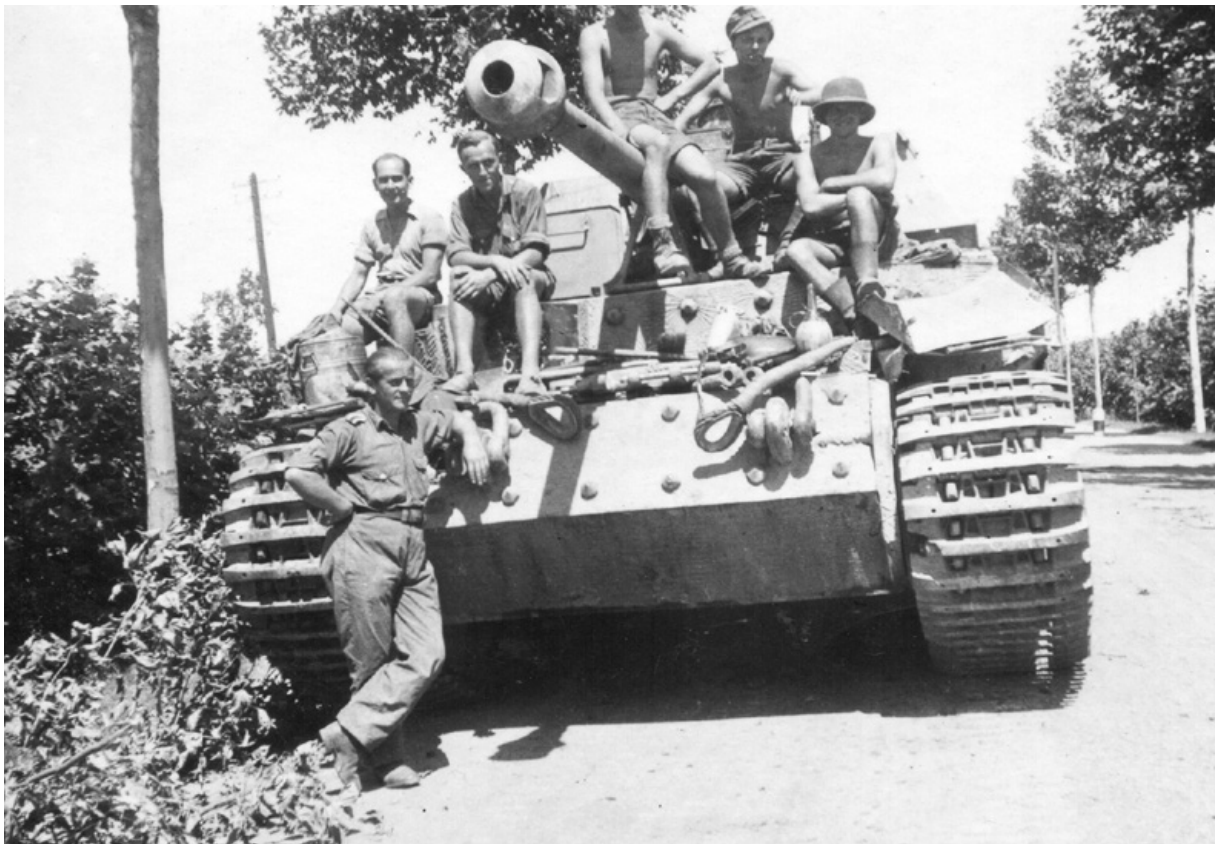
Parked under an avenue of trees, the crew is apparently not concerned by patrolling Allied aircraft. The track on the right-hand side of the Ferdinand has a damaged link, which indicates that this did not seriously affect the vehicle's mobility.

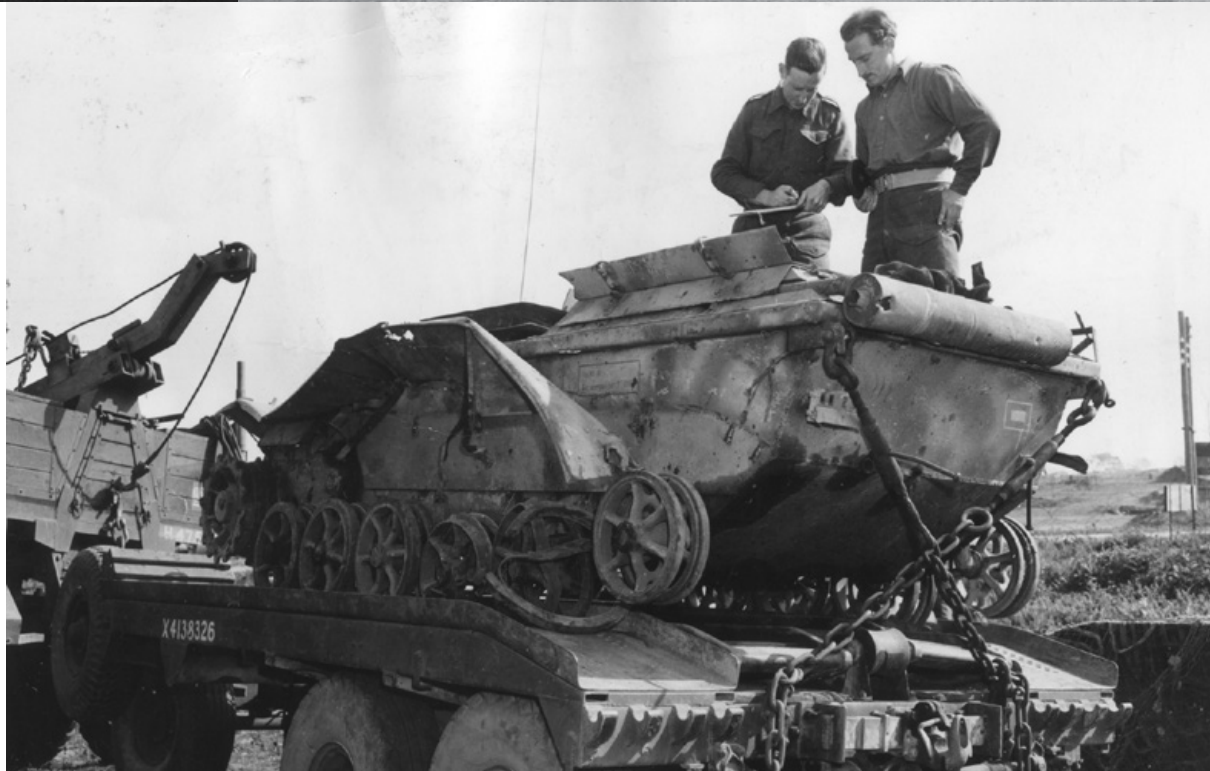
A Borgward B IV from PzAbt (Fk) 301 captured by British troops near Nettuno, Italy, is loaded on a transport vehicle to be taken away for evaluation. The tracks are badly damaged due, probably, to the vehicle being guided in to clear a minefield. The bay for the 450kg explosive charge is empty. (NARA)

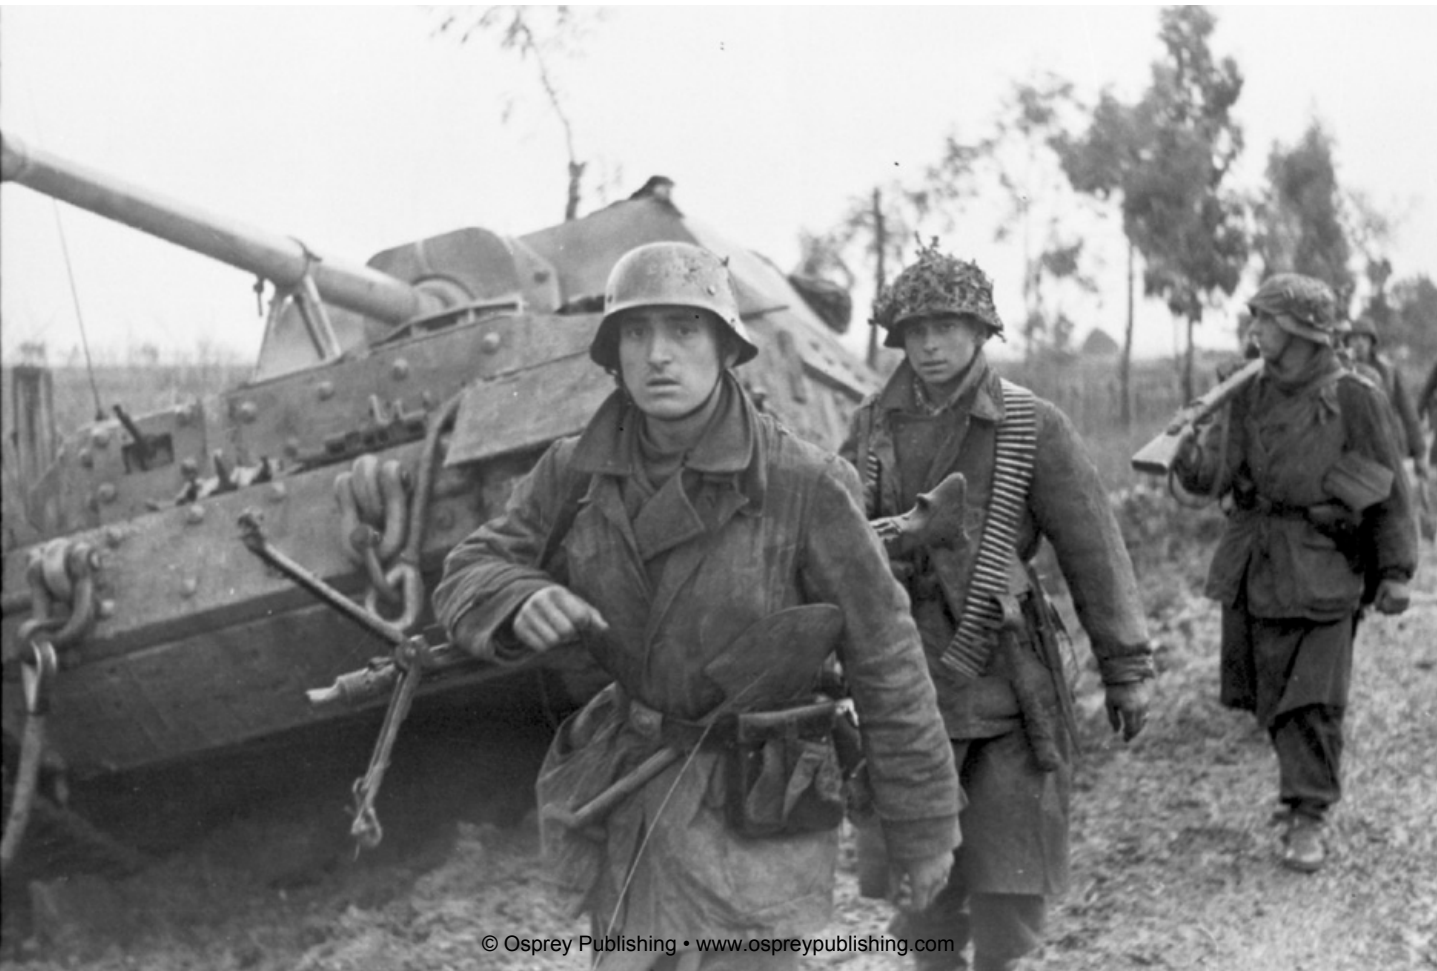
Men of a *Luftwaffe* field unit pass a damaged Ferdinand near Nettuno, Italy. Under normal circumstances this valuable asset would have been recovered by all means; the towing cables have been attached in preparation. If recovery was not possible, the vehicle would have been blown up by the crew or the recovery team. (BA 1011-311-0940-35)

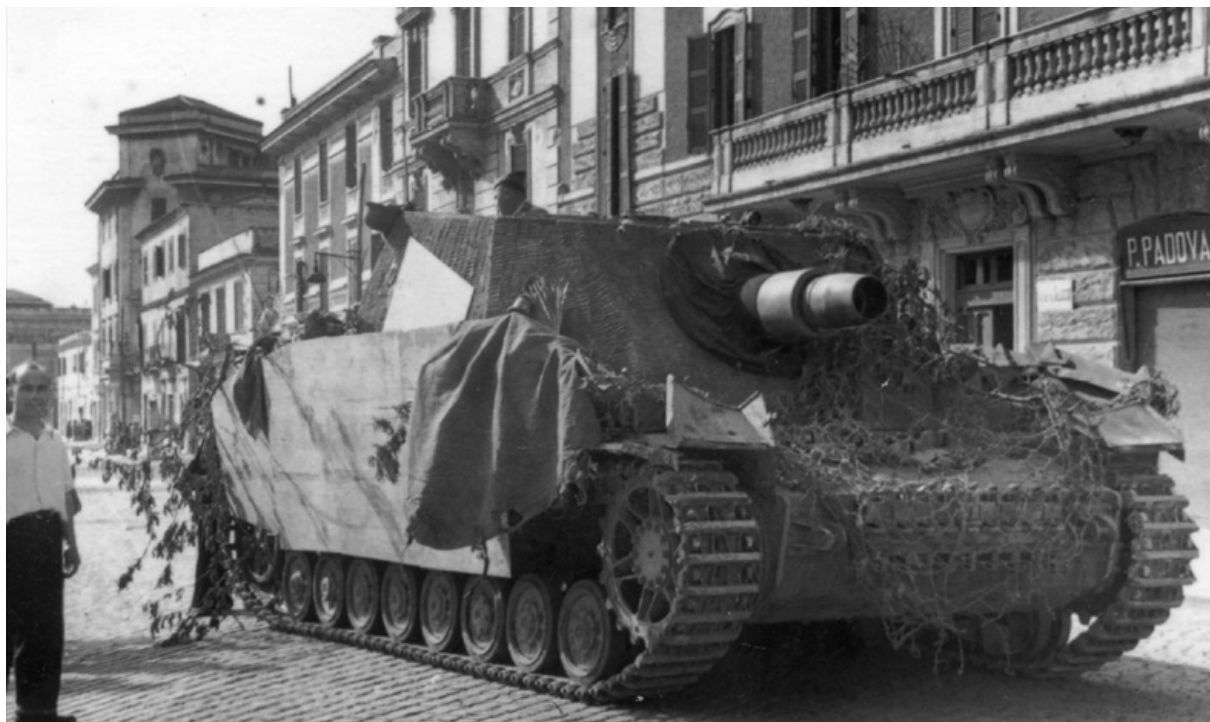
A *Sturmpanzer* with almost intact side skirts; the front segment is stored on the superstructure. (Anderson)

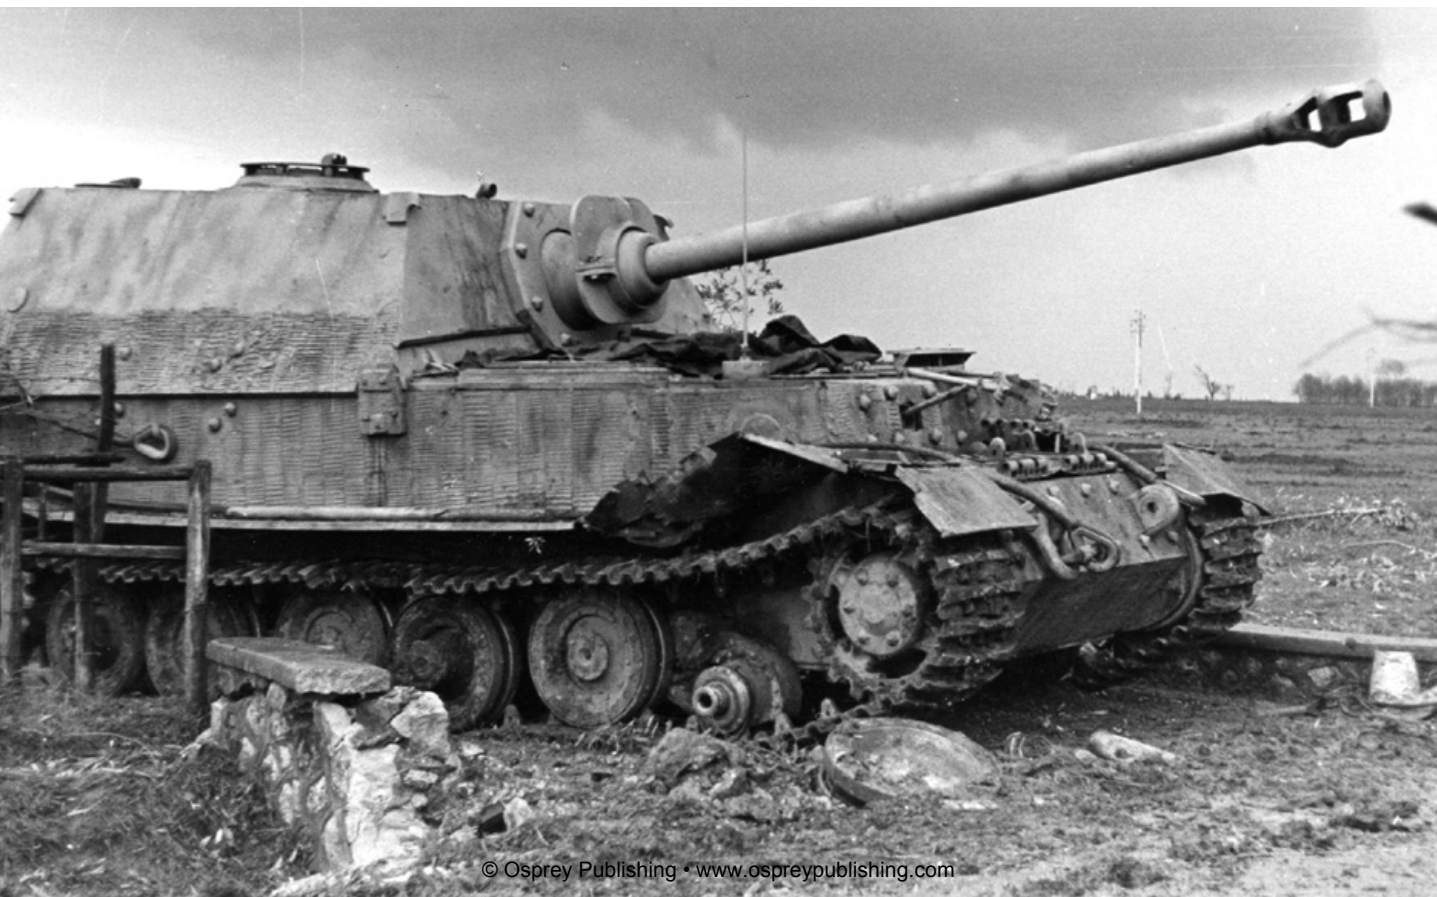
Undetected mines were a constant danger to any armoured vehicle. This *Elefant* struck a mine, near Nettuno, which destroyed the front running wheel. Although such damage was repairable, an immobilized tank was a soft target for enemy artillery. (BA 1011-313-1004-25)

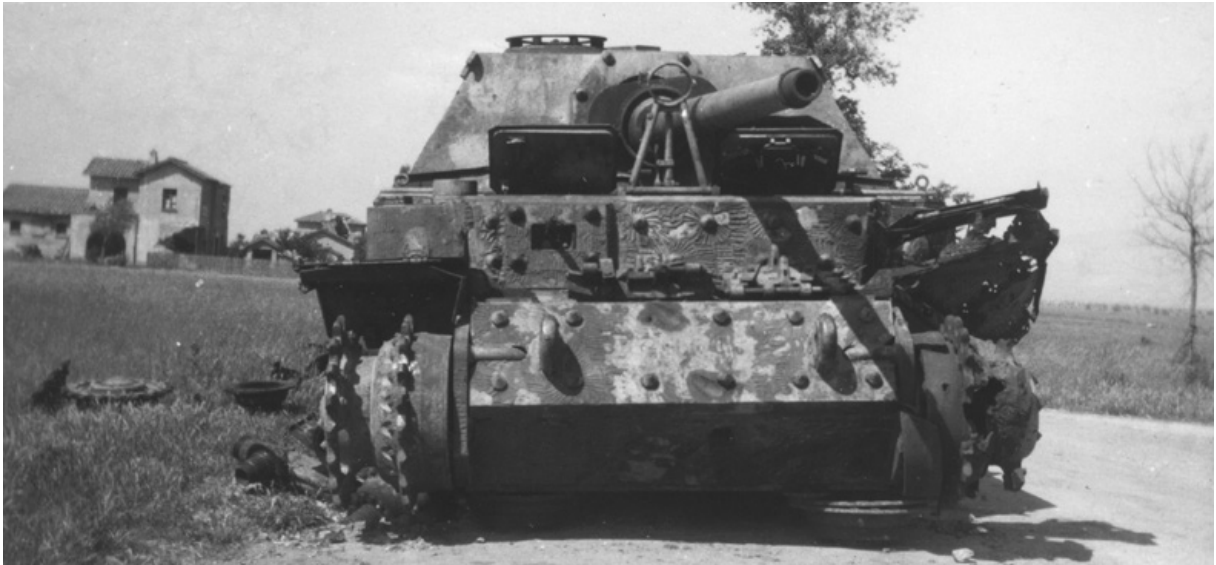
Apparently this vehicle was used as a training target for US tank gunners. Numerous hits are visible on the glacis plate, but none appear to have penetrated the heavy armour. (NARA)

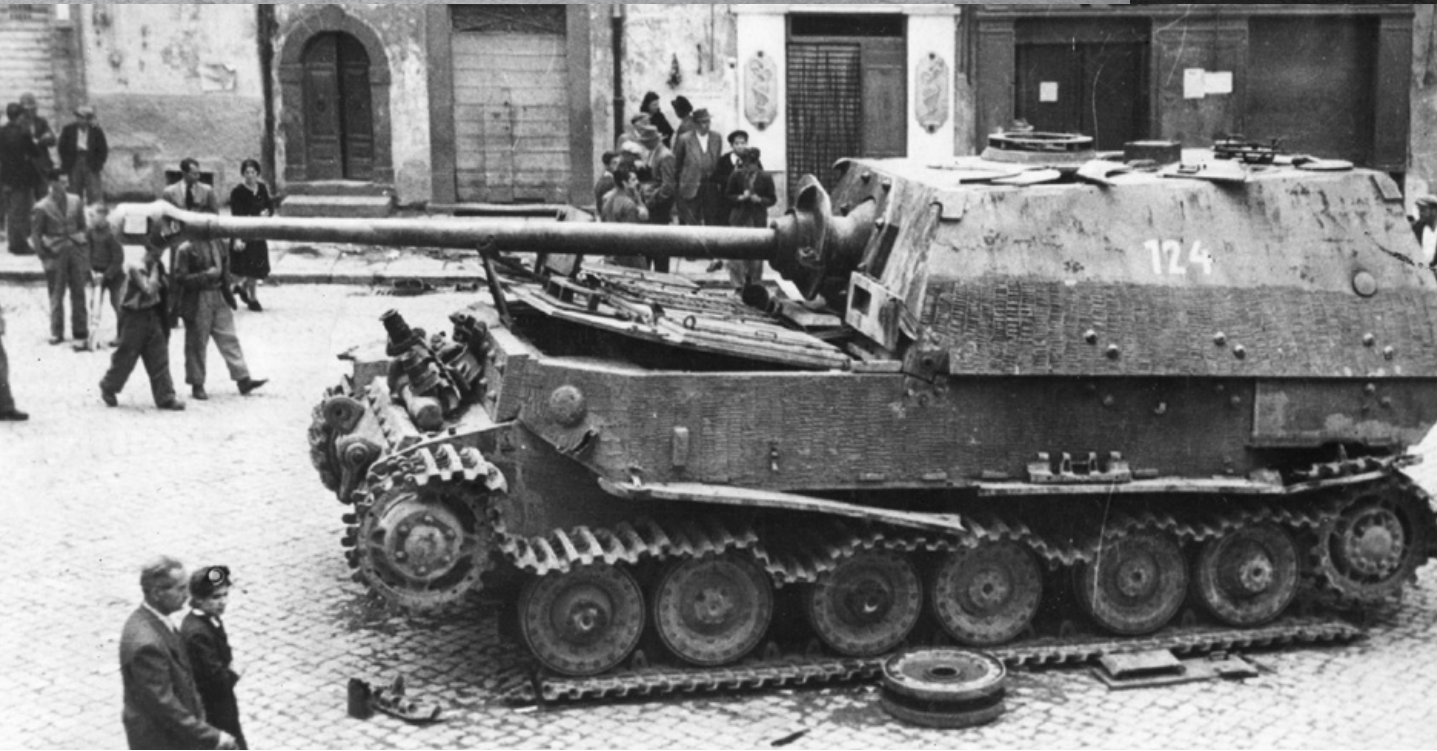
An *Elefant*, on a street in Nettuno: It appears that the vehicle has been disabled by hits on the tracks and also an internal explosion. (NARA)

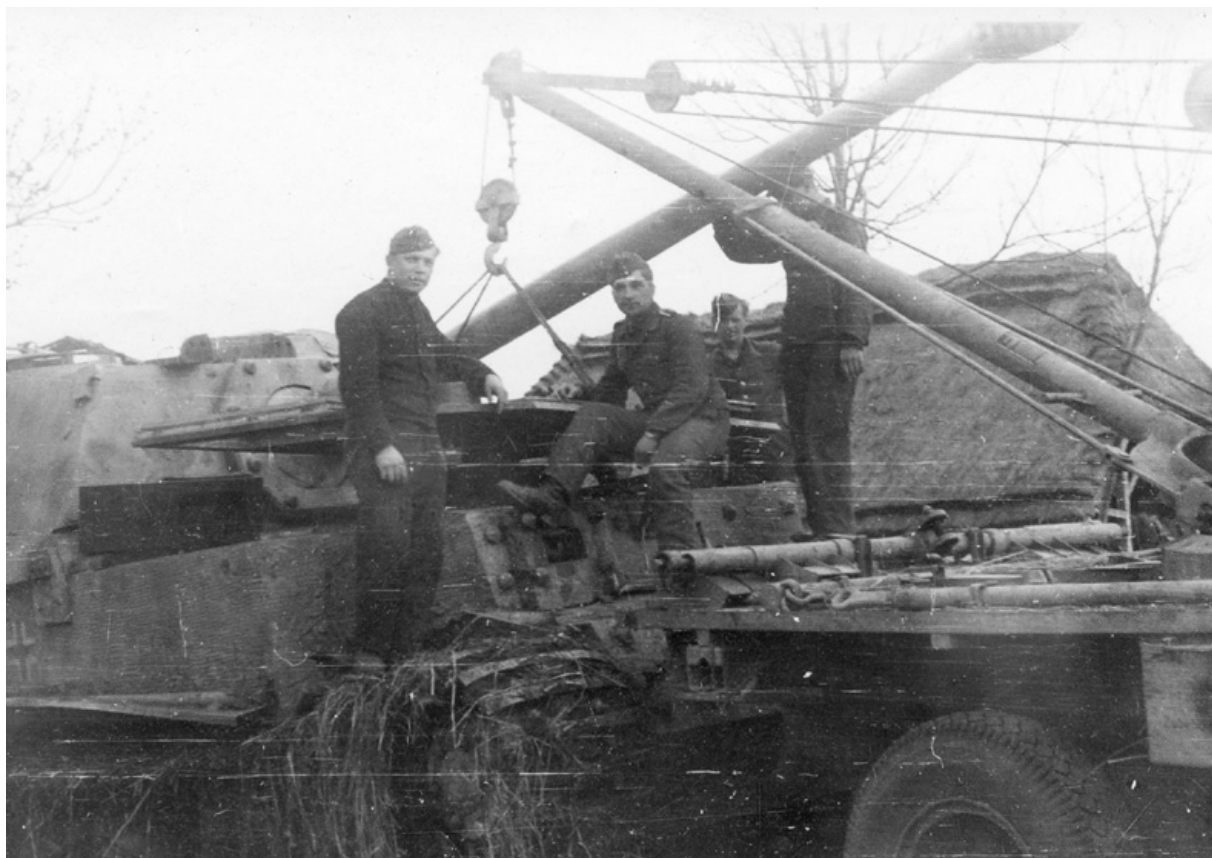
A Büssing-NAG 4.5-ton truck (Kfz 100), mounted with a 3-ton Bilstein turntable crane is used to remove the engine cover plate on a Ferdinand. The Maybach engines frequently overheated, and any serious repair work was only possible by removing this plate. (Anderson)

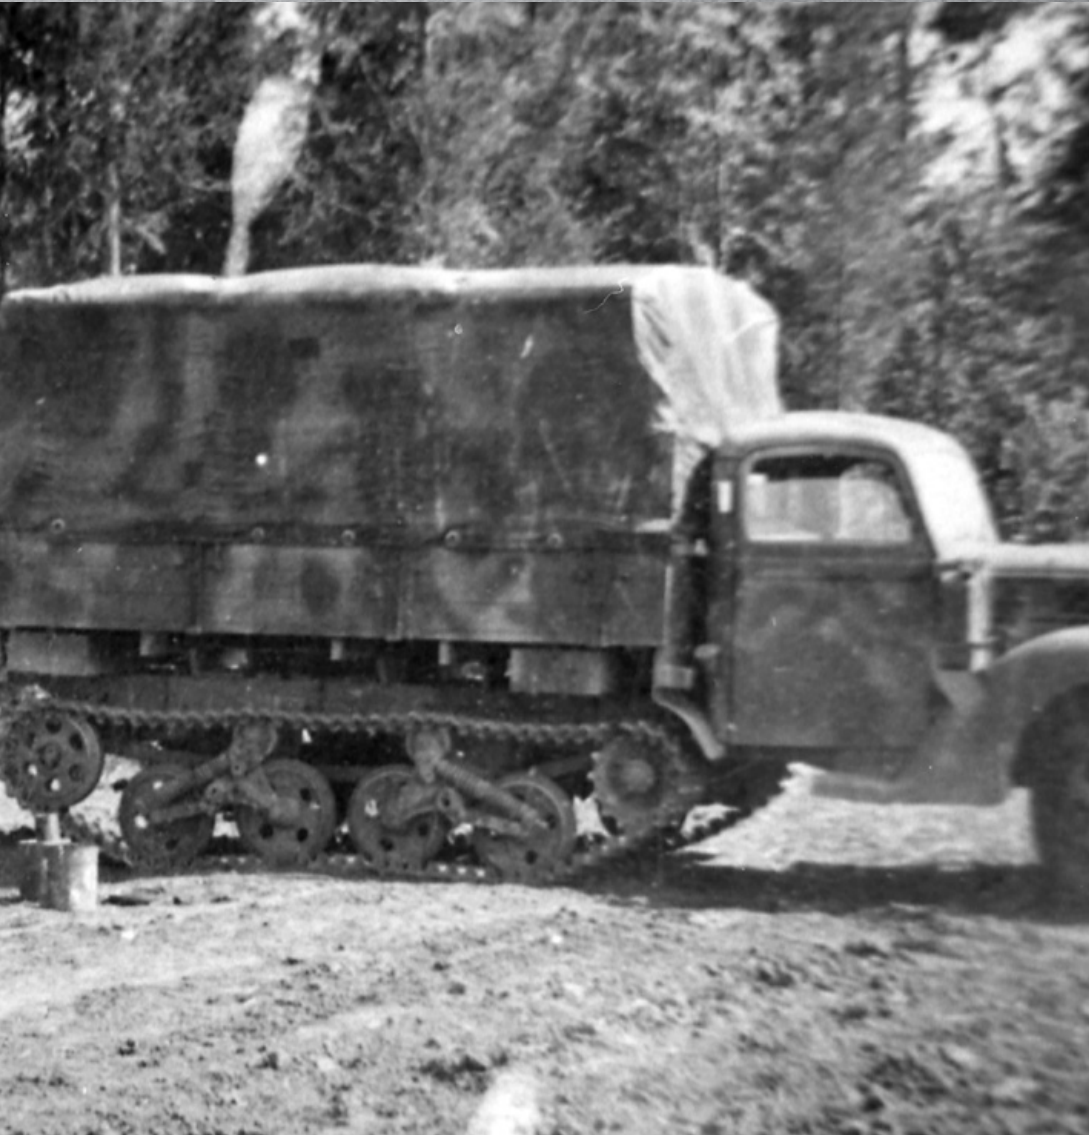
A Ferdinand being refuelled and loaded with ammunition delivered by a *Maultier* (Mule) half-tracked truck: the only type of truck that was able move supplies under all conditions on the battlefield. Note the badge of sPzJgAbt 653 on the front of the superstructure. (Münch)

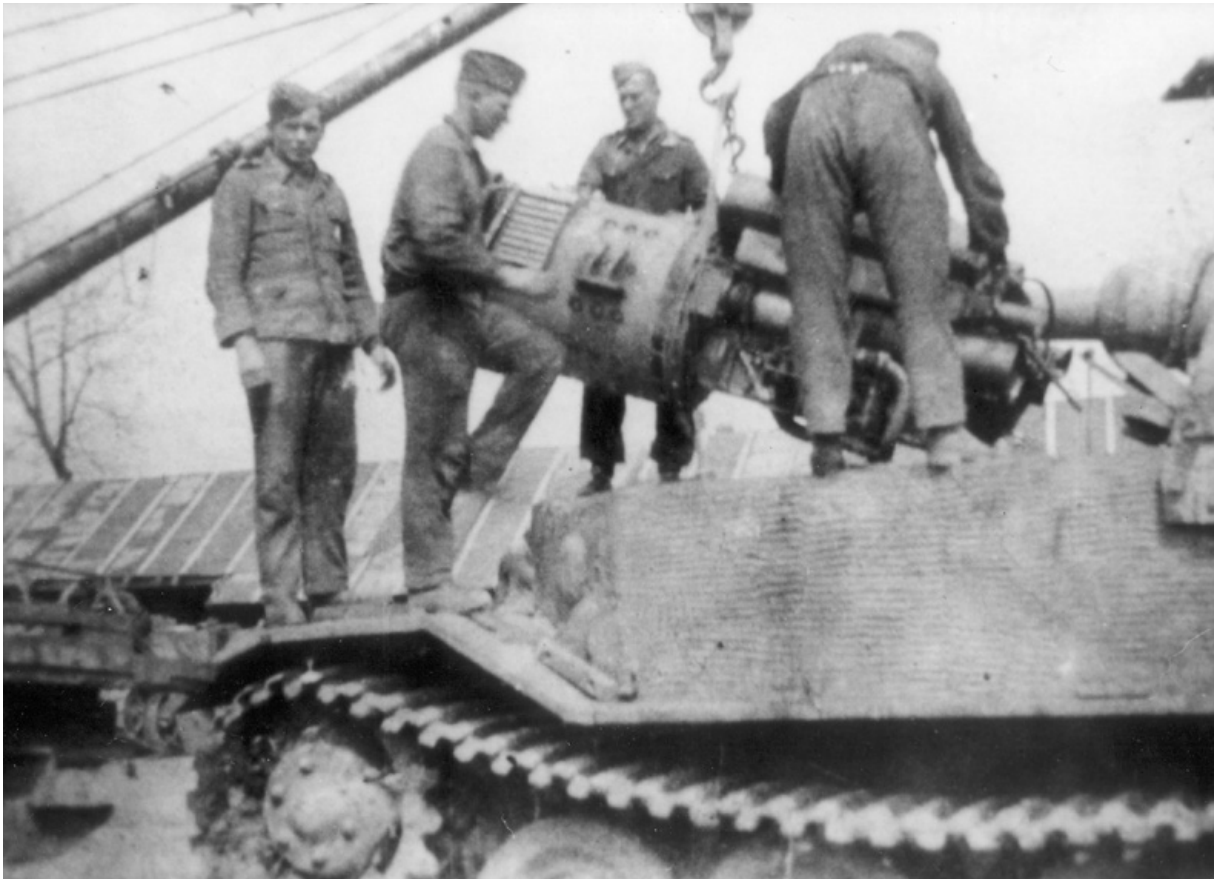
The engine compartment in the Ferdinand was very limited which made any repair work virtually impossible without removing the engine cover plate. A maintenance crew use a truck-mounted 3-ton crane to remove a complete power unit – generator and a Maybach HL 120 engine – out of the vehicle. (Münch)

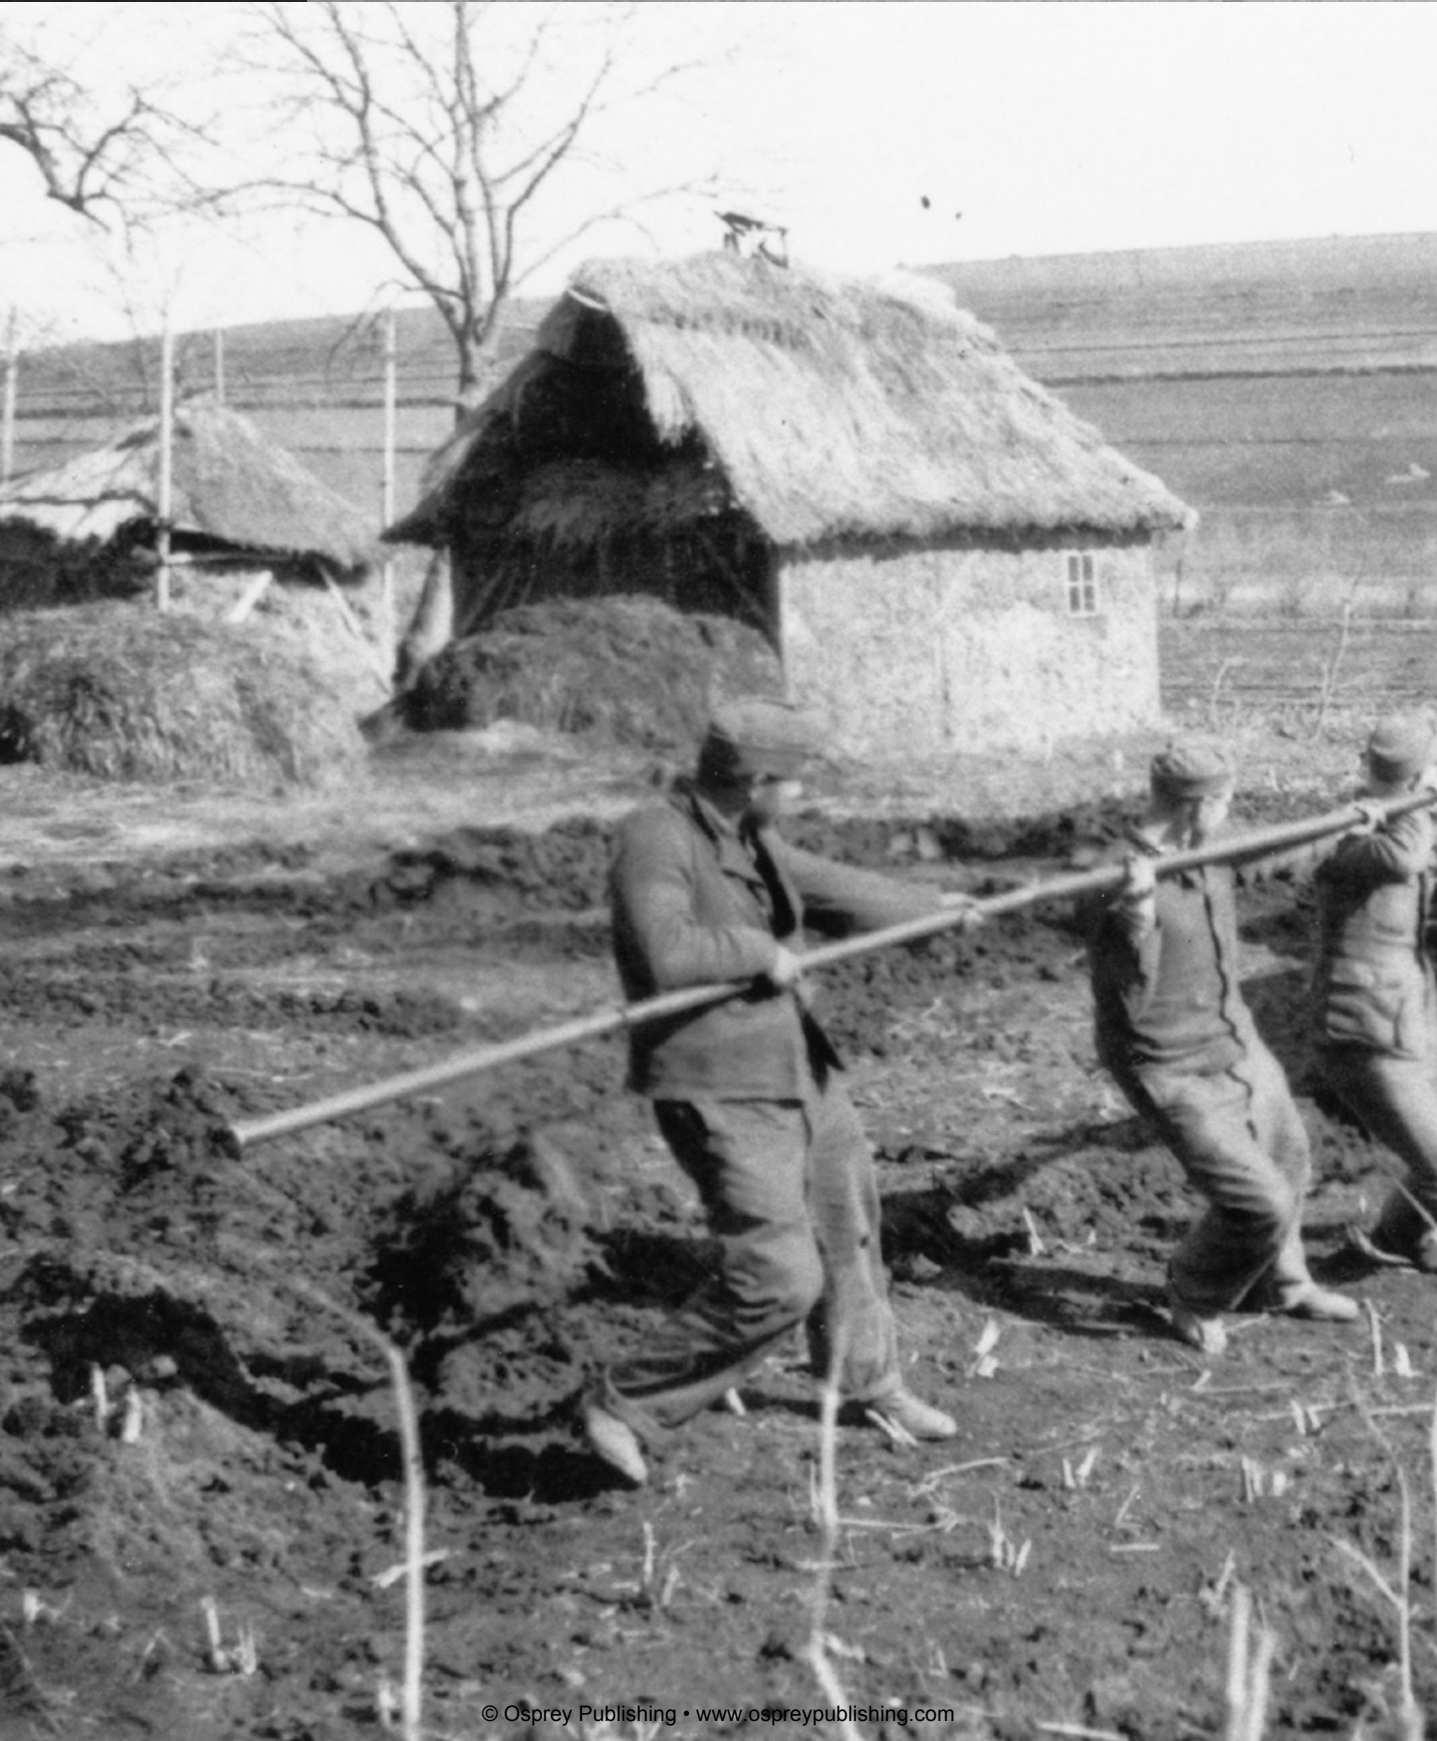
The crew of an *Elefant* uses a *Rohrwischer* (stiff brush) to clean the barrel of the 8.8cm KwK. The high-performance gun on the *Elefant*, was much feared by Soviet forces, and it allowed sPzJgAbt 653 to hold their positions while suffering very few losses in men and material. (Schneider)

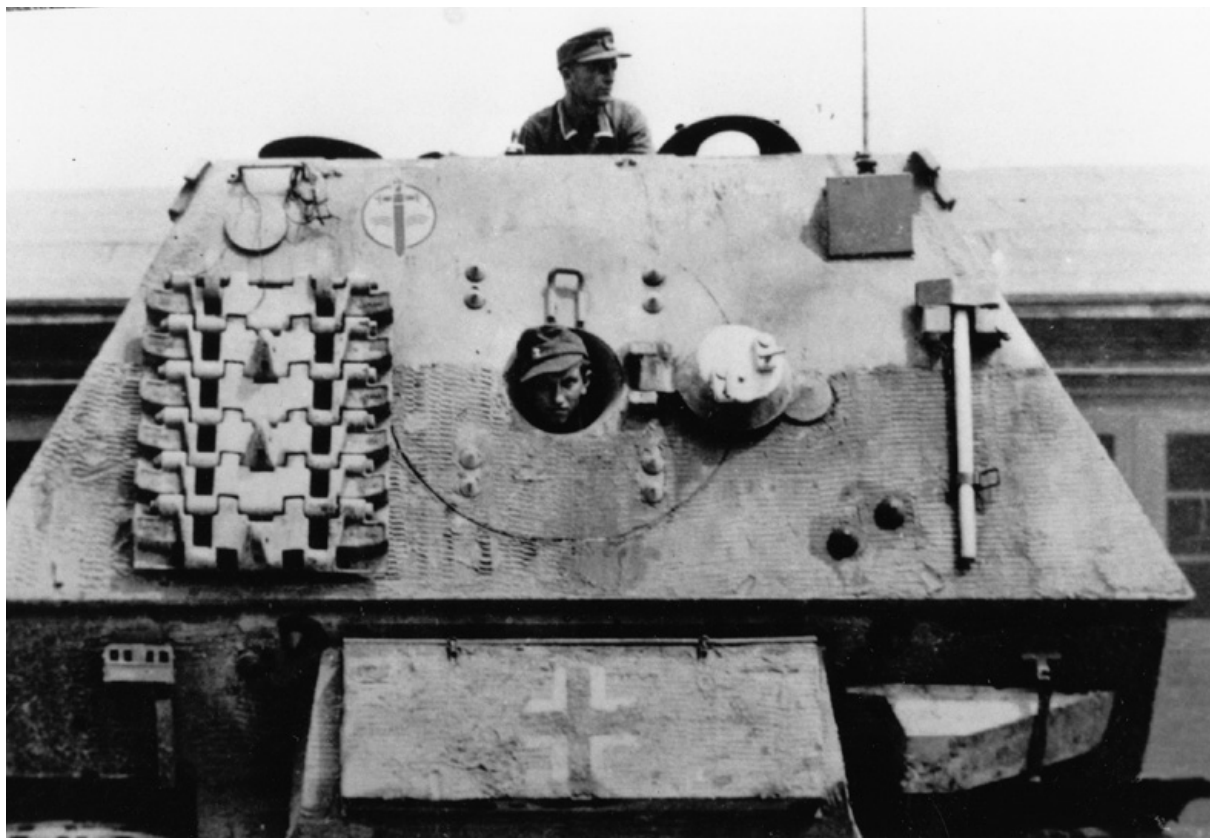
An *Elefant* fitted-out as a command tank, note the second radio antenna mounted on the rear of the vehicle. The large box mounted on the exhaust cover contained the gun-cleaning kit. (Schneider)

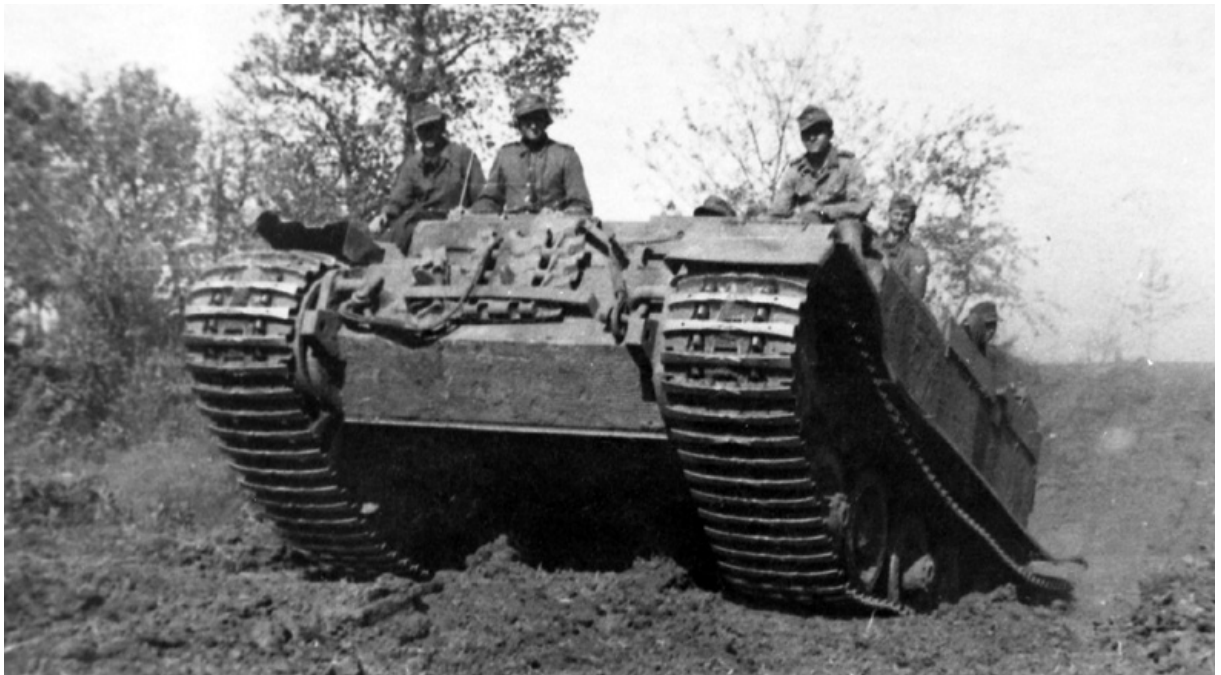
The *Berge-Elefant* recovery tank was a powerful vehicle, but it was not fitted with a winch. Any immobilized *Elefant* would have to be towed out of the mud, a procedure which stressed the vehicle's delicate transmission. (Münch)

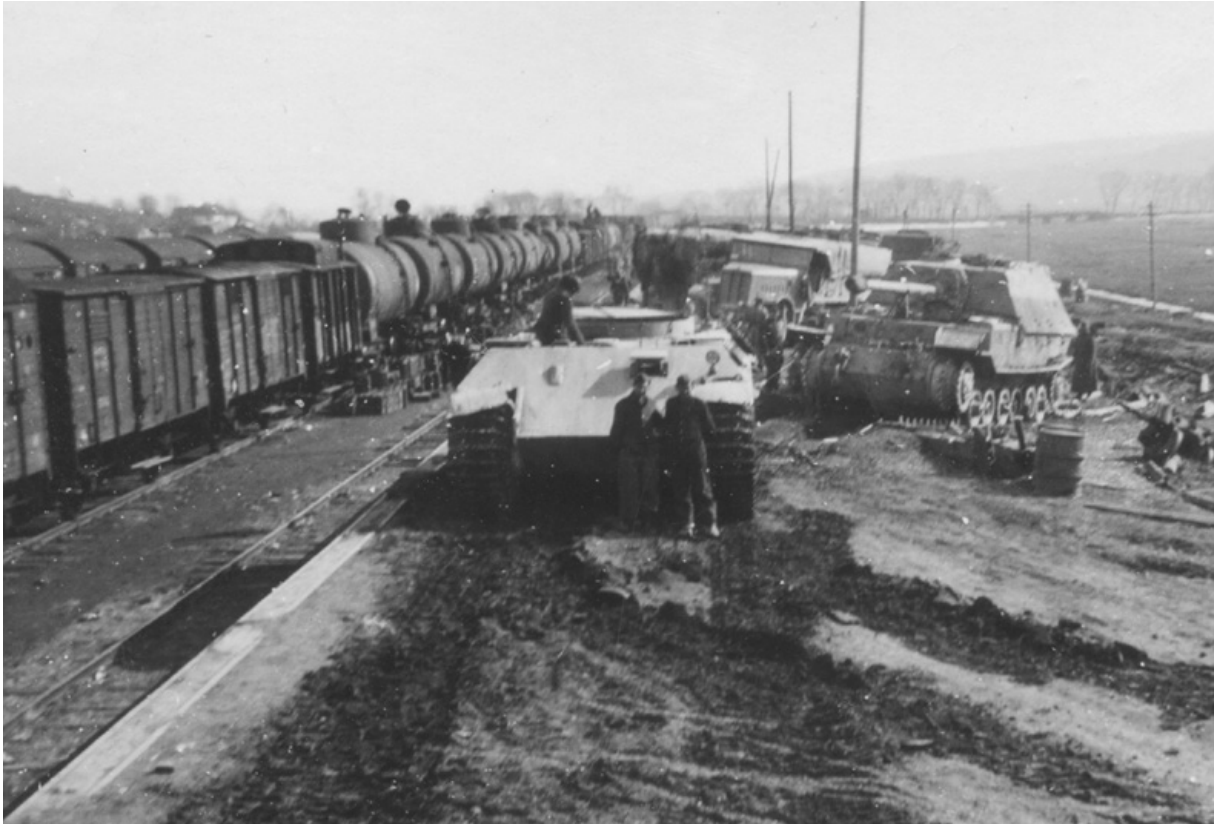
Loading damaged *Elefants* onto a railway wagon was a very difficult task, and almost impossible without a head ramp. A *Bergepanther* is being used to haul a trackless *Elefant* nearer to the loading platform. (Anderson)
