FERDINAND AND ELEFANT TANK DESTROYER

OSPREY
PUBLISHING

Thomas Anderson

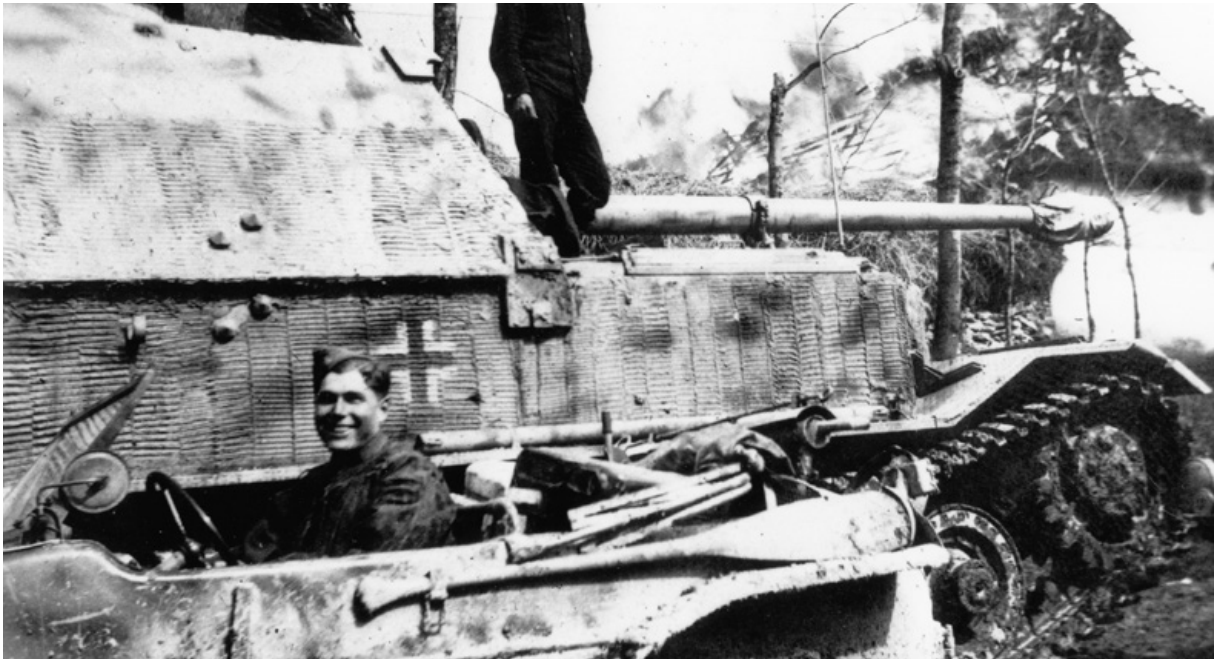
The crew of *Elefant* '221' assisted by men of the workshop company attempt to repair a damaged bogie; a replacement running wheel is ready to be fitted. (Anderson)

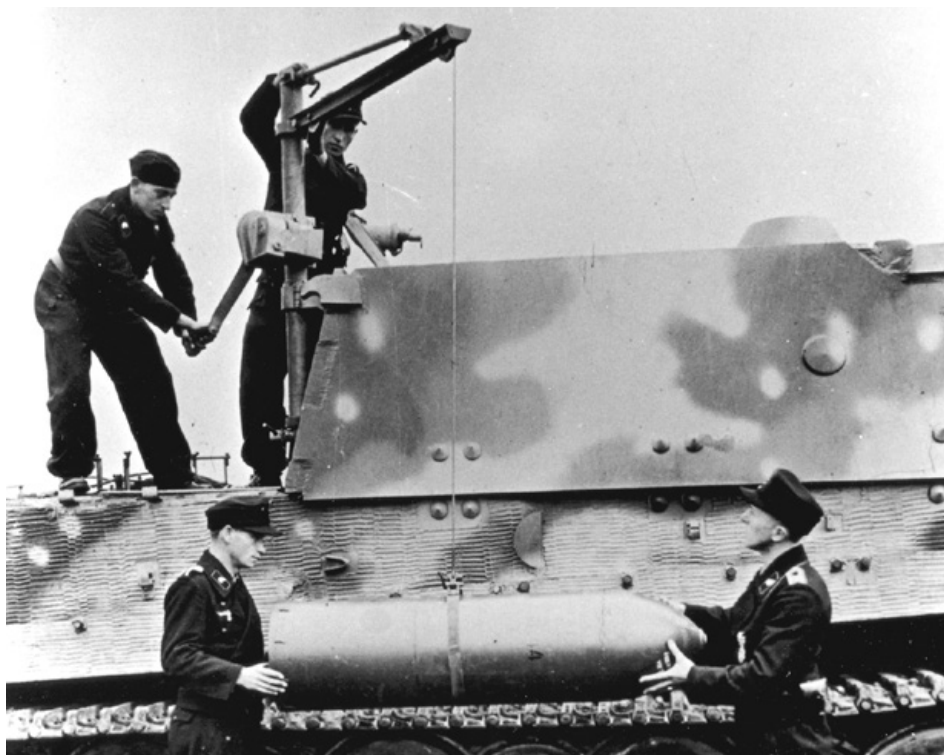
The crew of a *Sturmörser* carefully loads a massive 38cm rocket shell using a turret-mounted gantry crane. The tank is painted in the *Licht-und-Schatten Tarnung* (Light and Shadow camouflage), also known as the ambush scheme. (Historyfacts)

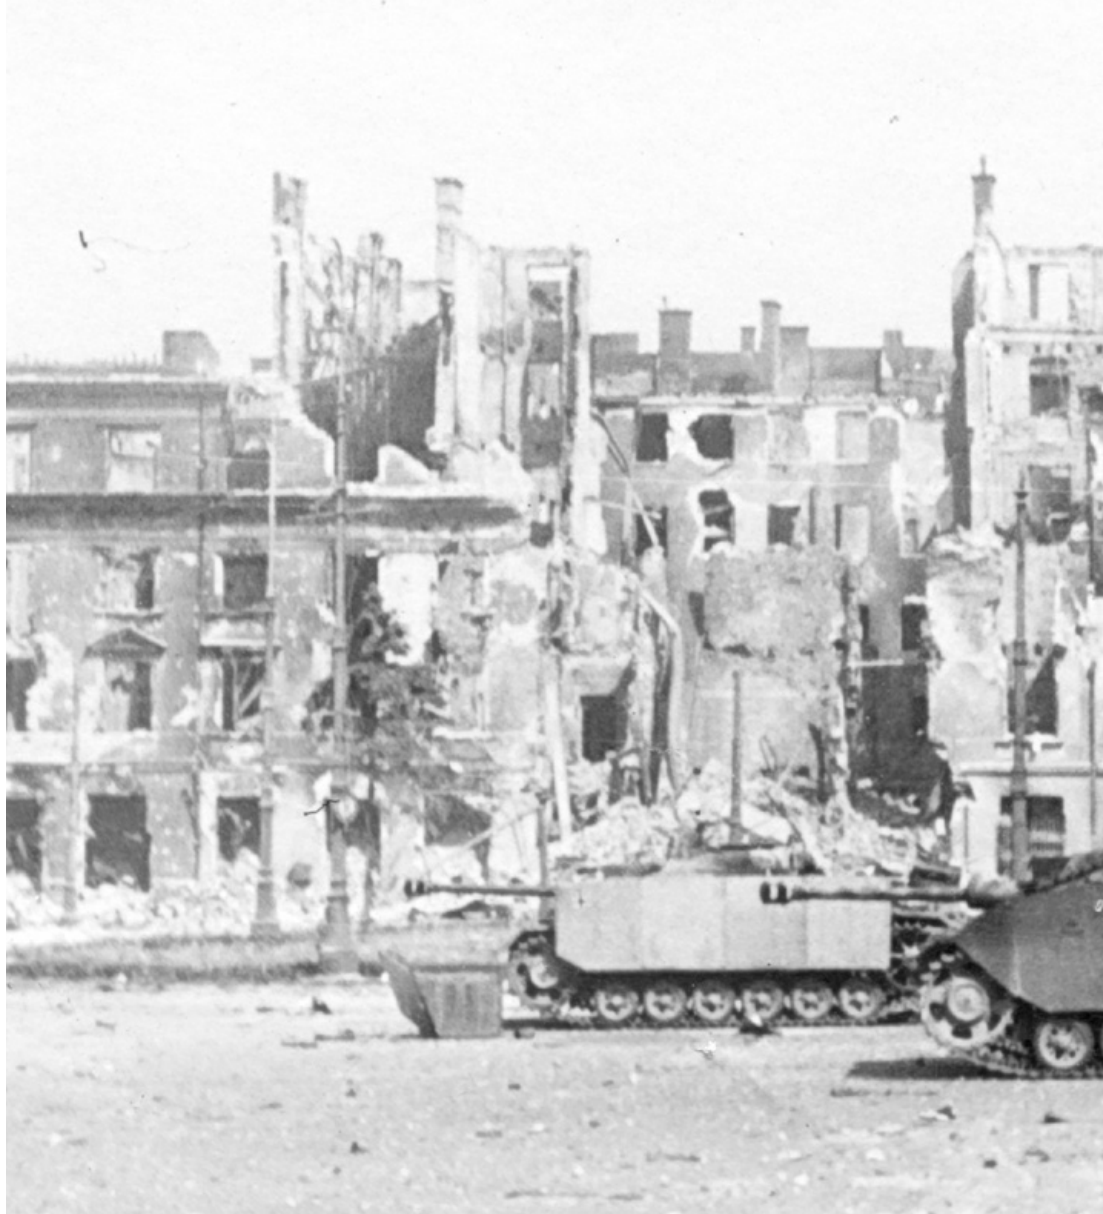
Two *Leitpanzer* (StuG III Ausf G) hold a defensive position amongst the shattered buildings of what had been Warsaw. Some *Sturmgeschütze* in the unit were fitted with the somewhat smaller PzKpw III-style side skirts. (Anderson)

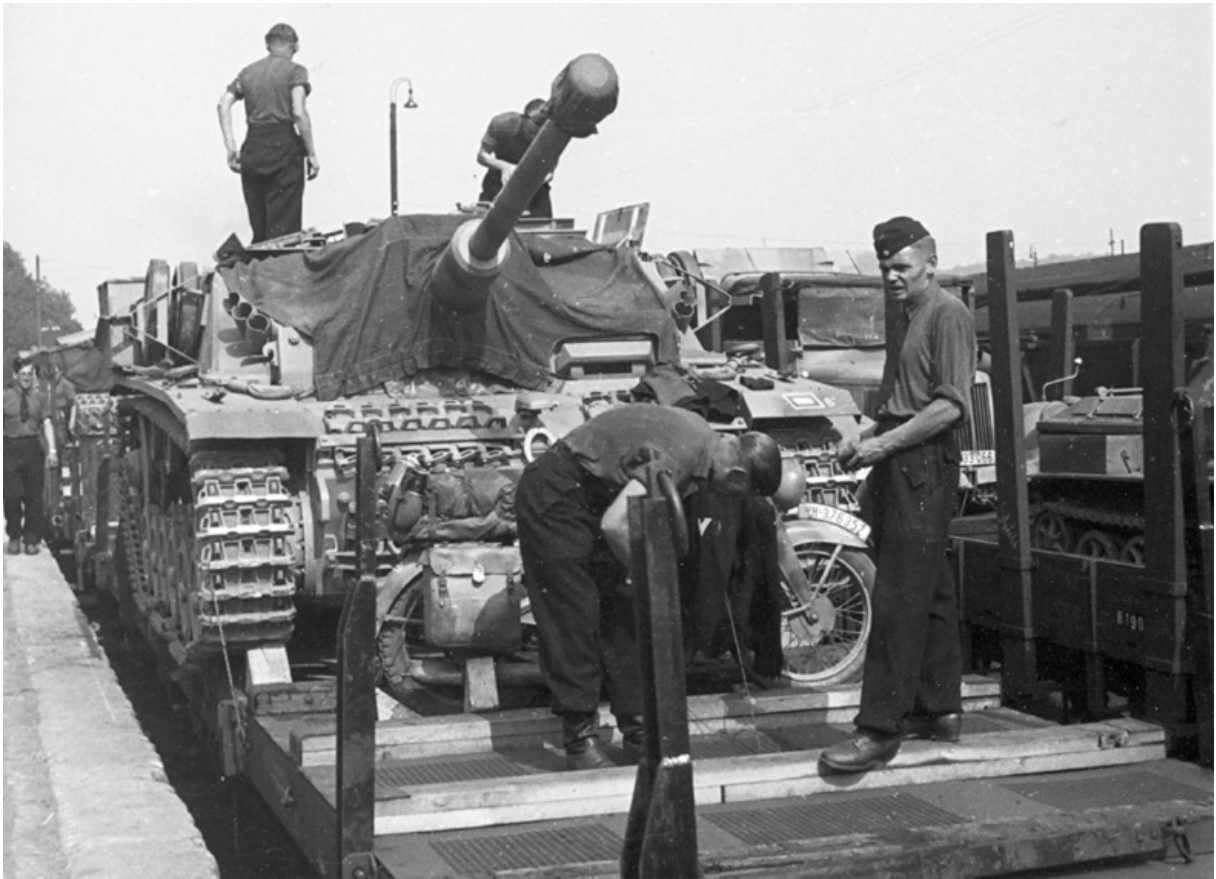
A *Leitpanzer* (StuG III Ausf G) with a large tarpaulin cover over the gun mantlet. Note the tactical marking on the track guard, the letter 'B' refers to the name of the company commander. (Schneider)
