# Steyr 1500A

PHOTO MANUAL FOR MODELERS

n° 9

**Steyr 1500A in detail**

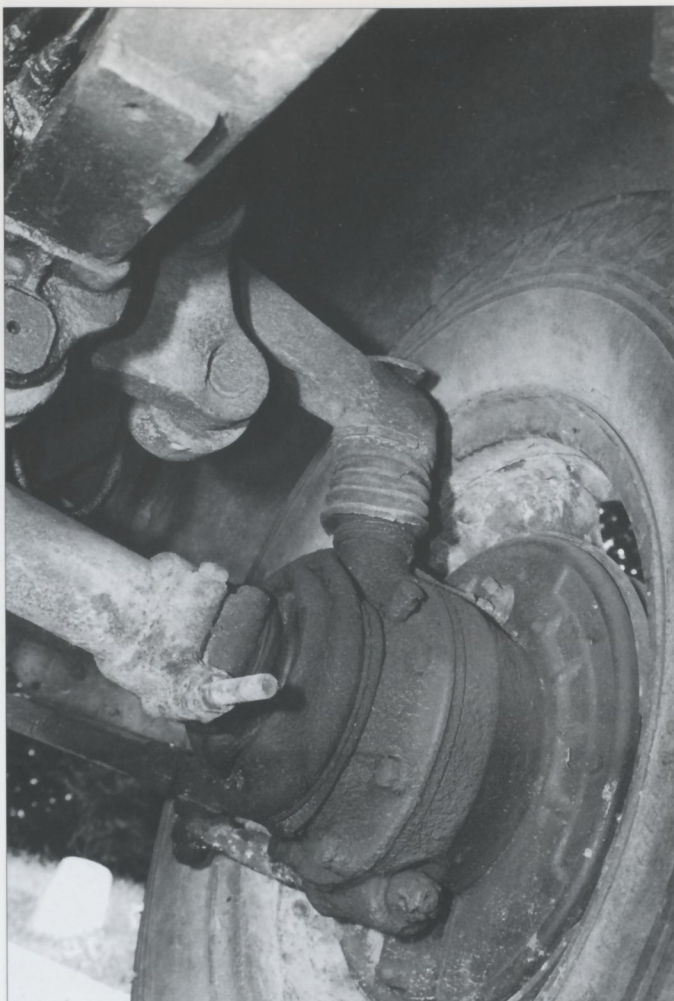
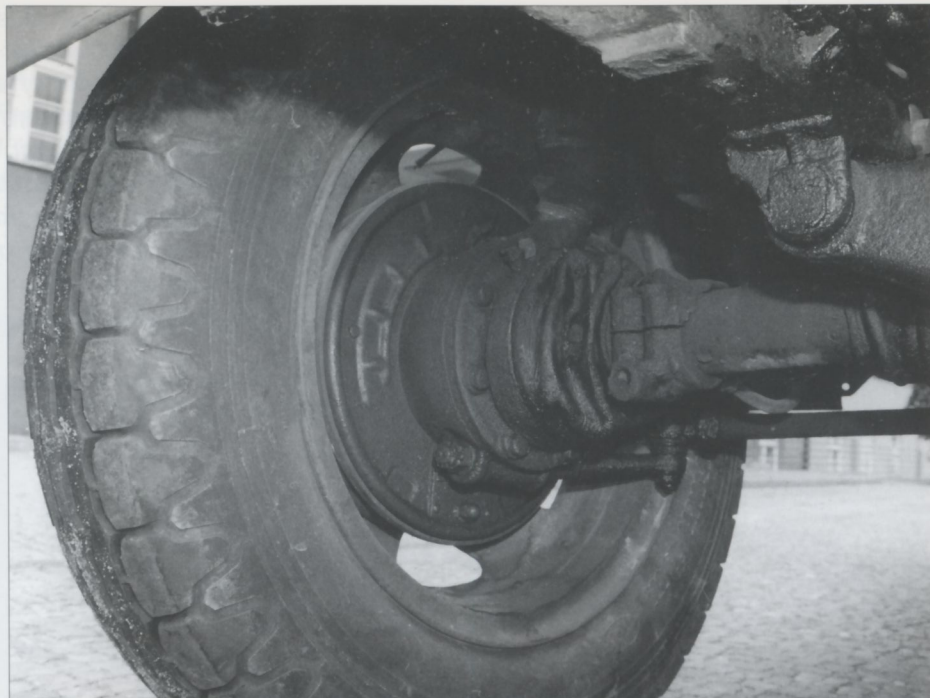
*The picture above shows the same front semi-axle, like the picture on the opposite page, taken from a different direction.*

*The right picture shows the transfer case and tie rods.*

*The vehicle shown here is not fitted with front shock absorbers, probably due to a lack of original parts. Note also the position of the knuckle arm below the wheel hub.*

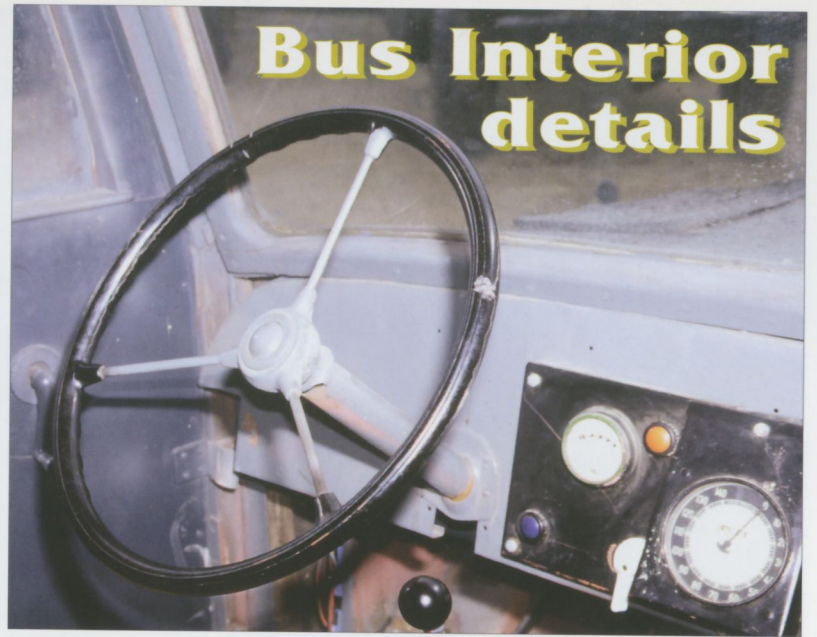
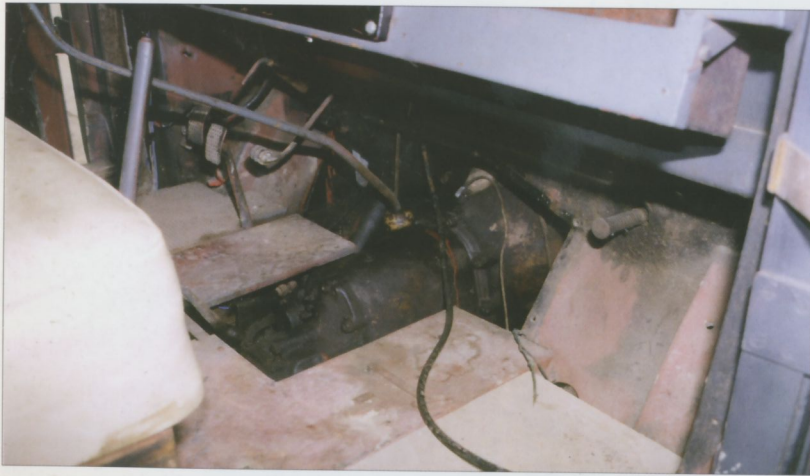
*The pictures on this page show interior details. Most of them are identical with the other Steyr 1500A variants. The floor panels are missing probably due to a lack of original parts.*

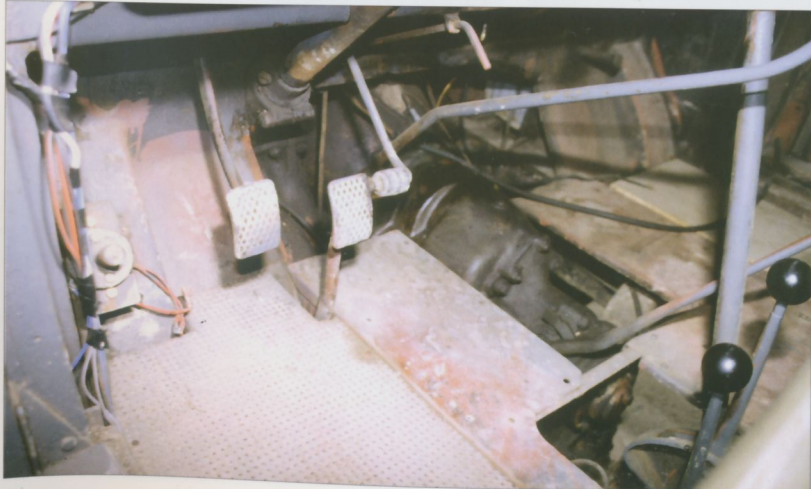
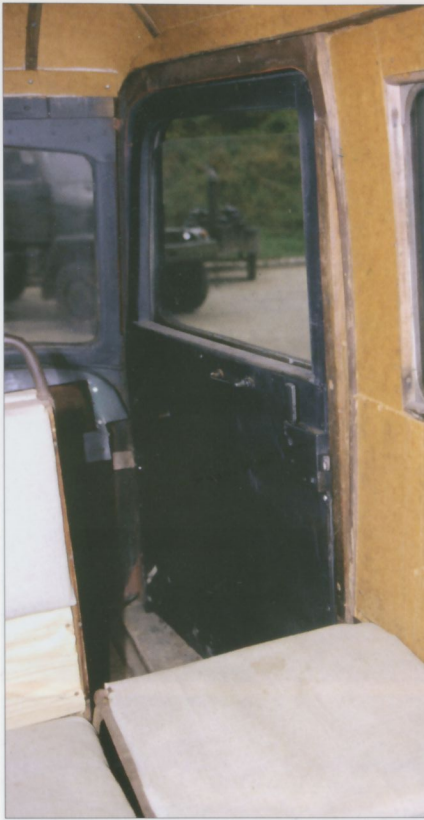
*Top and middle right pictures show the bus body construction. The body is constructed of wooden beams and ribs, with the outer skin of sheet metal. The inner skin is made of impregnated cardboard, see the pictures on the right. The compartment behind the rear bench is accessible by the door located below the rear window, see the picture on pages 20 and 21.*

str. 23  
Obrázky nahoře a uprostřed vpravo ukazují konstrukci autobusové nástavby. Konstrukce karoserie sestává z dřevěných žeber a podélníků, s vnějším plechovým potahem. Vnitřní plášť je vytvořen z impregnované lepenky, viz obrázky napravo. Prostor za zadní lavicí je přístupný dvířky pod zadním oknem, viz obrázky na str. 20 a 21.

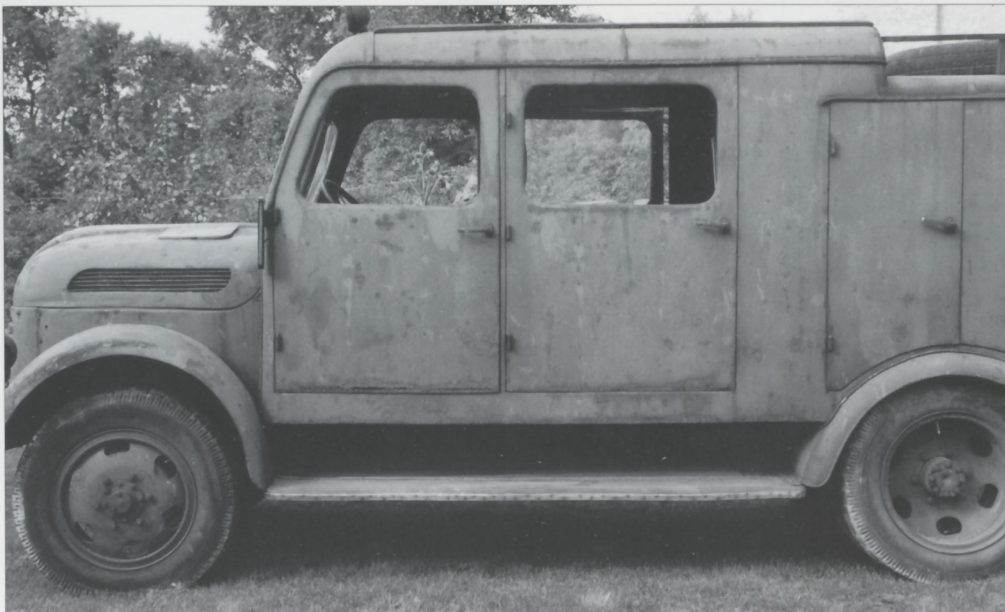
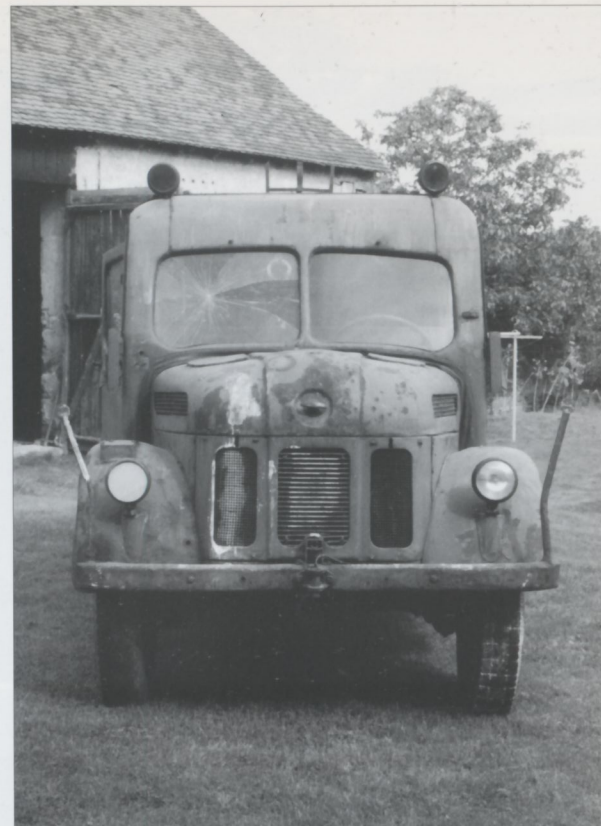
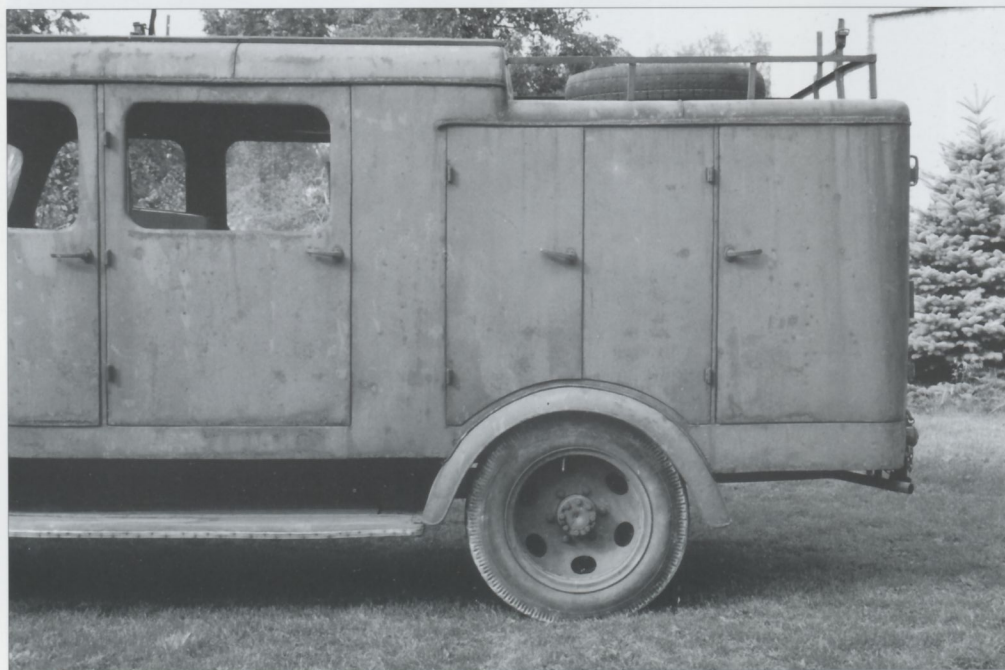
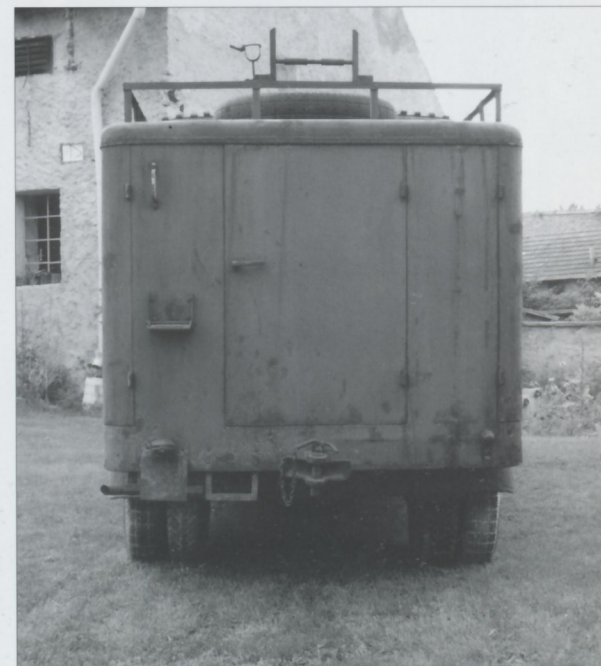
## Steyr 1500A Fire Engine Walk Around

*The Steyr 1500A chassis was ideal for the installation of a fire engine body. Pictures here show this vehicle with standard German crew body LF-8 (LF for Löschfahrzeug or fire engine). A similar body was installed also on other chassis like f. e. Mercedes Benz L 1500(A).*

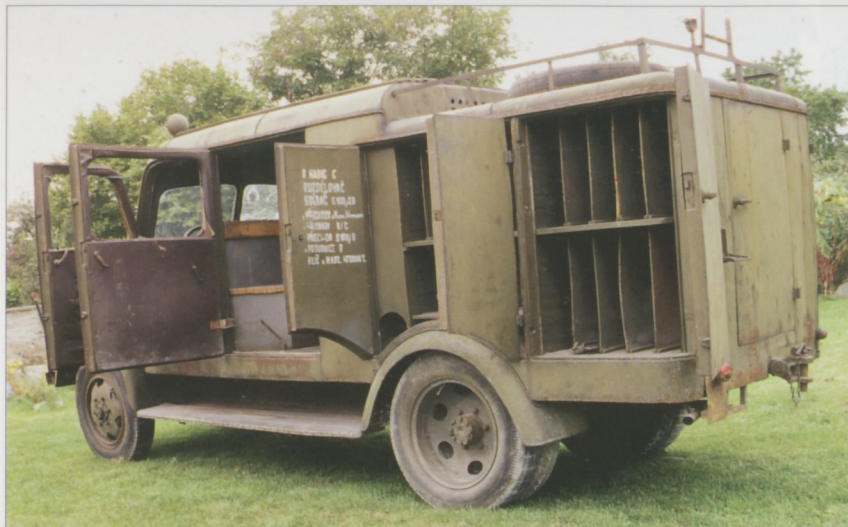
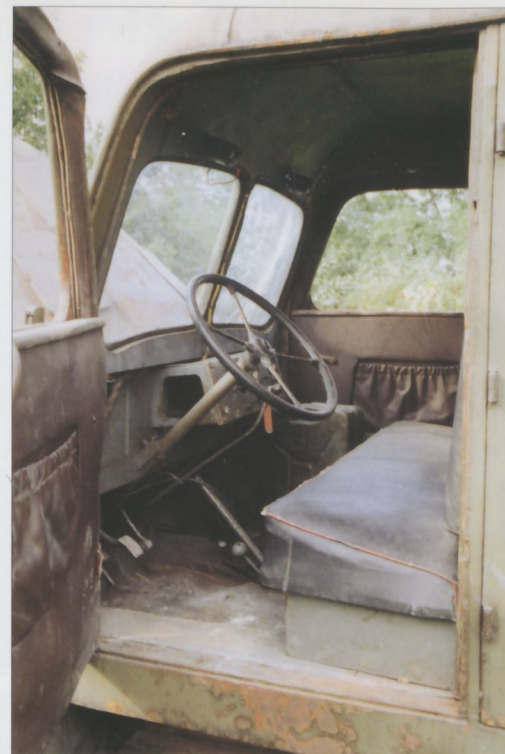
*Lockers in the rear part of the body were used for storing fire-fighting equipment, especially hose reels, nozzles, hose fittings etc. Lettering shown on some pictures is in Czech and is obviously a reminder of post-war service with a Czech fire brigade.*

Popisky na stěnách prostoru posádky jsou pozůstatkem poválečné služby u českého požárního sboru. Sedačka s koženkovým čalouněním je údajně původní, zatímco dřevěná sedačka byla instalována až během poválečné služby.

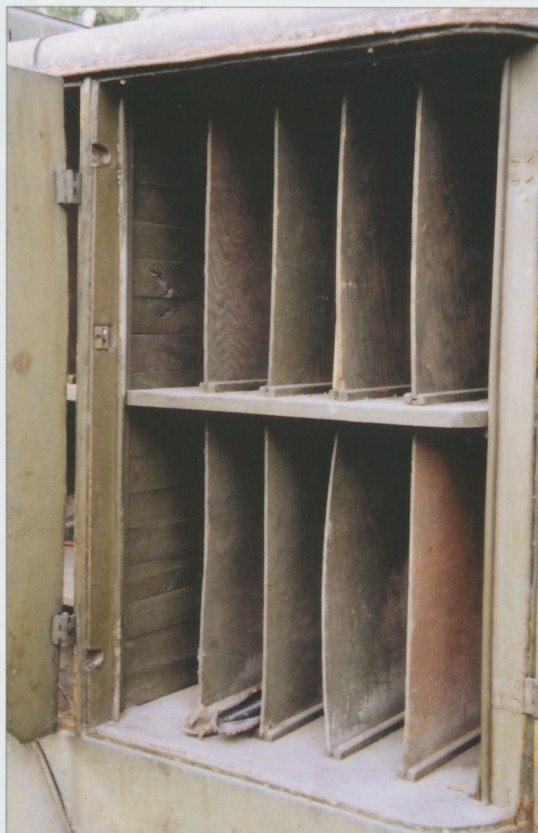
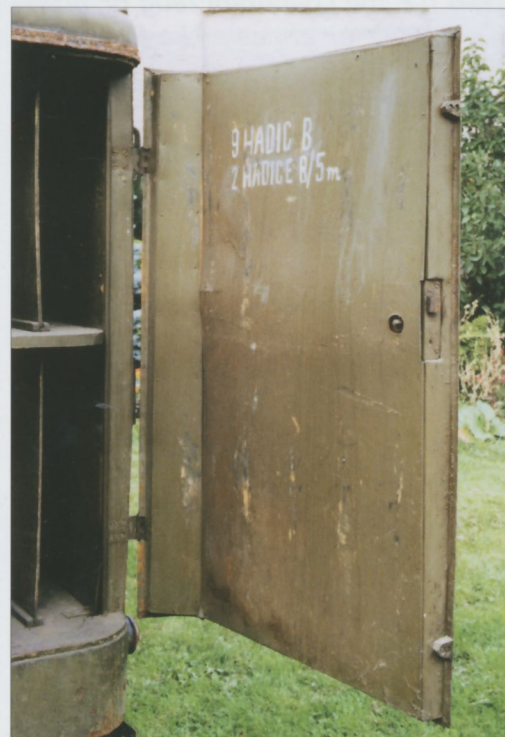
## Fire Engine Accessory Compartments

*The compartment behind the rear door was used for transporting the water pump unit, top left picture. The seats in the rear crew compartment fold up and the area beneath was used for storing the firemen's gear, the left bottom picture.*

Str. 27  
Prostor za zadními dveřmi sloužil k převozu motorové pumpy, obrázek vlevo nahoře. Sedačky v zadním prostoru posádky byly sklápěcí a prostor pod nimi sloužil k uložení hasebních pomůcek, obrázek vlevo dole. Vyklápěcí směrovky byly instalovány až během poválečné služby.

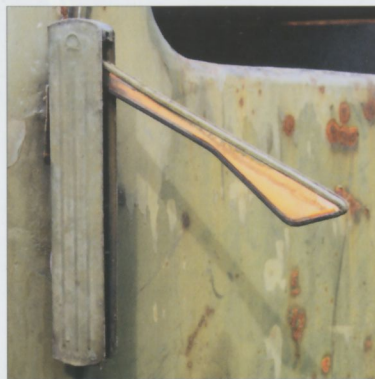
*The turn signals, shown above, were added during the post war service.*

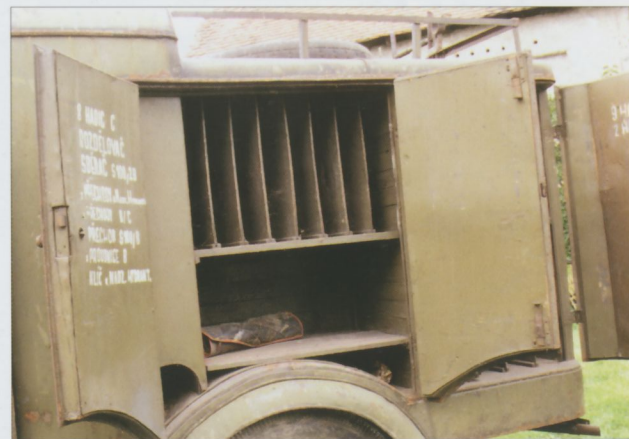
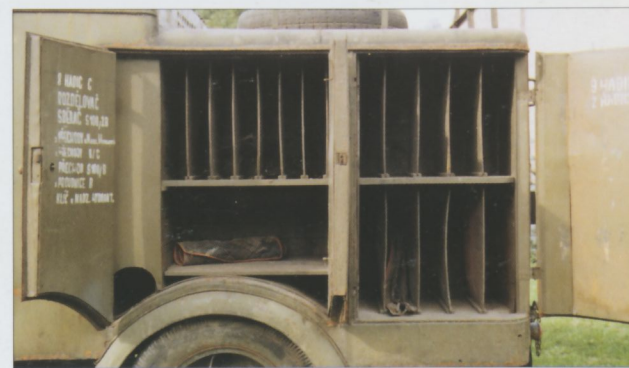
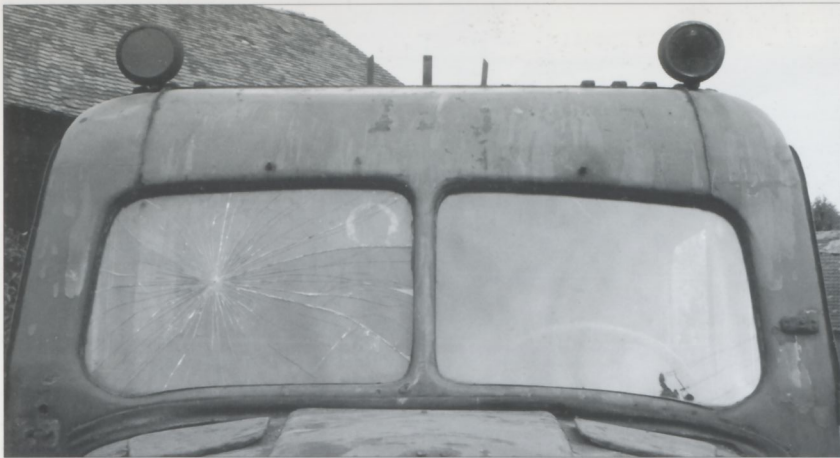
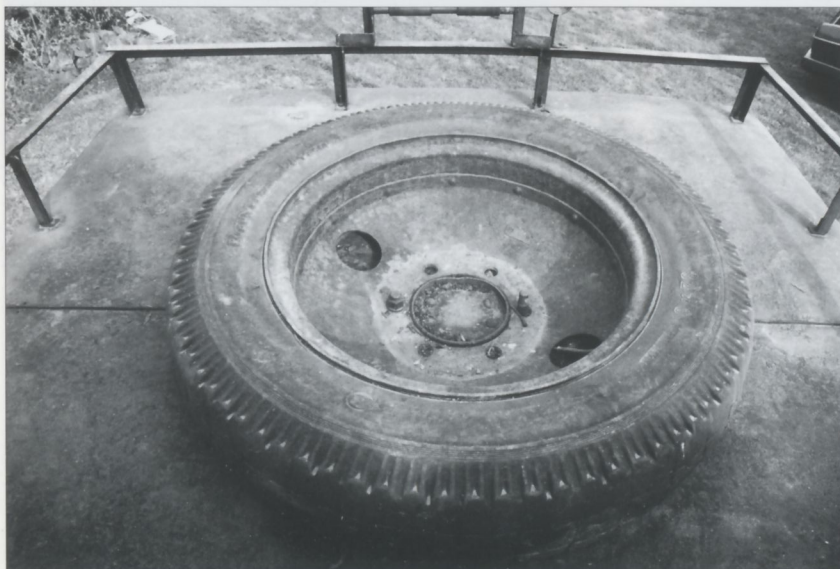
*The roof above the crew compartment was reinforced by wooden framing, which allowed it to be stepped on. Fittings on the front end of the roof and on the rear handrail, shown in detail in the top right pictures, were used for securing the ladder and hooks.*

Obr. 28  
Střecha nad prostorem posádky byla zesílena dřevěnými latěmi, což dovolovalo stoupnout si na ni. Spony na přední části střechy a na zadní ohrádce sloužily k upevnění žebříků a háků.

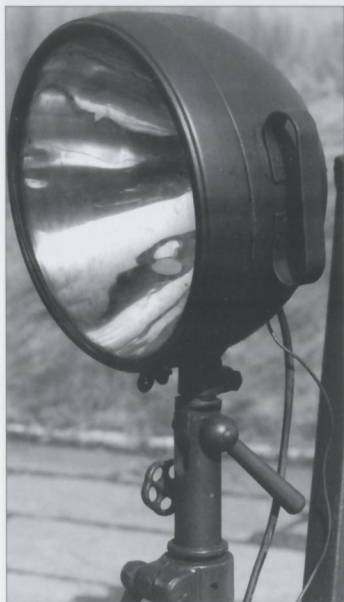
*The spot light, shown here installed on the Opel Blitz, was a standard piece of equipment on German fire engines and did not appear on this Steyr due to the lack of original spare parts.*

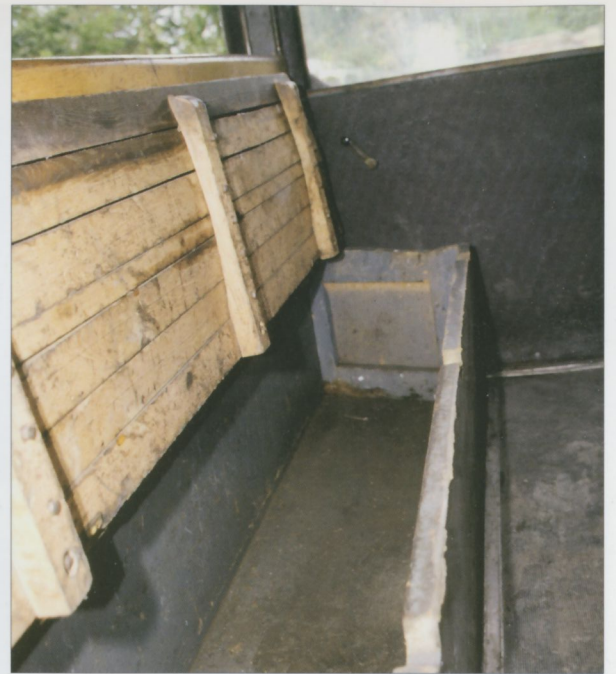
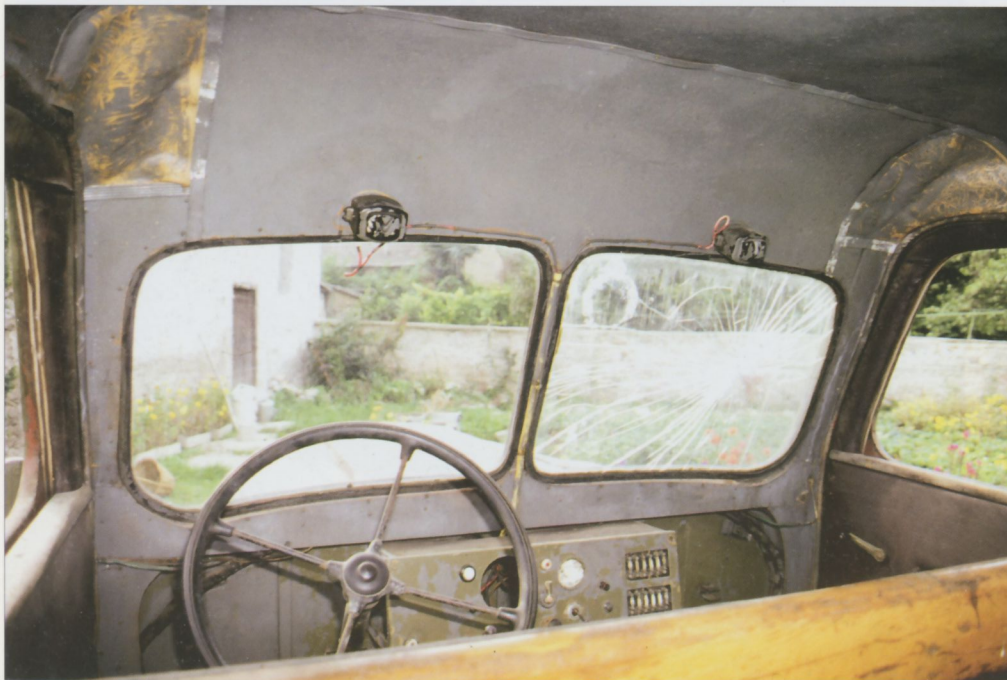
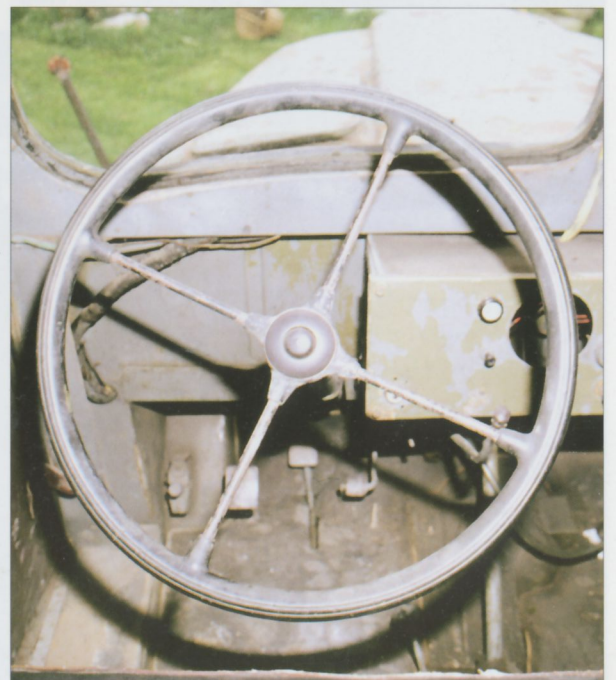
*Vehicle controls shown in the picture below were taken from the standard Cargo cab, as well as the front windows. The above left picture shows the rear wall of the crew cab. Two rows of circular openings visible above the opened locker are manually operated air vents. Note also the open locker beneath the folding bench, the top right picture.*

str. 30  
Ovládací prvky vozidla, viz obrázek dole, jsou převzaty ze standardní kabiny nákladního automobilu, stejně jako přední okna. Na obrázku nahoře je vidět zadní stěna prostoru pro posádku. Dvě řady kruhových otvorů, viditelných nad otevřenou přihrádkou, jsou ručně ovládané ventilační průduchy. Pověšněte si také úložného prostoru pod sklápěcí lavicí na obrázku vpravo nahoře.

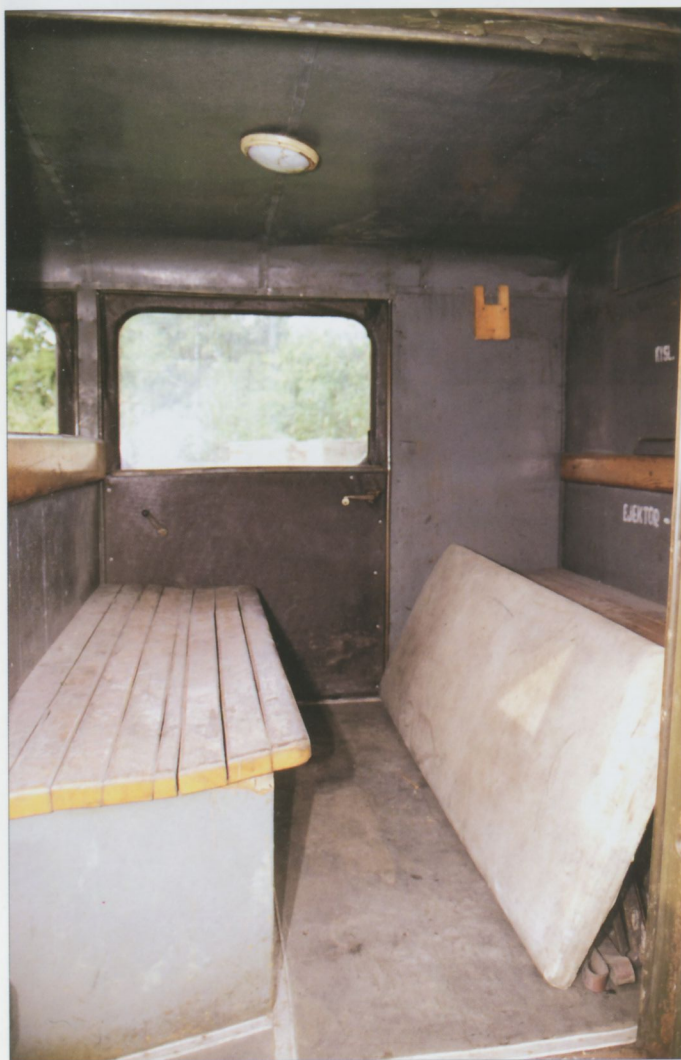
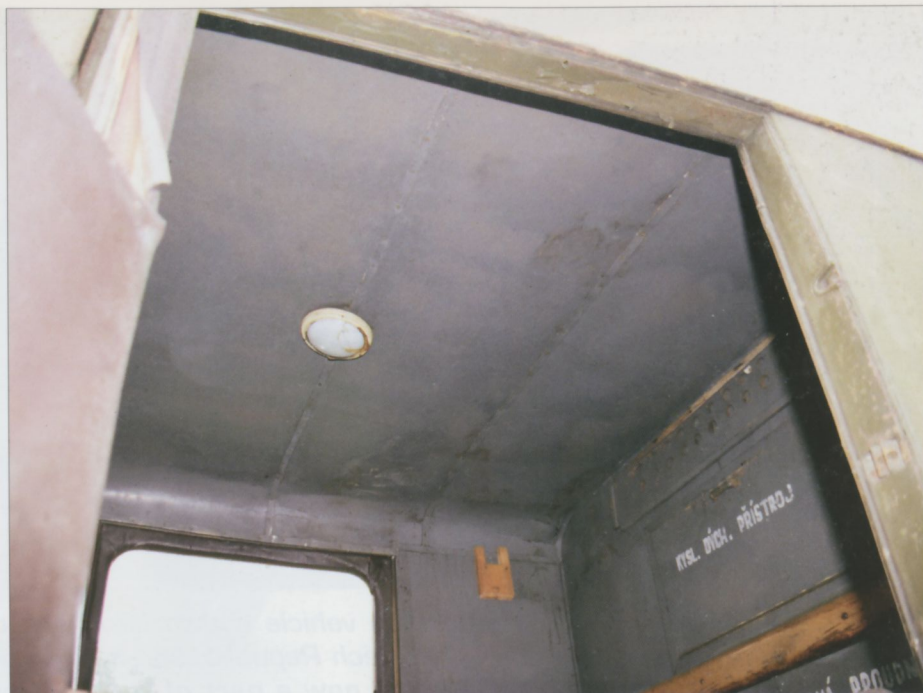
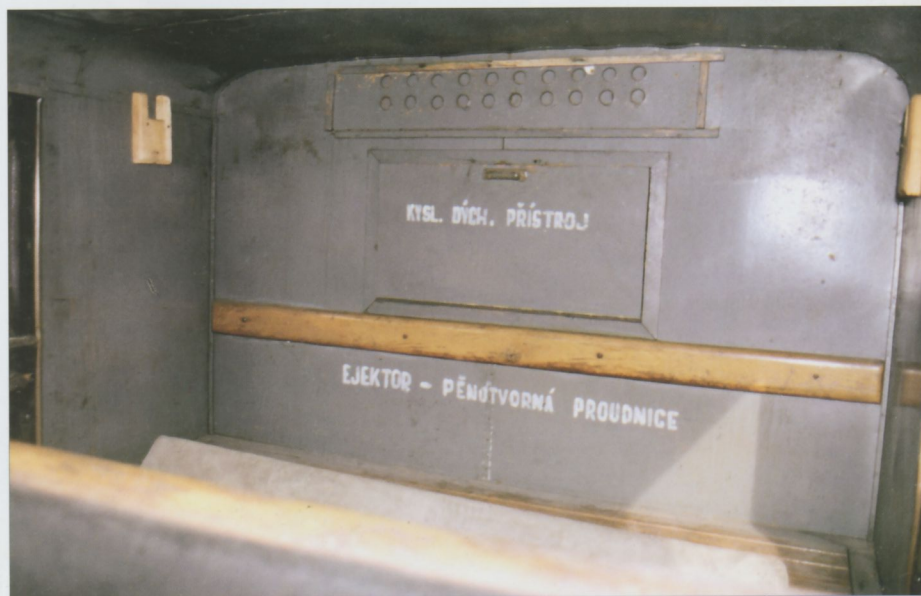
# Crew Cab Interior Details

Vehicle controls shown in the picture below were taken from the standard Cargo cab, as well as the front windows. The above left picture shows the rear wall of the crew cab. Two rows of circular openings visible above the opened locker are manually operated air vents. Note also the open locker beneath the folding bench, the top right picture.

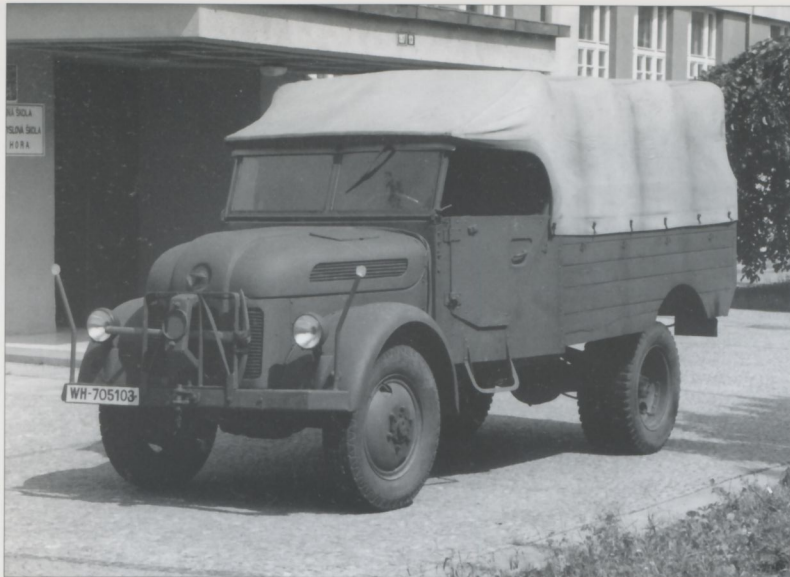
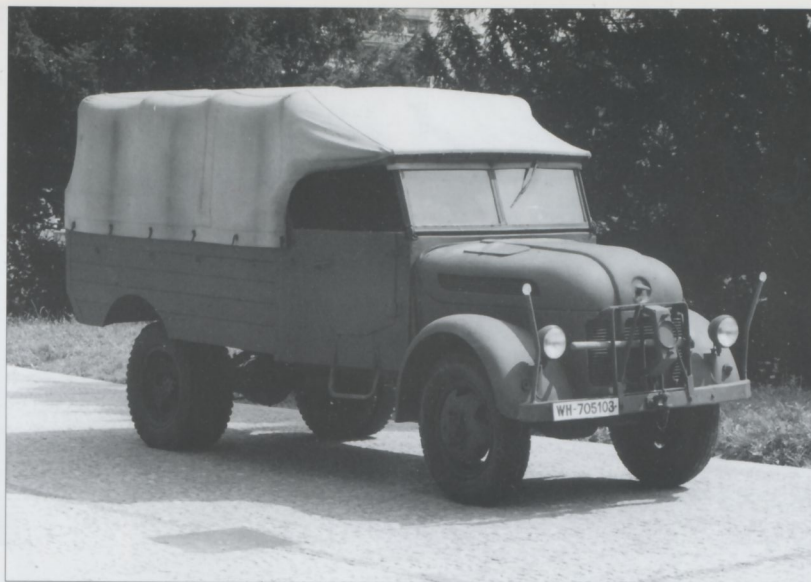
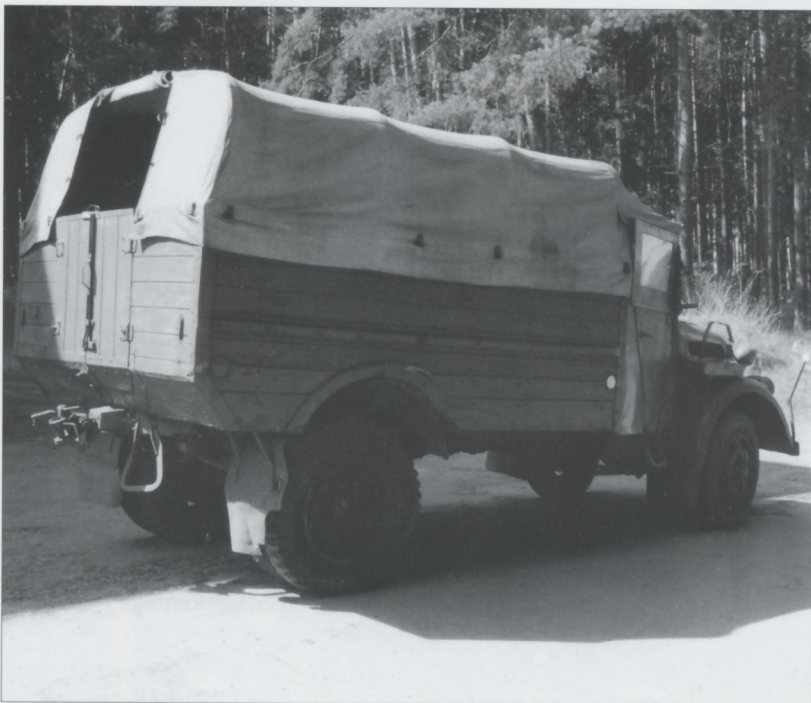
*According to the rear body interior the vehicle shown here was used for transporting military personnel. At least two identical vehicles survived in the Czech Republic, one being a part of Mr. Āoupalik's private collection (the vehicle painted grey) and the other one being now a part of the Leřany Museum collection (bottom left picture shows the vehicle painted green before being displayed). It is also possible that this modification was made after the war when many Steyr 1500A vehicles of different variants, were collected from Italian and Austrian locations and after overhaul and other essential modifications they were handed over to the Austrian Government for civil use.*

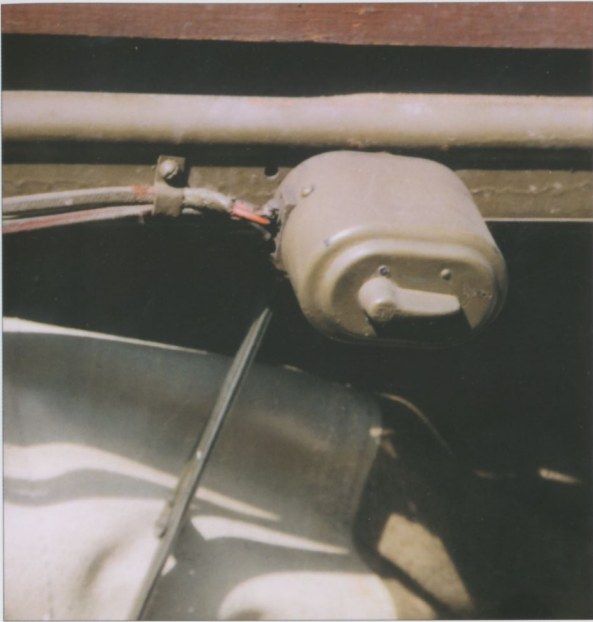
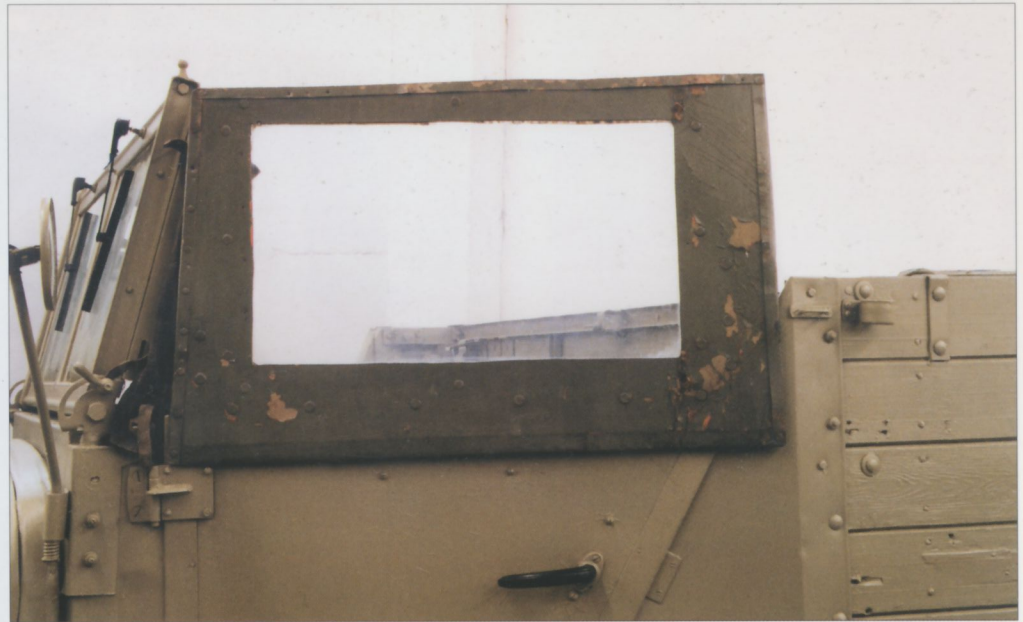
*Original windshield wiper motors pictured above and below, were painted glossy black enamel. During actual vehicle service they were painted the body color.*

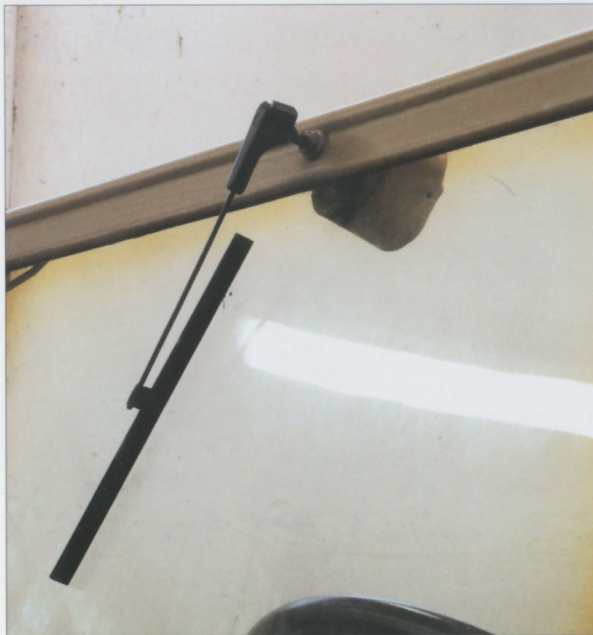
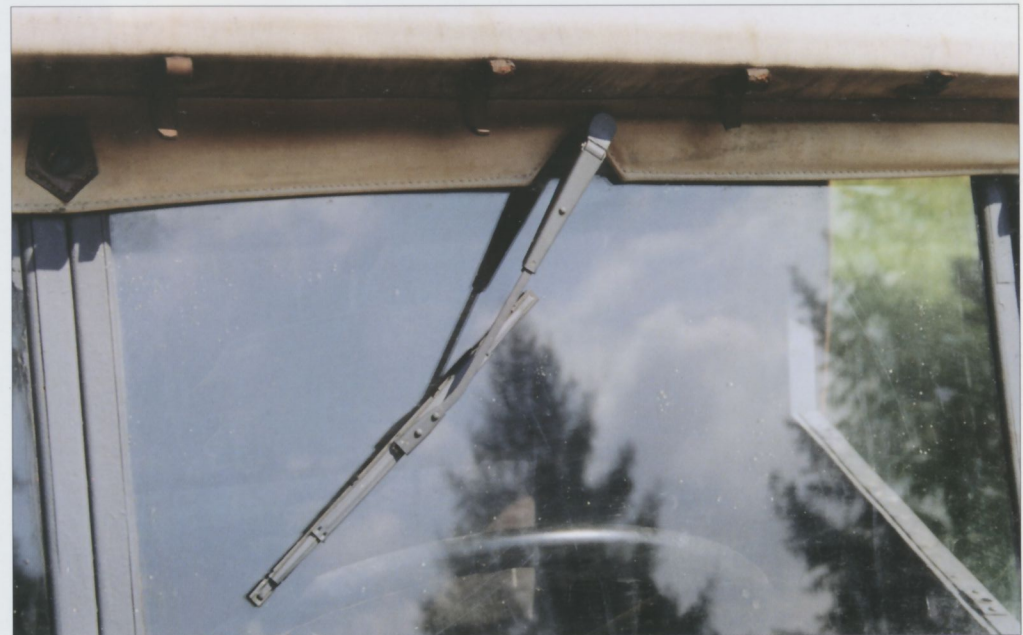
*Door windows are made of transparent plastic and the frame is detachable. Lower picture shows the attachment of the front part of the canvas top. The canvas top itself is fixed to the wooden framing by means of straps. Clamps and plugs fasten the frame to the windshield.*

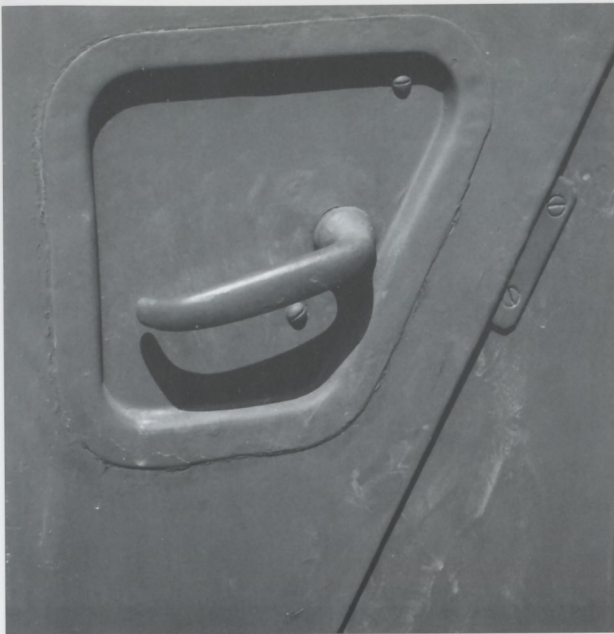
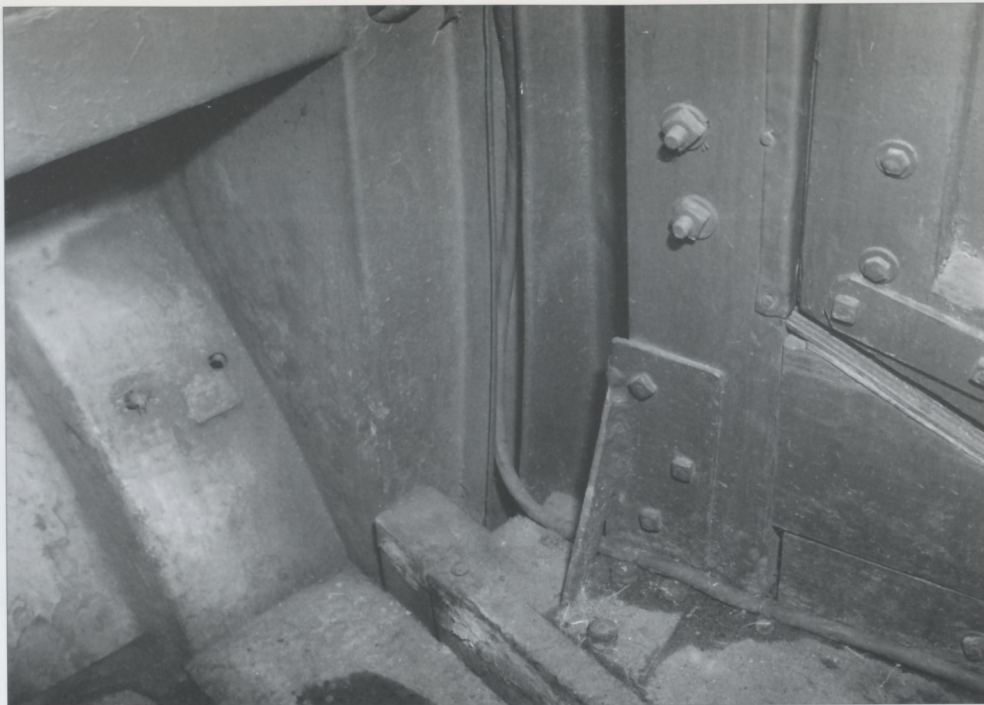
*Picture below shows the construction of the wooden doorframe covered by sheet metal. Note also the inner door handle and the lock mounted into the wooden frame.*

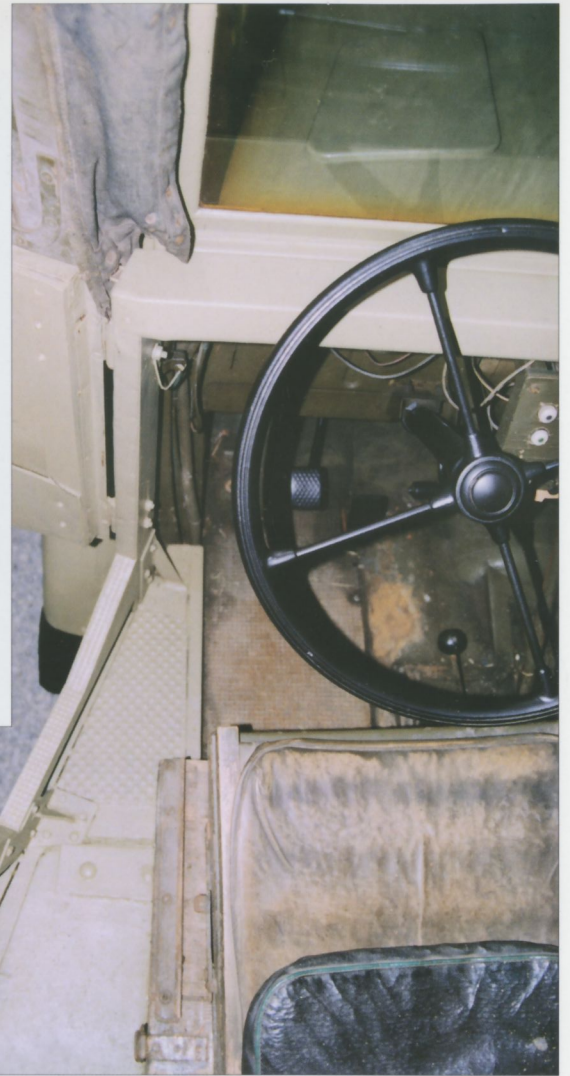
*Reinforced steel steps are installed on both body sides just beneath the front door.*

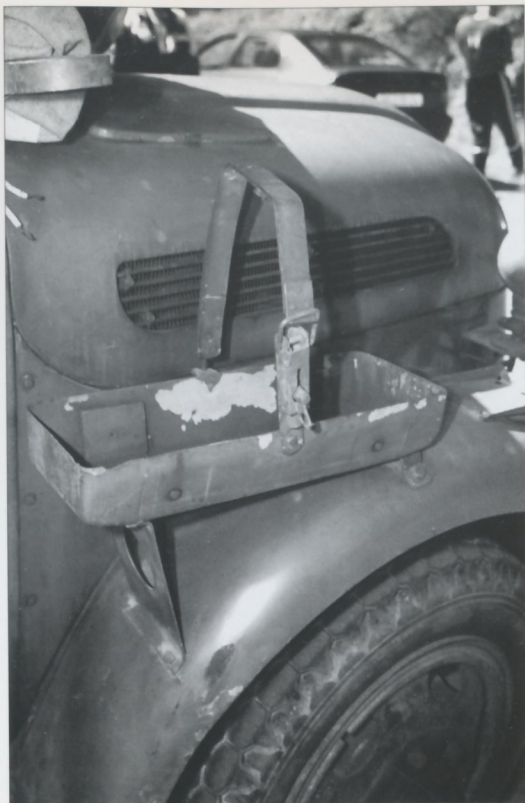
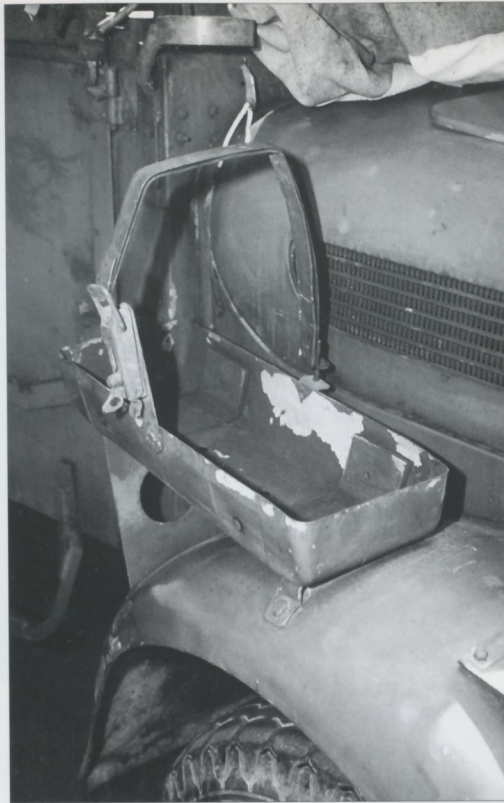
*A bird's eye view of the hood shows two ventilating doors on the hood sides. Below the door on the vehicle's right side there is a fuel tank filling neck, top and bottom right pictures.*

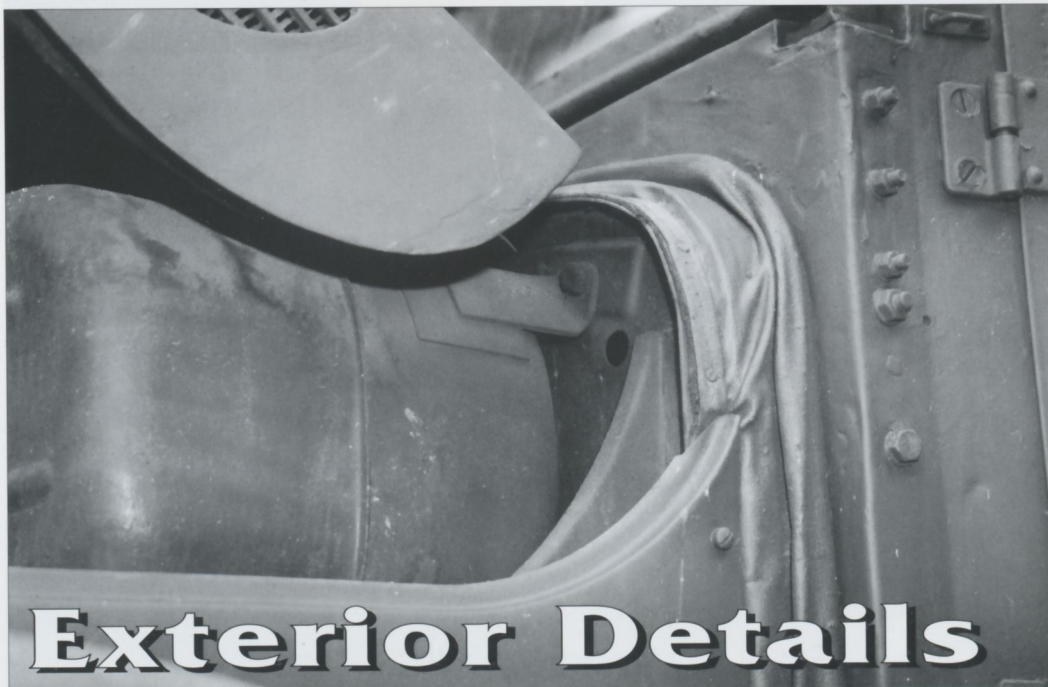
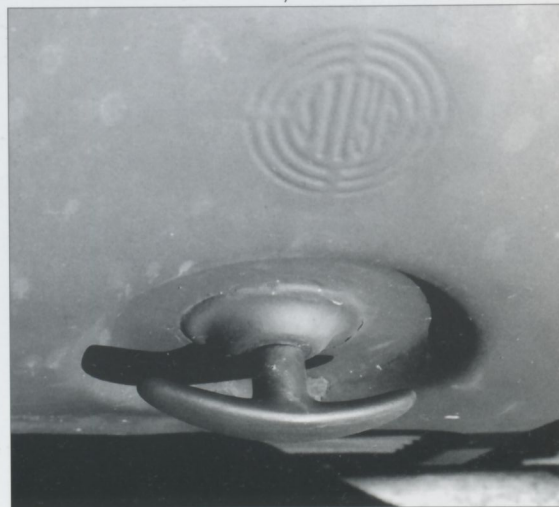
*The jerry can holder shown in the top left picture is reportedly original. Note the hood lock and Steyr logo stamped above the lock handle, bottom right picture.*

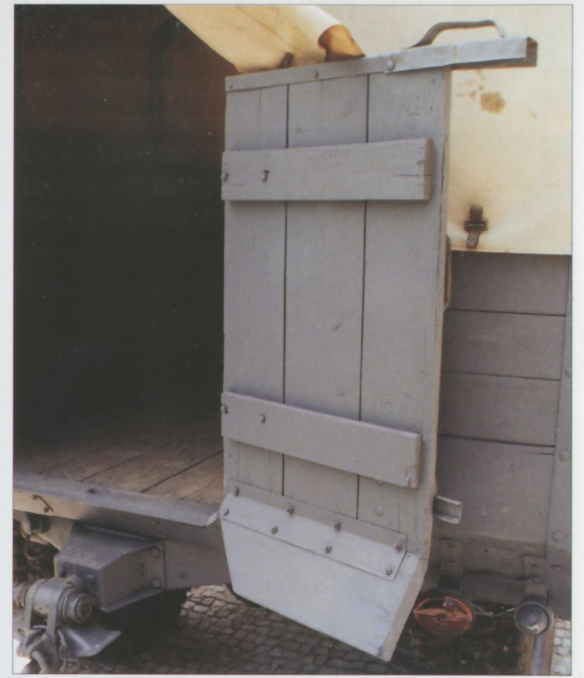
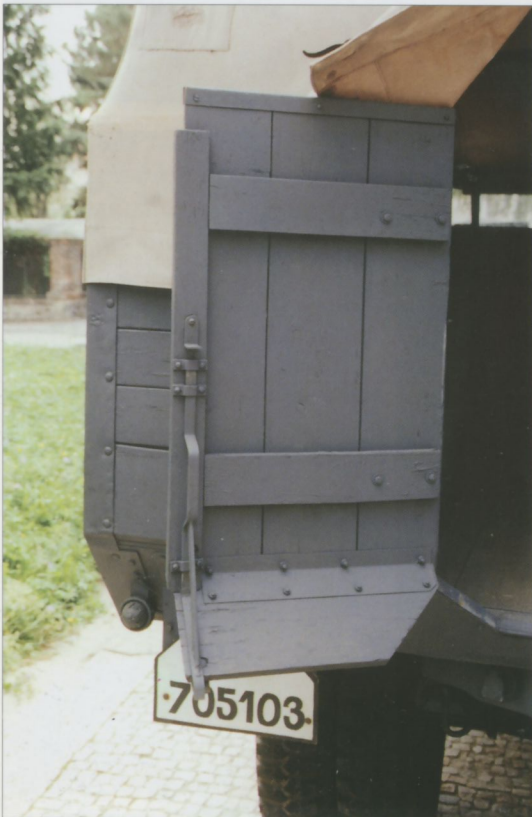
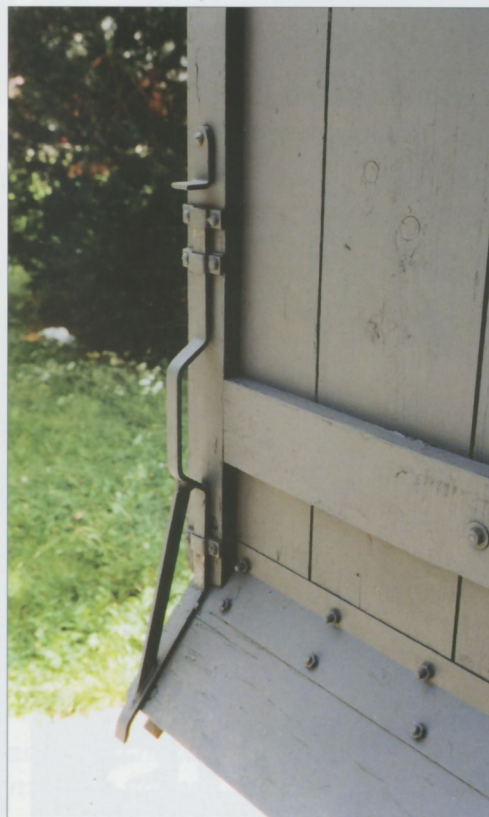
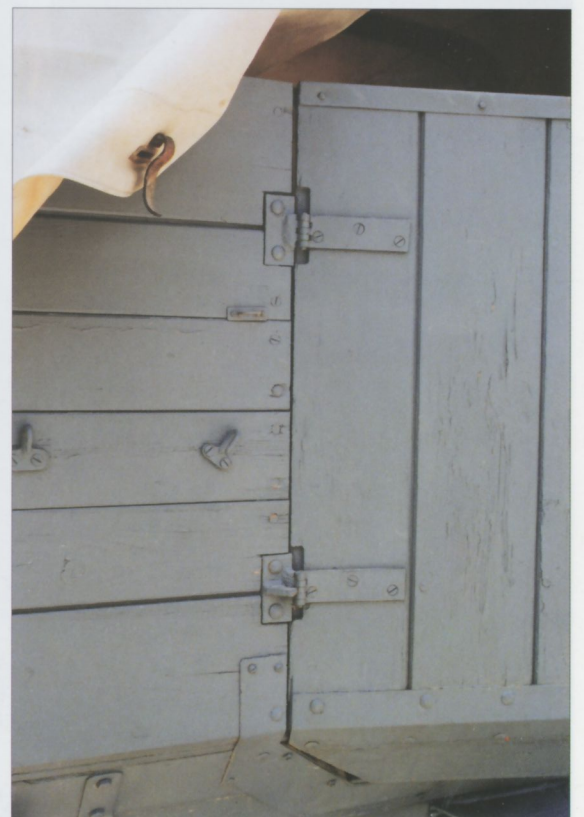
## Troop Compartment Details

*The rear side of the body is fitted with twin entrance doors instead of the common drop side, pictures on the opposite side. Pictures on this page show the layout of the troop compartment with two longitudinal folding seats. Note also the sheet metal wheel wells.*

Str. 43  
Korba vozidla má vzadu dvojité dveře místo obvyklé sklápěcí postranice, obrázek na předcházející straně. Na obrázcích na této straně je vidět uspořádání prostoru na korbě s dvojicí podélných sklápěcích lavic. Také si povšimněte plechových podběhů.

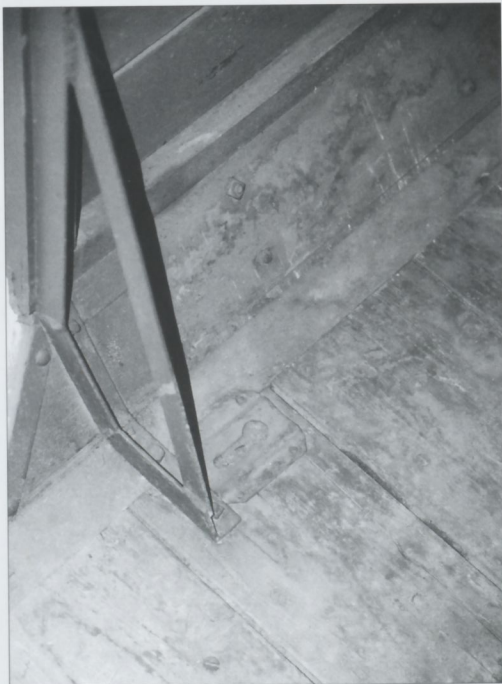
*Pictures on this page show the layout of the troop compartment with two longitudinal folding seats. Note also the sheet metal wheel wells.*
