# Steyr 1500A

PHOTO MANUAL FOR MODELERS

n° 9

**Steyr 1500A in detail**

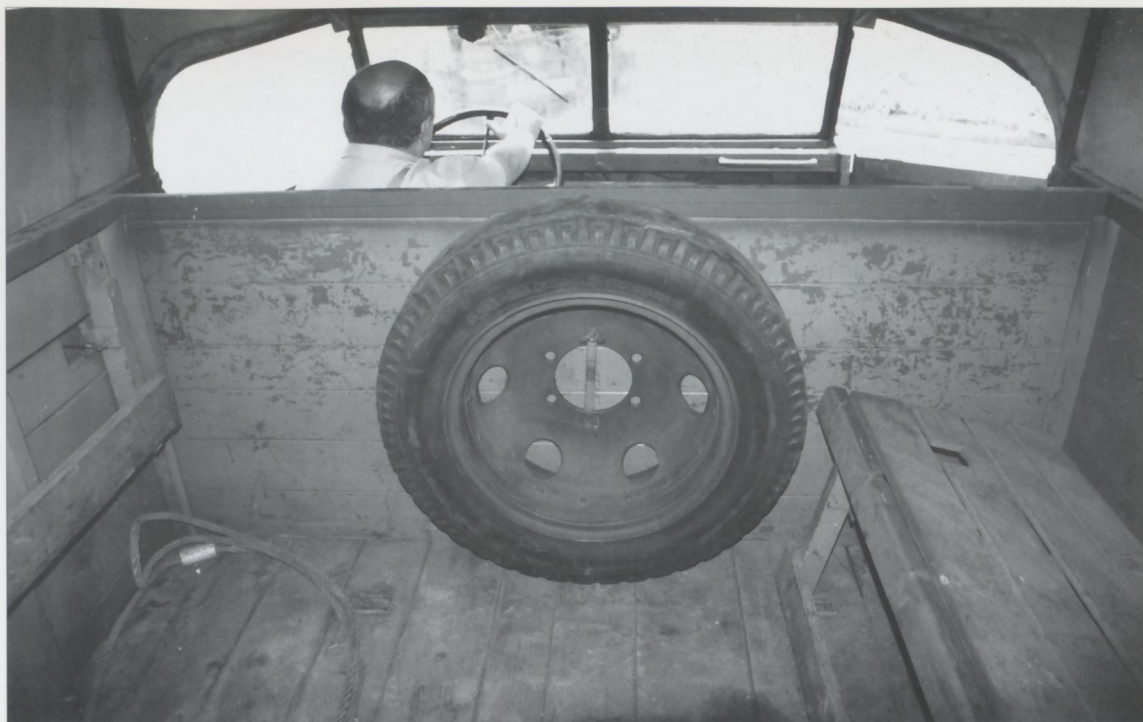
**Troop  
Compartment Details**

*Although there is a spare wheel carrier mounted on the front bumper (see also page 47), the spare wheel was repositioned inside the body, probably modified during the vehicle's service with the Czech Fire Brigades.*

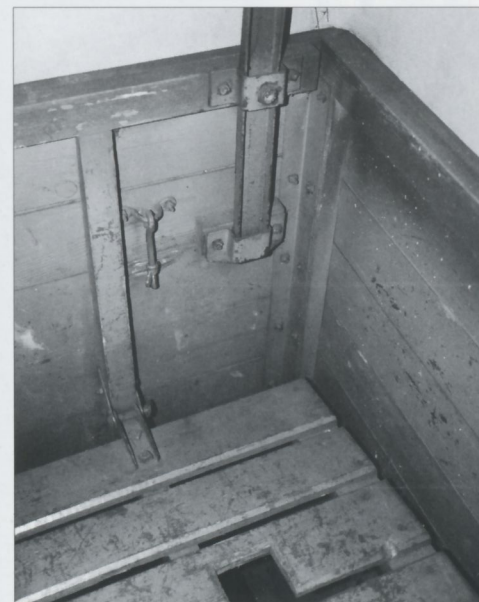
*Compare the seat locking clamps shown here with the seat folded down with those on the page 44 (with the seat folded up).*

Str. 44  
**Detaily prostoru posádky.**  
Pověšněte si, jak jsou sklápěcí sedačky fixovány ve sklopené poloze, obrázky vlevo. Vyobrazené vozidlo má na zadní nápravě nestandardní dvoumontáž, viz též strany 48 a 50. Ta byla pravděpodobně instalována buď během generální opravy v Rakousku, nebo (což je pravděpodobnější) během poválečné služby u českého požárního sboru. Přidaná vnitřní kola si vynutila rozšíření podběhů, takže se zdá, že zobrazené podběhy nejsou původní.

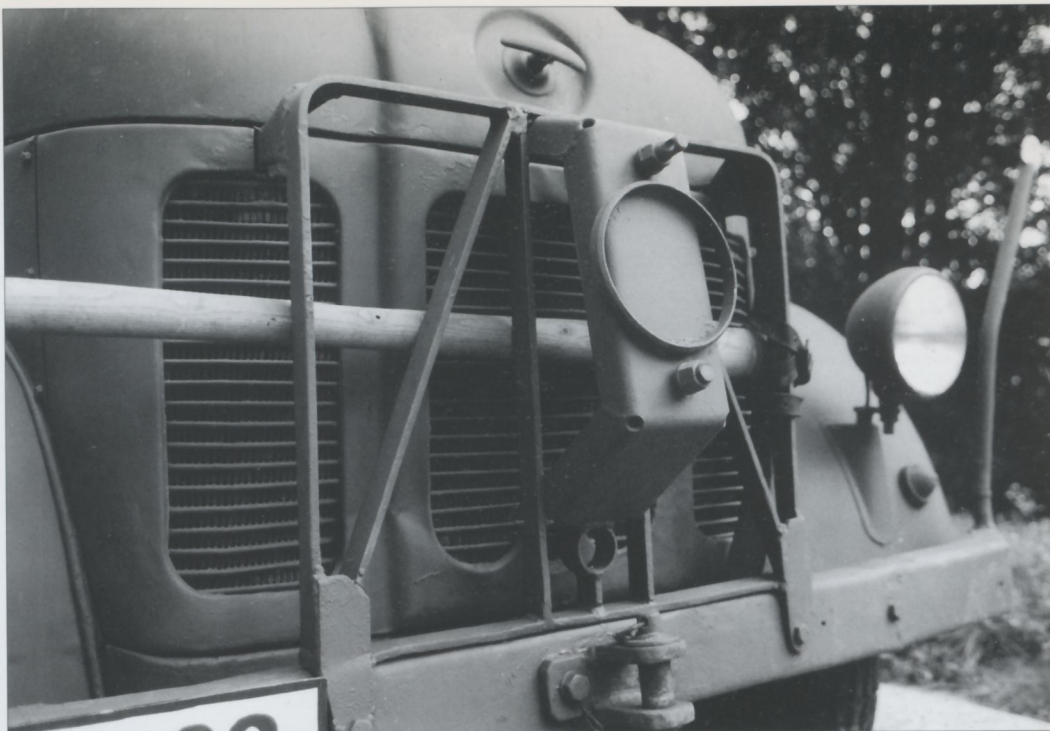
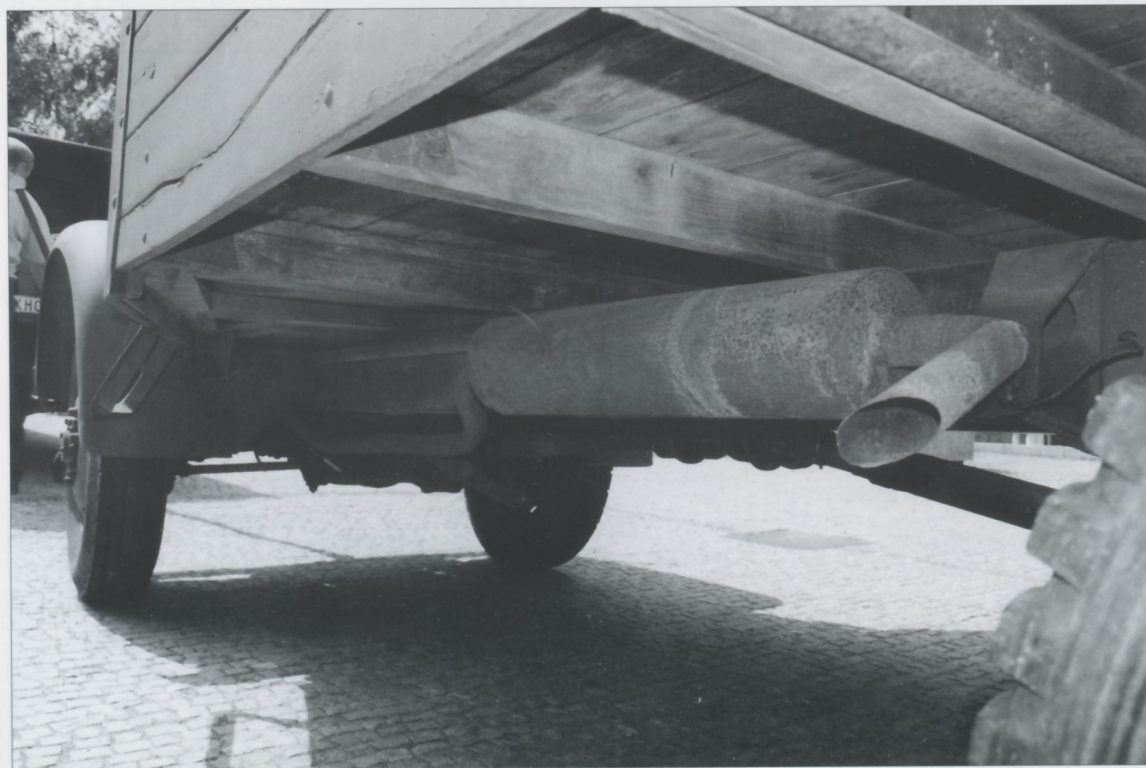
## **Personnel Carrier Exterior Details**

*The front brushguard is combined with the spare wheel carrier. The mattock fastened behind it is not original piece of equipment. The bottom pictures show rear body floor construction and location of the exhaust muffer.*

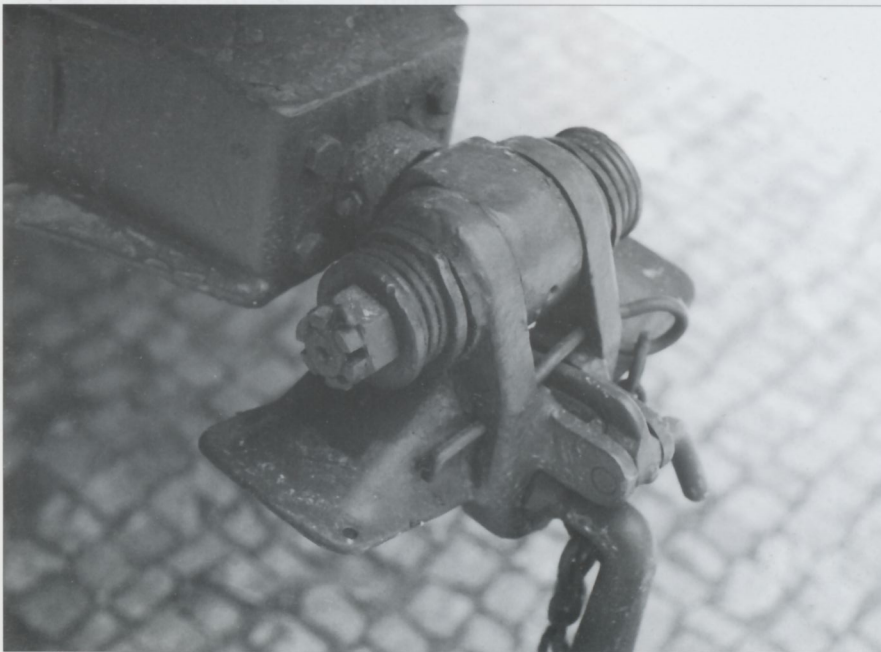
# Fintle Hook

*Pictures on this page show installation of the pintle hook. If it is original or if it was installed during the vehicle's post-war service, is not known to the authors.*

*The original (early) models were fitted with a different pintle hook, see pictures on the page 9 and 10.*

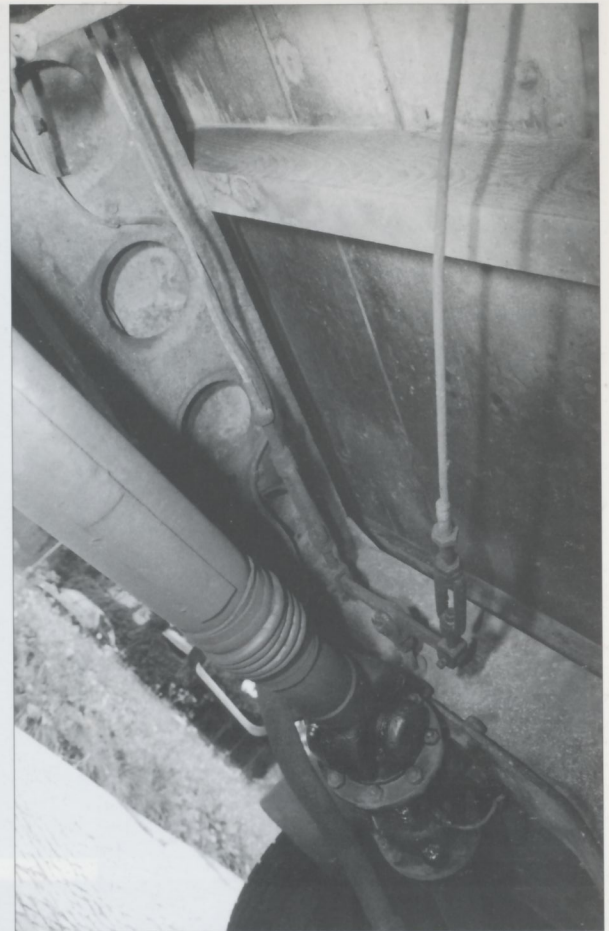
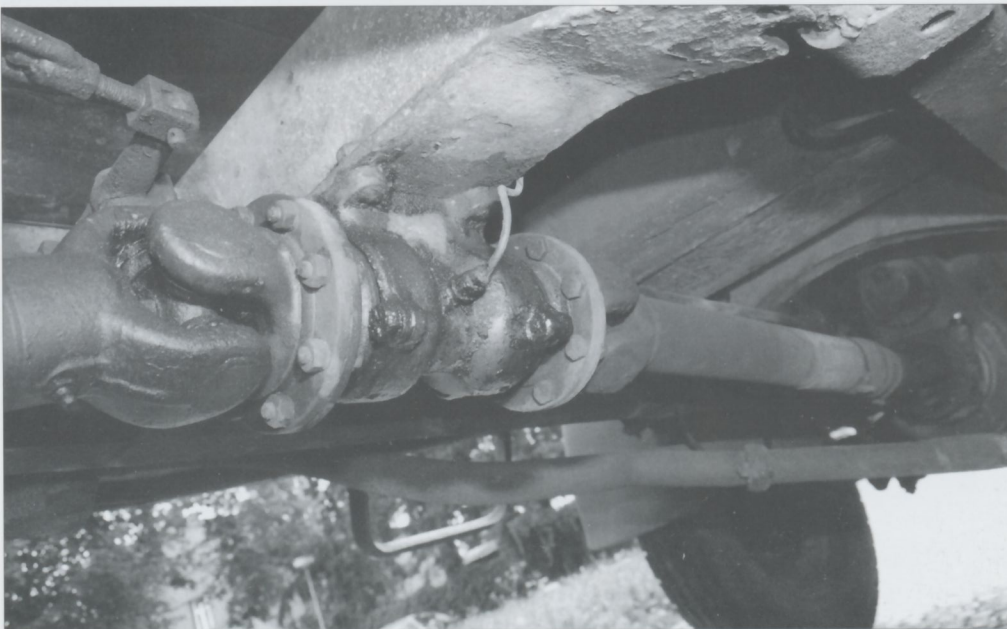
# Drive Train Details

*Pictures on this page show the auxiliary gearbox installation and constant velocity shafts. Note the tubing leading to the c.v. joint shown in the picture below. This is a part of the central lubricating system. See also the upper picture on the opposite page showing similar lines for lubricating the rear spring mounts.*

Na těchto obrázcích je vidět instalaci přídavné převodovky a kardany. Na obrázku dole si všimněte trubek, vedoucích ke kardanovým kloubům. Ty patří k systému centrálního mazání. Podobné trubky pro rozvod maziva k závěsům zadních per jsou i na obrázku nahoře na protější straně.

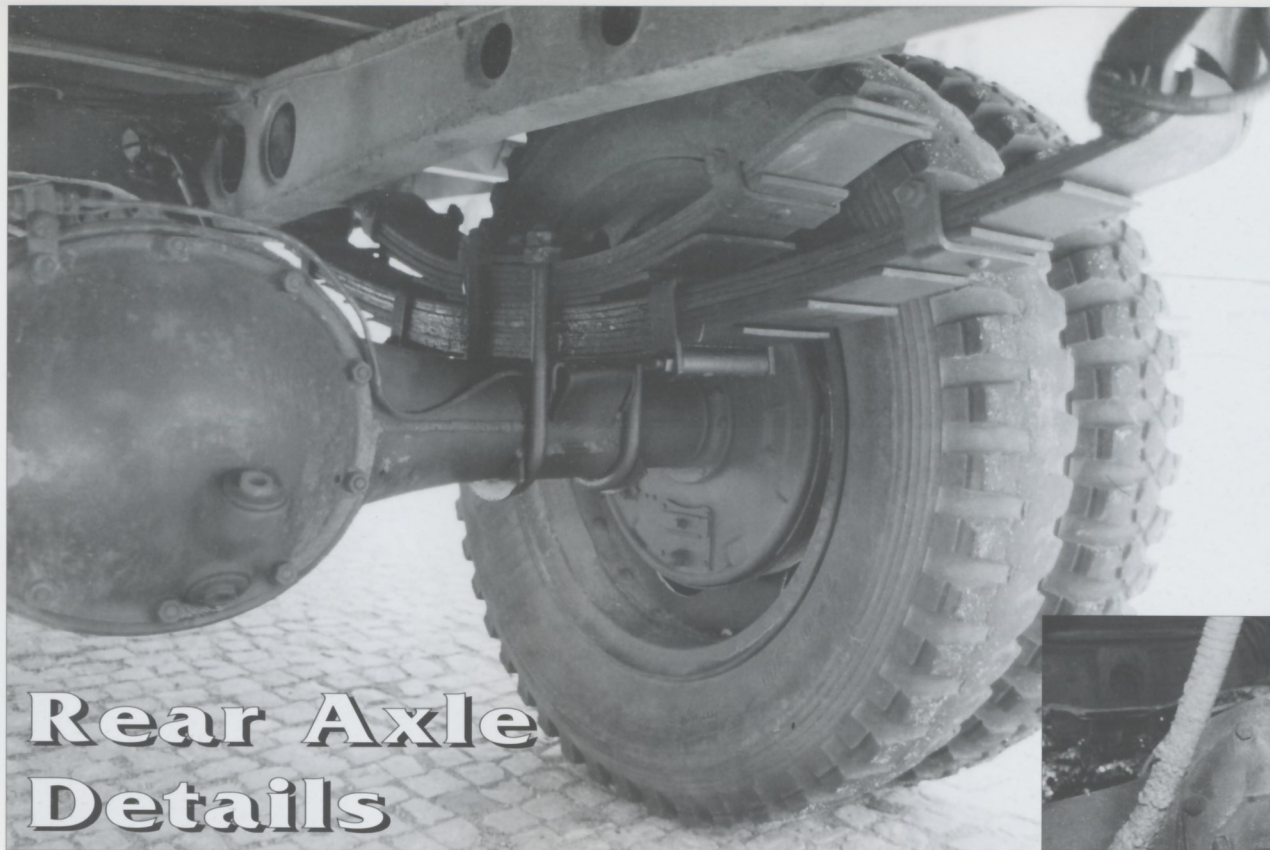
## Rear Axle Details

*Pictures on this page show details of the rear axle and rear springs. Note the rear wheels: to get approximately equal front and rear track the front wheels were mounted with their discs convex and the single rear wheels with their discs concave, compare this with the pictures on page 53. The Dual rear wheels shown here are not standard and were probably installed after the war.*

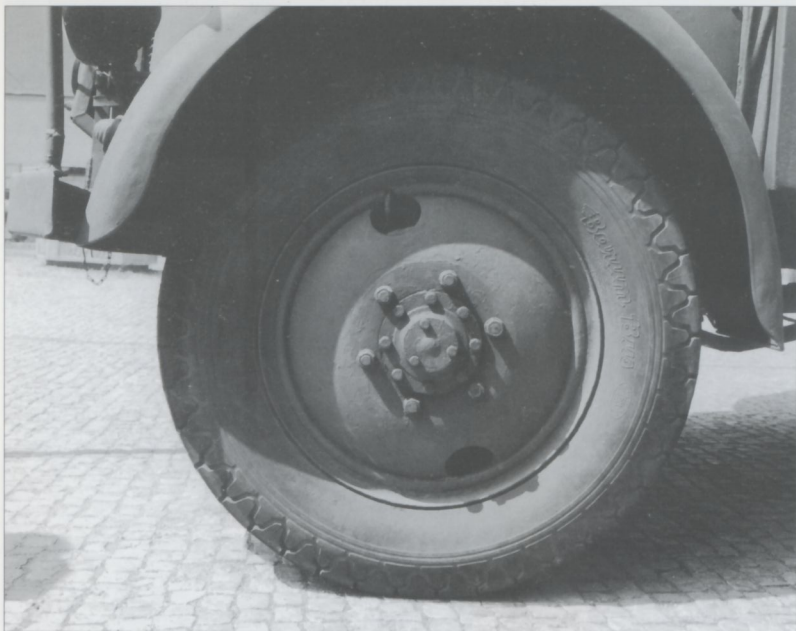
# Wheels Details

*Although this particular vehicle is fitted with two different types of wheel discs it seems that the one having six spokes is the original.*

*Tires used on Steyr 1500A's operating in Europe and Russia were 190x20 or 7,25x20, for desert conditions tires 270x16 were installed.*

Přestože toto vozidlo je vybaveno dvěma různými typy kol, původní se zdají být pouze ta kola s šesti otvory. Pro operace Steyrů v Evropě a Sovětském Svazu byly instalovány pneumatiky 190 x 20 nebo 7,25 x 20 a pro operace v prostředí pouště pneumatiky 270 x 16.

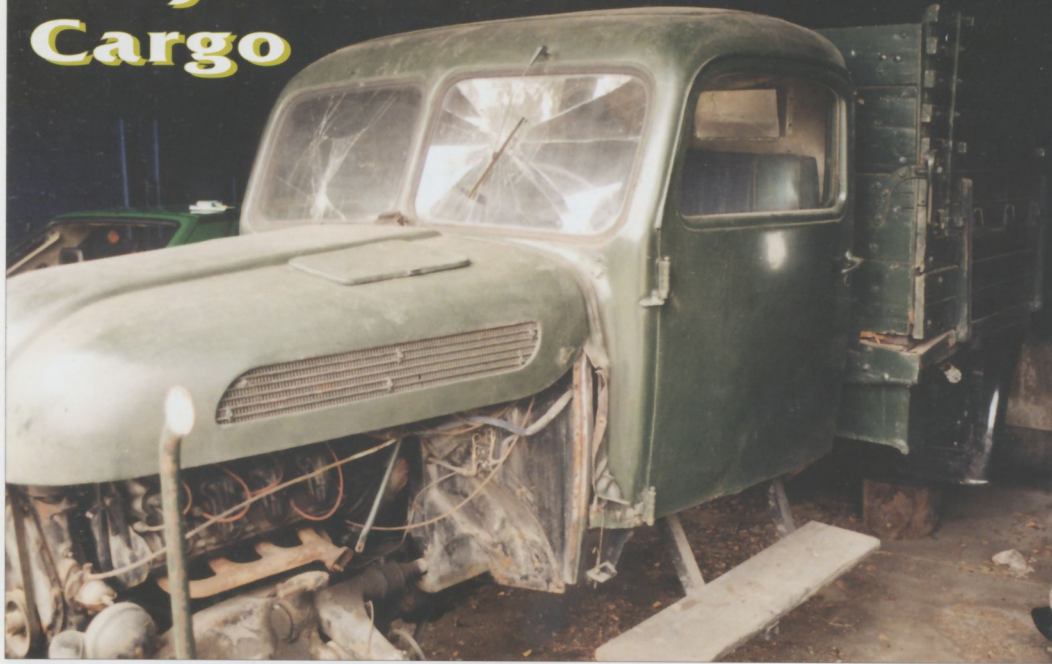
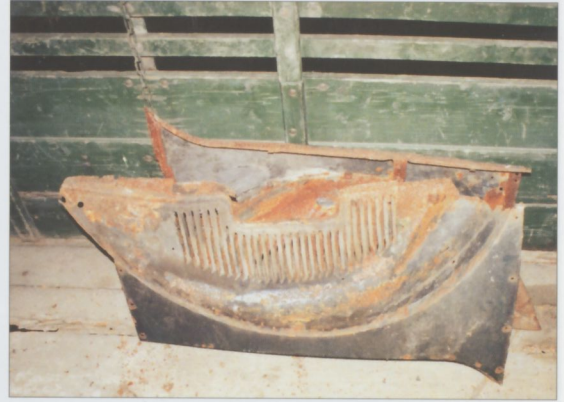
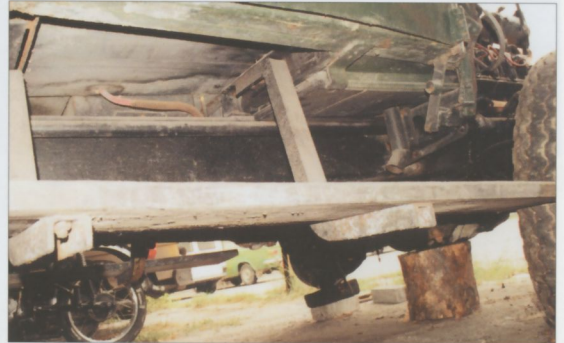
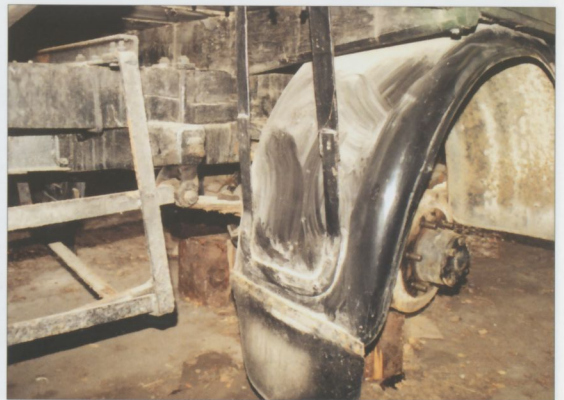
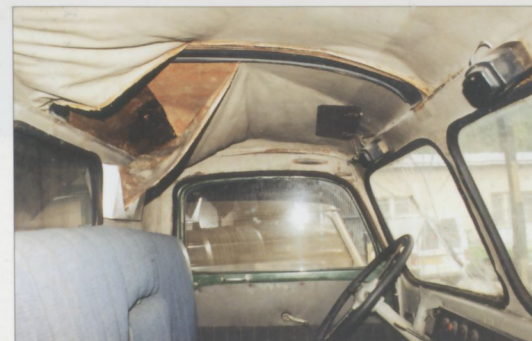
# Steyr 1500A Cargo

*The vehicle shown on these two pages is a 1,5 ton cargo truck, one of the three basic variants of the Steyr 1500A. These pictures were taken at the Lešany museum workshop where the vehicle was waiting for restoration. It seems however, that the cargo body is not original.*

*Since 1944 some these vehicles (if not all) were fitted with so called Einheitsfahrerhaus, or standardized substitute cab, made of wooden framing and pressed cardboard to save deep-drawn sheet metal.*
