MUSEUM ORDNANCE SPECIAL NUMBER 4

Elefant Panzerjäger Tiger (P)

Text by Thomas L. Jentz
Photos by Jeffrey D. McKaughan

THE "ELEFANT" AT ABERDEEN

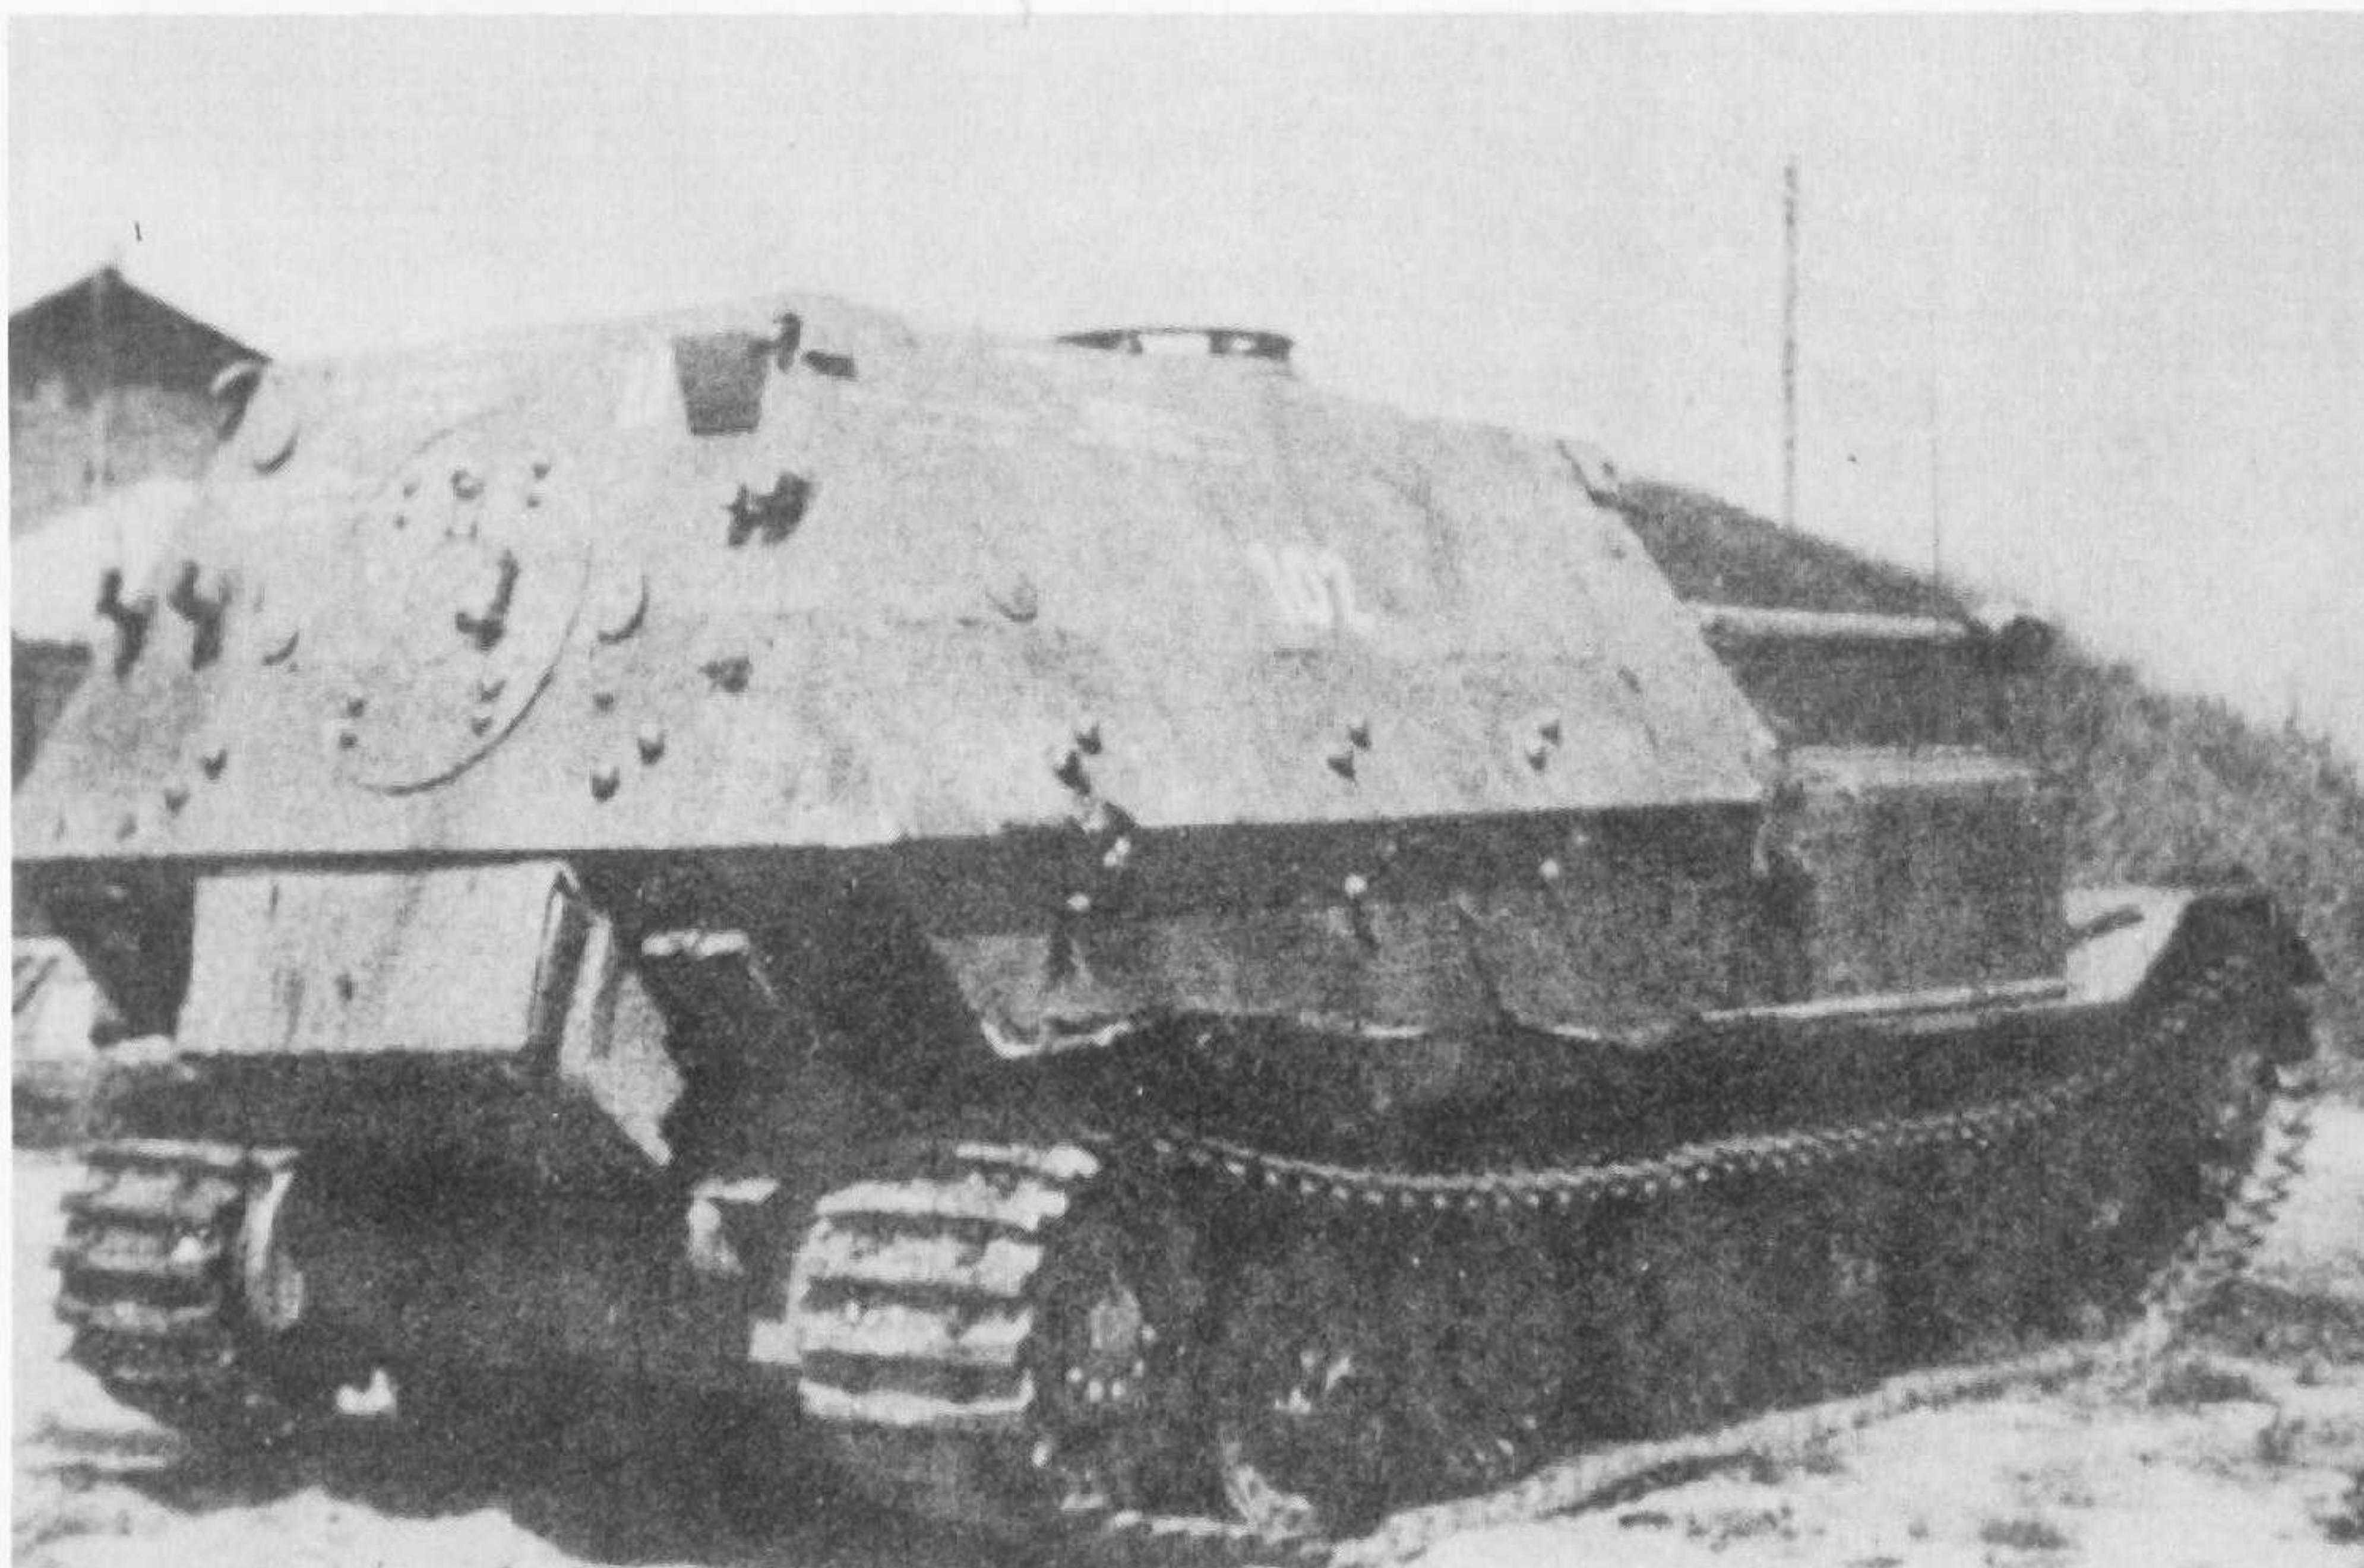
A rear view of the APG Elephant after capture. Much of the stenciling has been applied by US forces, however the "102" and the "U"-shaped marking in the upper right of the rear plate are German. The application of zimmerit can be seen on the hull and slightly less than half-way up the fighting compartment walls.

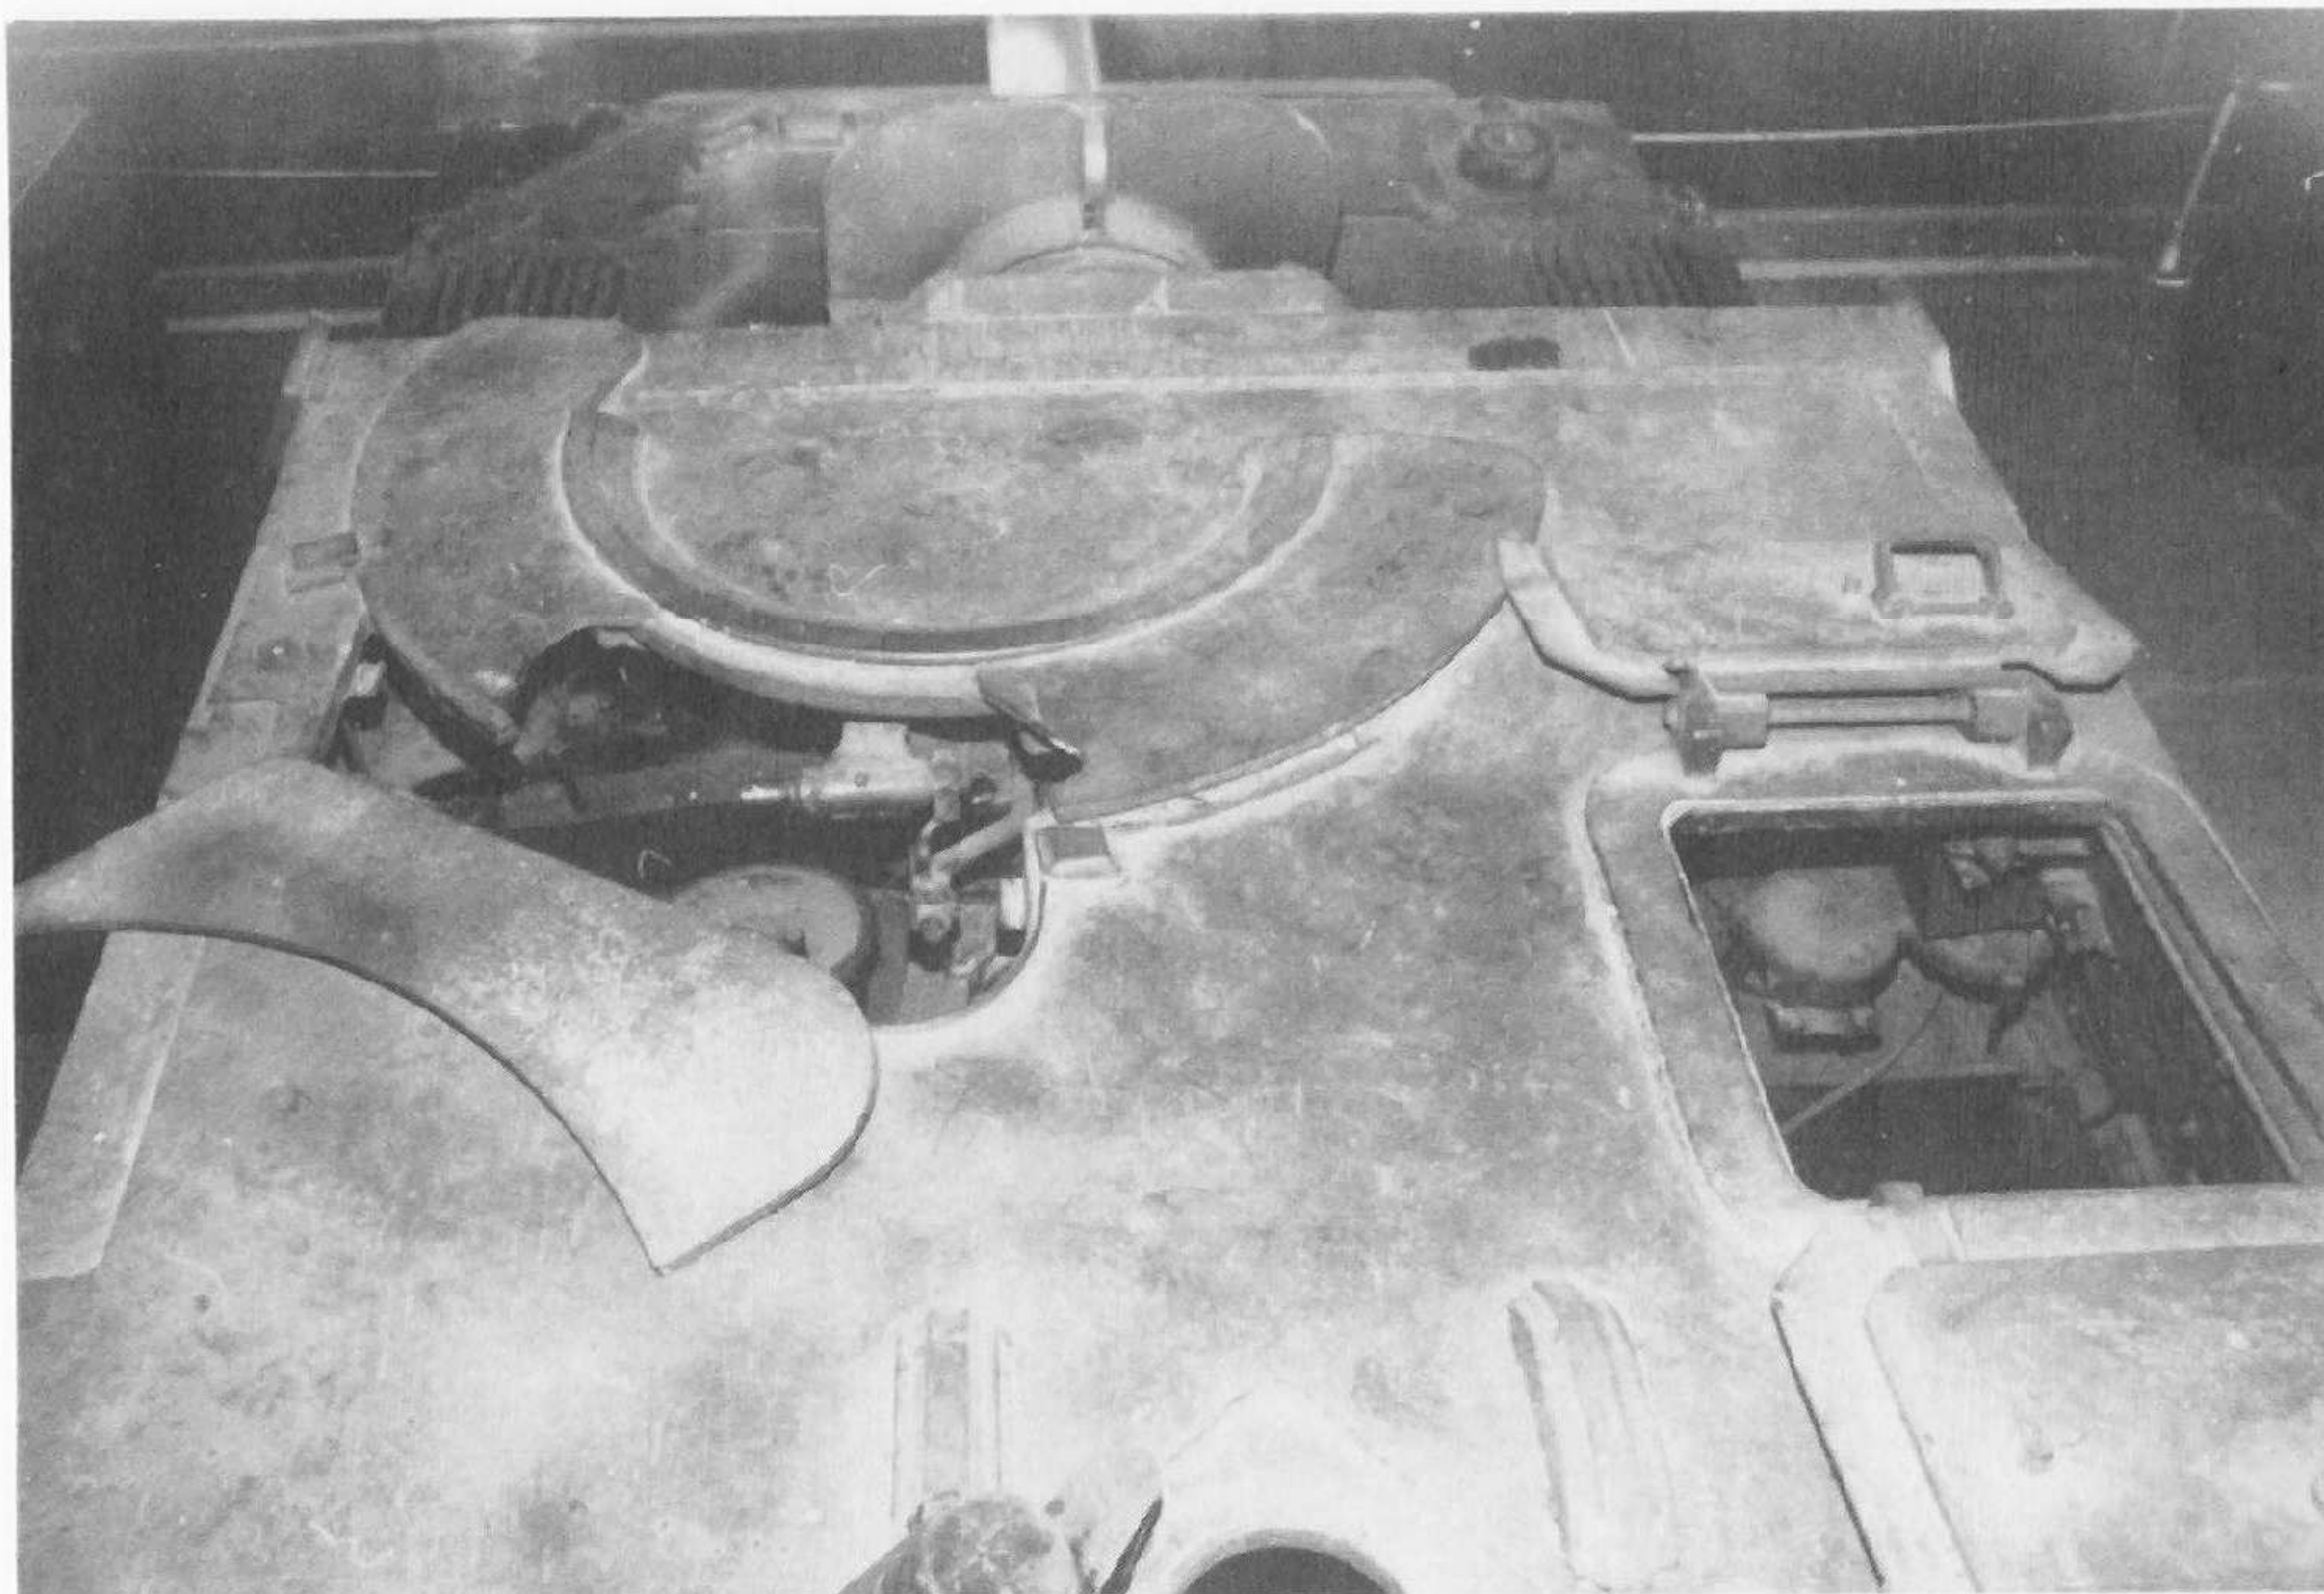
The photos to the left and below are of a Kursk-era Ferdinand. This example is housed in the Kubinka Museum in Moscow and clearly illustrates the differences in the early Ferdinand and the later Elefants. The photo at left shows the split, two-piece commander's hatch, which hinged front and back.

The photo below shows the back half of the roof with the circular rear hatch and some other fitting laying around. Note the shape of the rain guard around the hatch on the right.

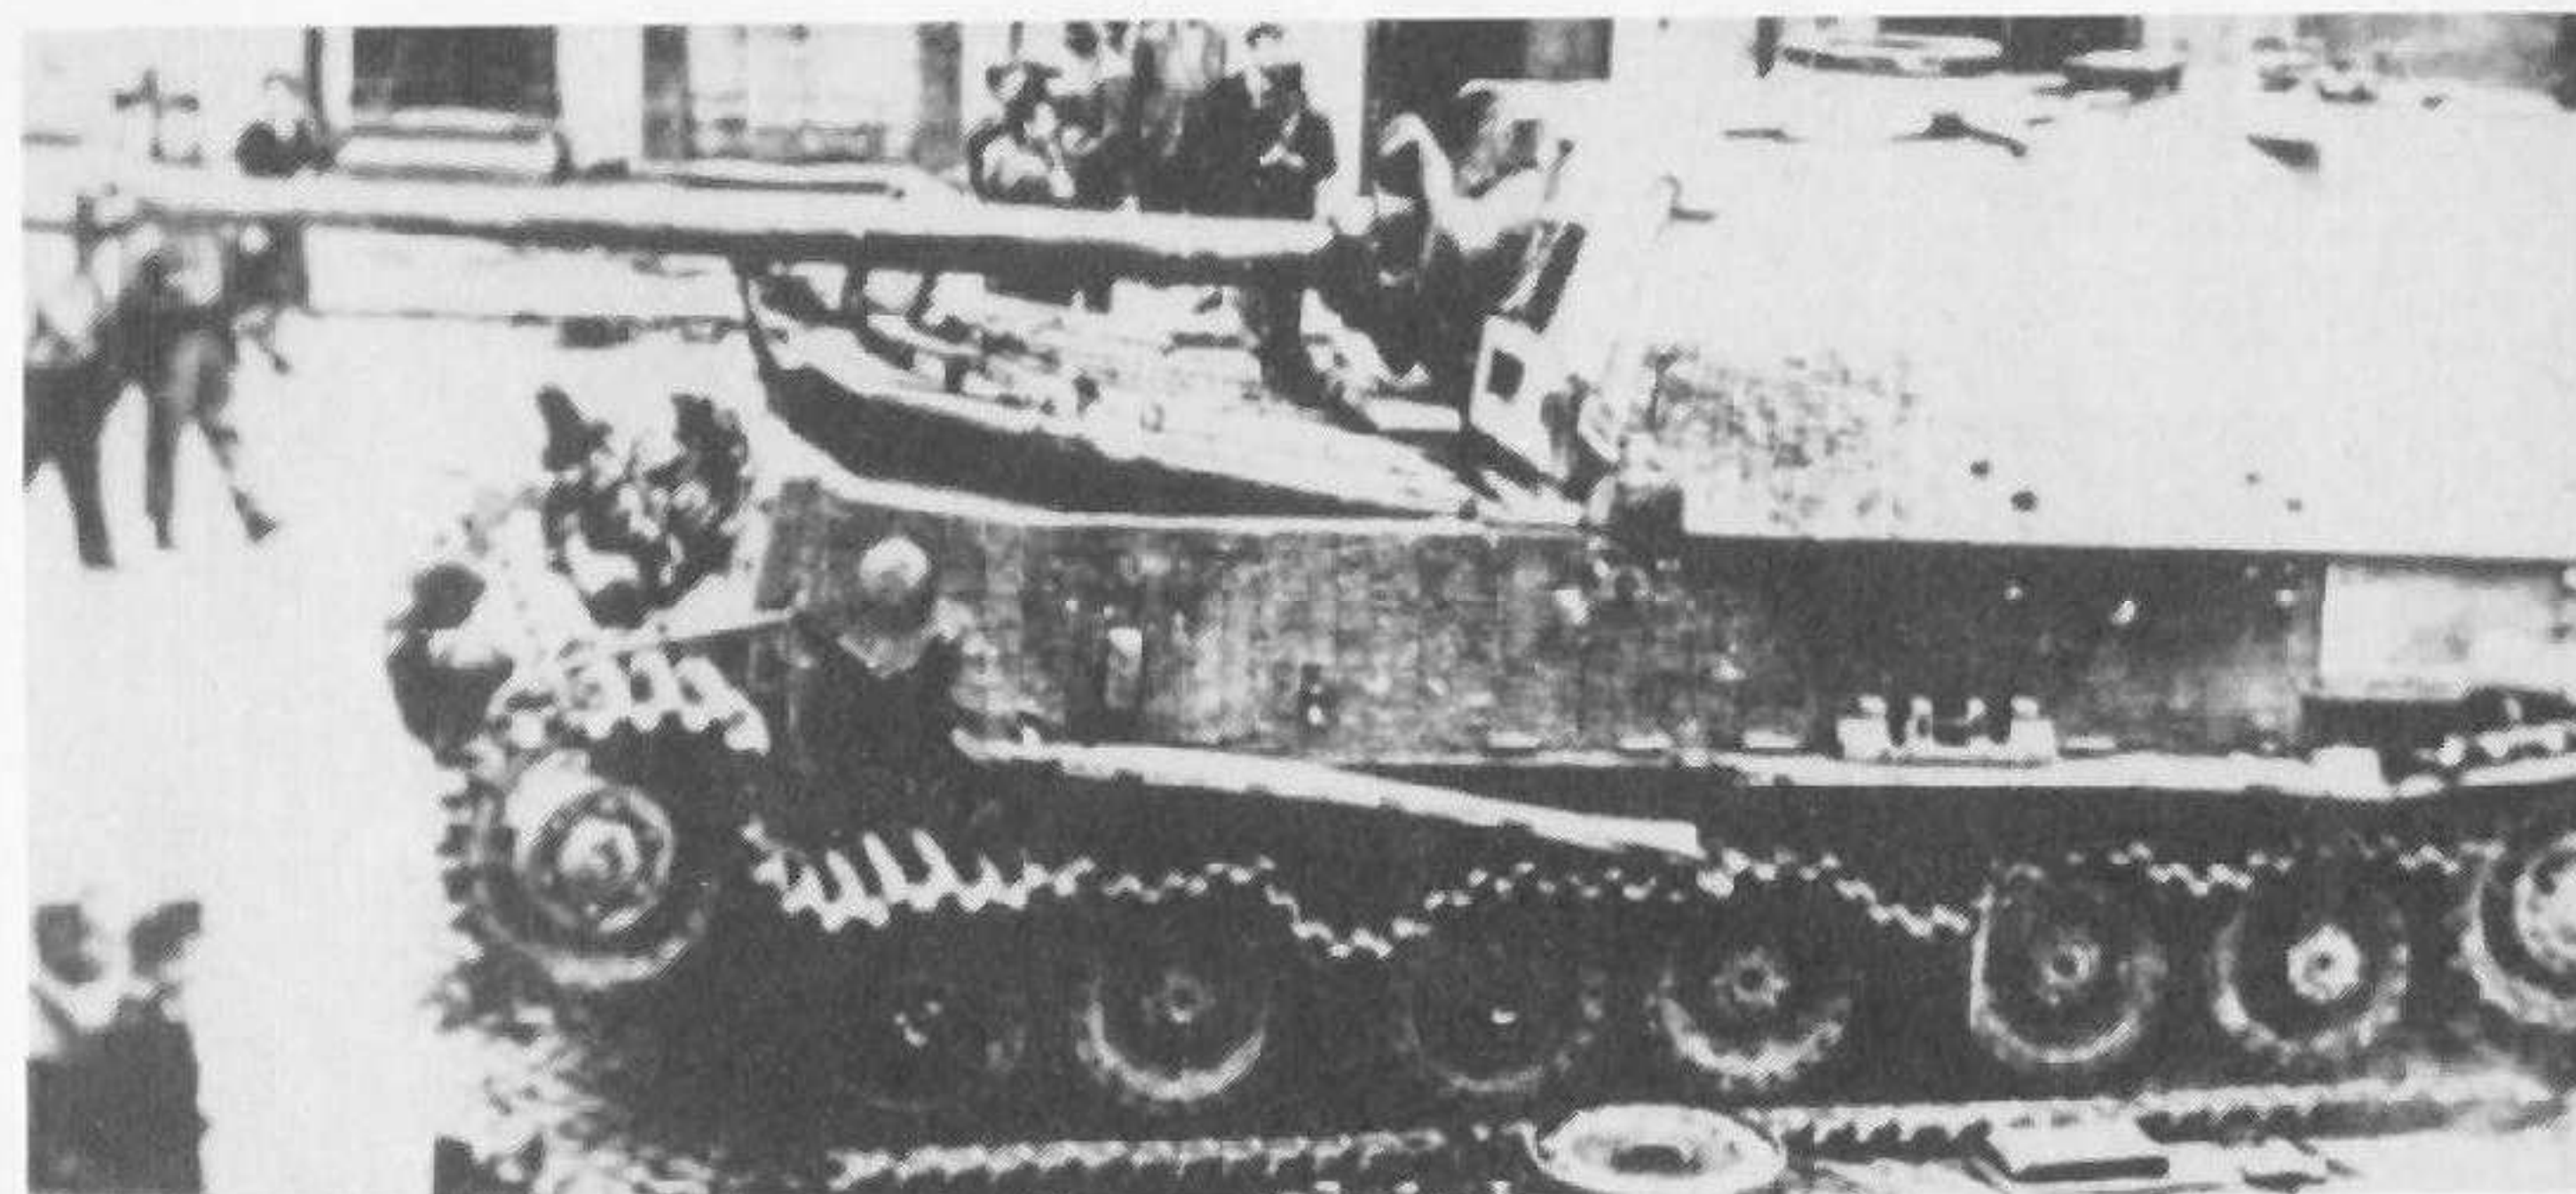
This Elephant has sustained damage. Note that the entire engine deck has been lifted up, almost as if it were being removed for maintenance.

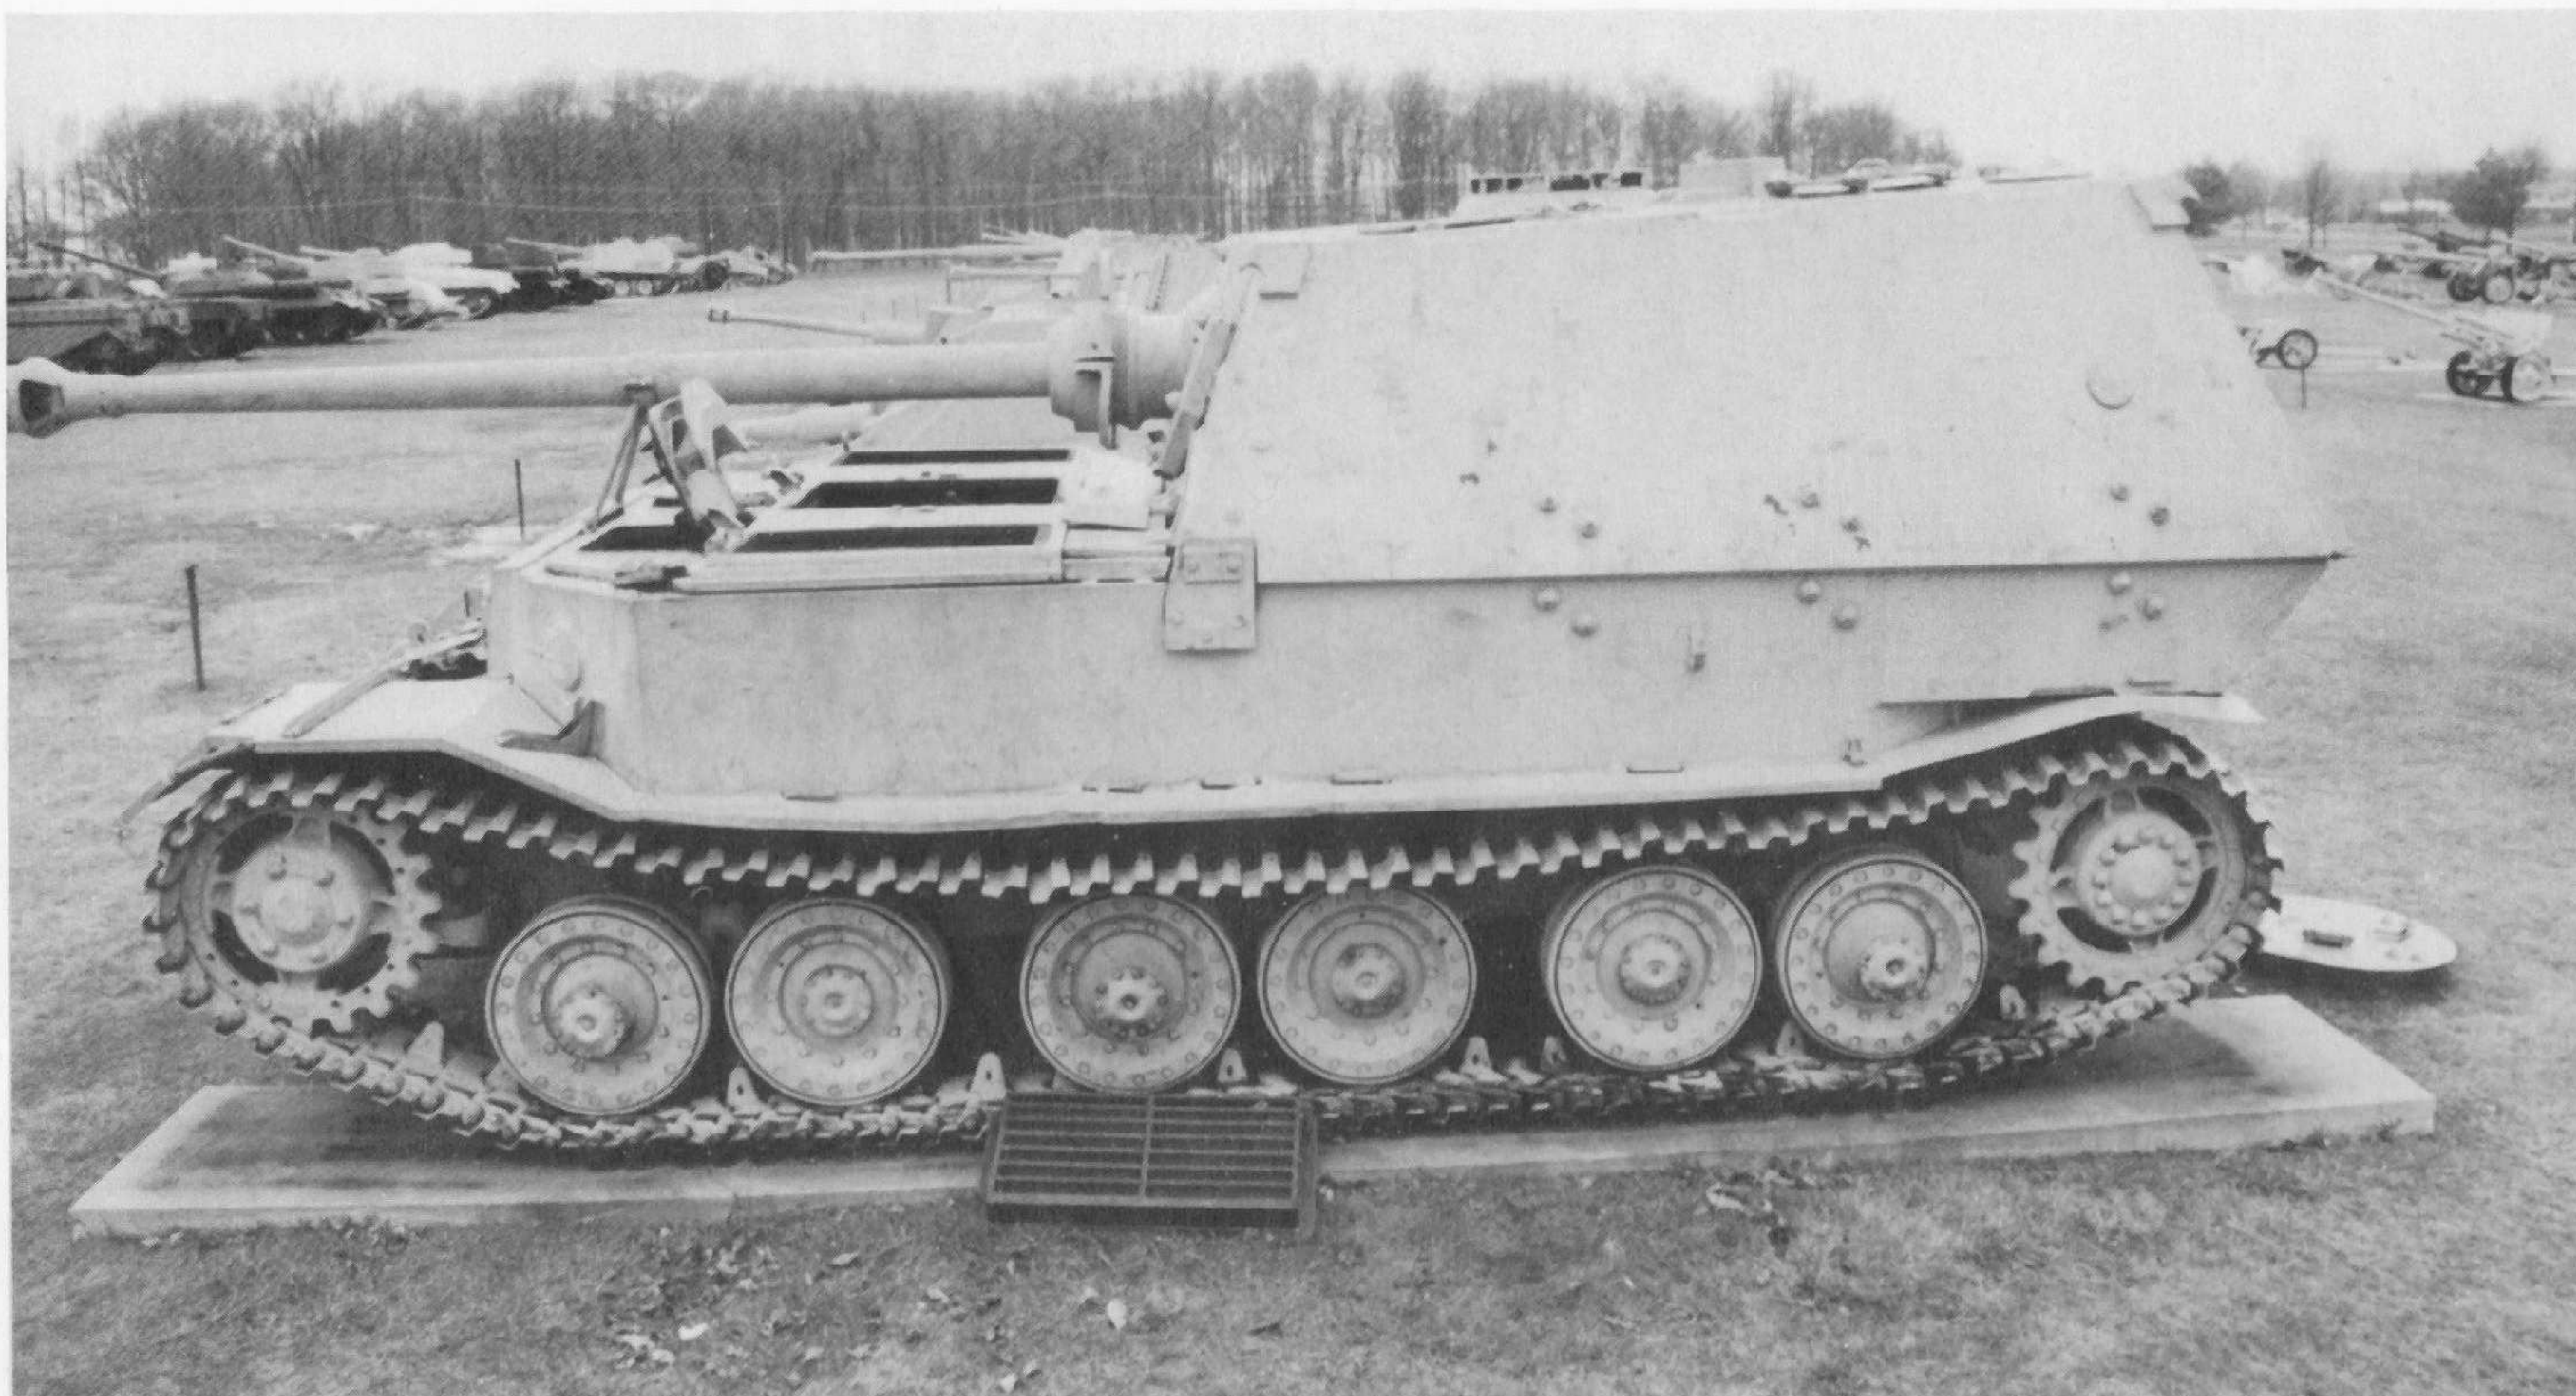
The hull shapes of the original Tiger (P) are clearly visible in this view of the left hand side.

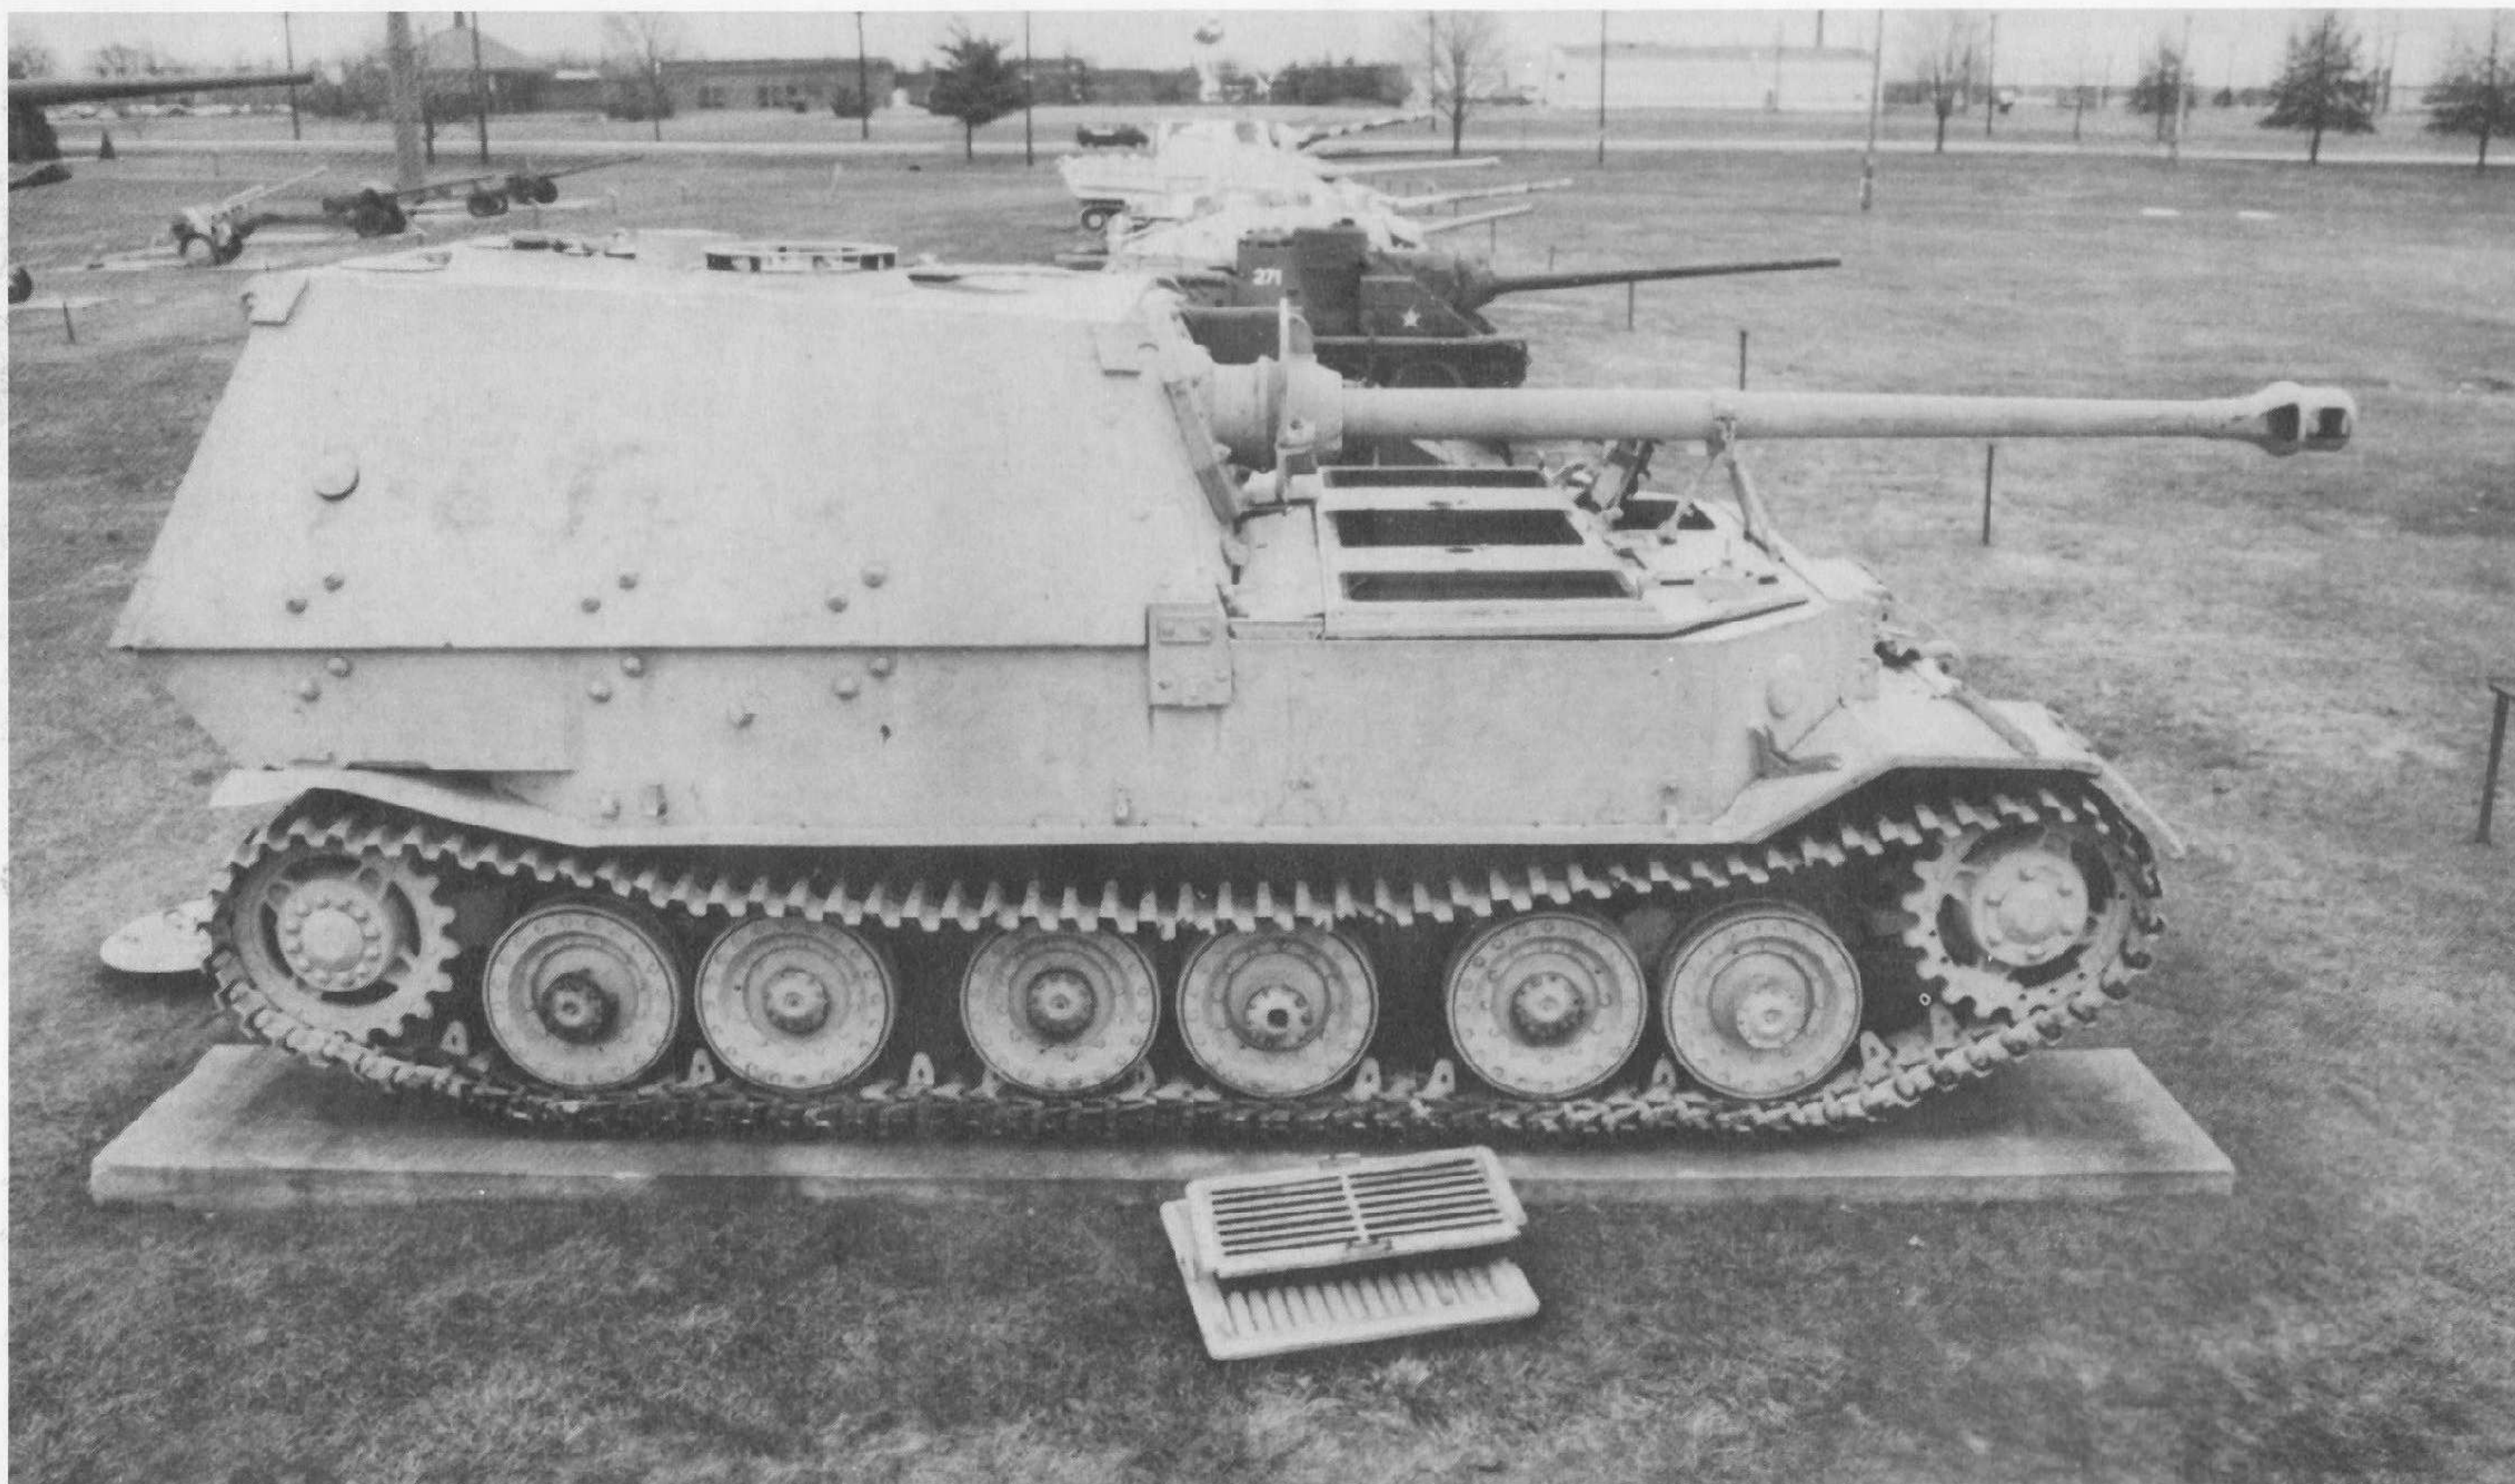
As in the photo above, the radiator air intake grill has been removed. On the ground underneath is the main engine access panel. These grillworks are enormously heavy and once felt can lend new appreciation to the difficulties of working on these vehicles, especially if you factor in combat and inclement weather.

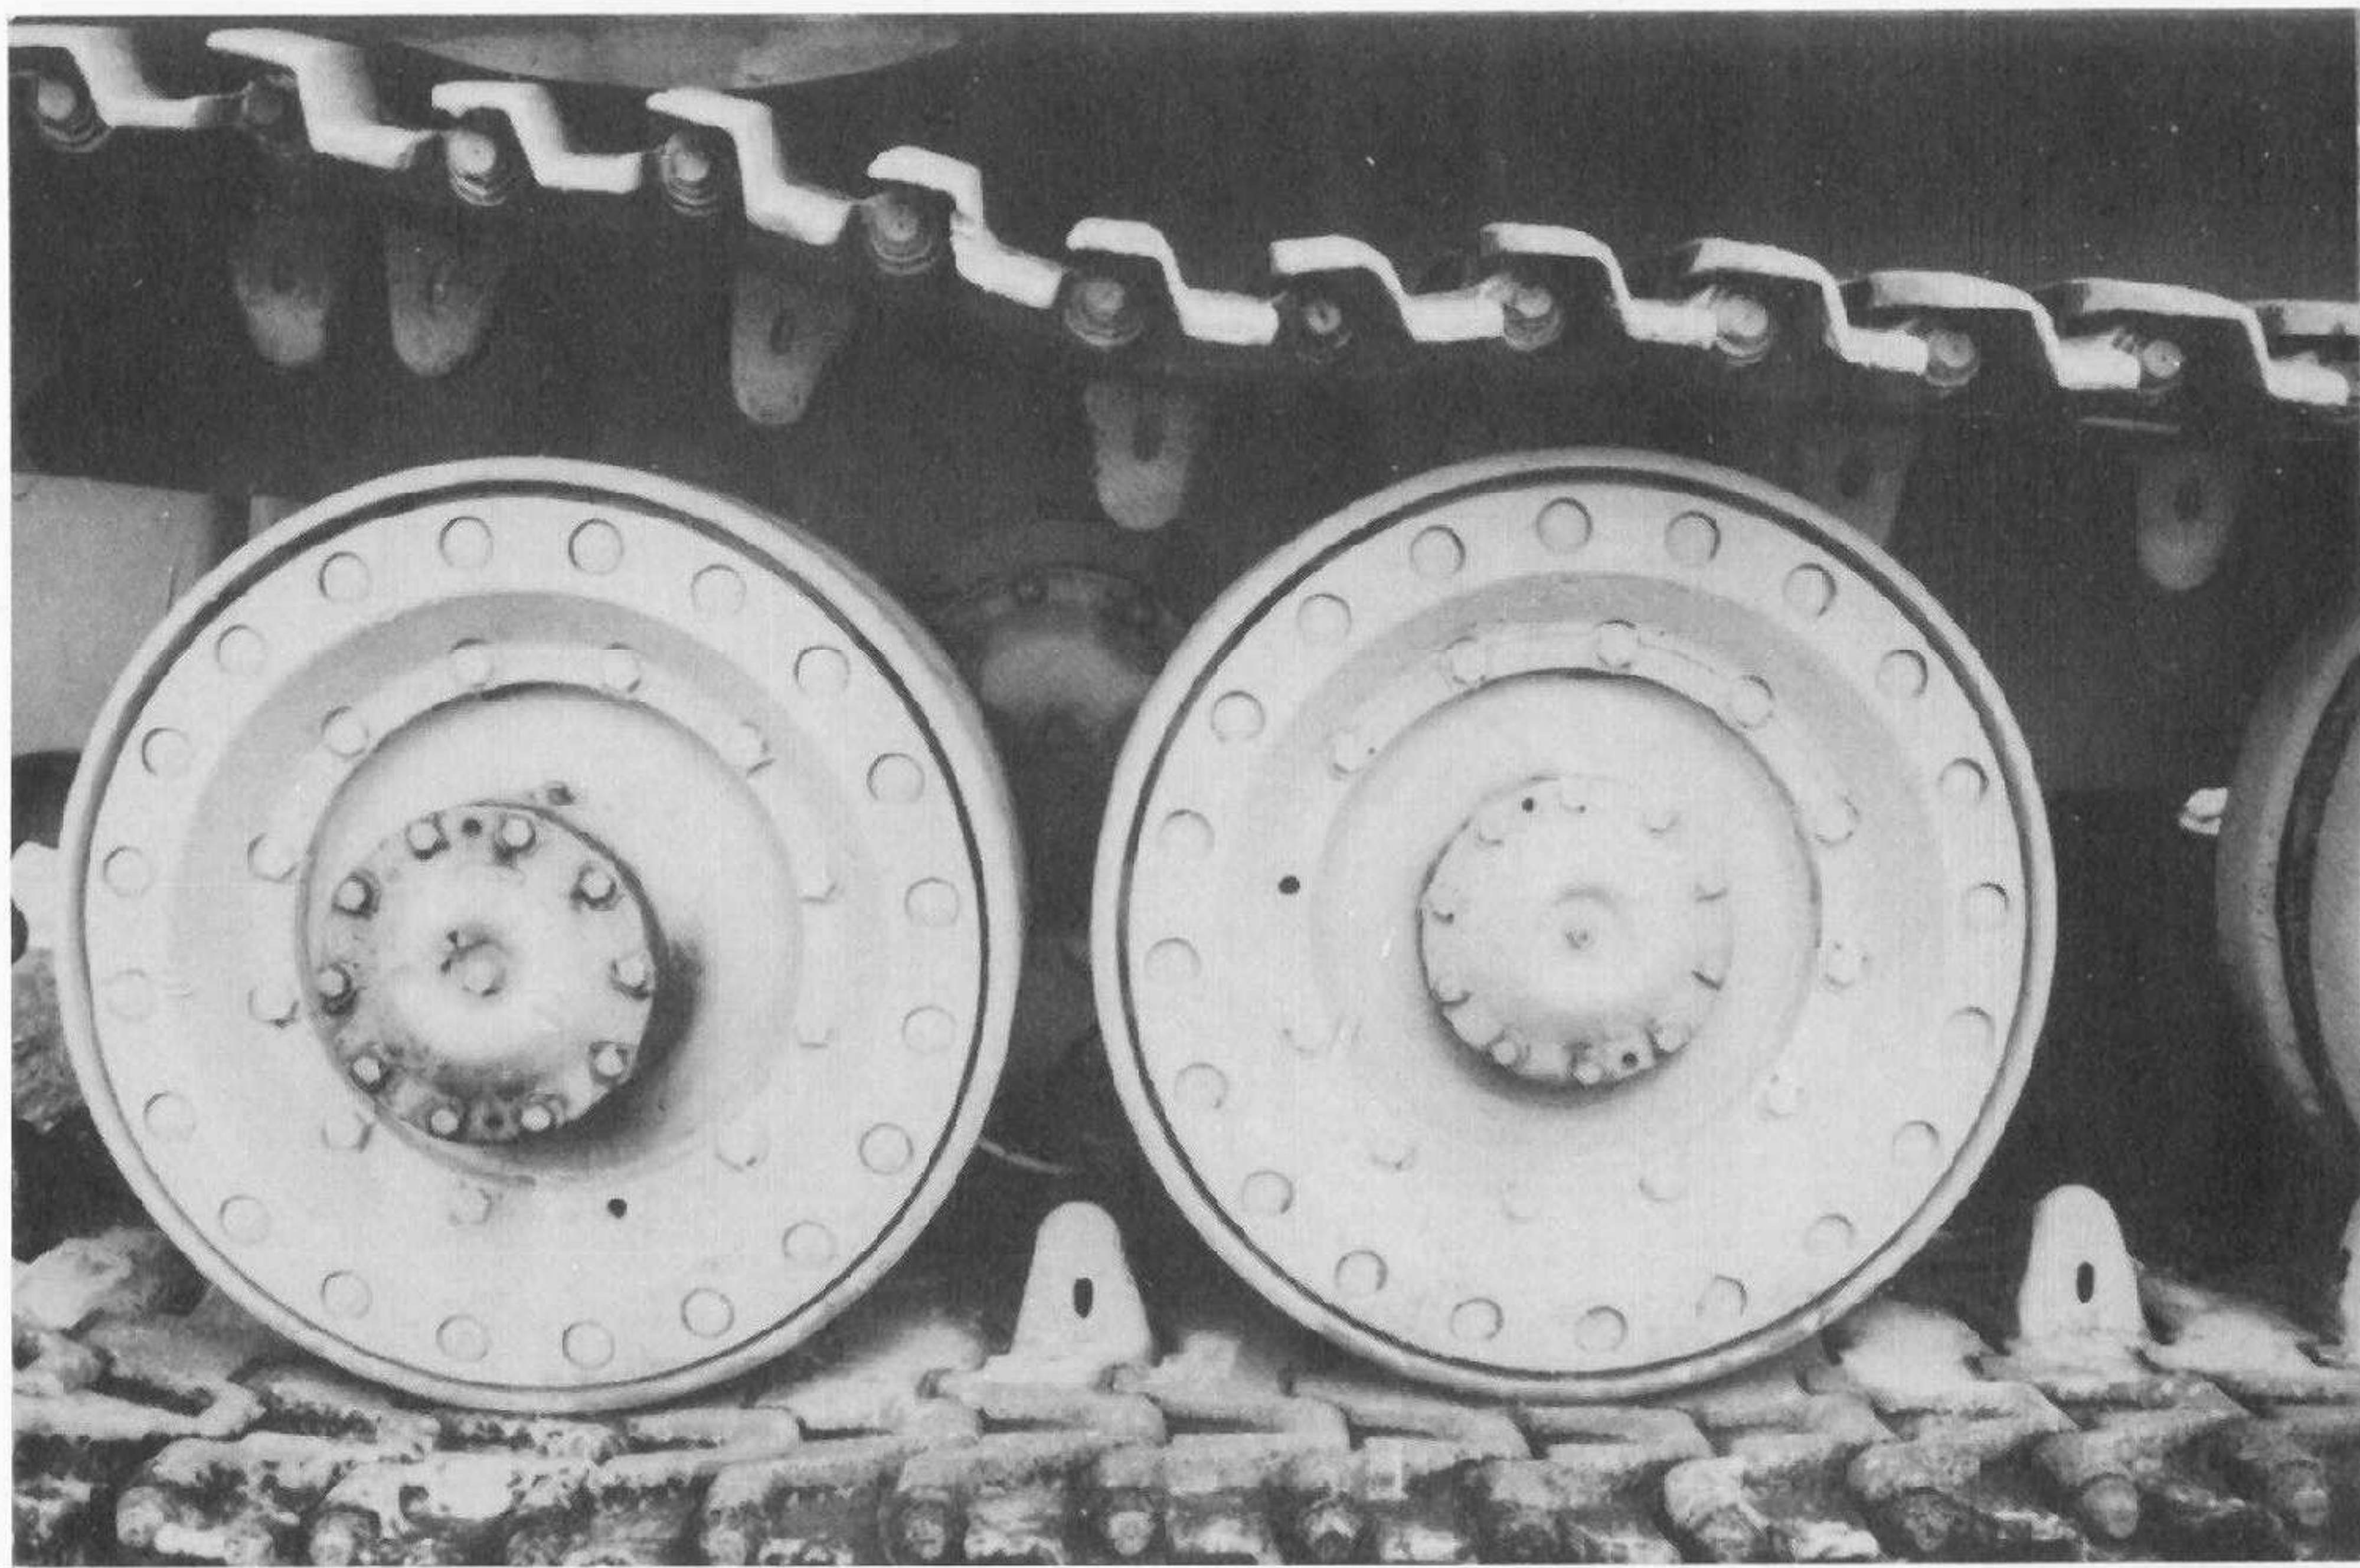
The road wheel system was designed around six (three per side) two-wheel bogie assemblies. Each assembly was pivoted to the hull and the suspension arranged externally.
