MUSEUM ORDNANCE SPECIAL NUMBER 4

Elefant Panzerjäger Tiger (P)

Text by Thomas L. Jentz
Photos by Jeffrey D. McKaughan

THE "ELEFANT" AT ABERDEEN

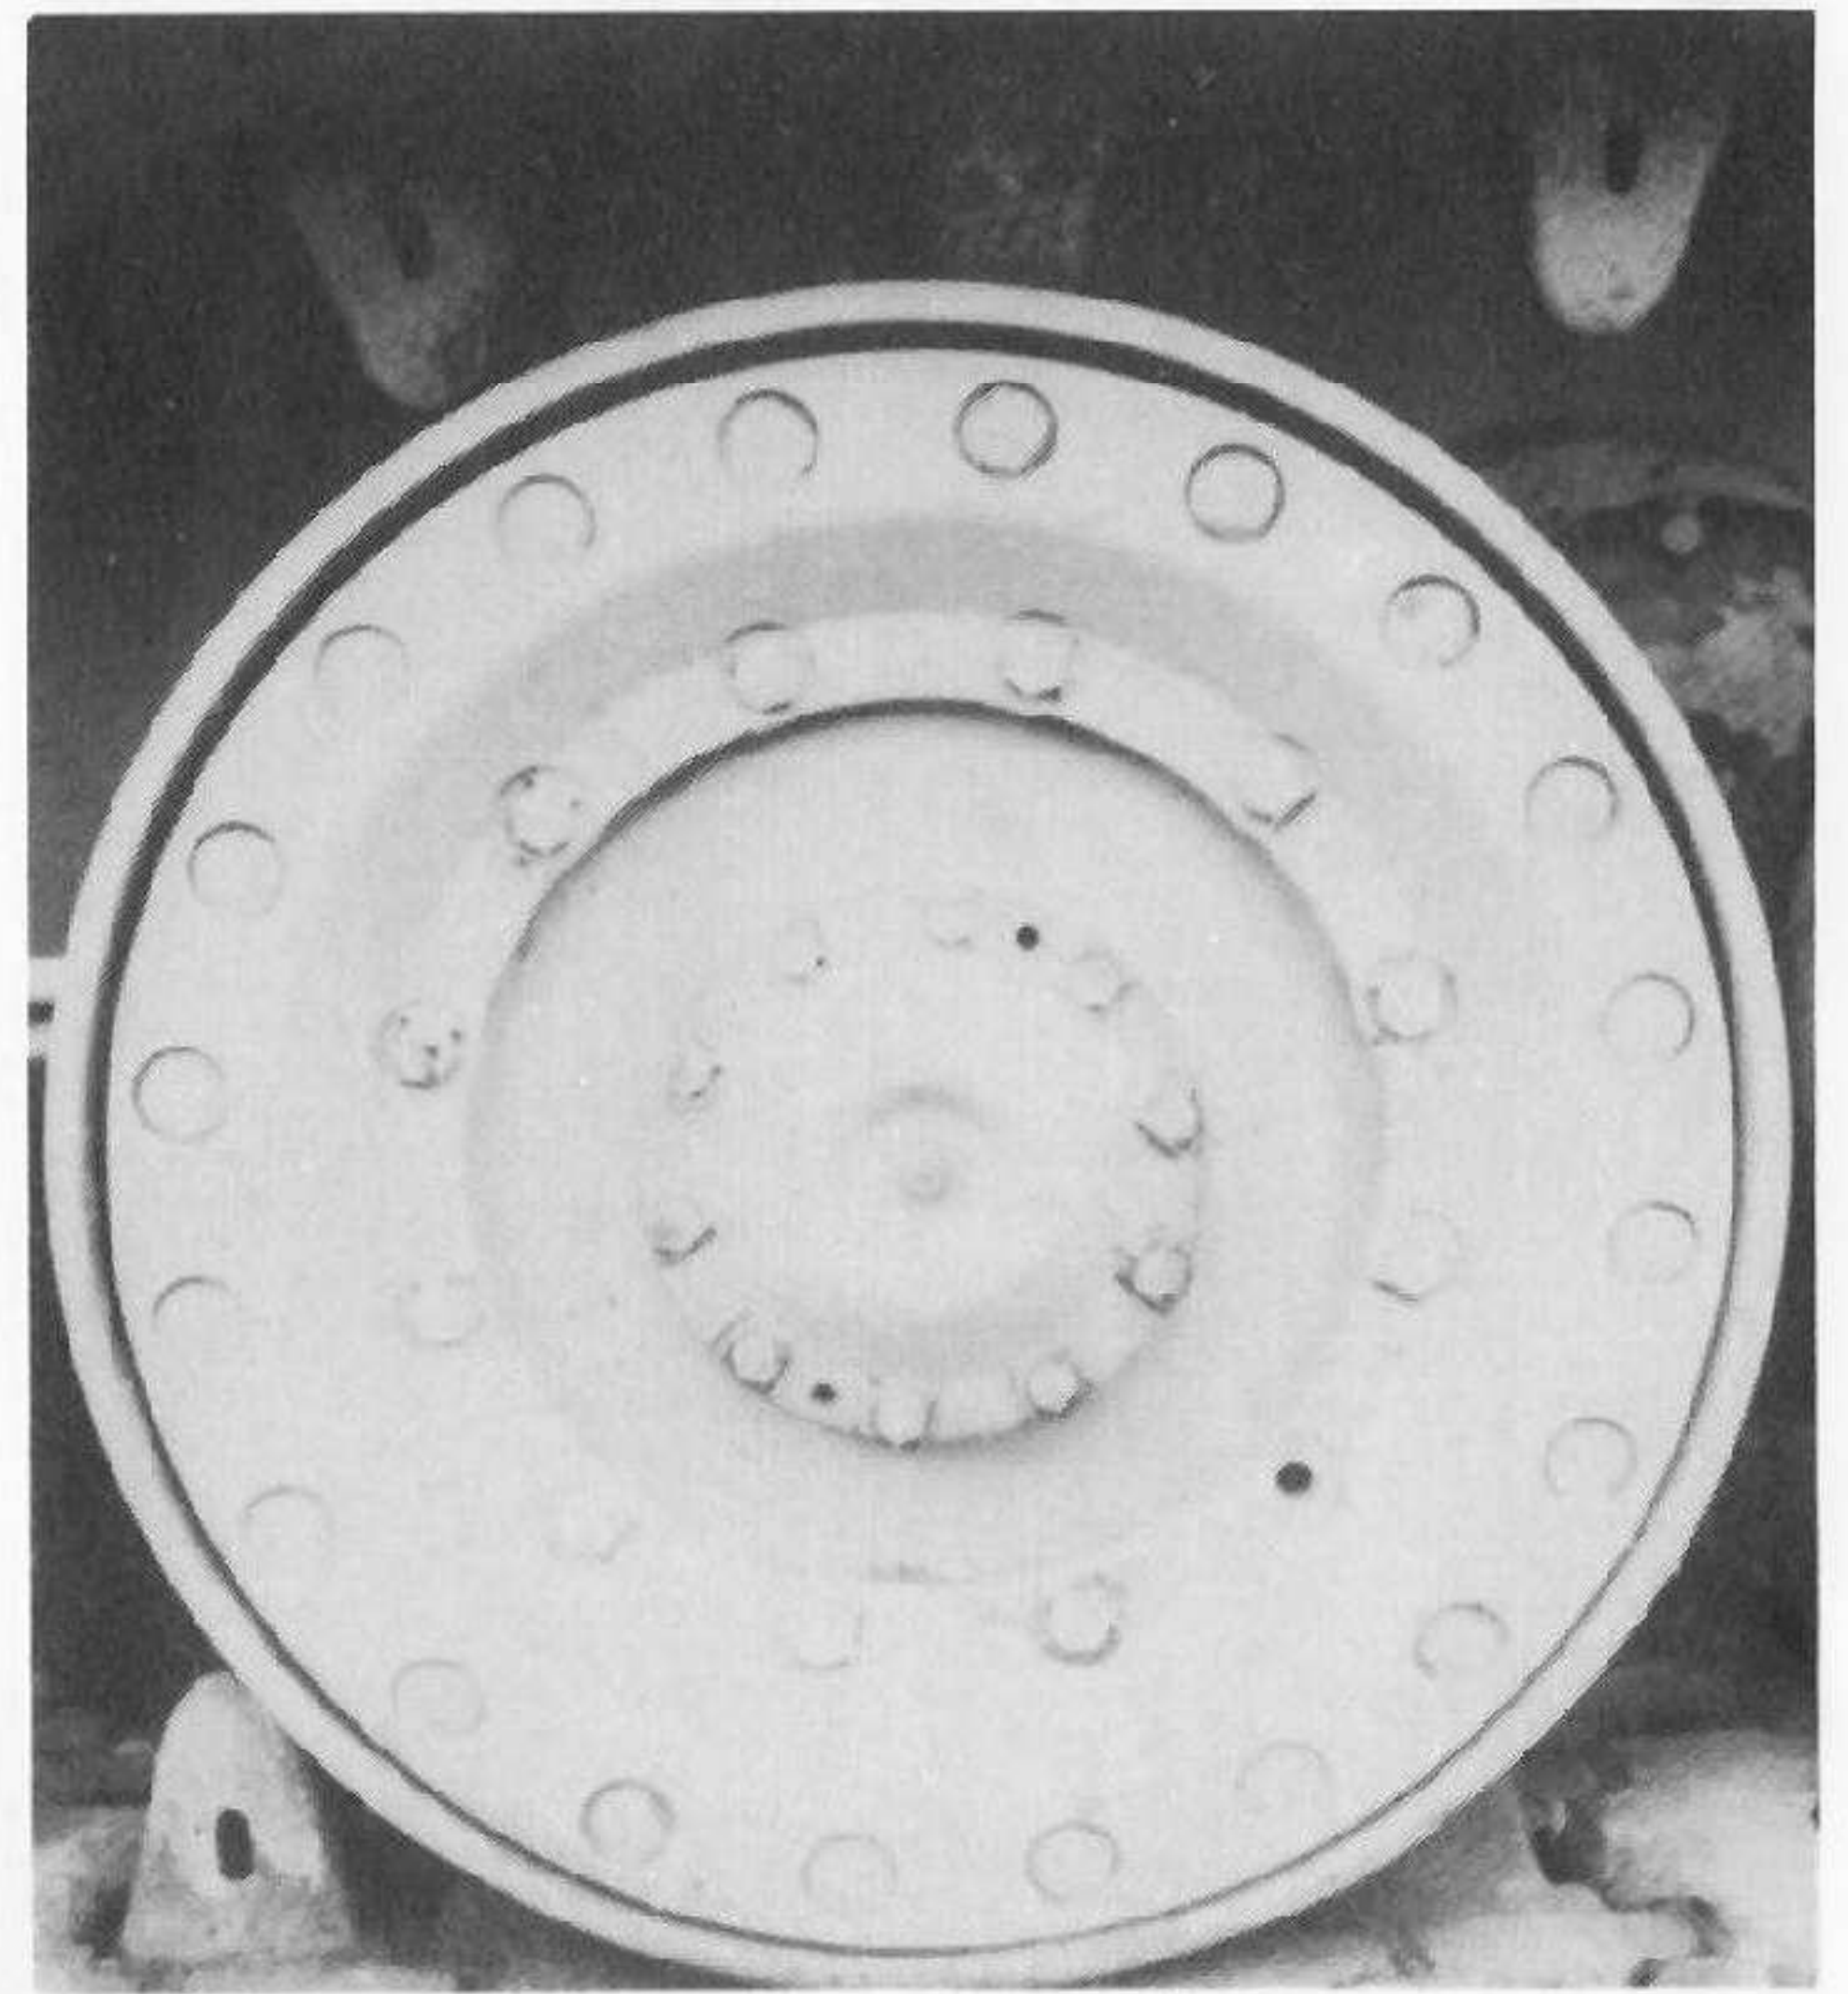
The steel wheels of the Elefant were part of the original Tiger (P) design, as were their smaller size in relation to the Henschel design. Porsche believed that their size would allow for larger wheel movement, that the steel could bear more weight than the rubber-edged ones, and that there were advantages in having six wheels per side versus eight,

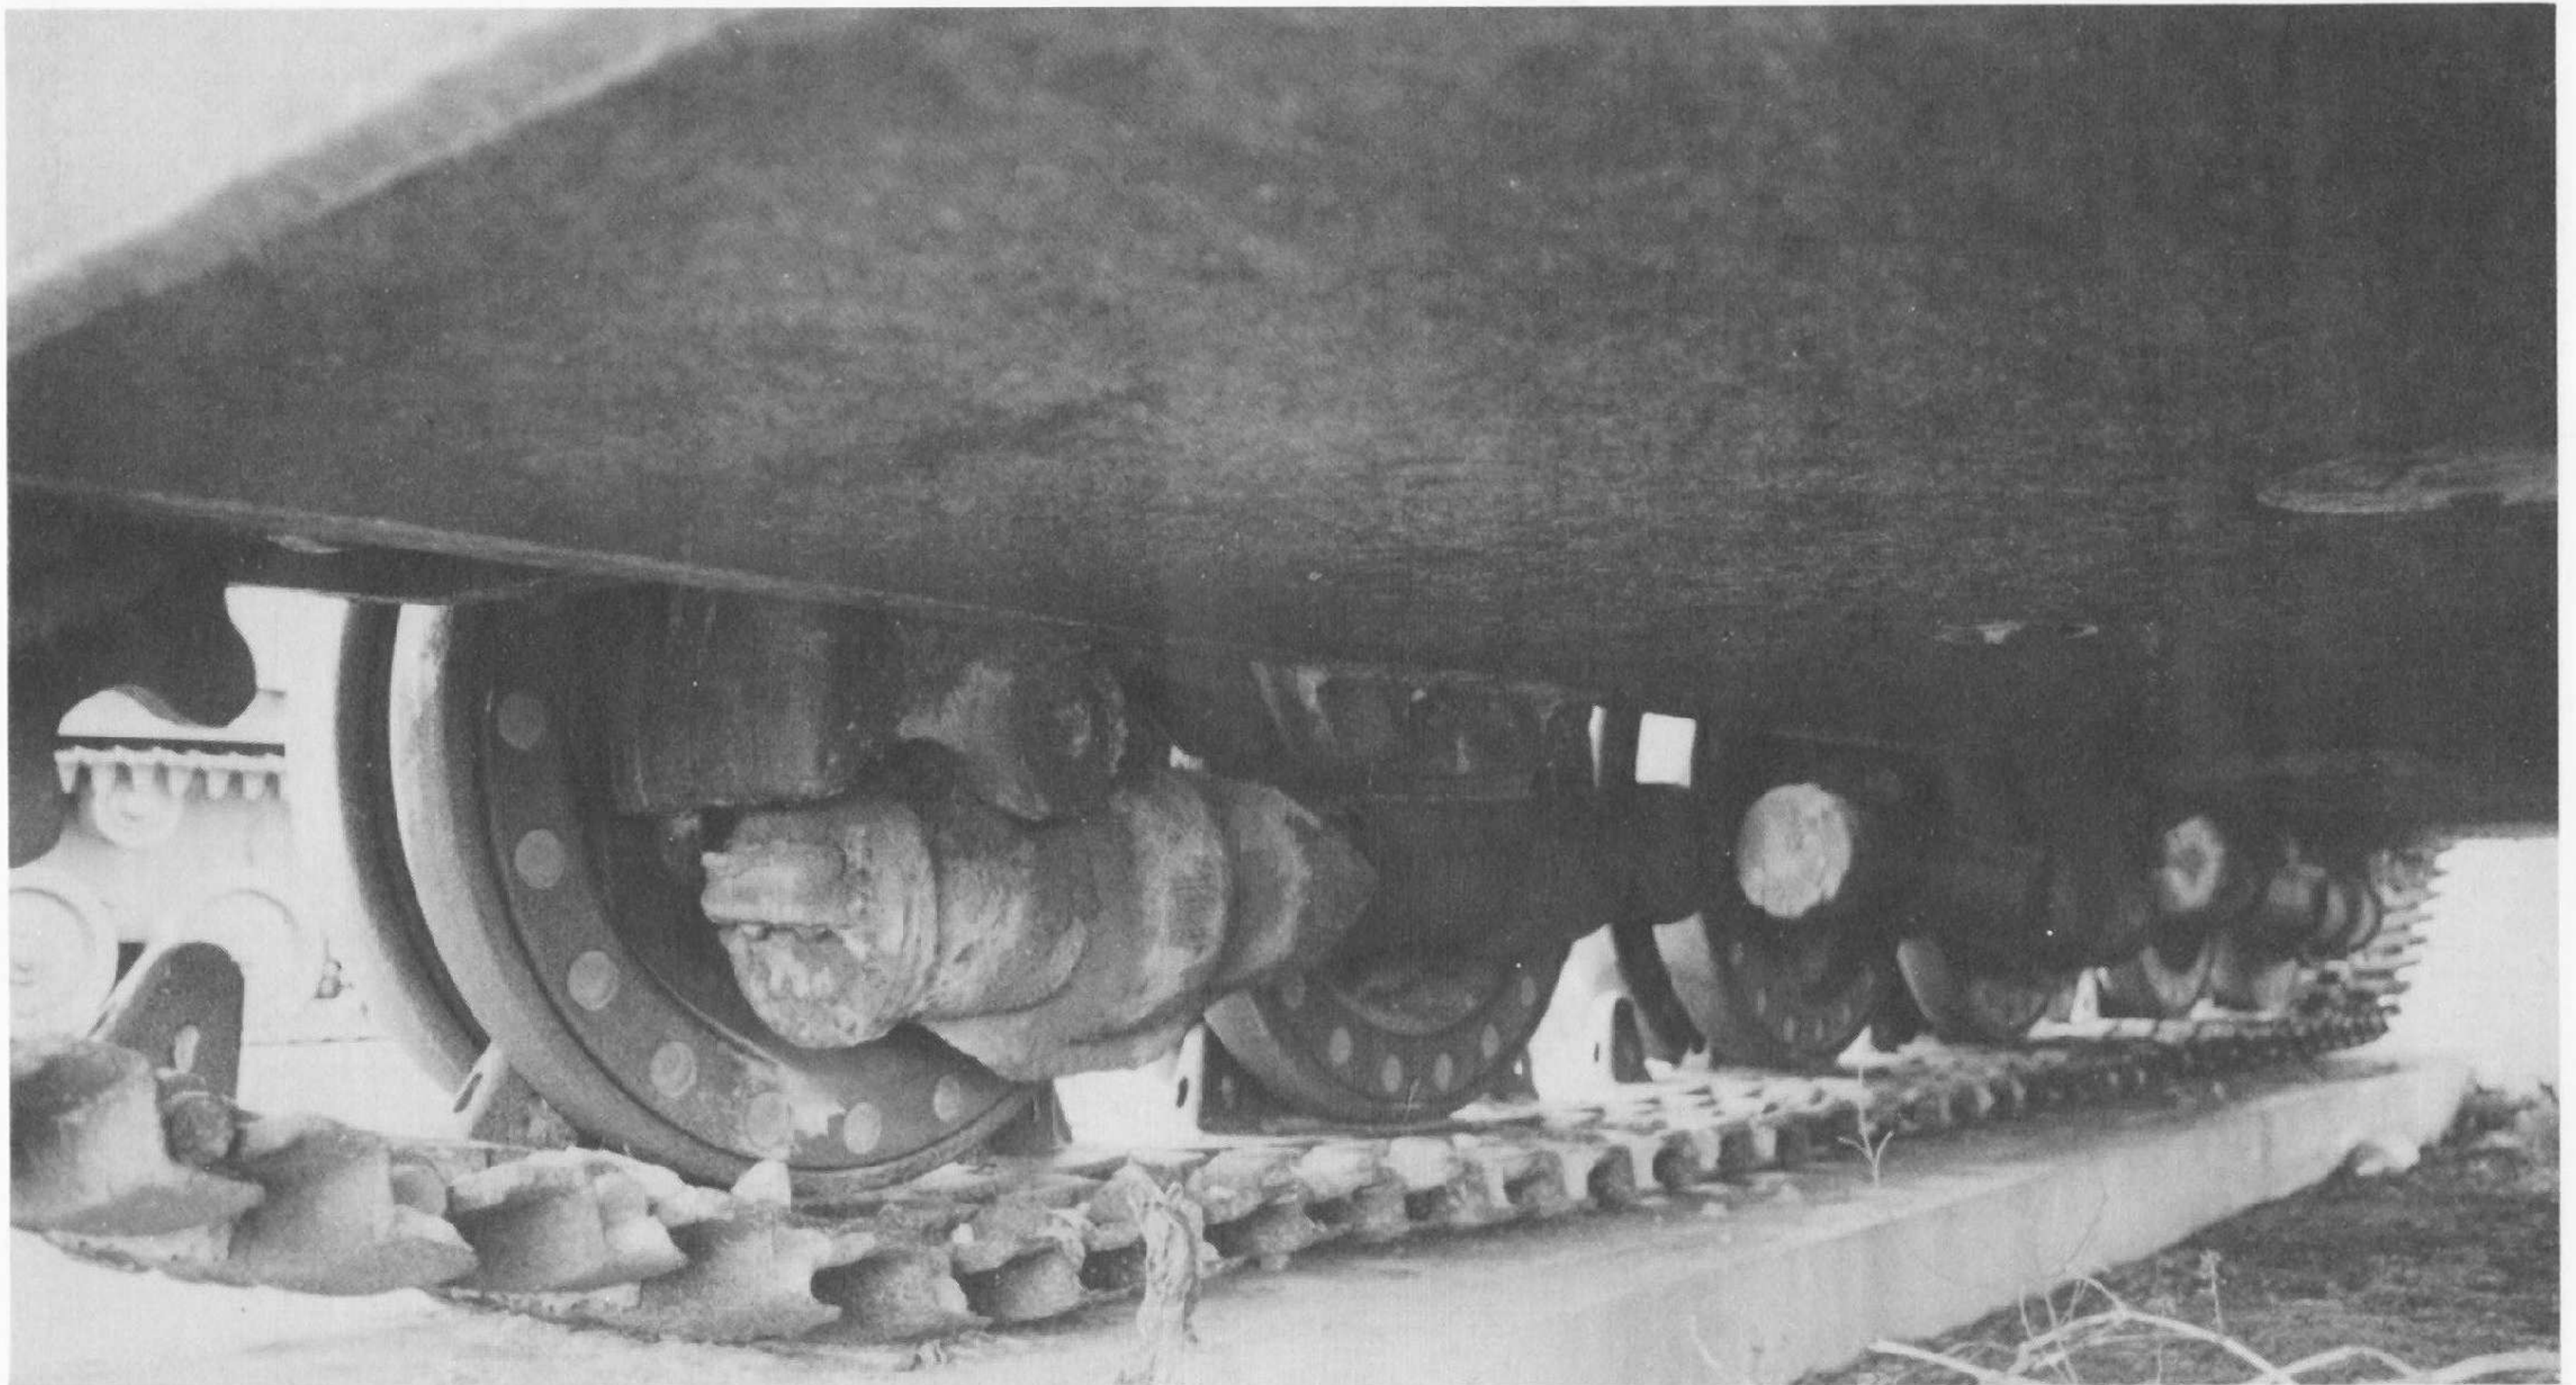
All six bogie assemblies are similar in principle, however, the rear assemblies on both sides are reversed. This can be seen in the photo. Despite their similarities, the assemblies are not interchangeable. For example a rear assembly cannot be mounted in either the center or forward positions, nor can an assembly be interchanged with its corresponding assembly on the opposite side.

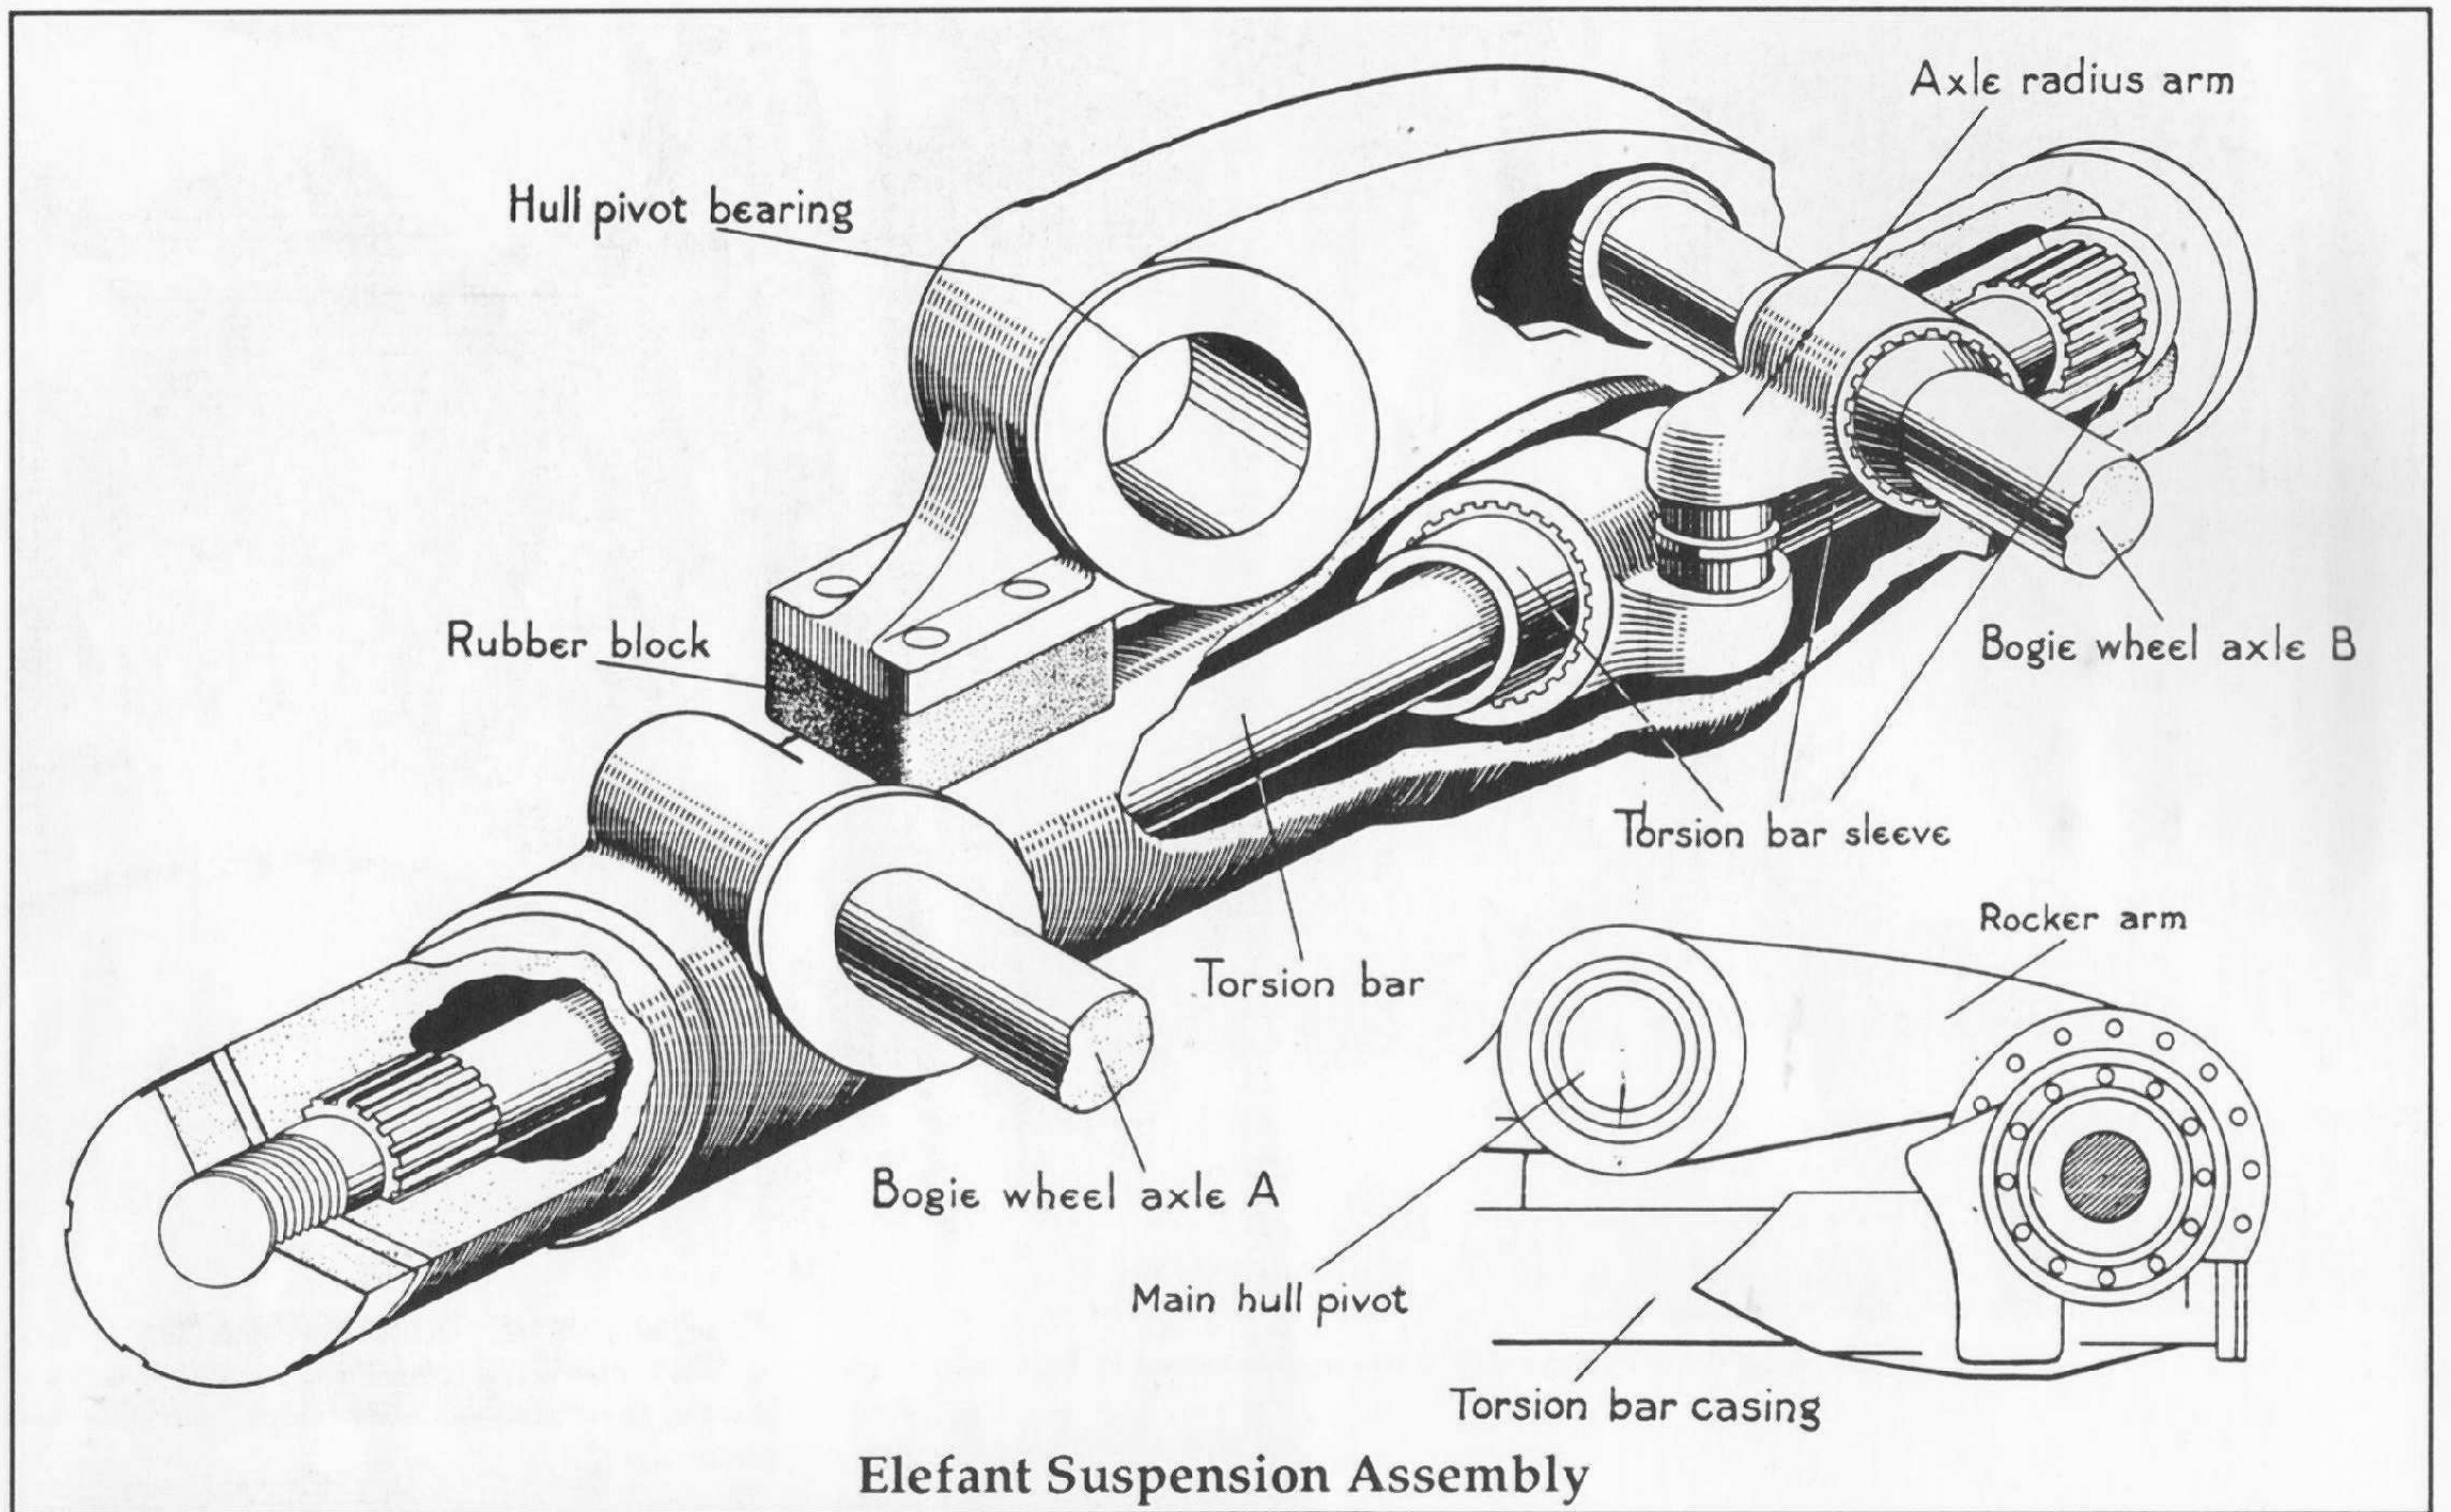
Elefant Suspension Assembly

A description of the suspension is provided by a British Technical Intelligence Summary:

"A diagrammatic drawing attached illustrates the general arrangement of the rather unusual type of bogie unit employed. Each of these units comprises a rocker arm, which is fitted on the main hull pivot, and a horizontal torsion bar casing arranged beneath the rocker arm and hinged to it at one end. Beneath the other end of the rocker arm is attached a rubber block, about 7 x 5 x 3 in., which rests lightly on the top of the torsion bar casing when the vehicle is stationary. One bogie wheel axle (A) is fixed to the torsion bar casing a short distance from its free end, while the other (B) is located at the pivotal axis between the casing and the rocker arm, and serves as the hinge pin between them. This last mentioned axle is fixed to the rocker arm and carried in bearings in the torsion bar casing. A short radius arm is splined on this axle, and consequently maintains a fixed angle with respect to the rocker arm.

The torsion bar is anchored at one end by splines into the free end of its casing, where it is secured by a nut and lock nut. At the other end it is splined into a sleeve which is journaled in the torsion bar casing and extends back around the torsion bar to a point some distance beyond the end of the axle radius arm. A second radius arm is splined on the torsion bar sleeve beneath the first radius arm and a thrust member is connected by ball and socket joints between the ends of the two arms."

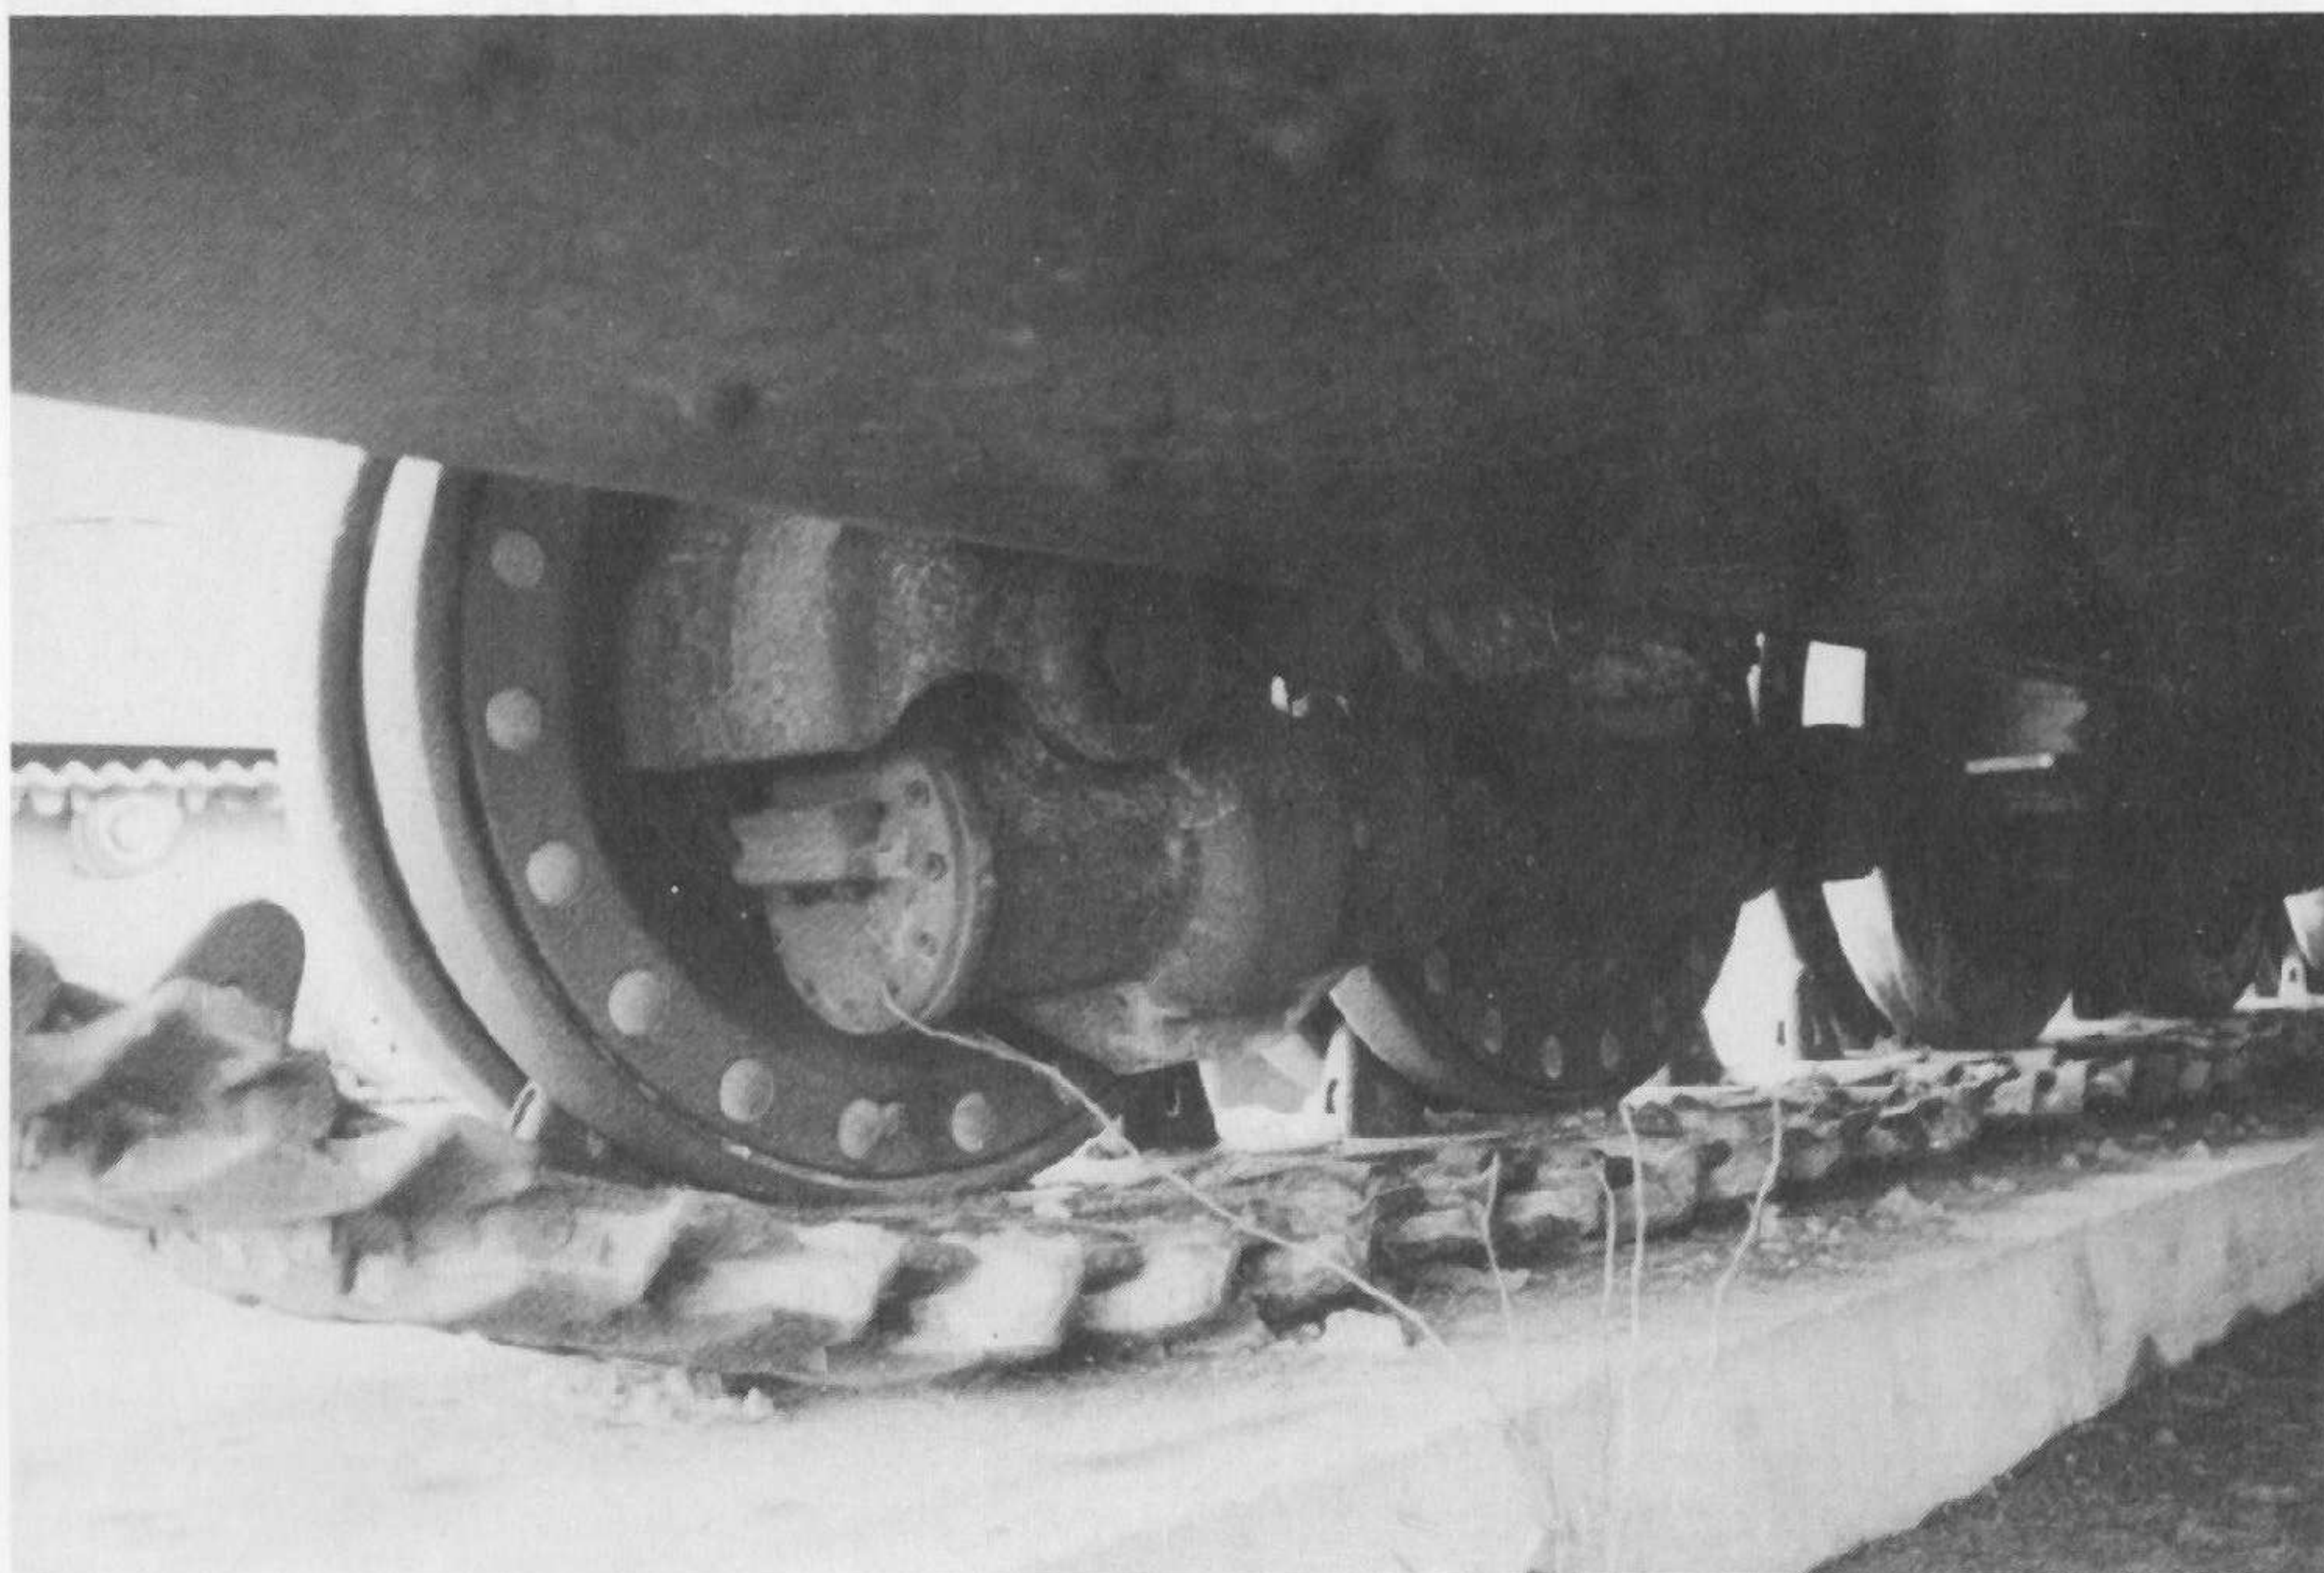
The backside of the front suspension assembly on the right side can be seen. This system was beset by problems and although its external design eliminated internal space requirements for torsion bars, it also contributed to the Elephant's tendency for mud and debris buildup on the underside of the hull.

The length of the torsion bar was 1155mm and it had a diameter of 72mm. The distance from center to center of the bogie assembly was 1660mm.

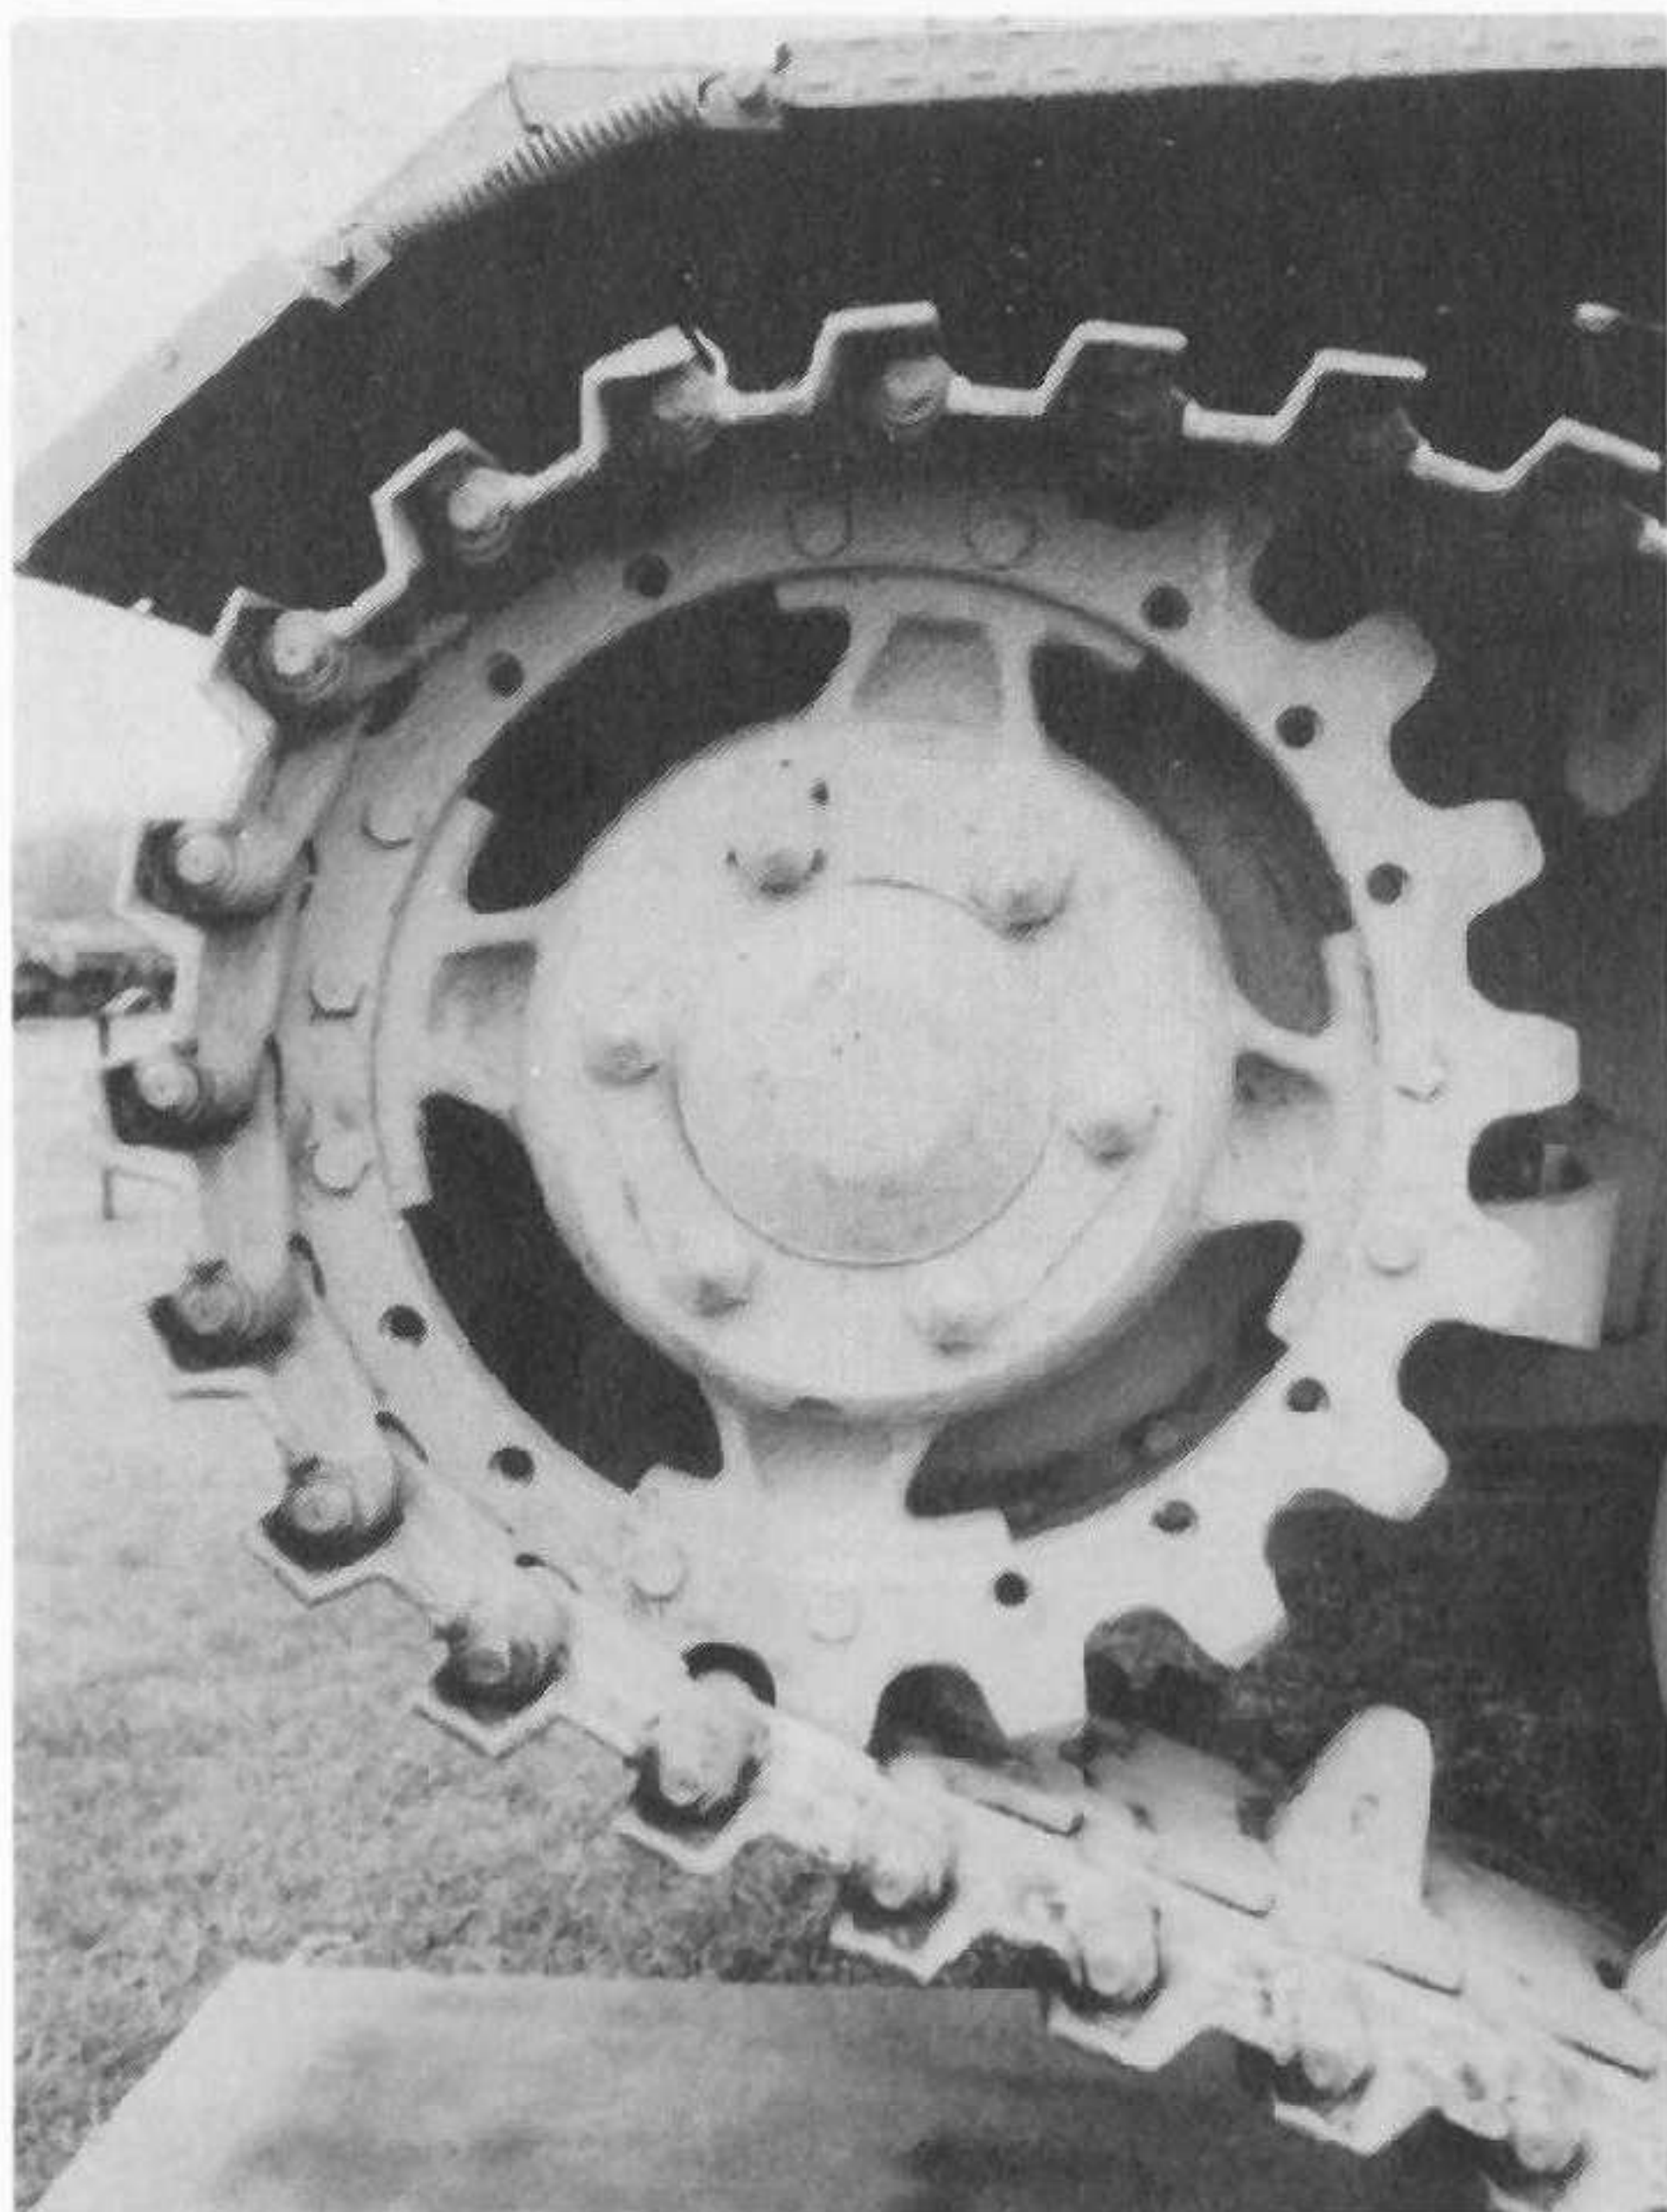
The front-mounted idler had 19 teeth.

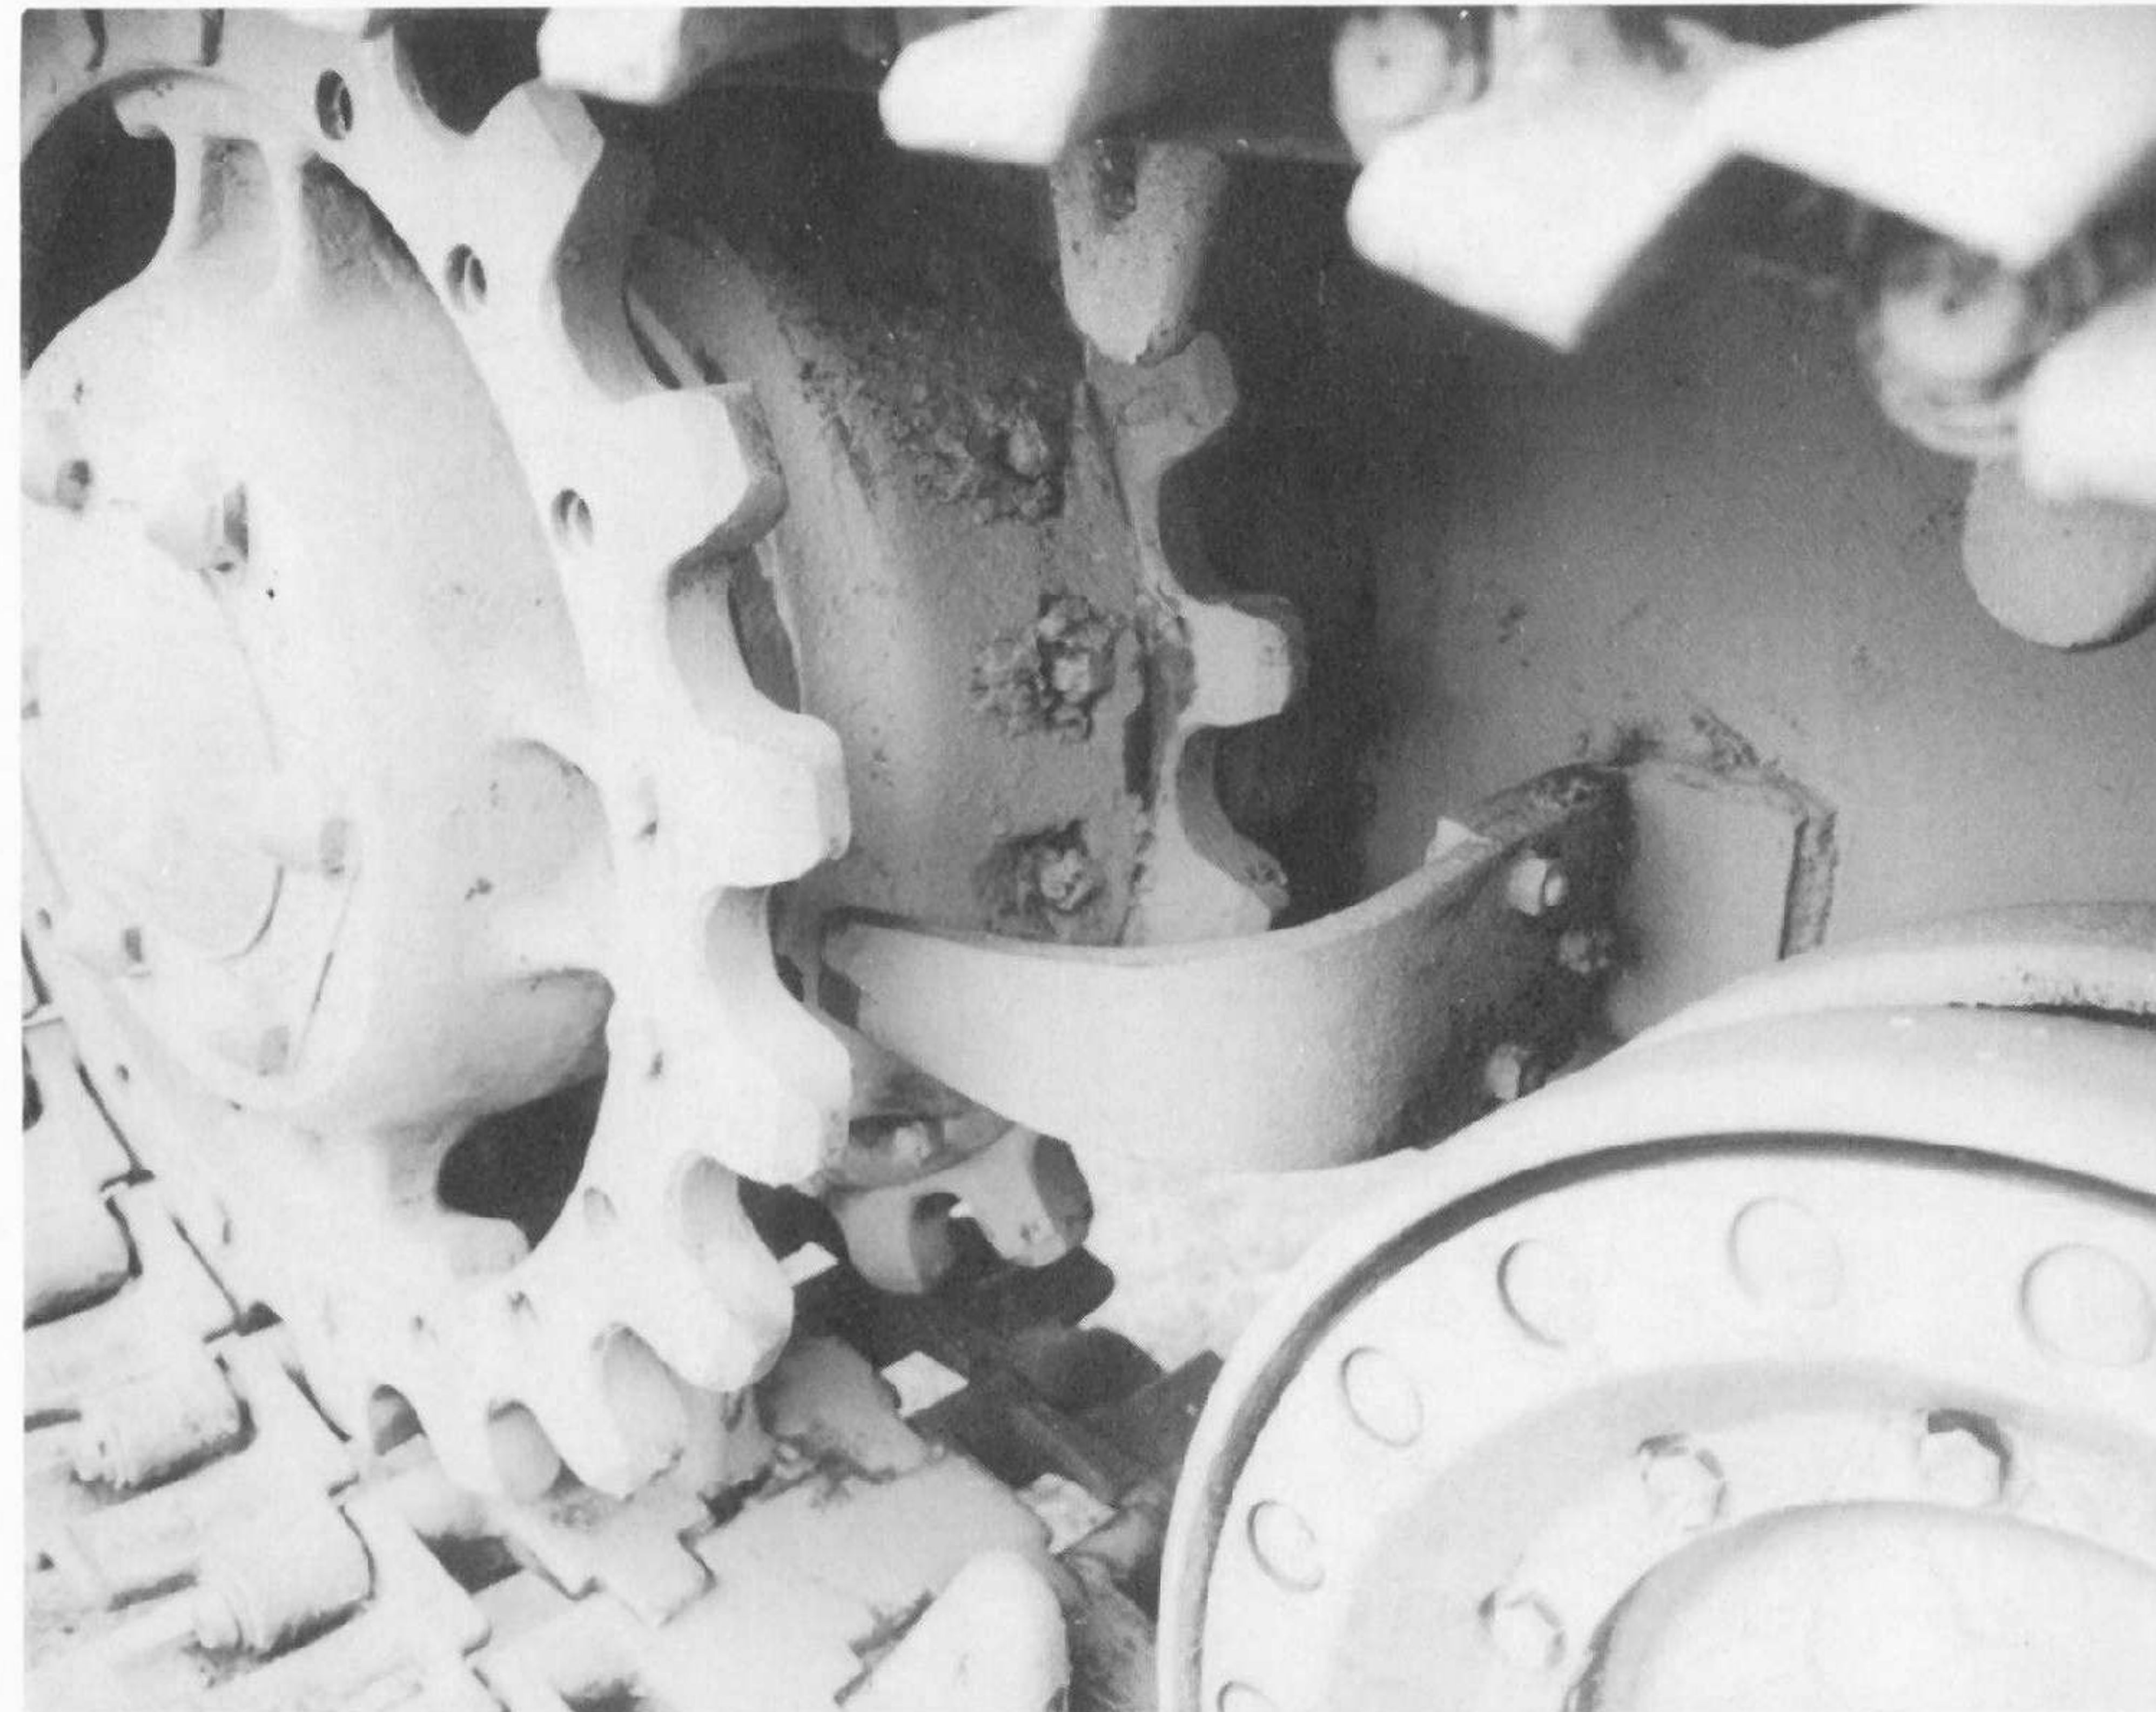
Combining the 65 ton weight of the Elephant with its high ground pressure ratio (1.23 kg/cm²) the Germans were left with a vehicle that liked to collect mud. To clear as much of this as possible by itself, the Elephant had a cleaning fixture attached to the lower hull just behind the idlers. You can clearly see that the small curved arm is bolted to an "L" bracket that is welded to the hull side.

From this angle you can also see the backside of the bolts that hold the teeth rim onto the idler wheel itself.
