MUSEUM ORDNANCE SPECIAL NUMBER 4

Elefant Panzerjäger Tiger (P)

Text by Thomas L. Jentz
Photos by Jeffrey D. McKaughan

THE "ELEFANT" AT ABERDEEN

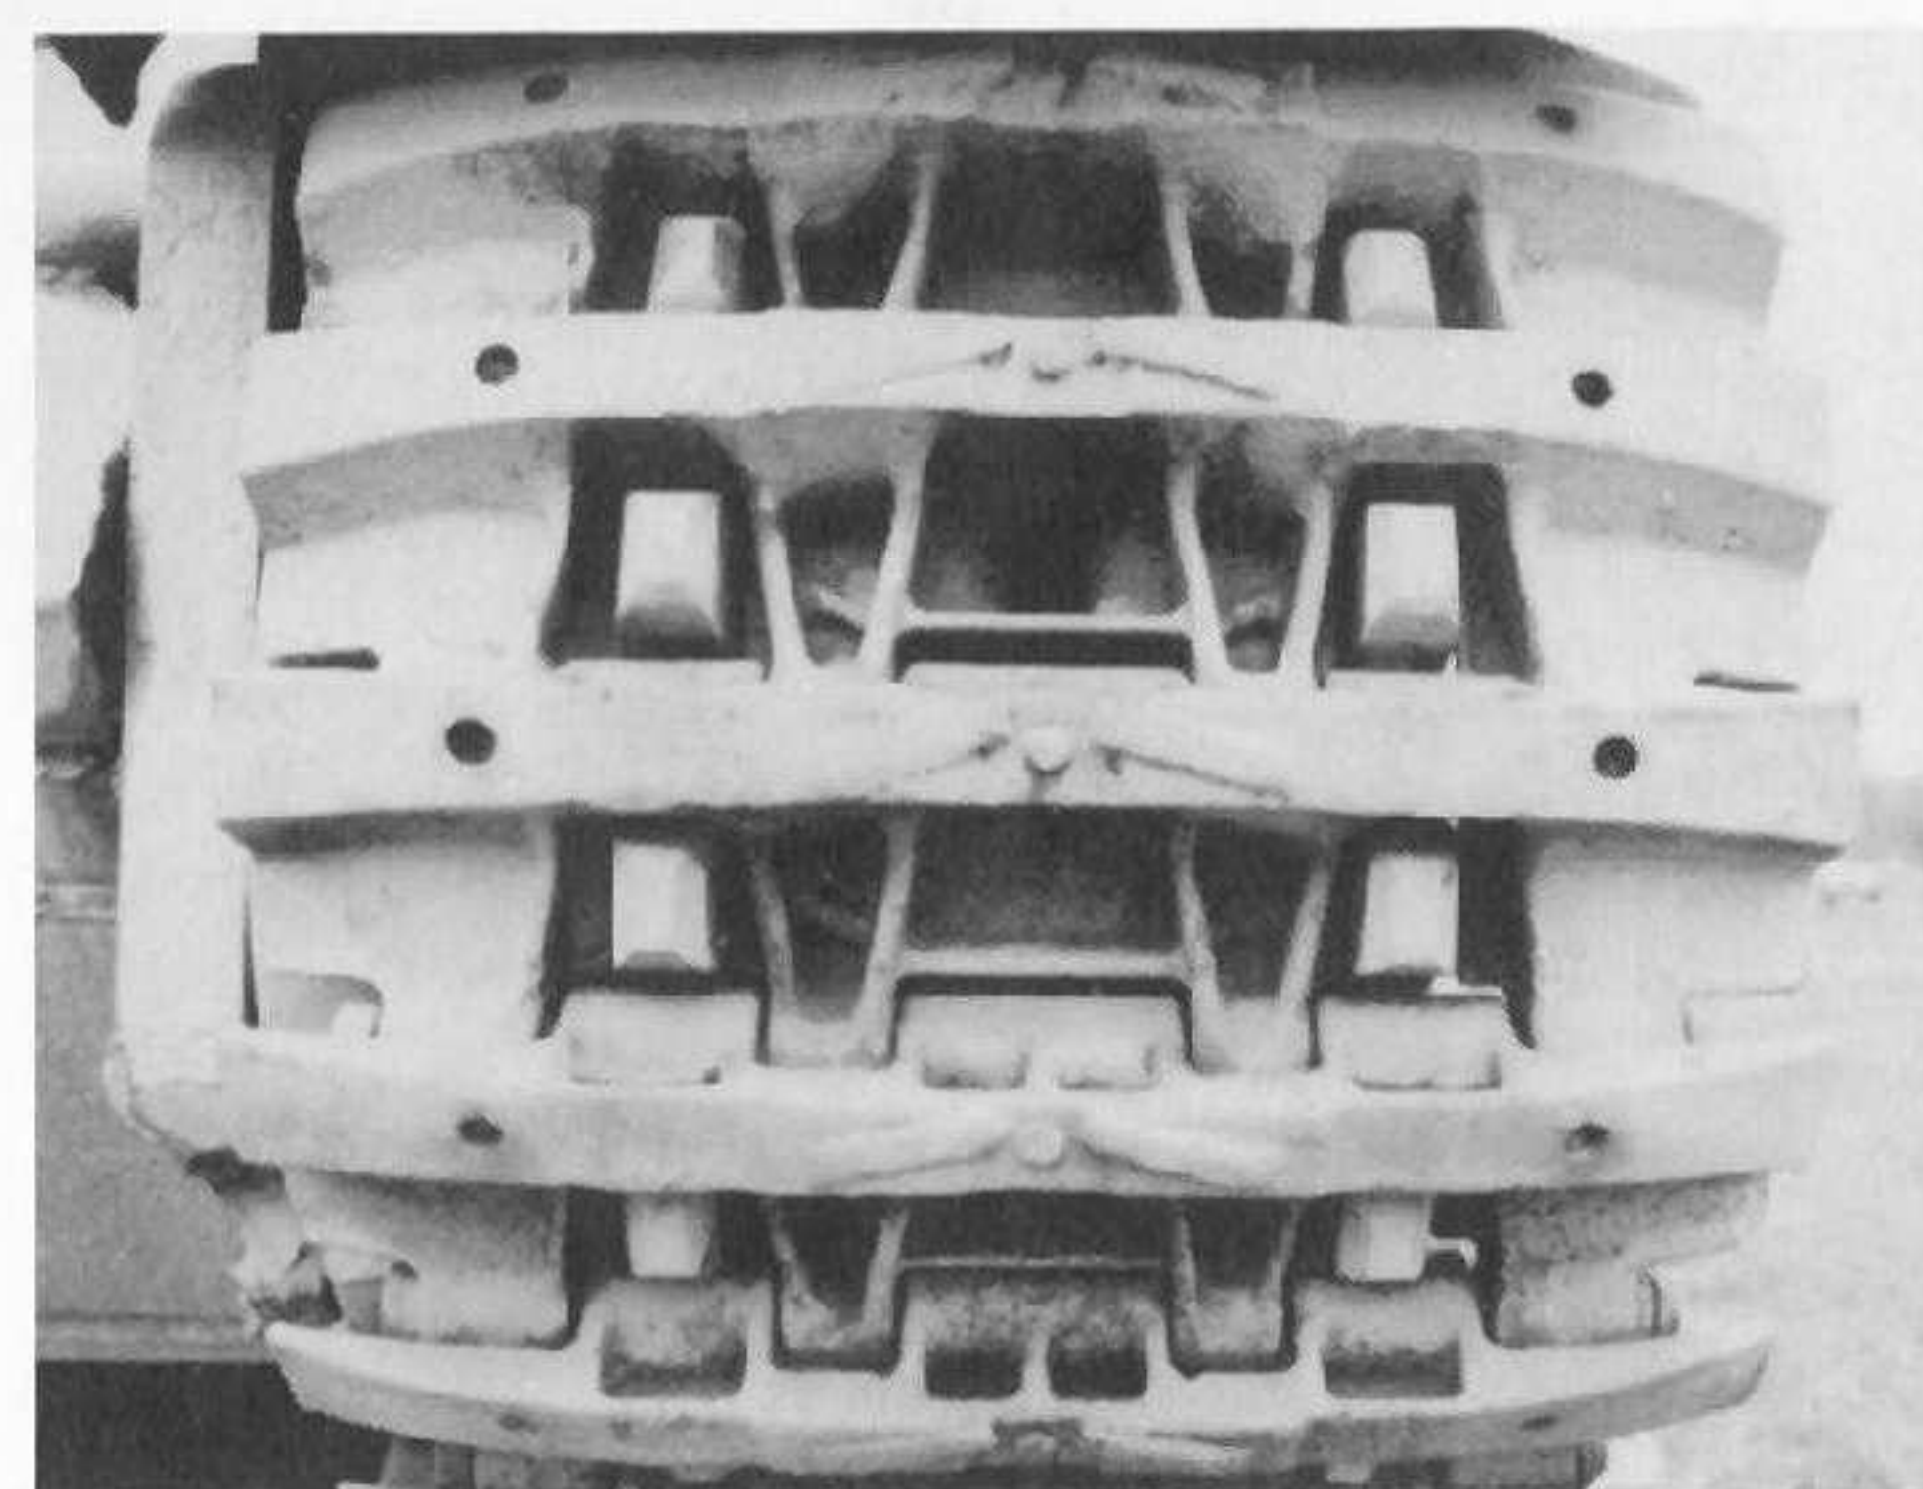
The all-steel tracks had 109 links.

LEFT: The Elephant was a rear-drive vehicle, hence the drive sprocket at the rear of the running gear. In the upper left opening of the sprocket you can see part of the curved mud scraper.

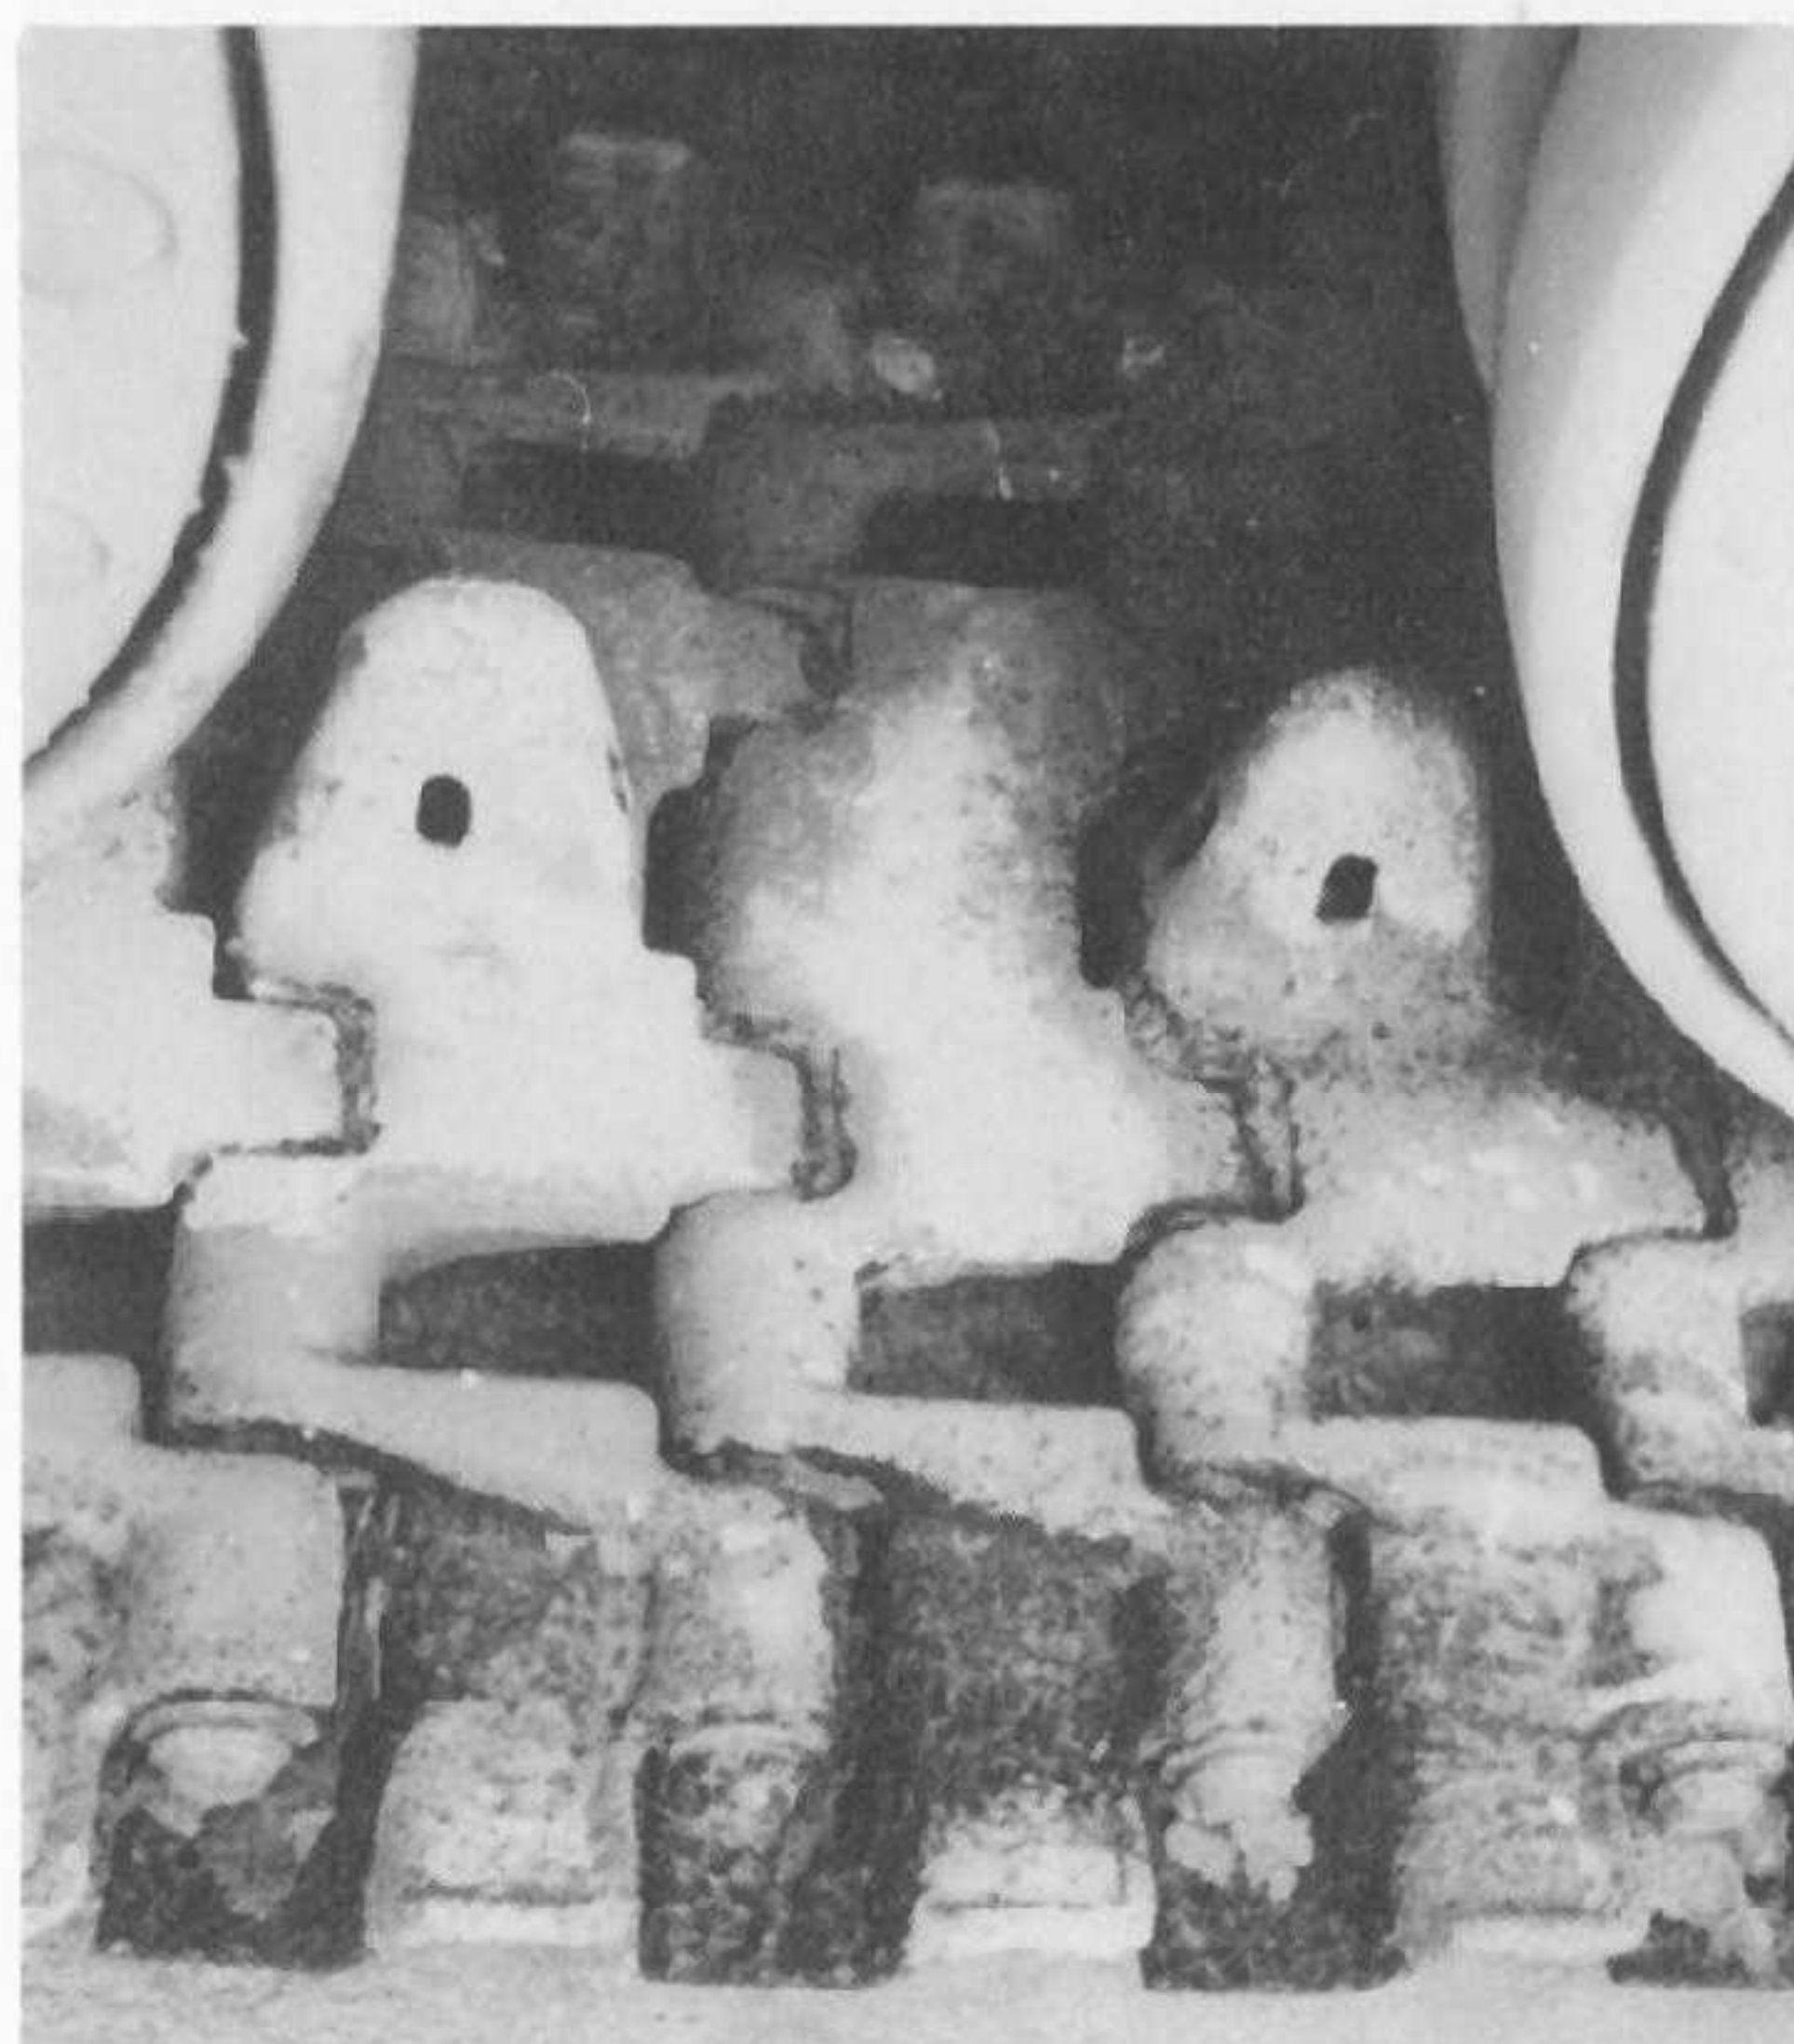
The track guide teeth had four small holes, one on each "side" and one on each "edge."

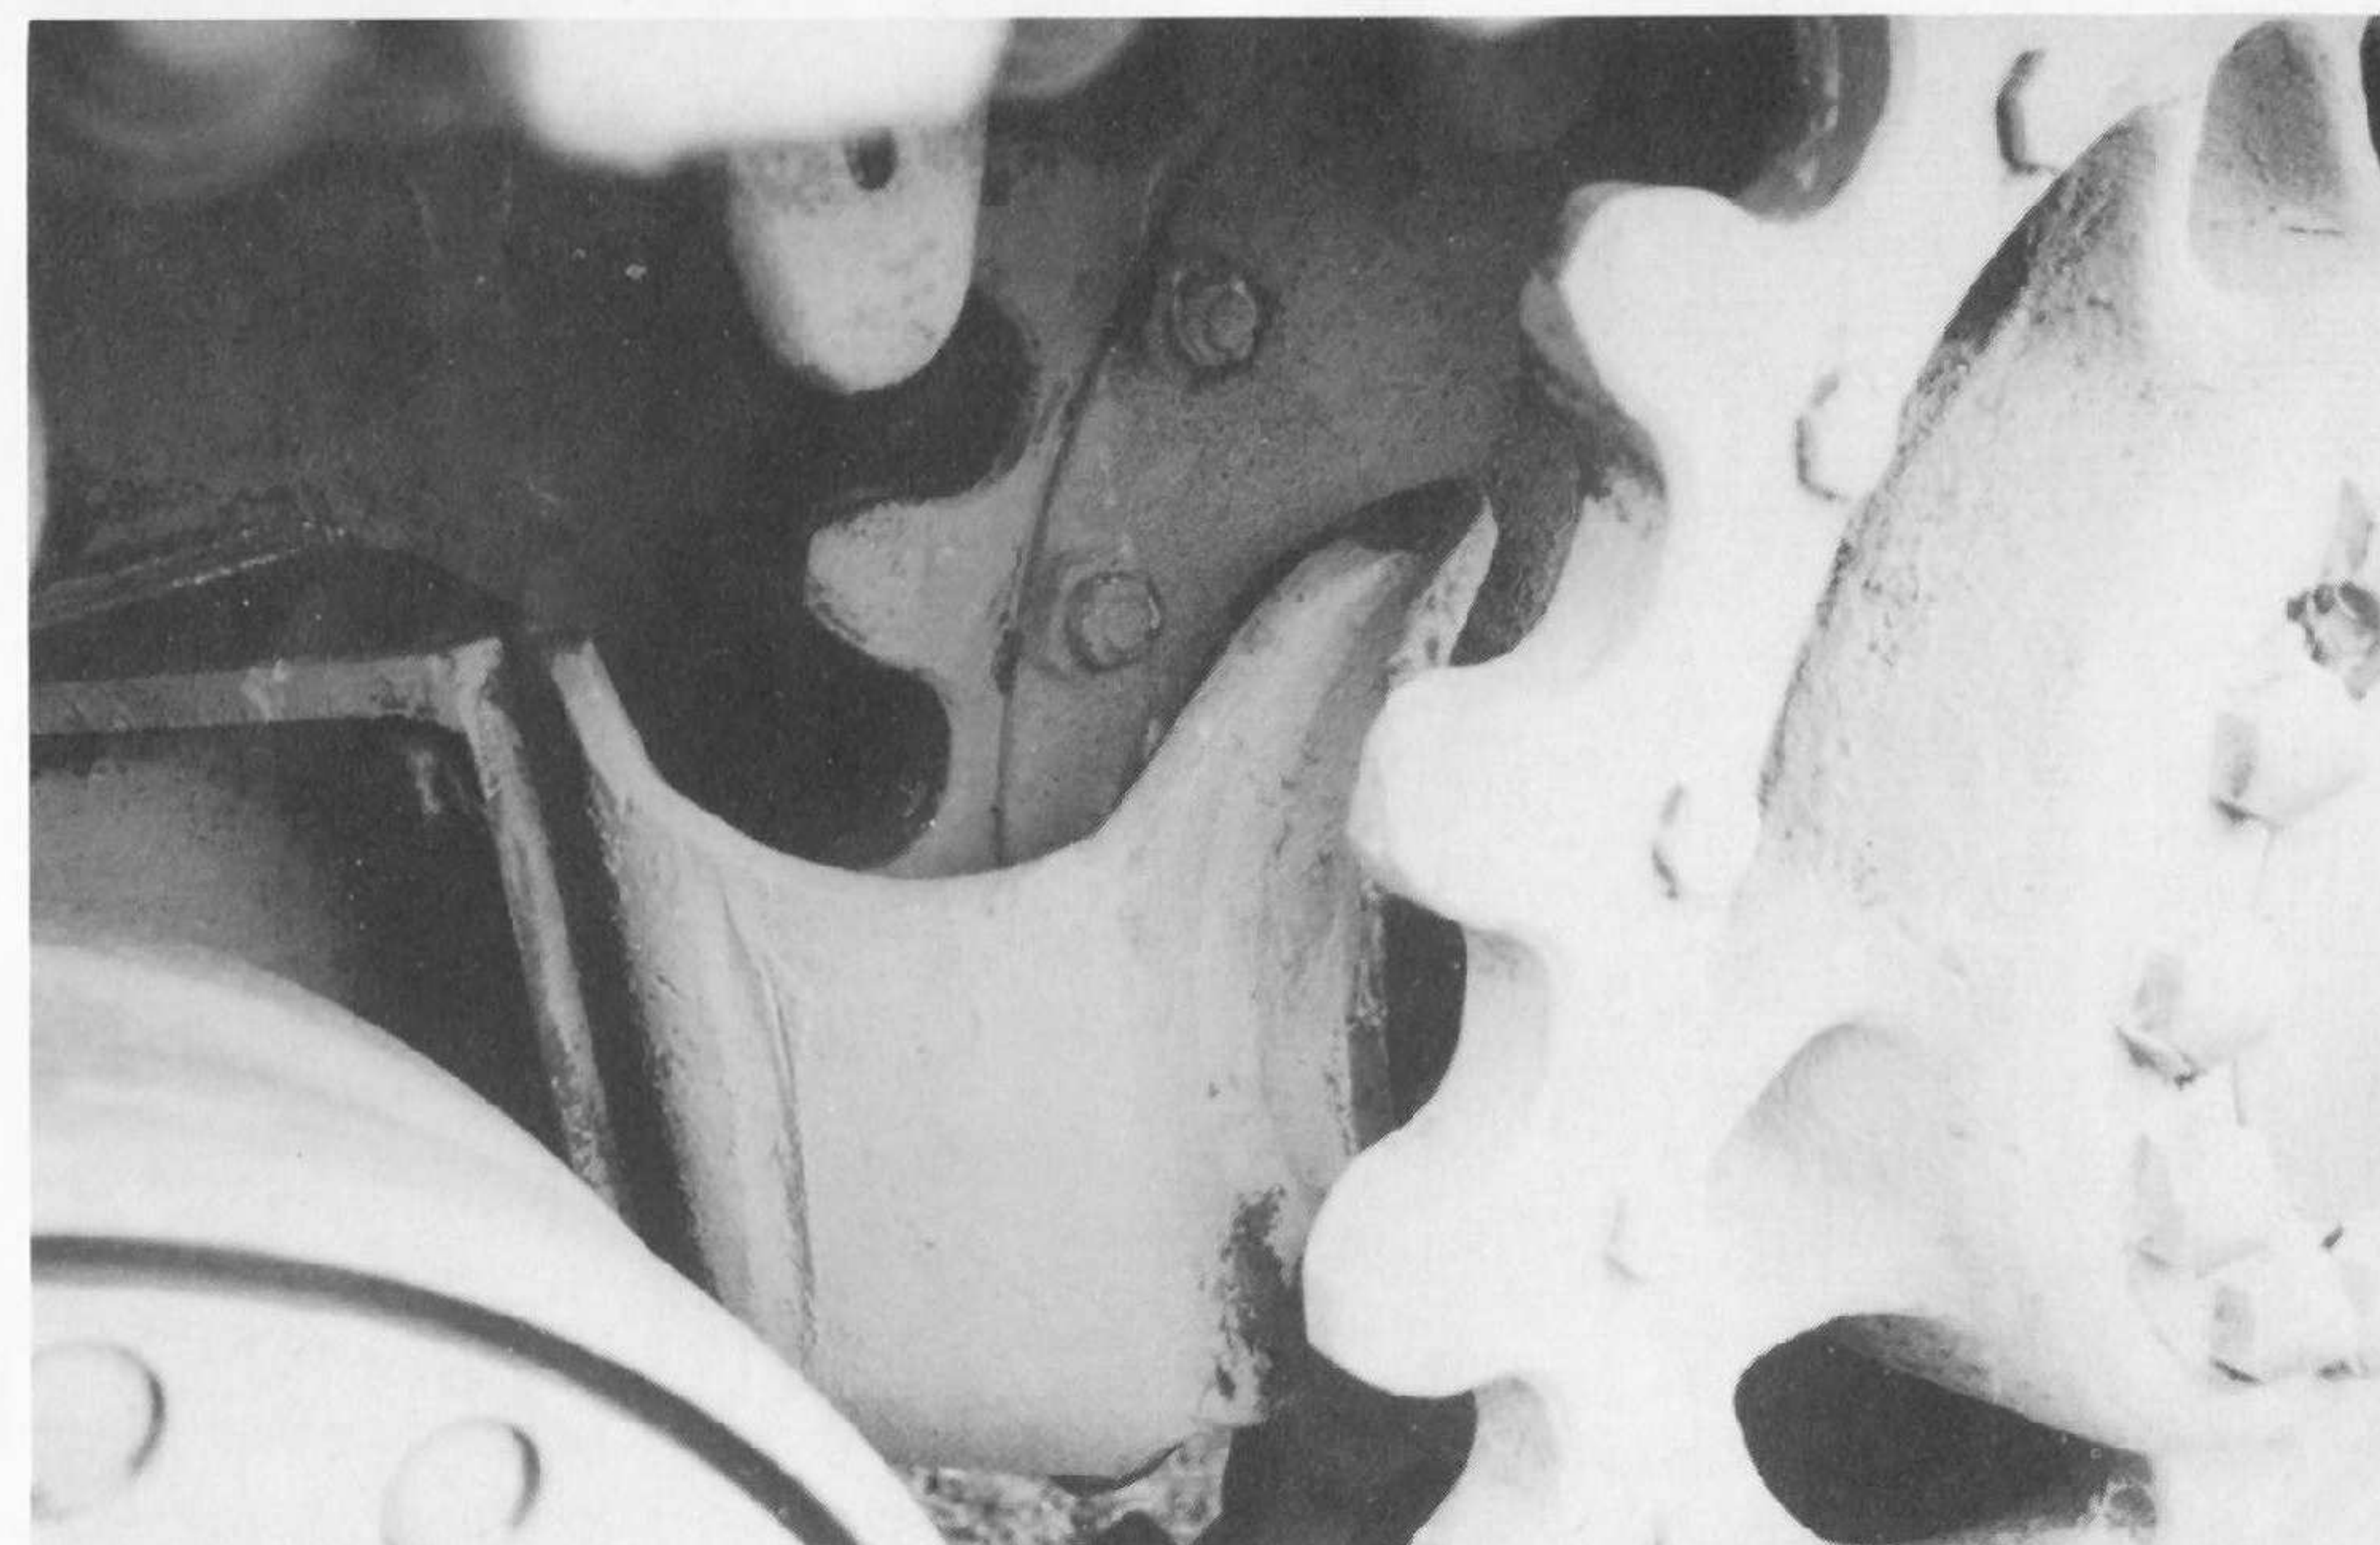
The drive sprocket's mud scraper is heavier and more substantial. The bracket and the scraper itself are thicker and more ruggedly built.

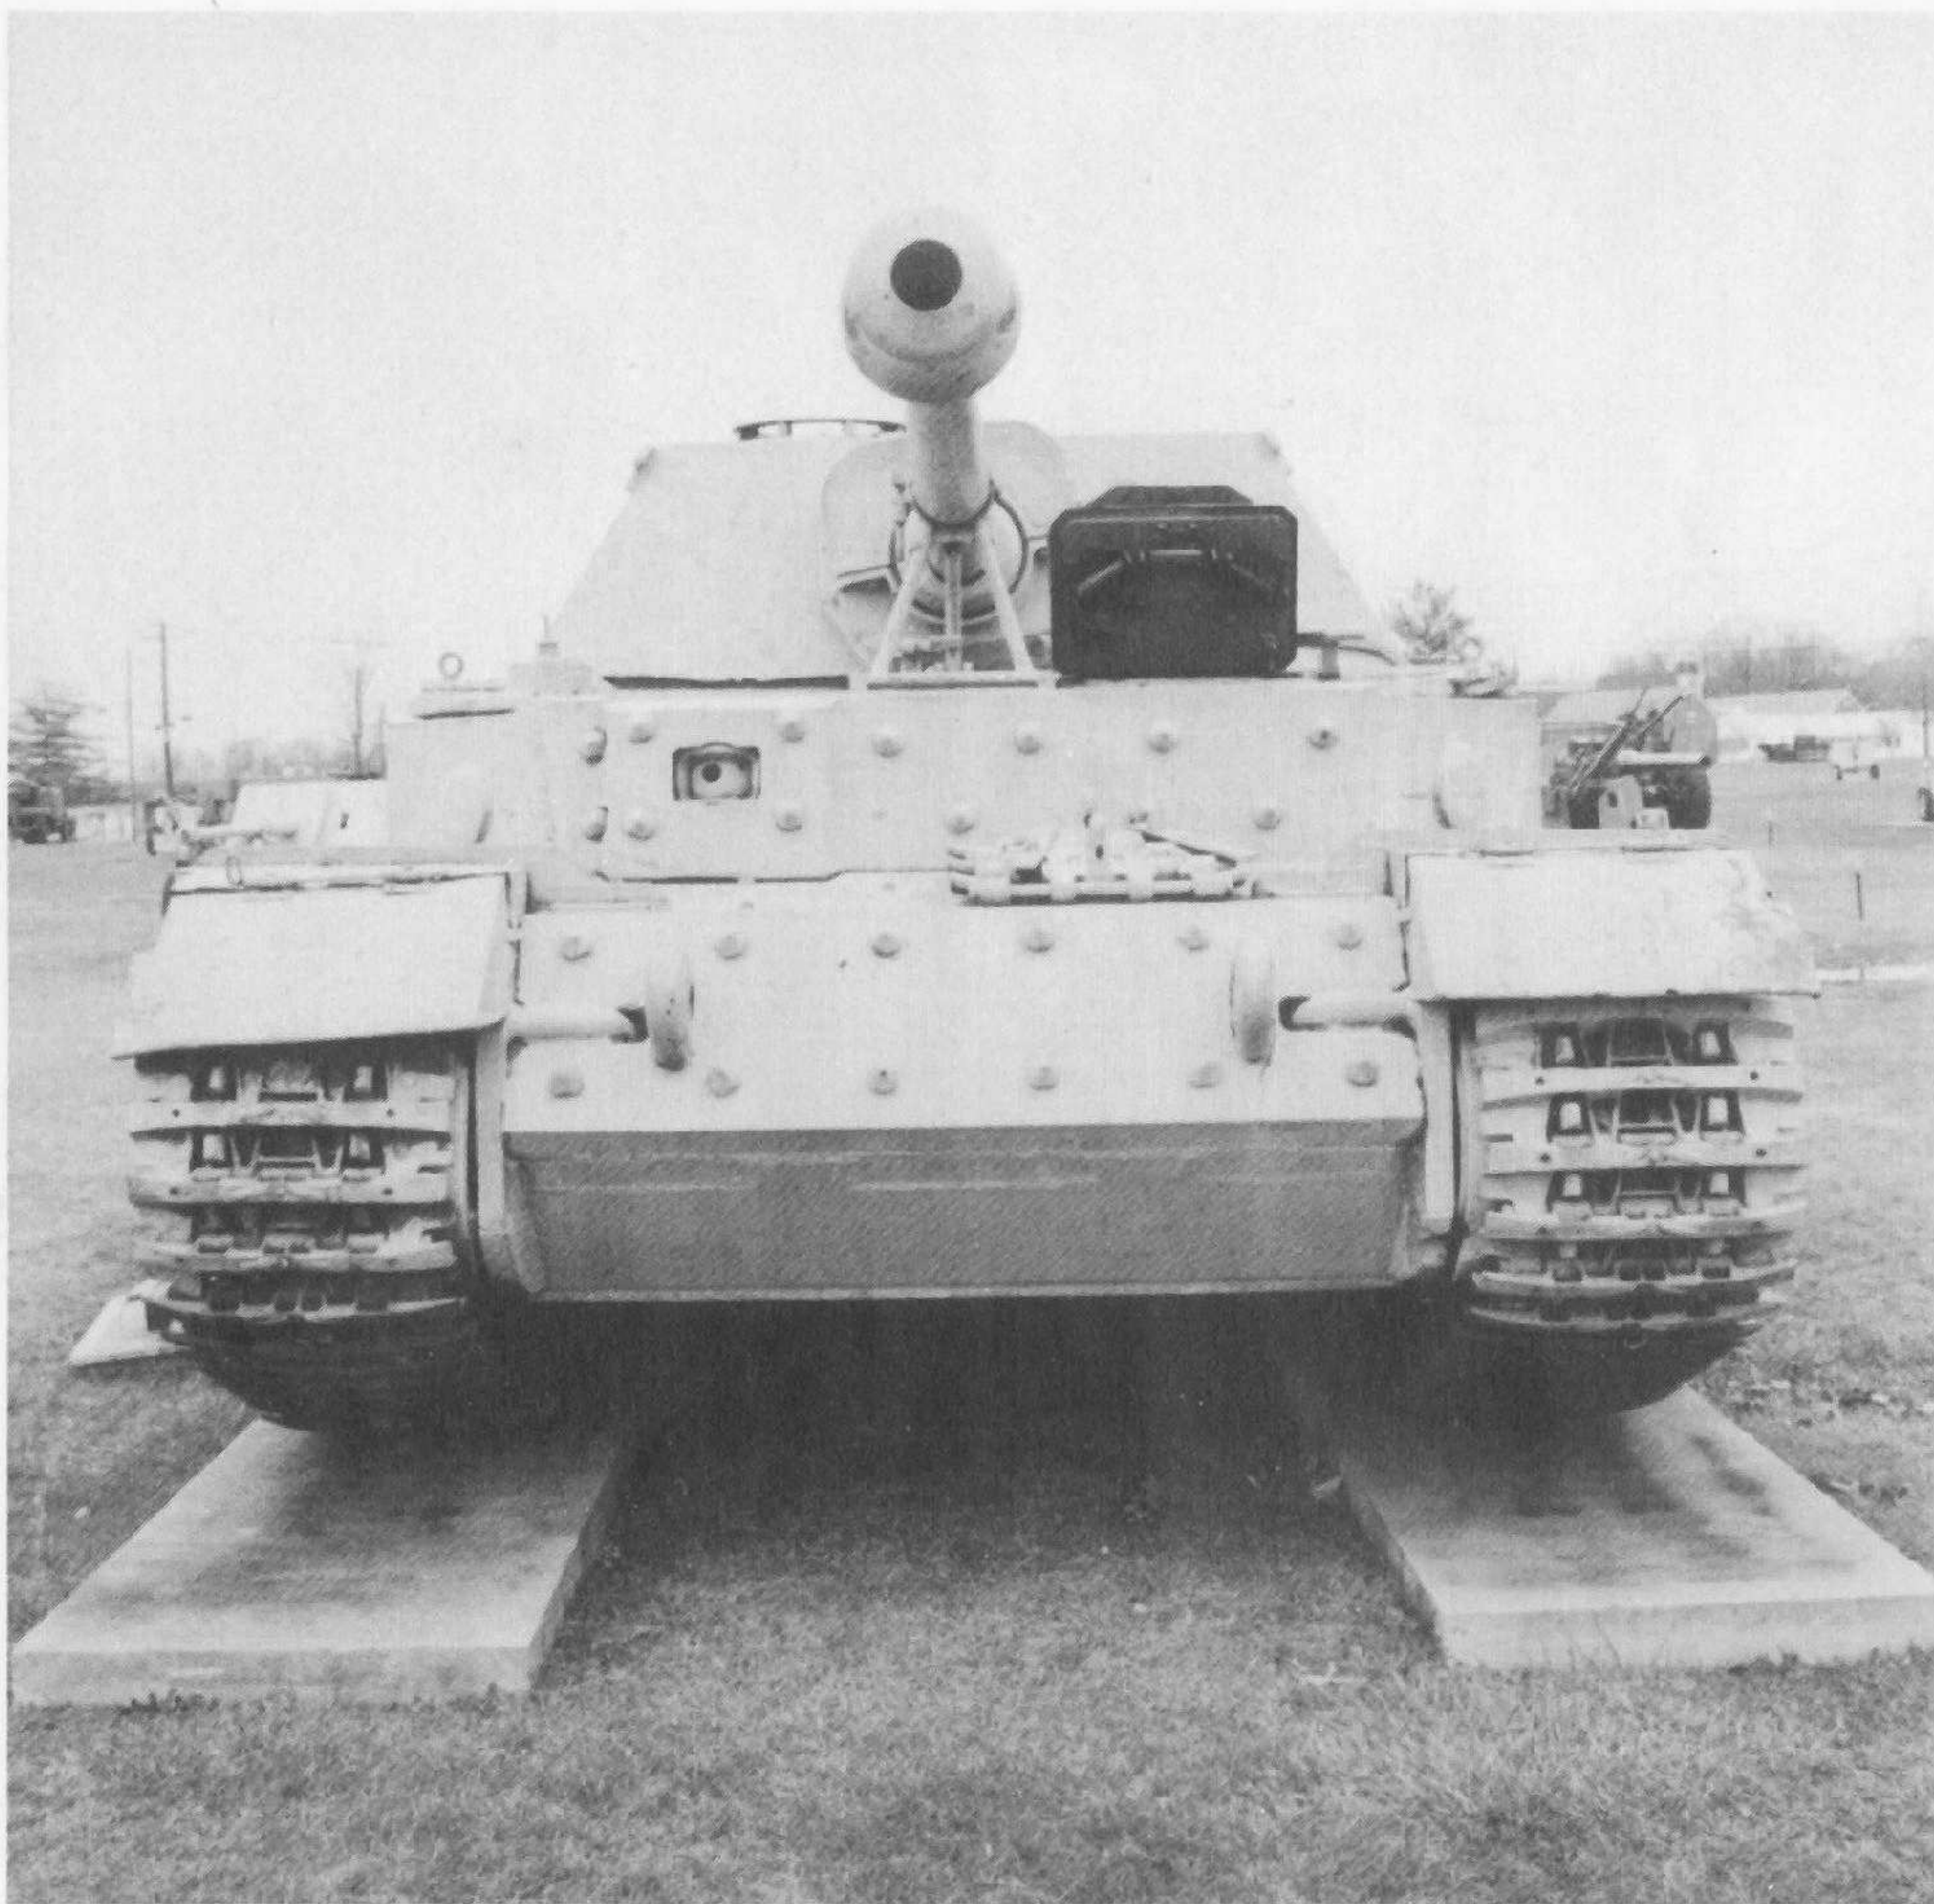
From a full frontal view, a "late" model Elefant is distinguishable from the first version (Ferdinand) by looking at the front vertical plate. If a bow machine gun has been added, this identifies it as a modified version. Other signs are the added commander's cupola, of which the top of the vision block frame can be seen here, and the added armor collar around the main gun near the mantlet, although the collar alone is not conclusive evidence.

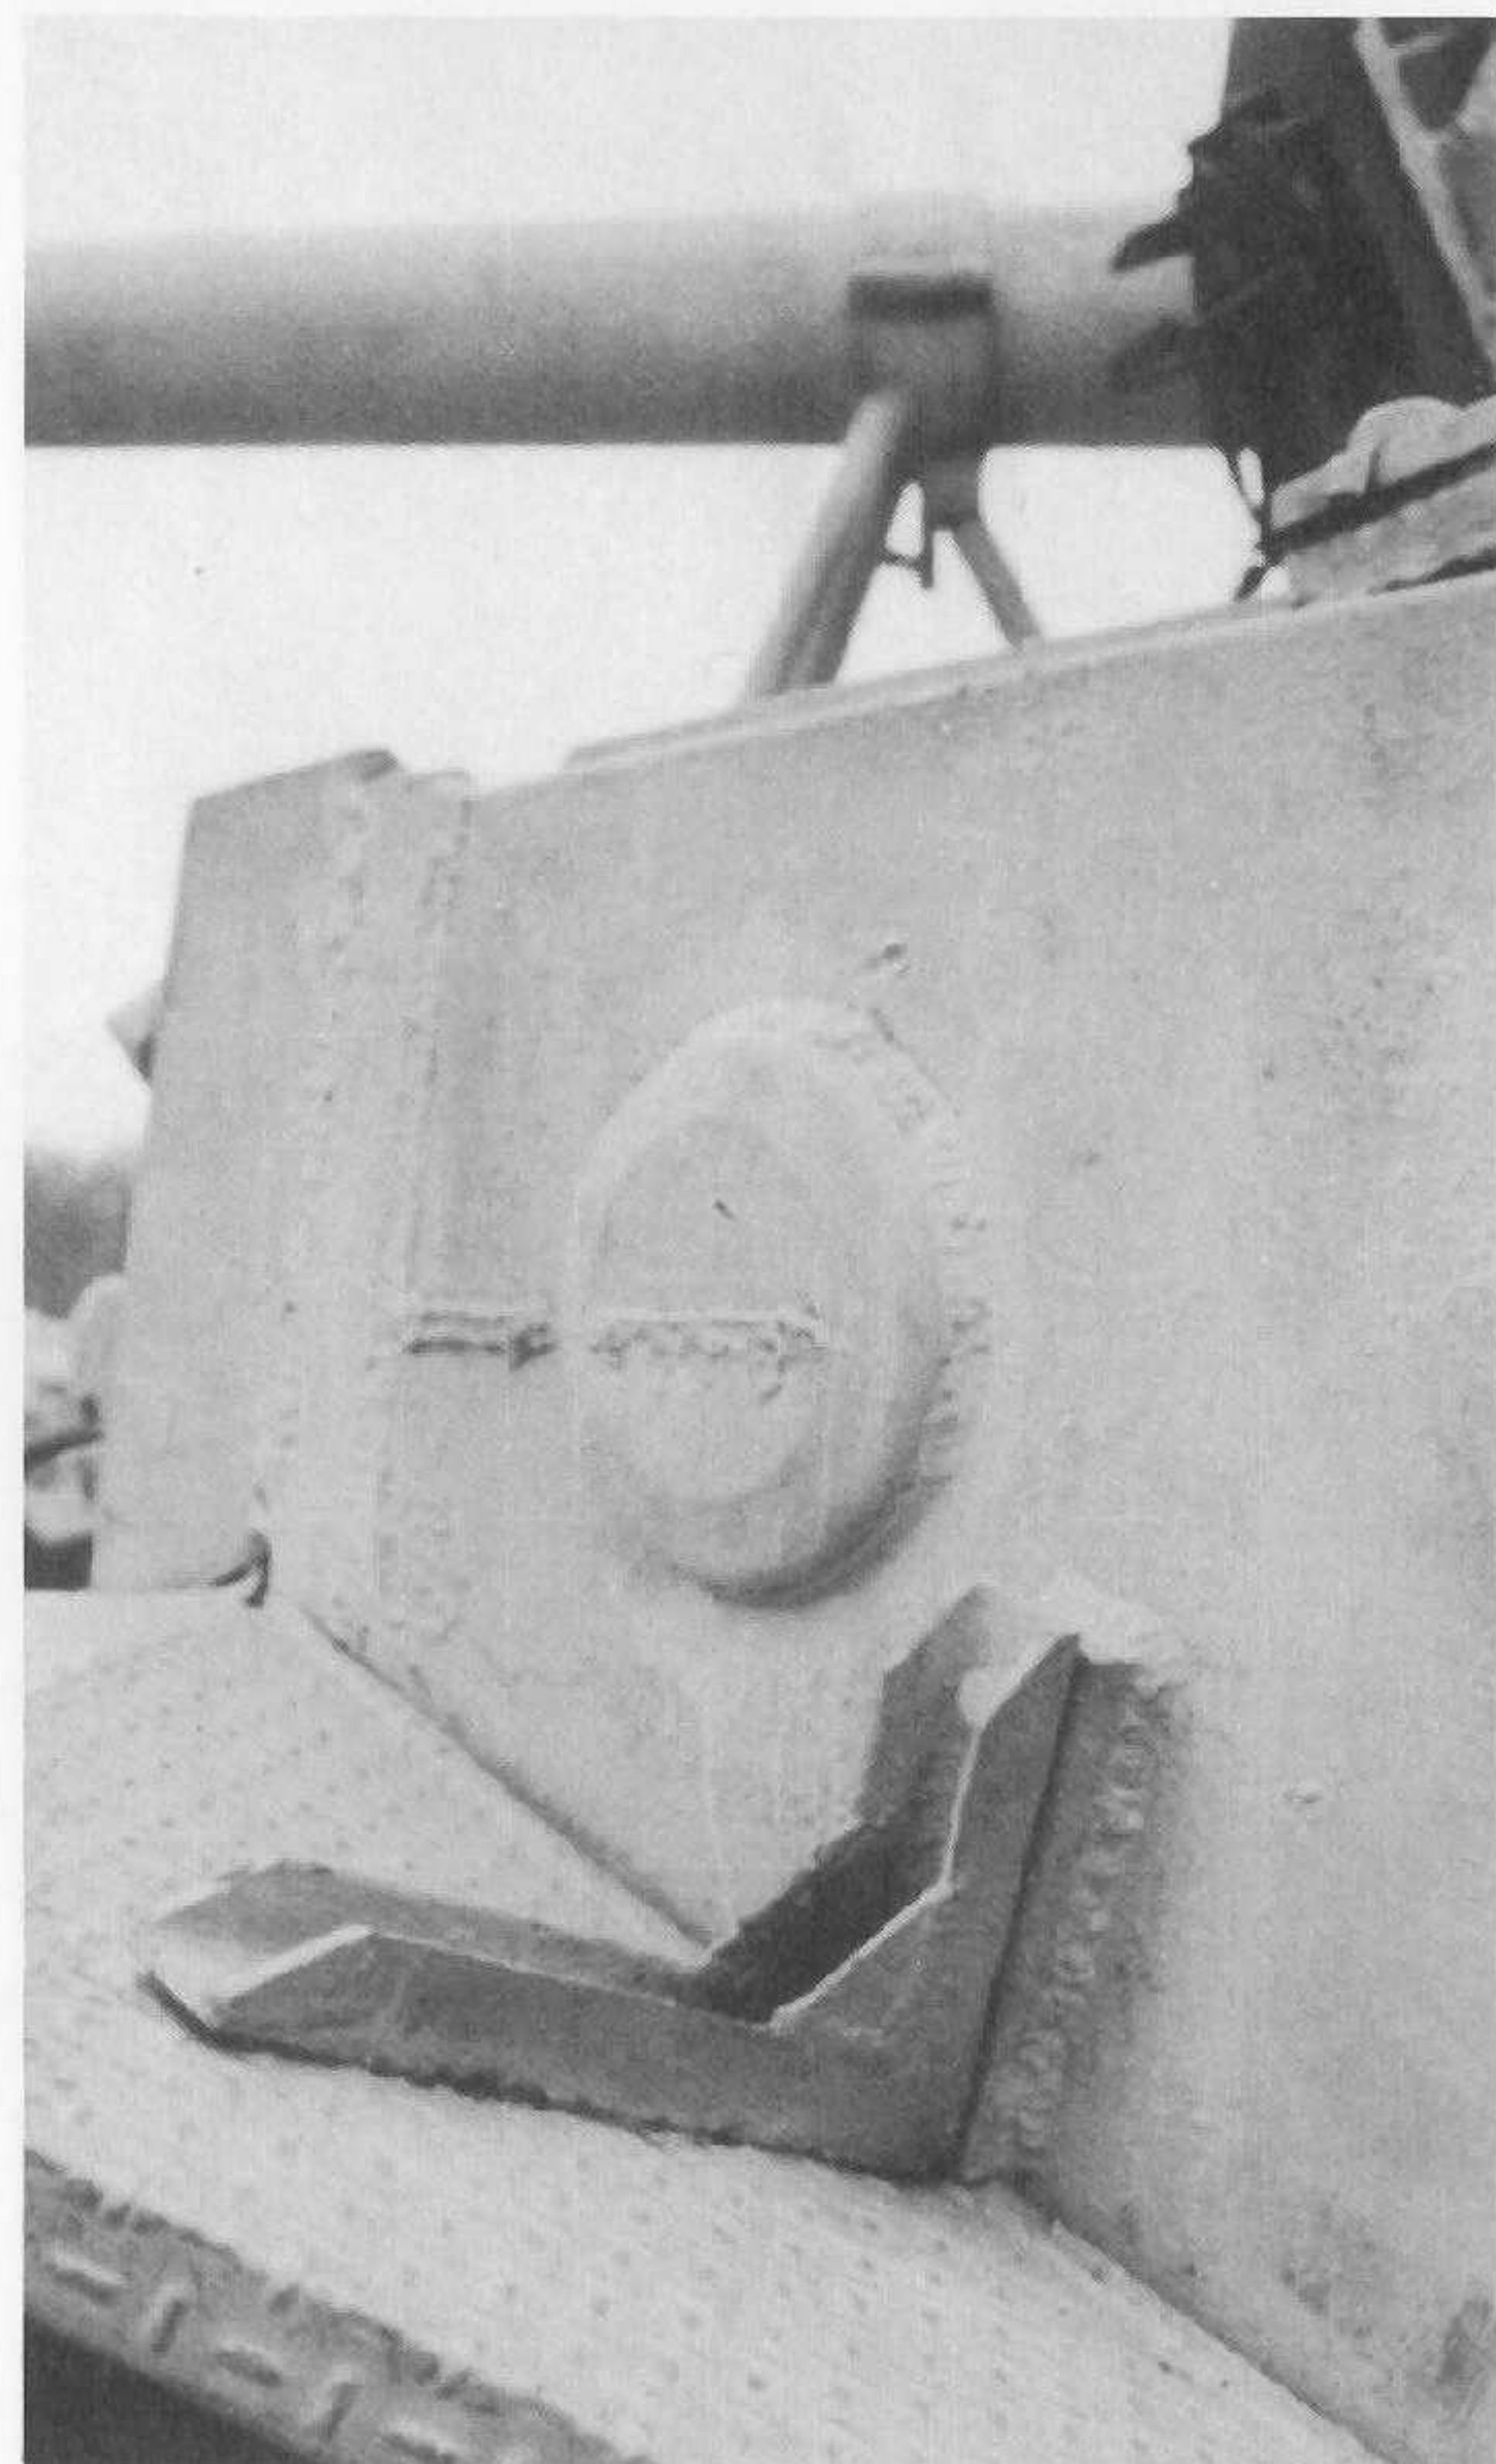
The angled plate off of the frontal armor on each side had a round view plate with a view slit in the center. The front fender support and the thickness of the frontal add-on plate are shown here as well.

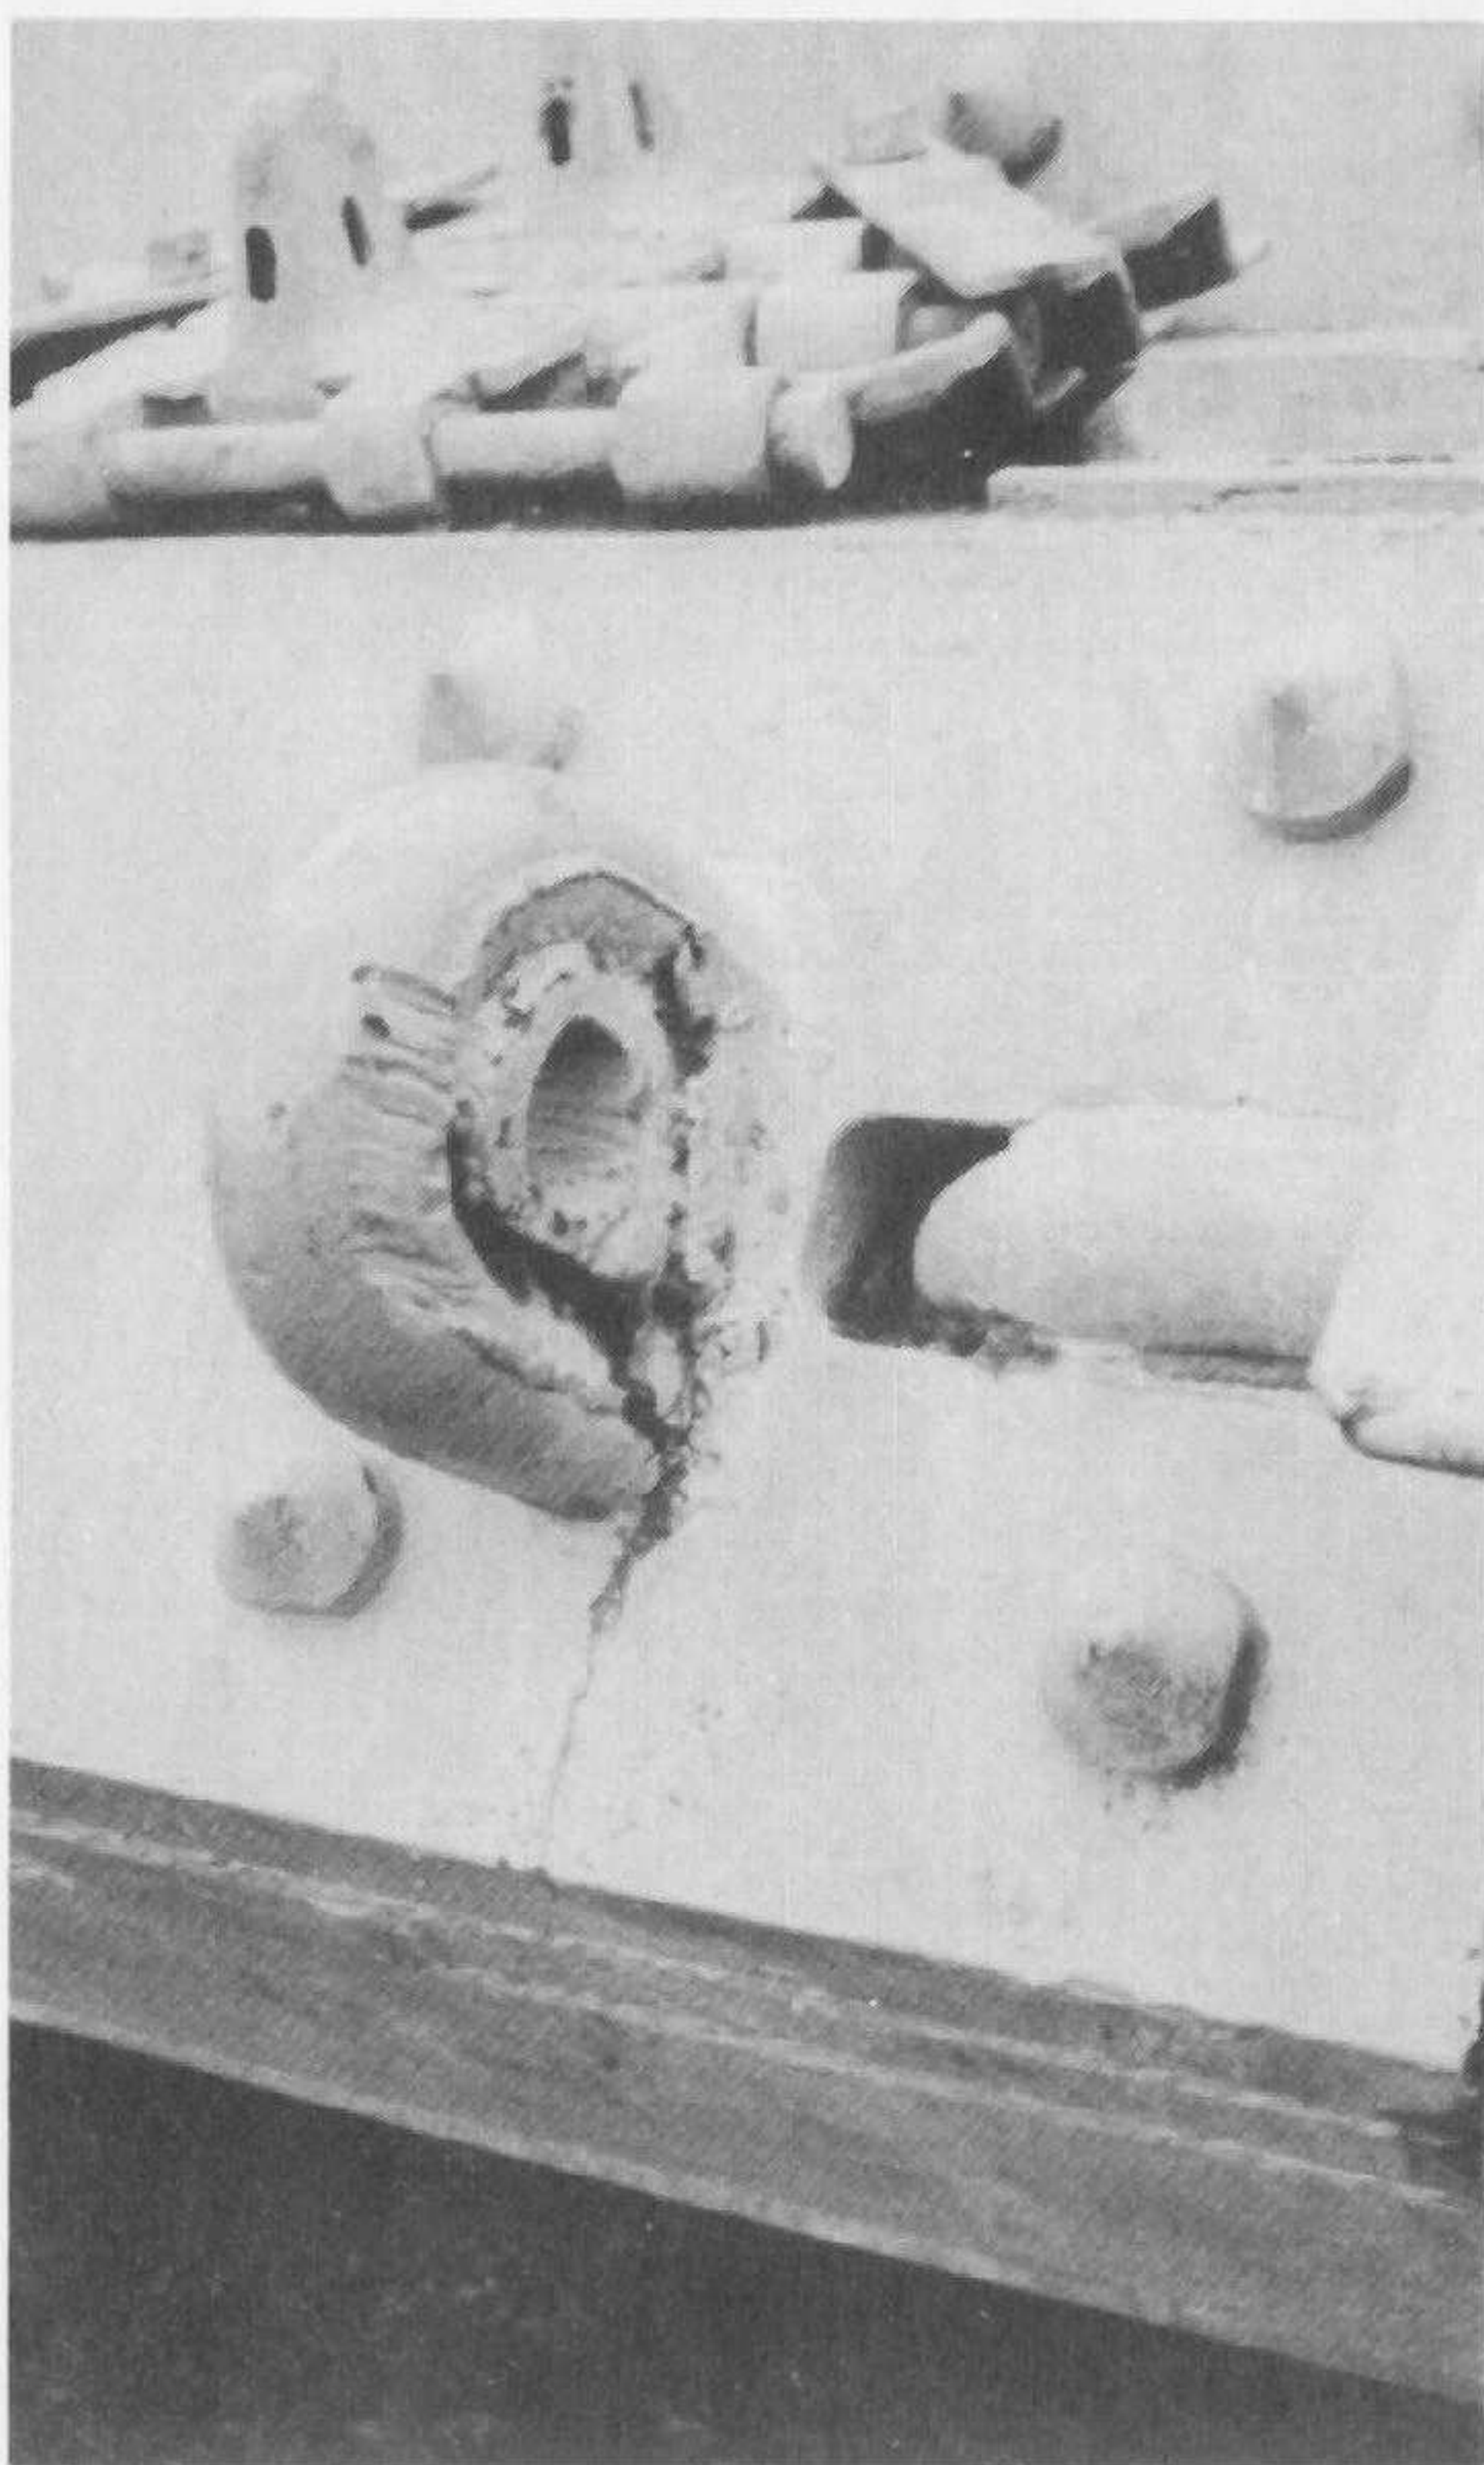
The unrefined construction of the towing shackle is evident here. The cutout on the right side of the photo allows the original towing shackles from the Tiger (P) to be retained, although they served no purpose.
