MUSEUM ORDNANCE SPECIAL NUMBER 4

Elefant Panzerjäger Tiger (P)

Text by Thomas L. Jentz
Photos by Jeffrey D. McKaughan

THE "ELEFANT" AT ABERDEEN

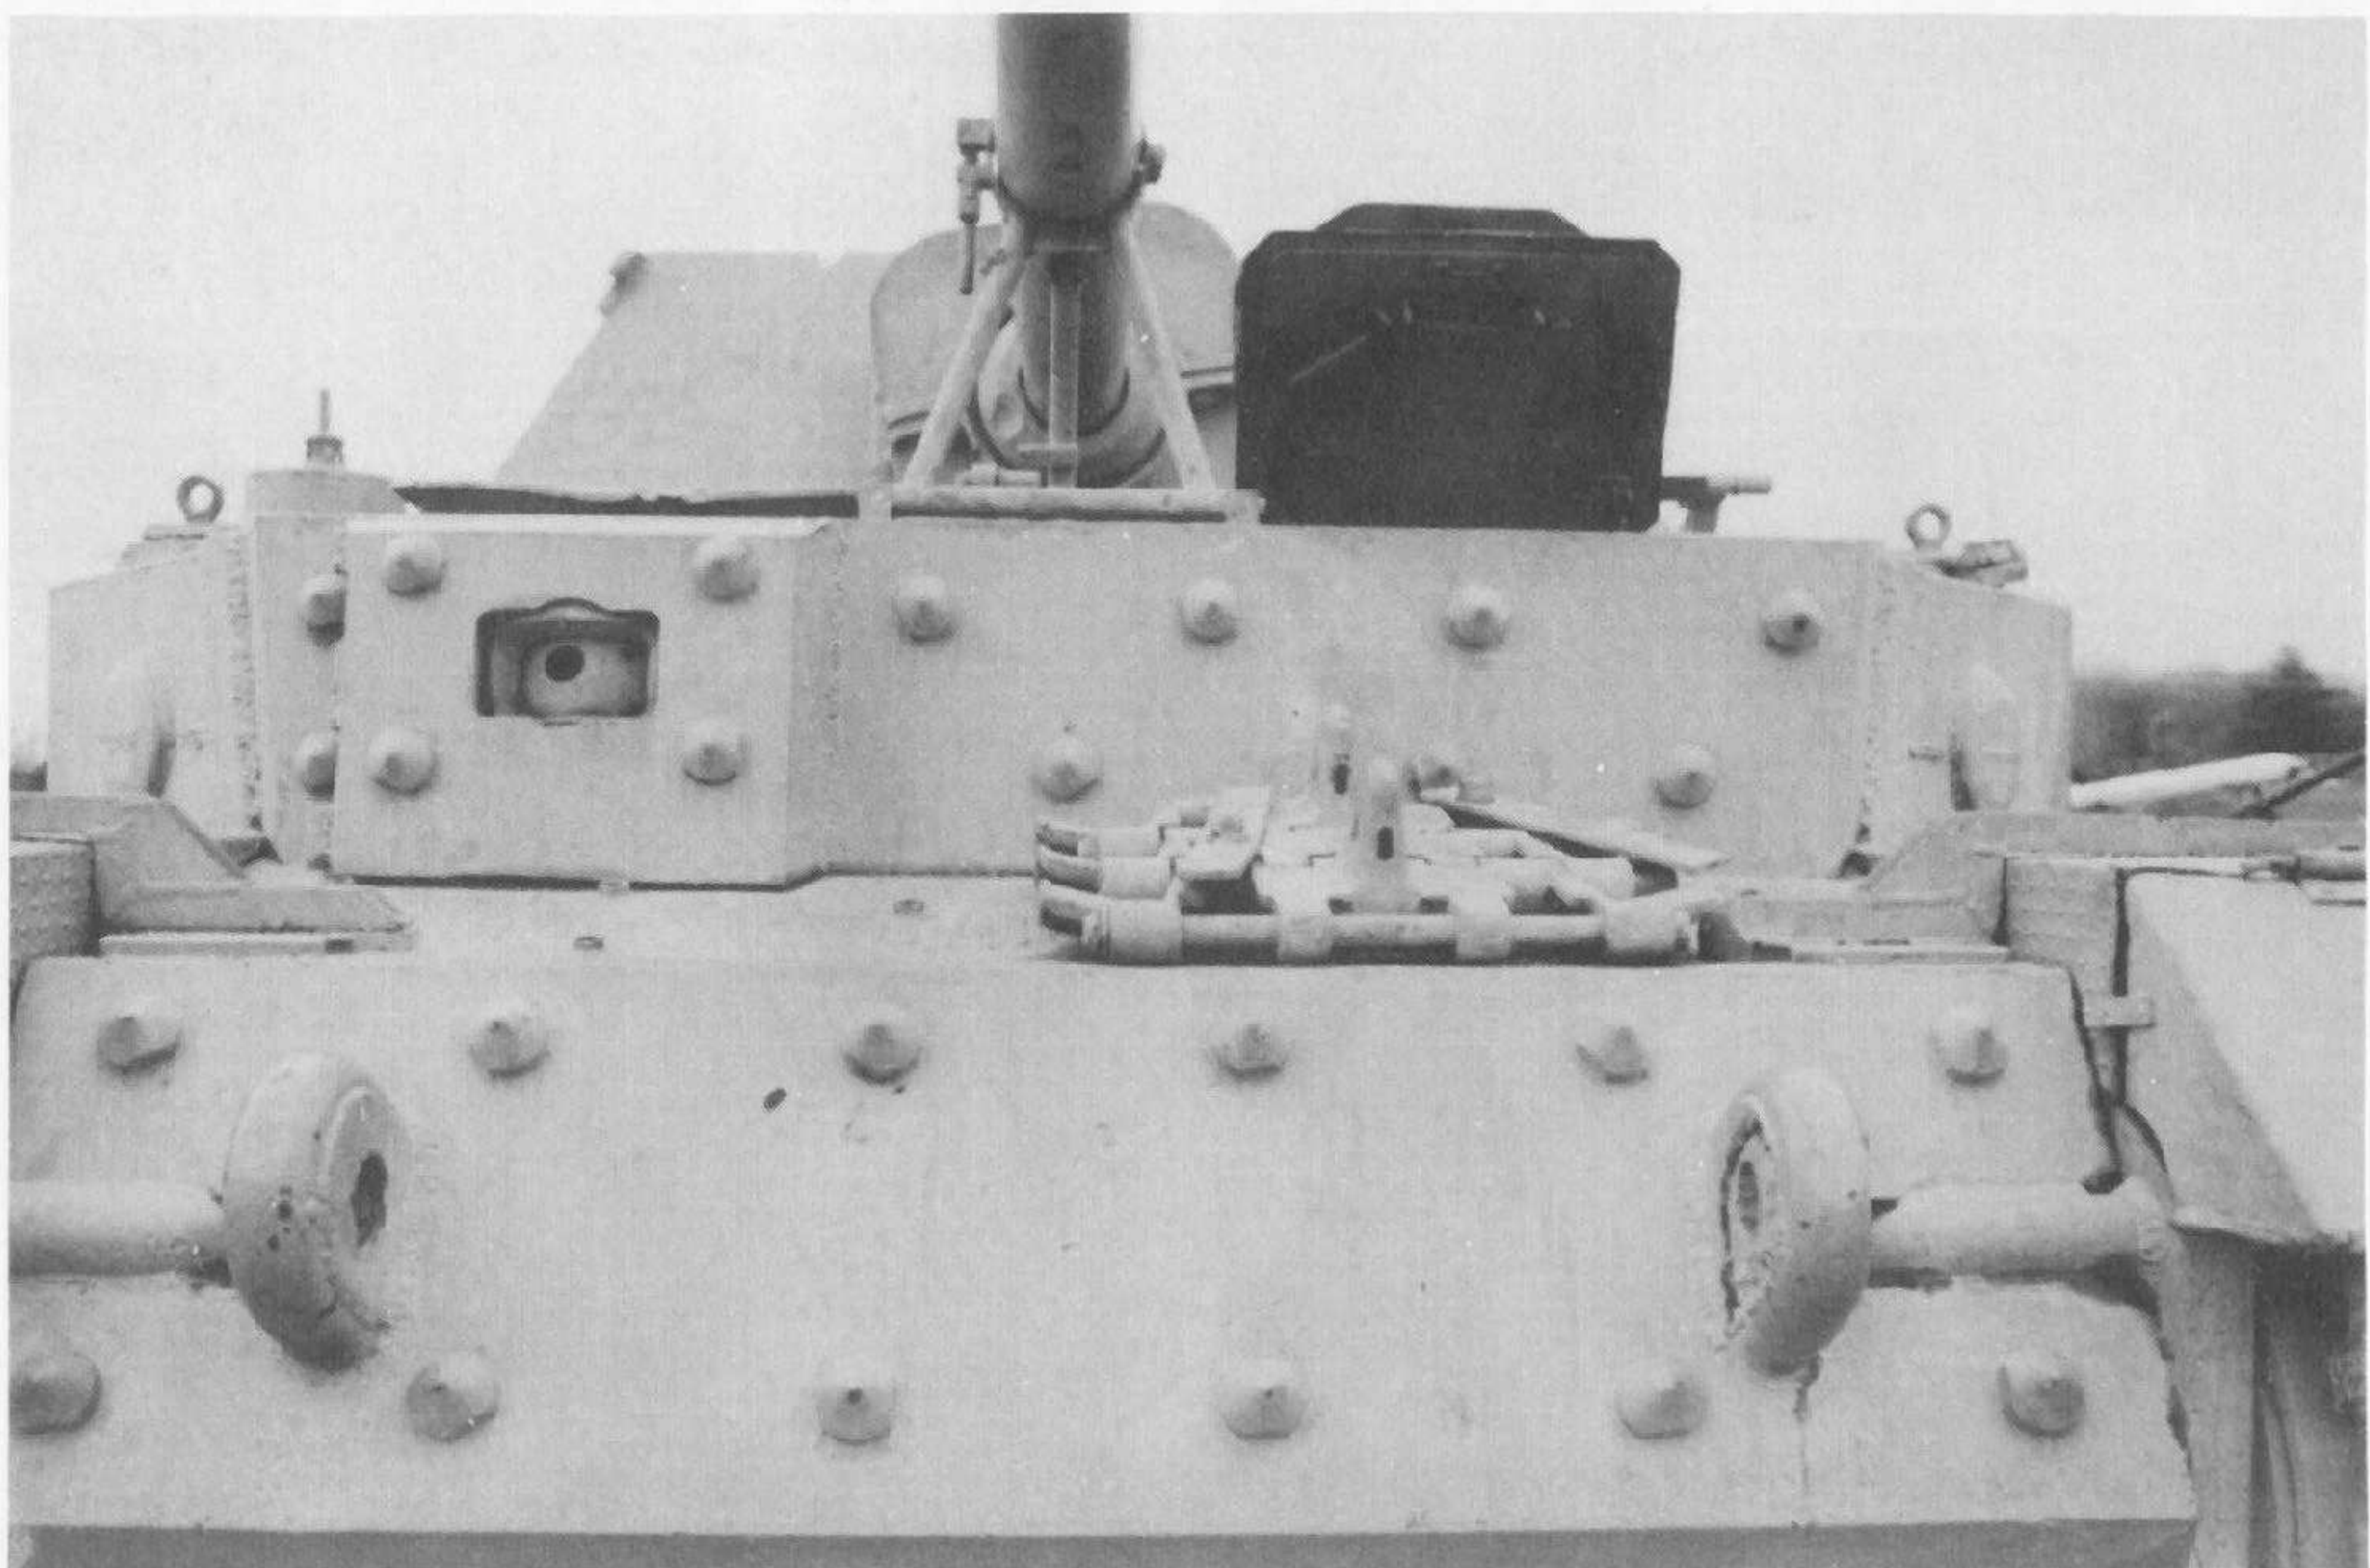
The layout of the front plates. The large conical bolts are not round at the base but instead have two flat sides so that a wrench can grip them. The flat edges are also not all in alignment with each other, but "point" in a variety of directions. This also presents a nice view of the underside of the gun lock.

The bow machine gun was added to the Elefants after the disaster at Kursk. Vehicles like this proved extremely vulnerable to infantry attacks because they lacked any close-in defenses. It is very suspect as to how much benefit the Elephant could gain from this addition. With only a relatively small arc of fire forward and the small telescopic sight in the ball mount for forward vision (along with the side vision slit), its usefulness would surely be marginal.

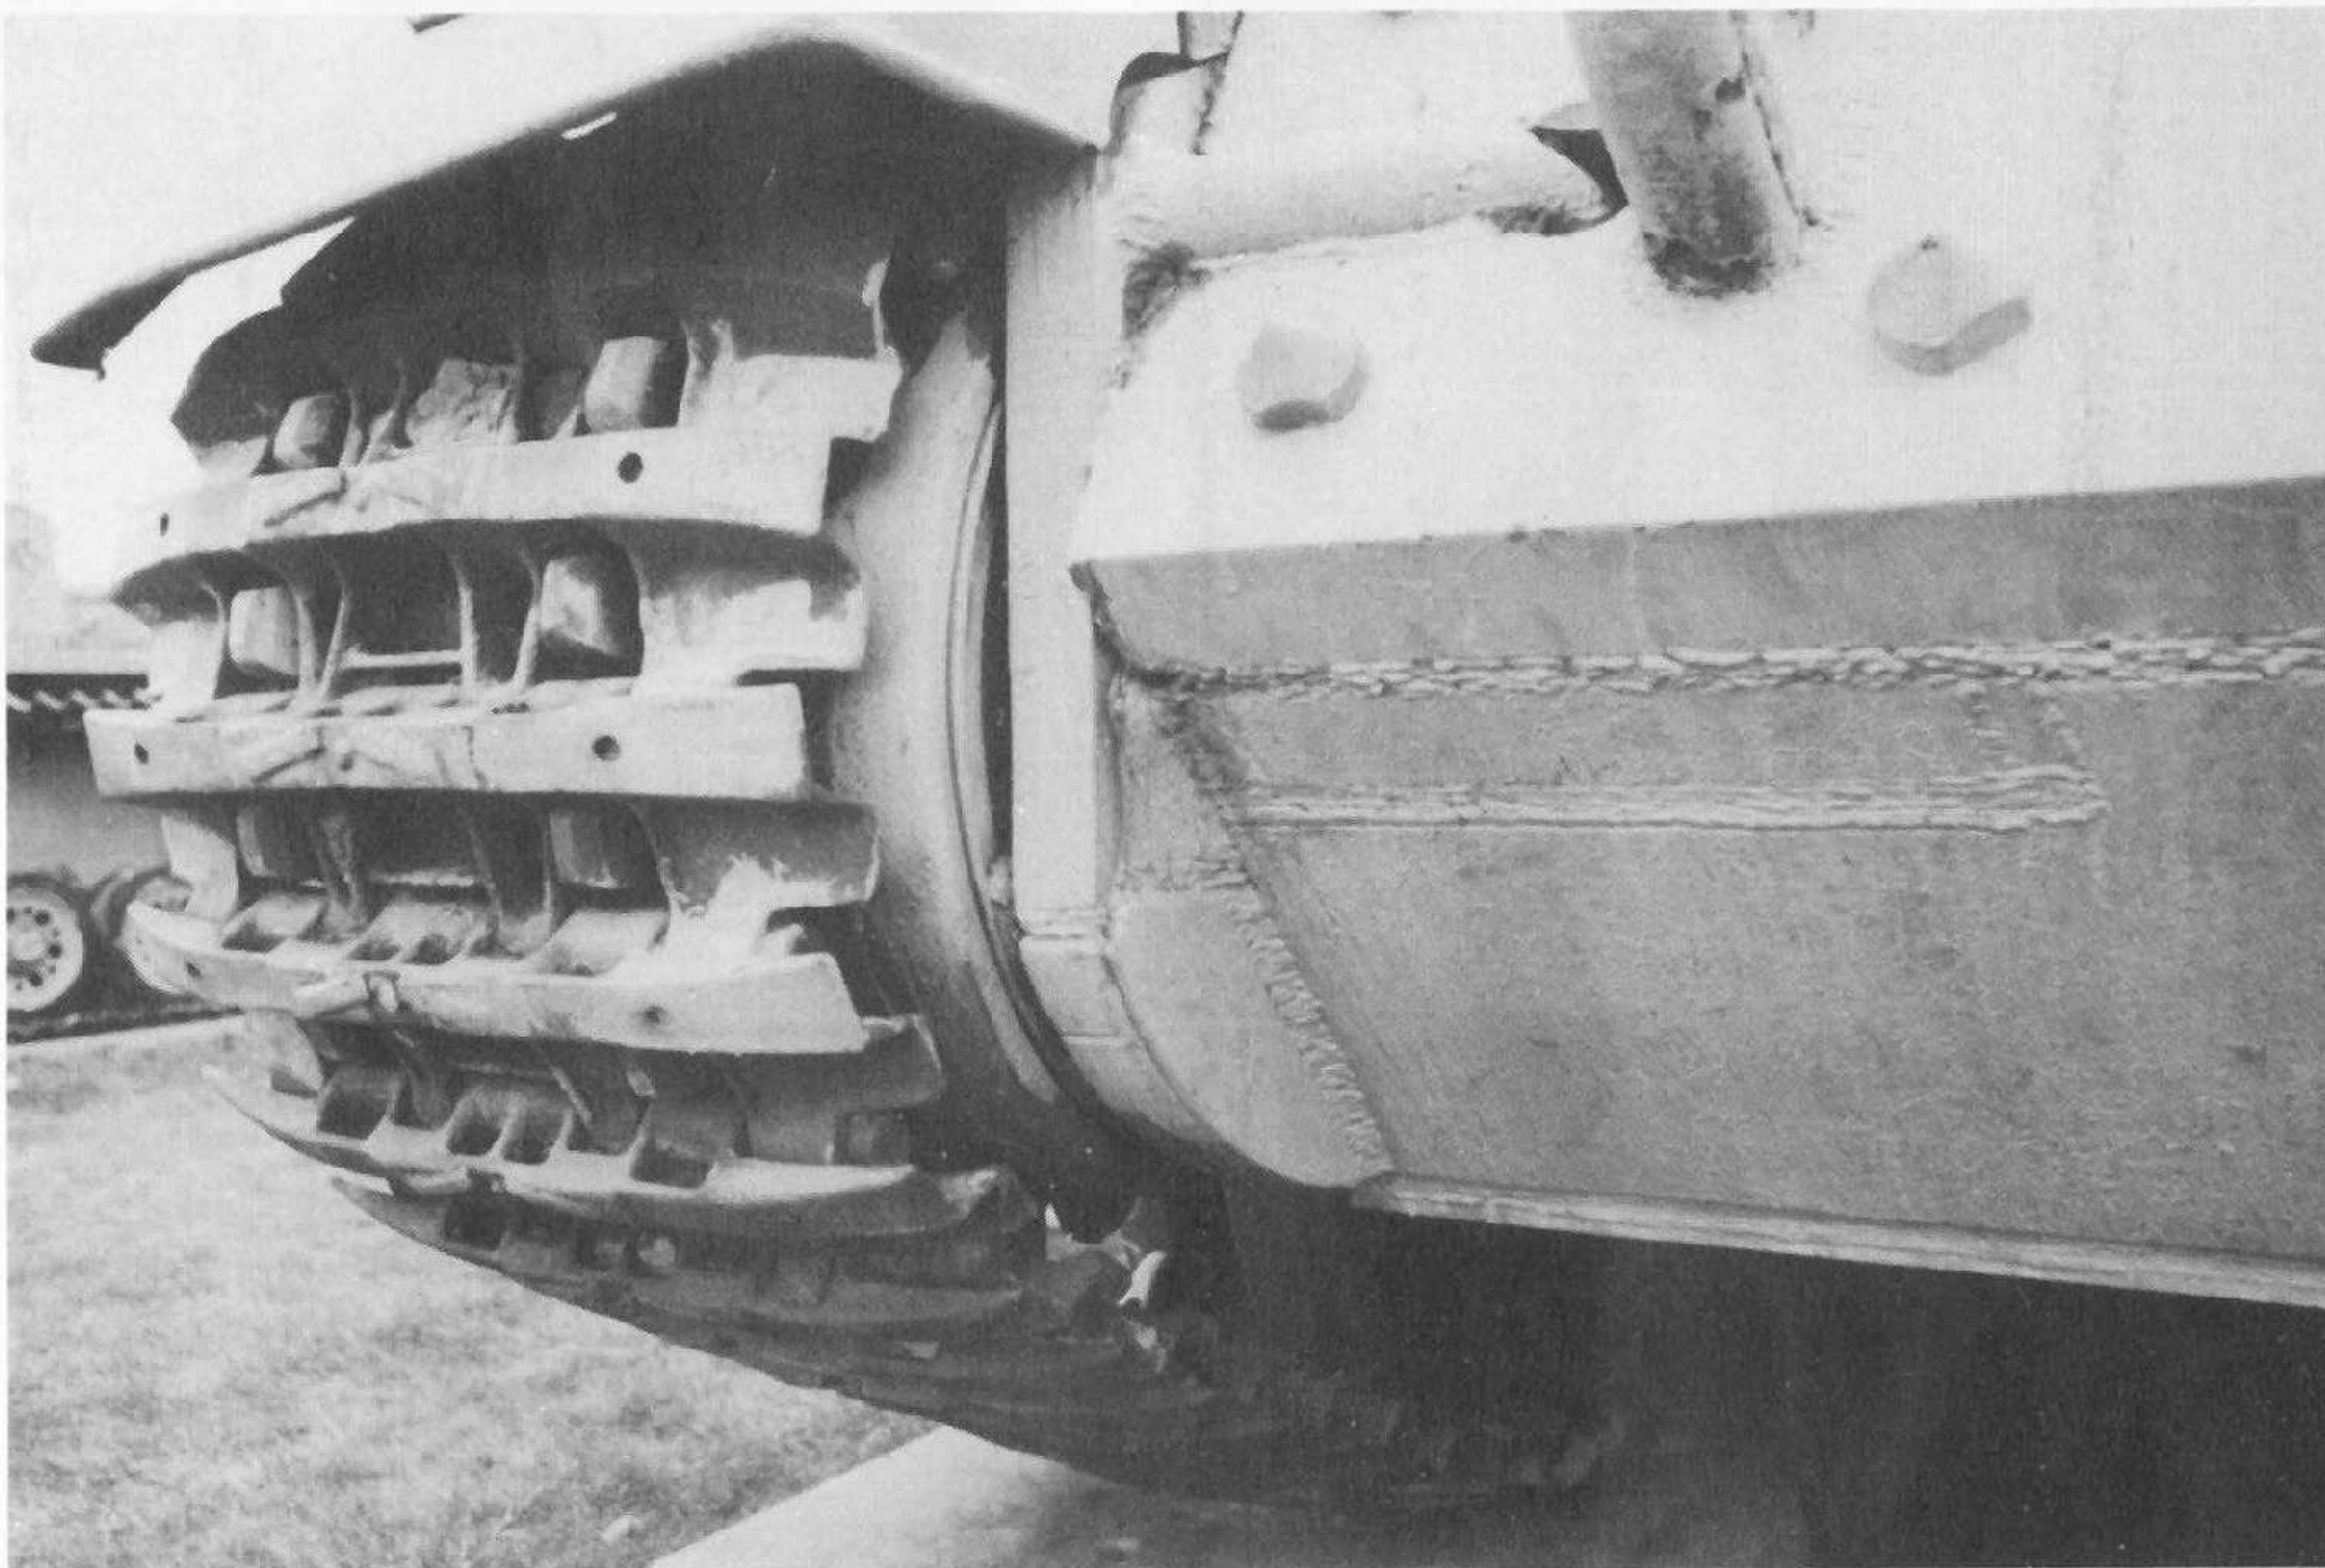
Another look at the front add-on armor and the location of the original tow shackle. The shape of the guide teeth on the idler sprocket is also interesting and can be seen here as well as the close-up photo of the tracks earlier. Near the end they are angled in to create a wedge-shape. While large bolts hold on the add-on armor and are used in attaching the fighting compartment to the hull, the Elephant featured an all-welded construction.

The front of both fenders was held in place by two hinges and one long hinge pin. There was a cut-out on the outside of the fender to accommodate a spring. Each end of the spring ended in a loop that simply fit over a nail head-shaped fixture. You are also looking straight down on the front-most fender support and the four bolts that keep it in place on the fender.

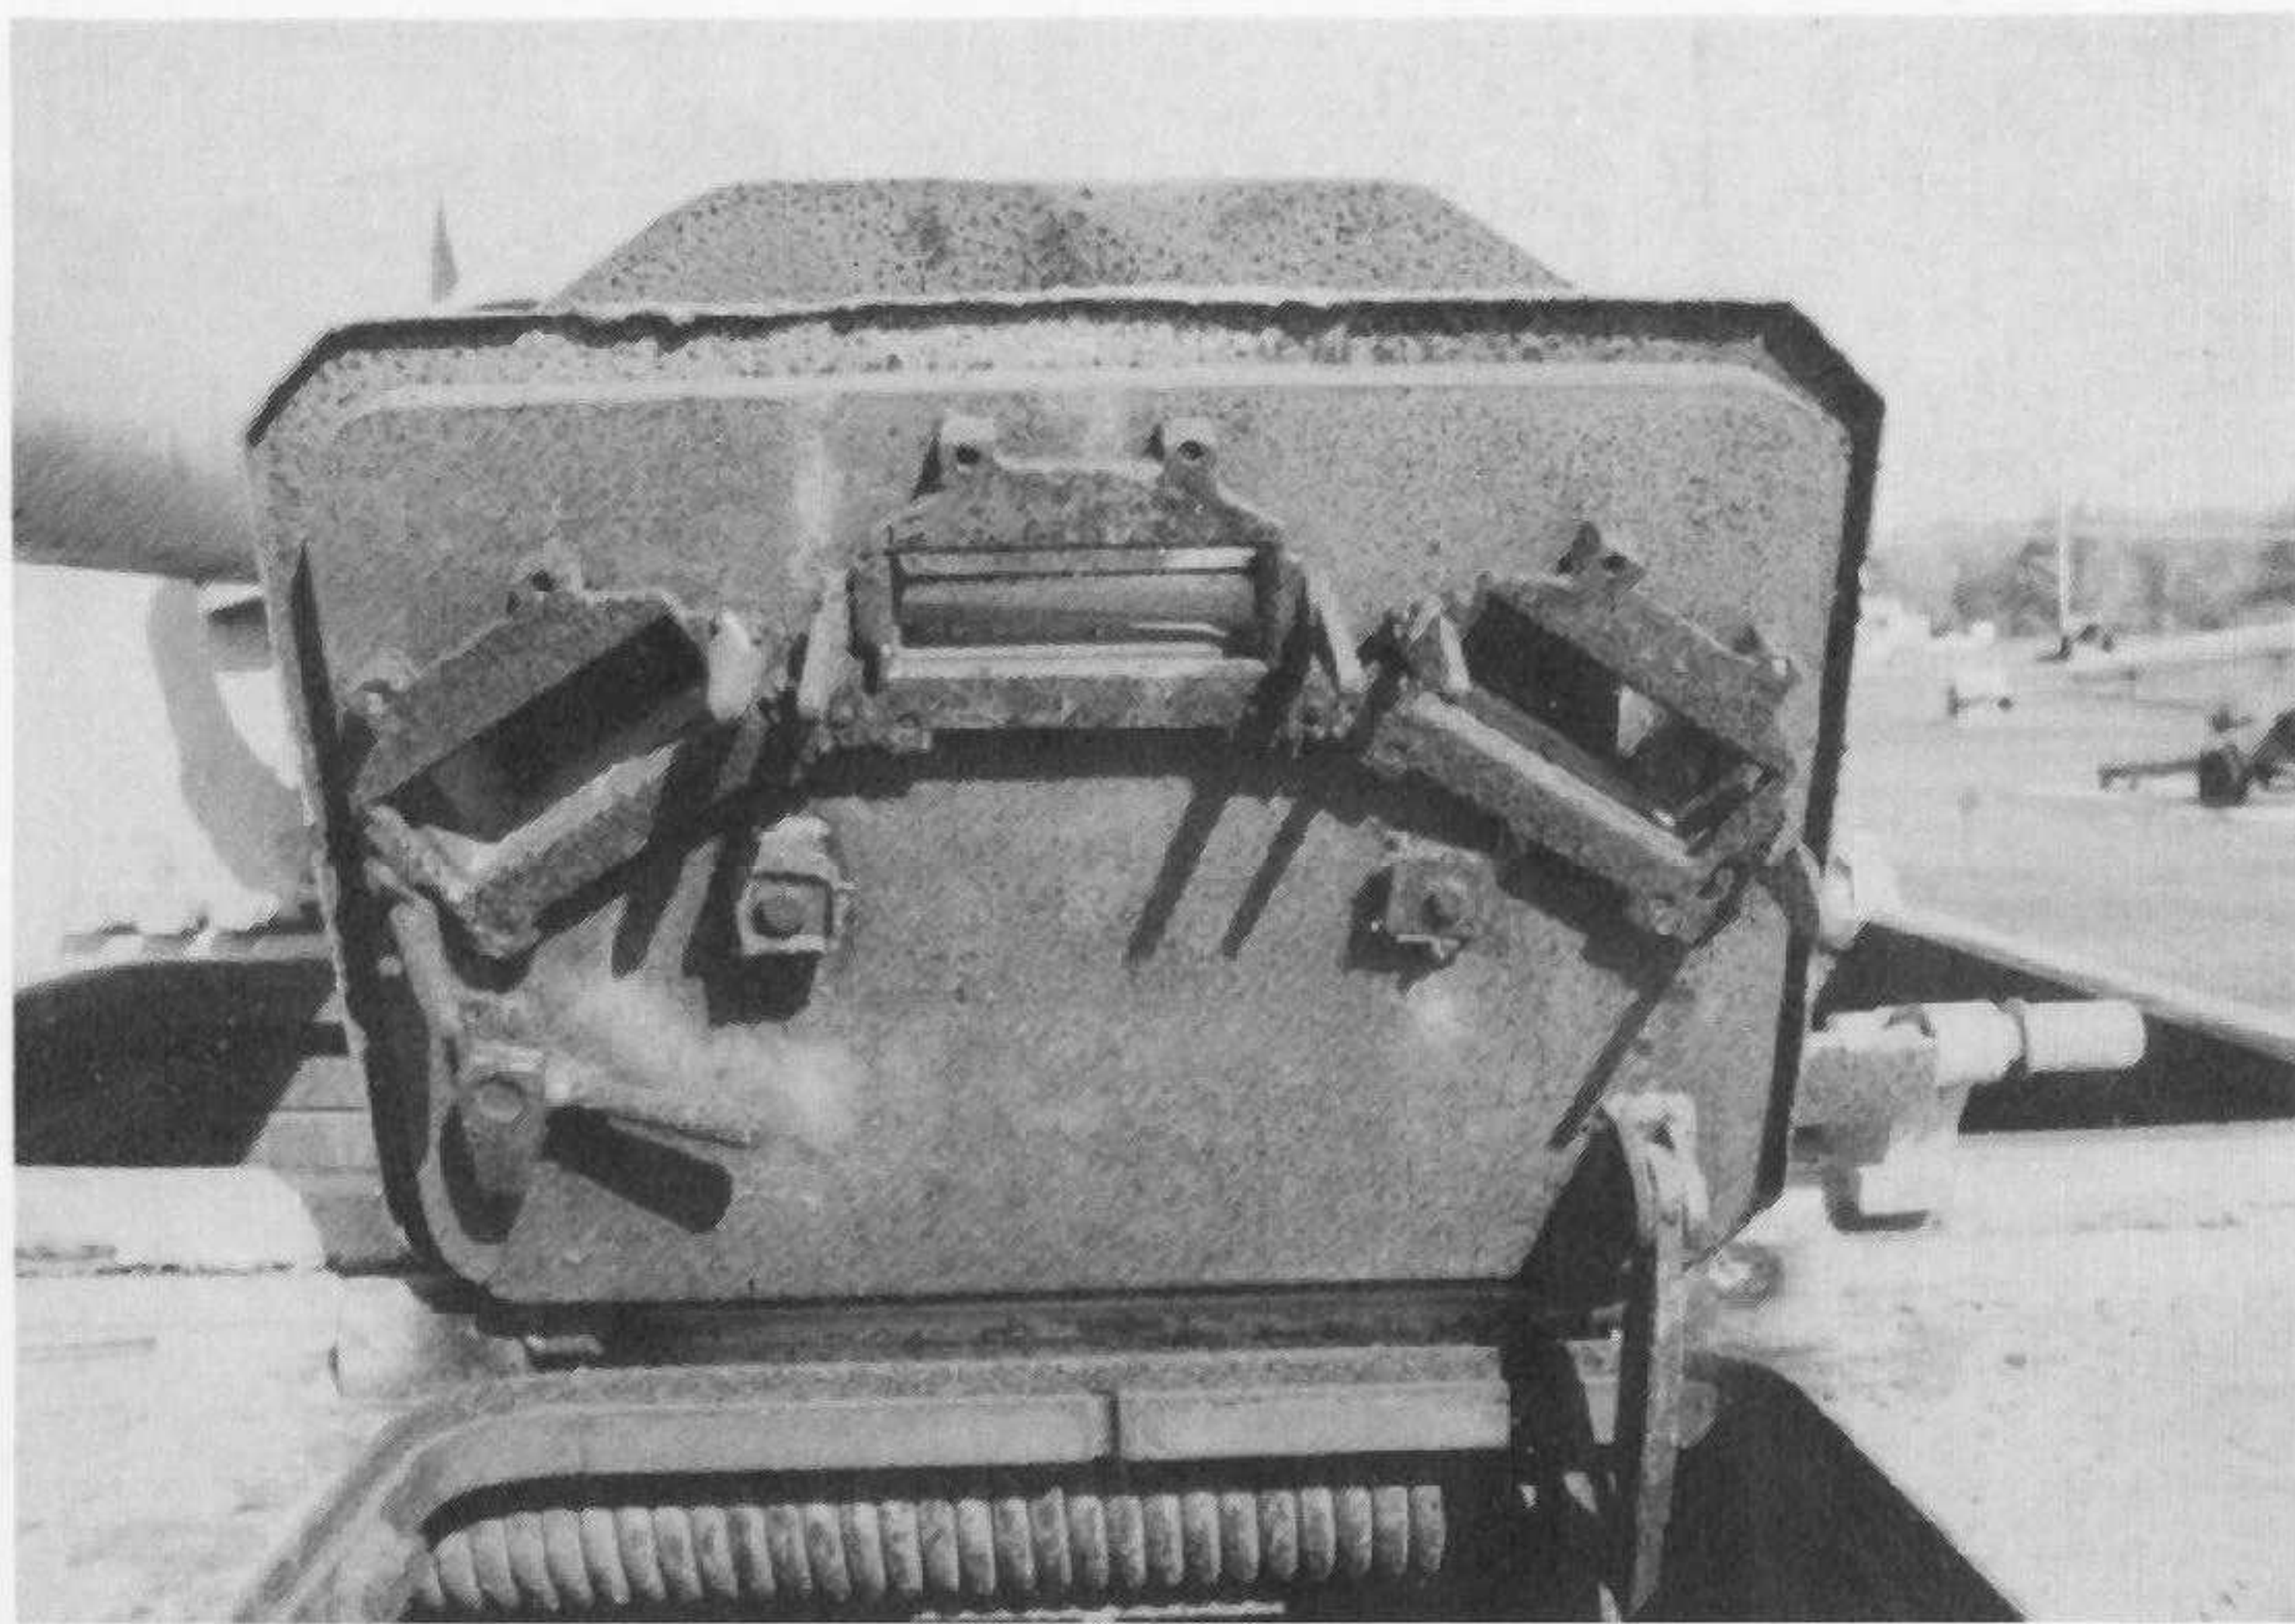
The driver was provided with three vision blocks. The hatch locking mechanism is in the lower left hand corner of the hatch in this view. Also visible is the large spring necessary to operate the heavy hatch. There is a small lip around the outside of the hull opening that acts as a rain guard.

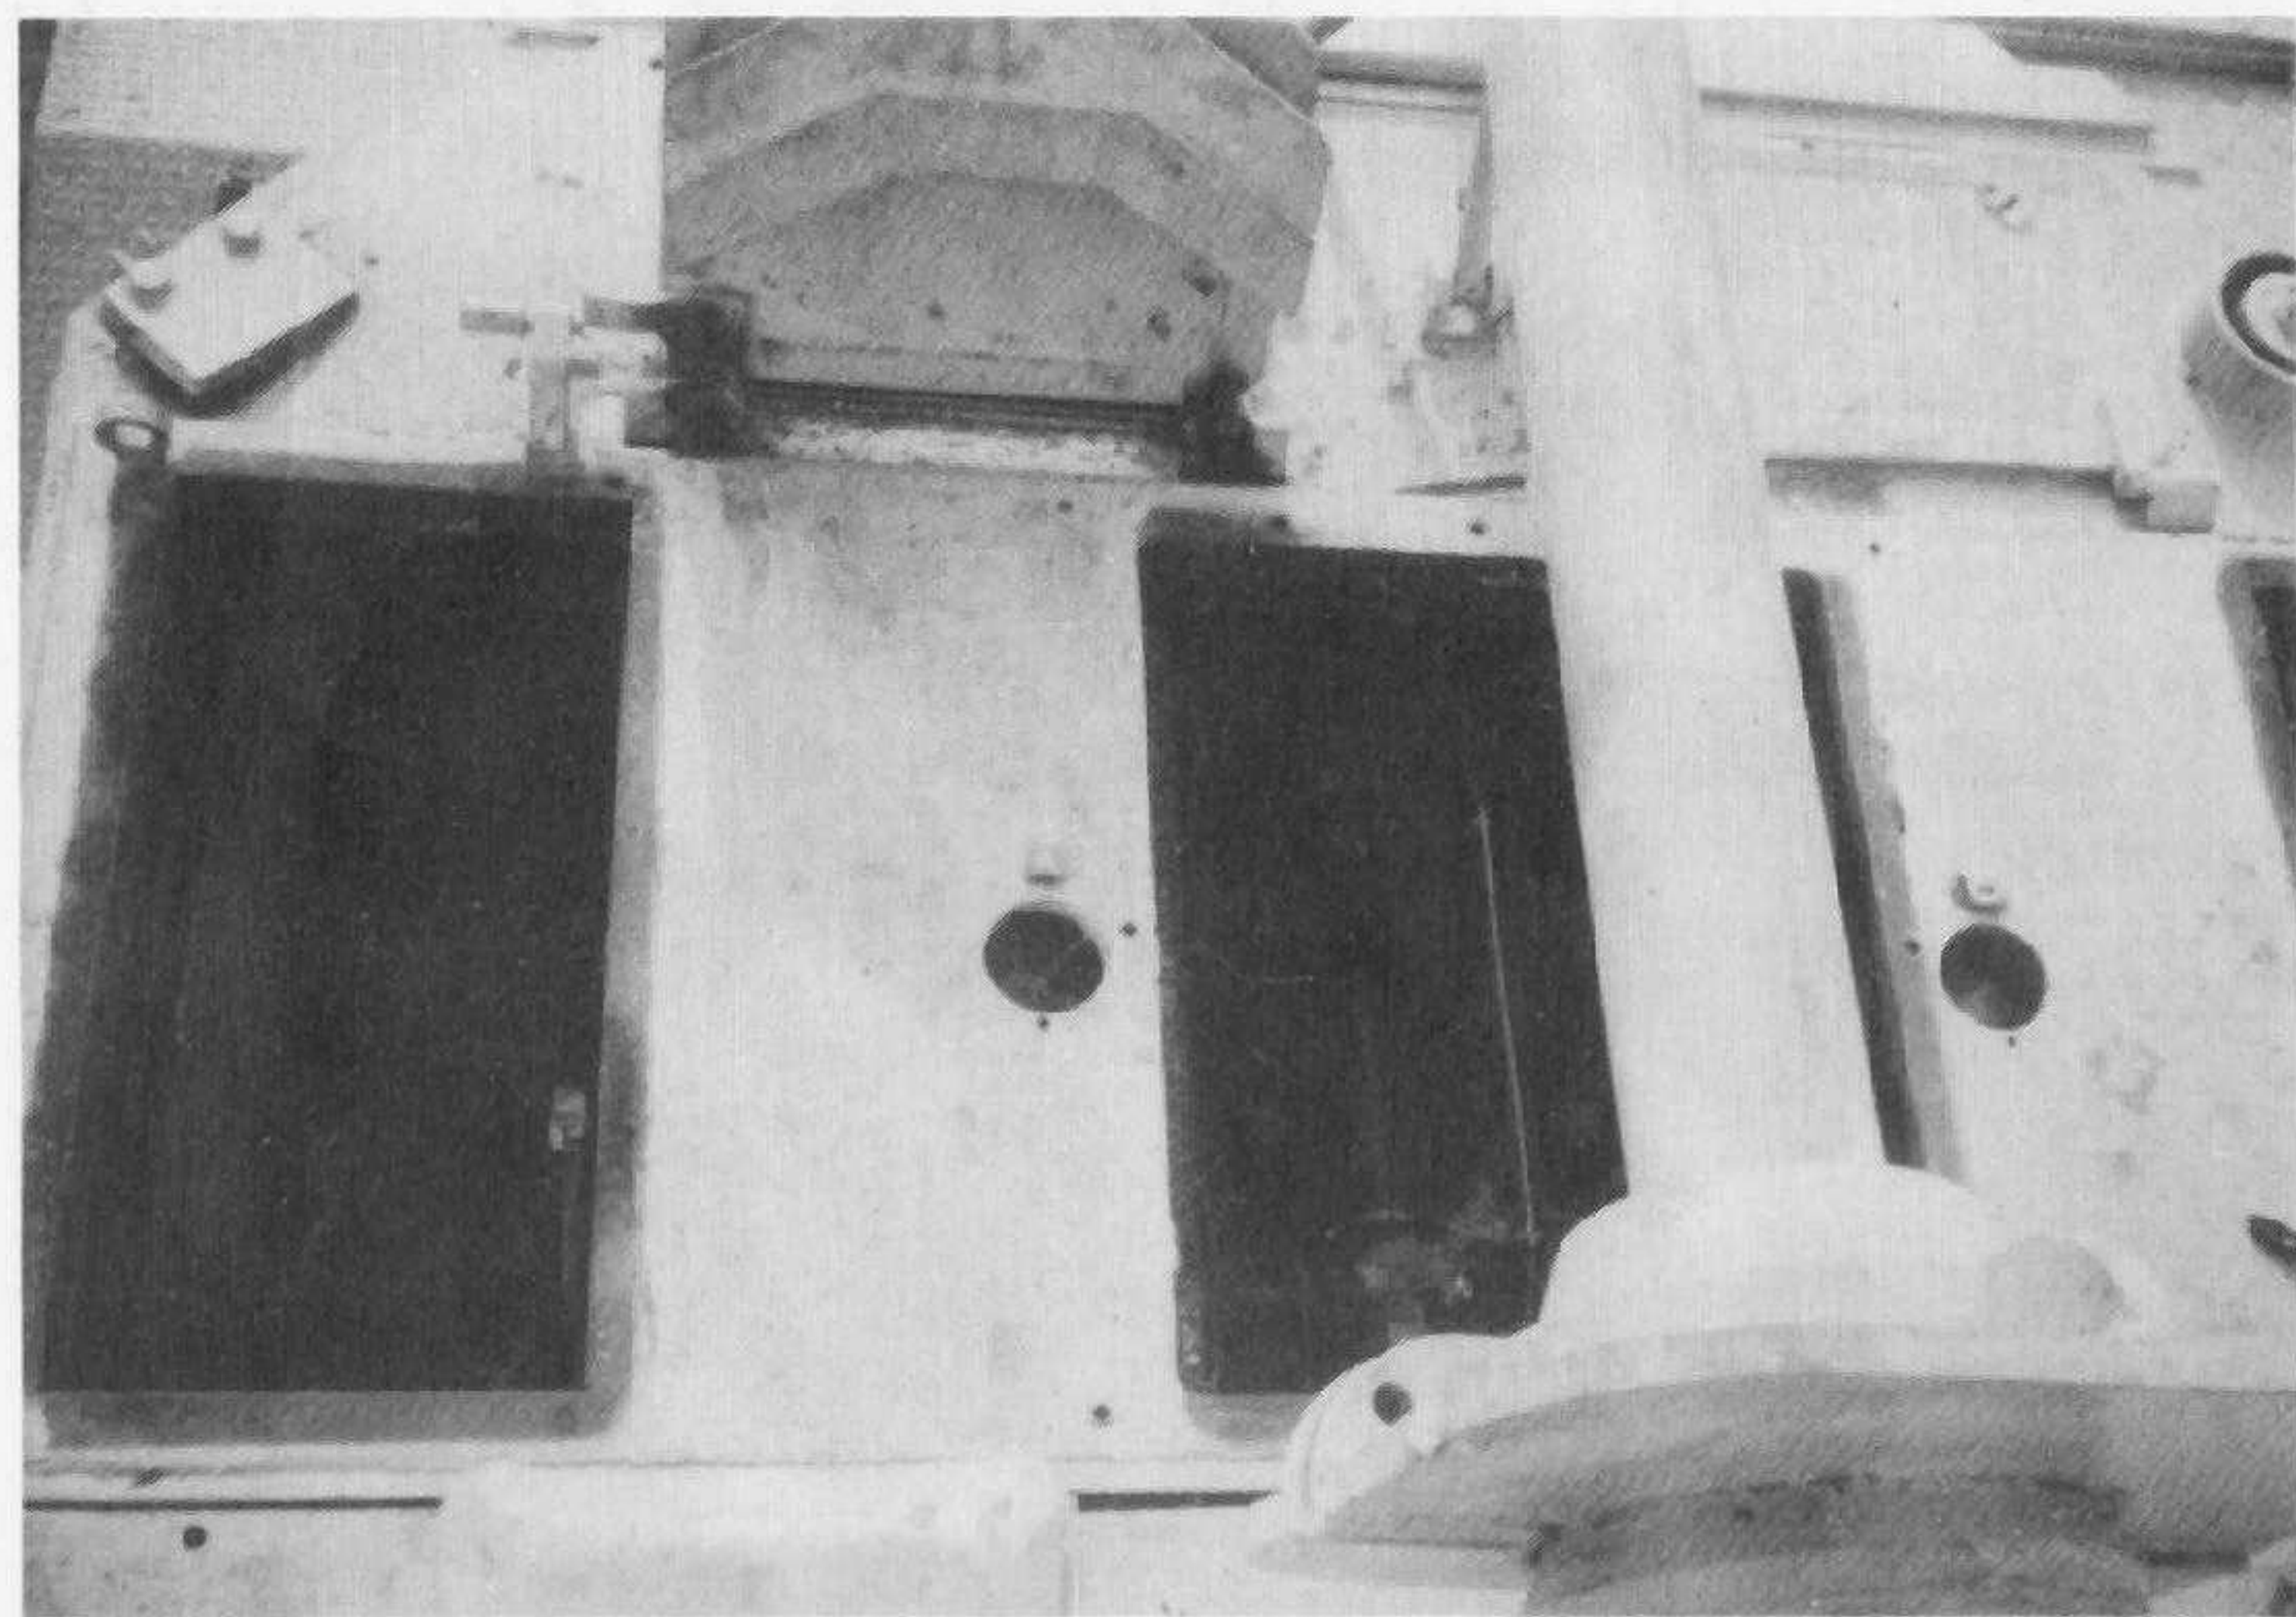
Looking down on the engine deck and the driver and radio operator/bow gunner's positions. Although he served a dual role, for our purposes we will refer to the later as the "bow gunner" or "gunner" throughout the remainder of this publication.

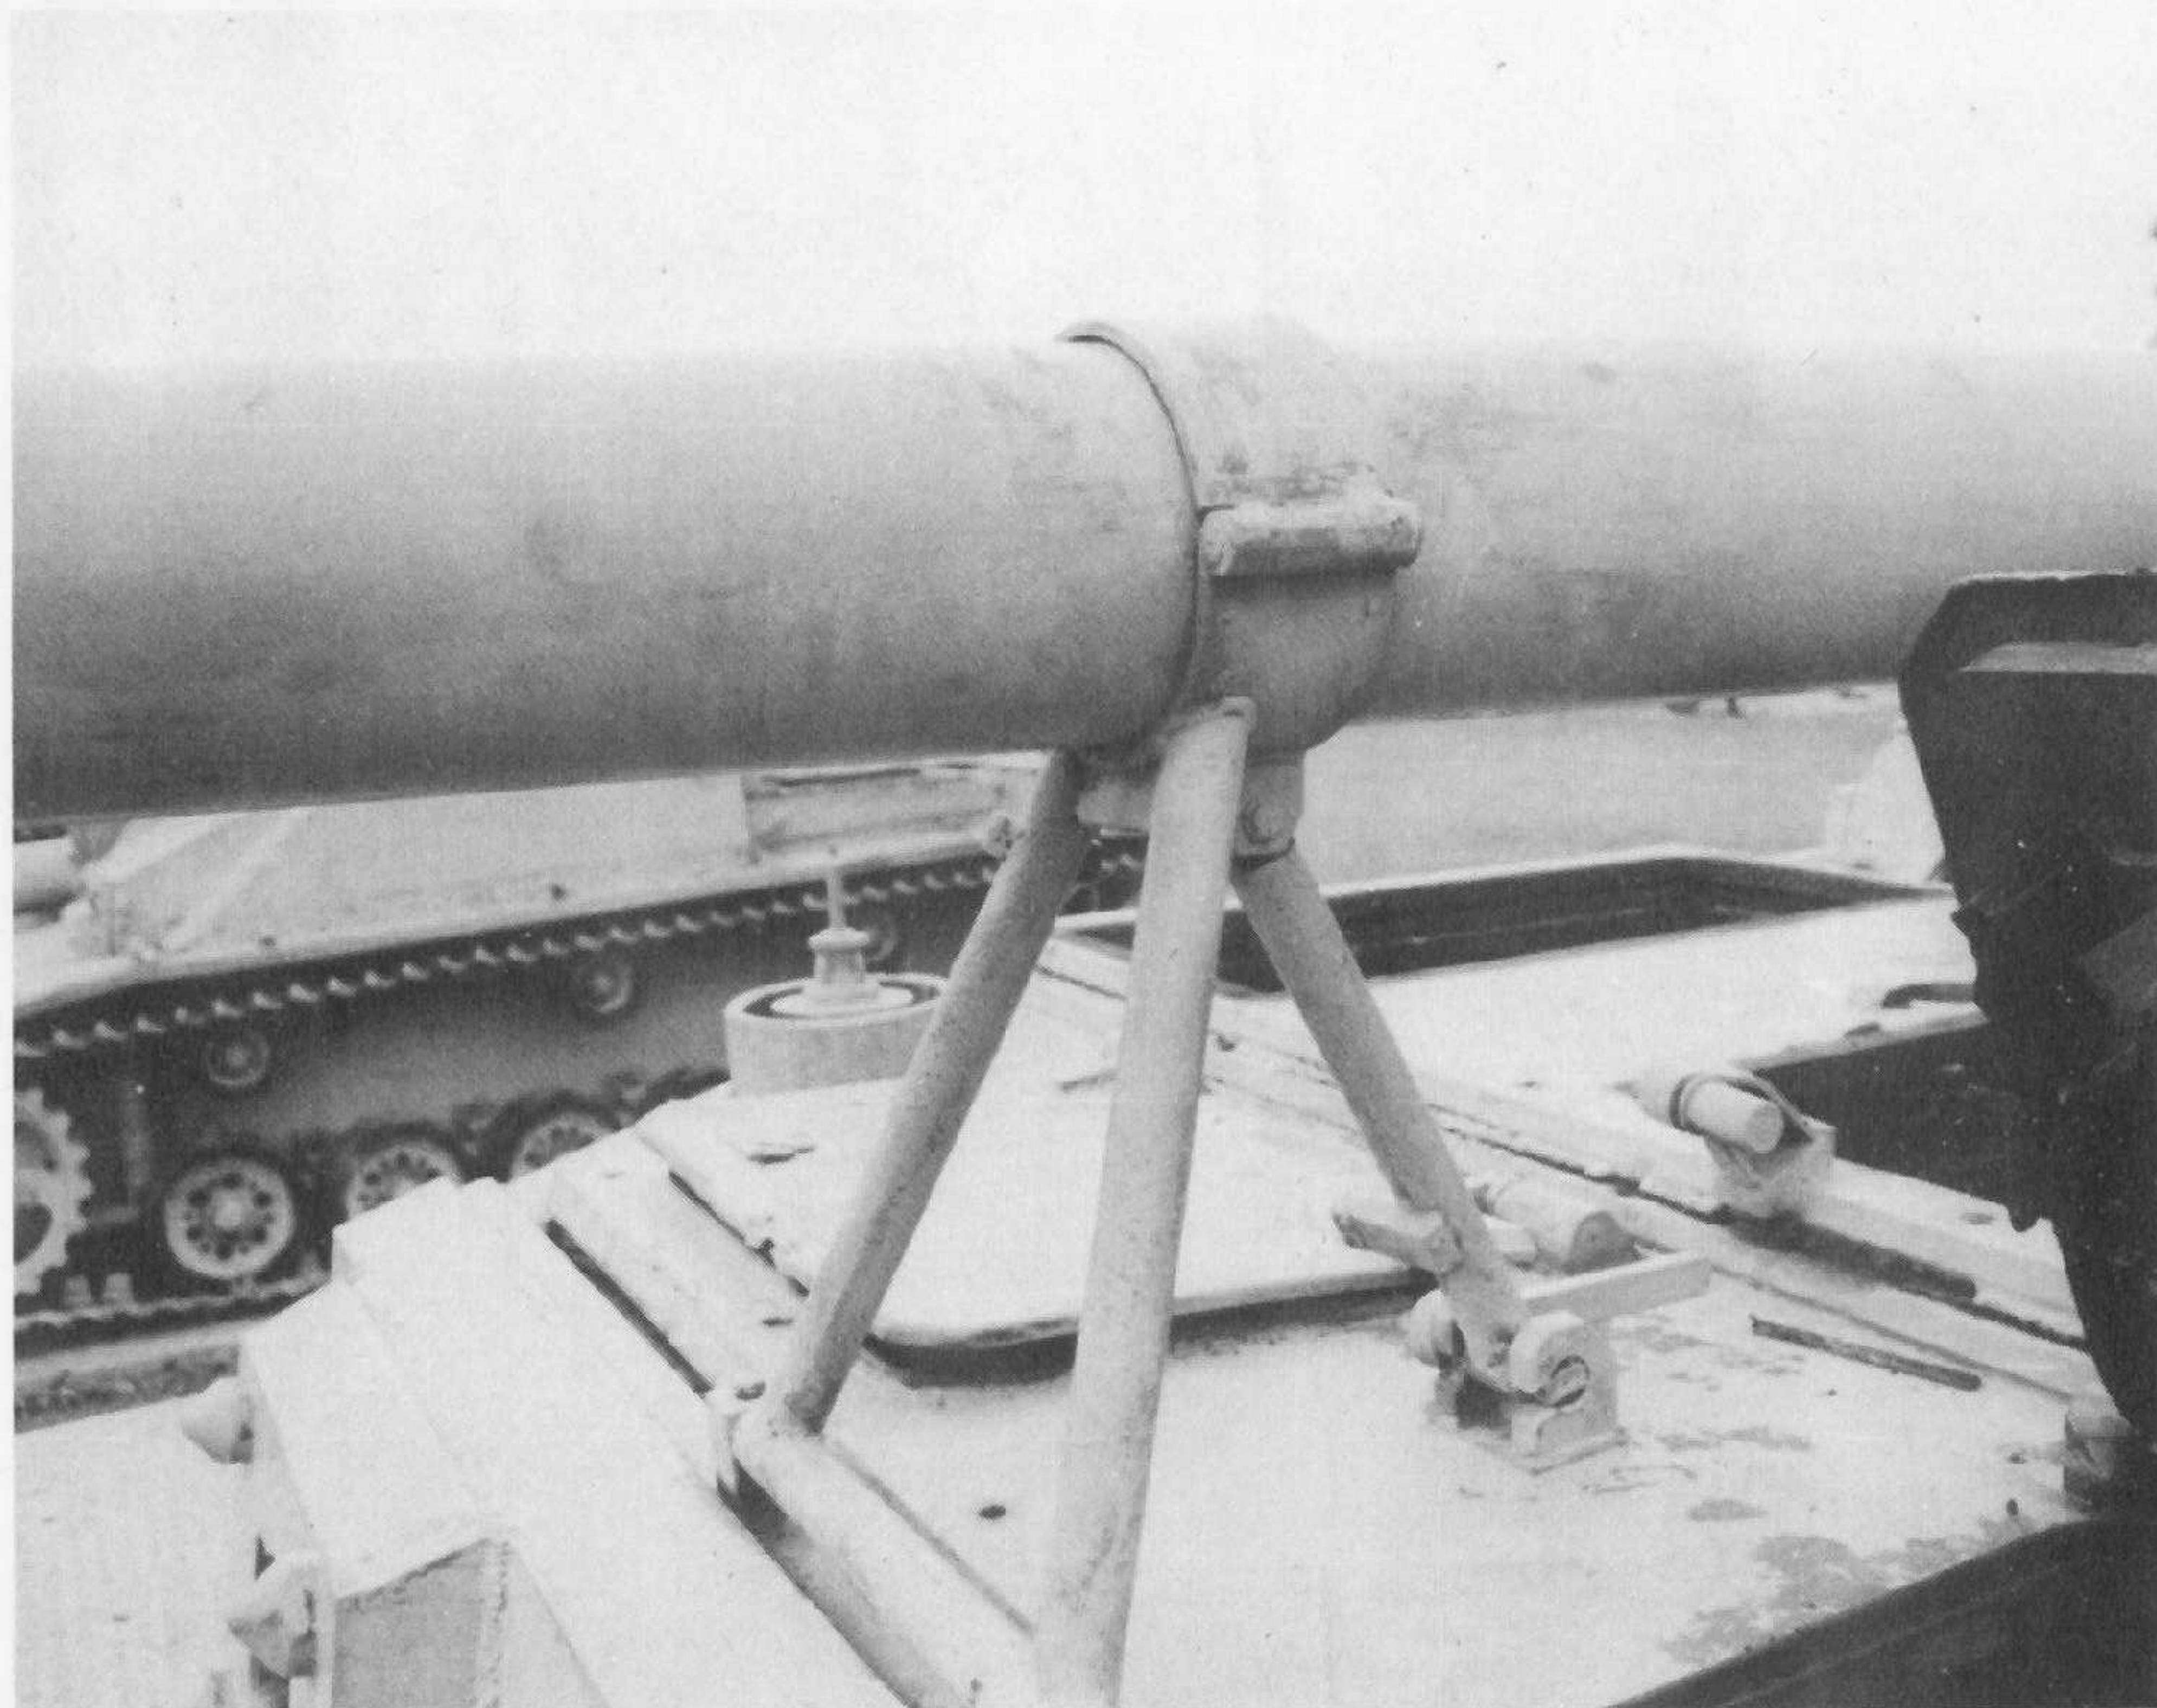
Looking across at the gun travel lock and the bow gunner's hatch. Conspicuous by their absence are any vision forward vision blocks in the gunner's hatch.

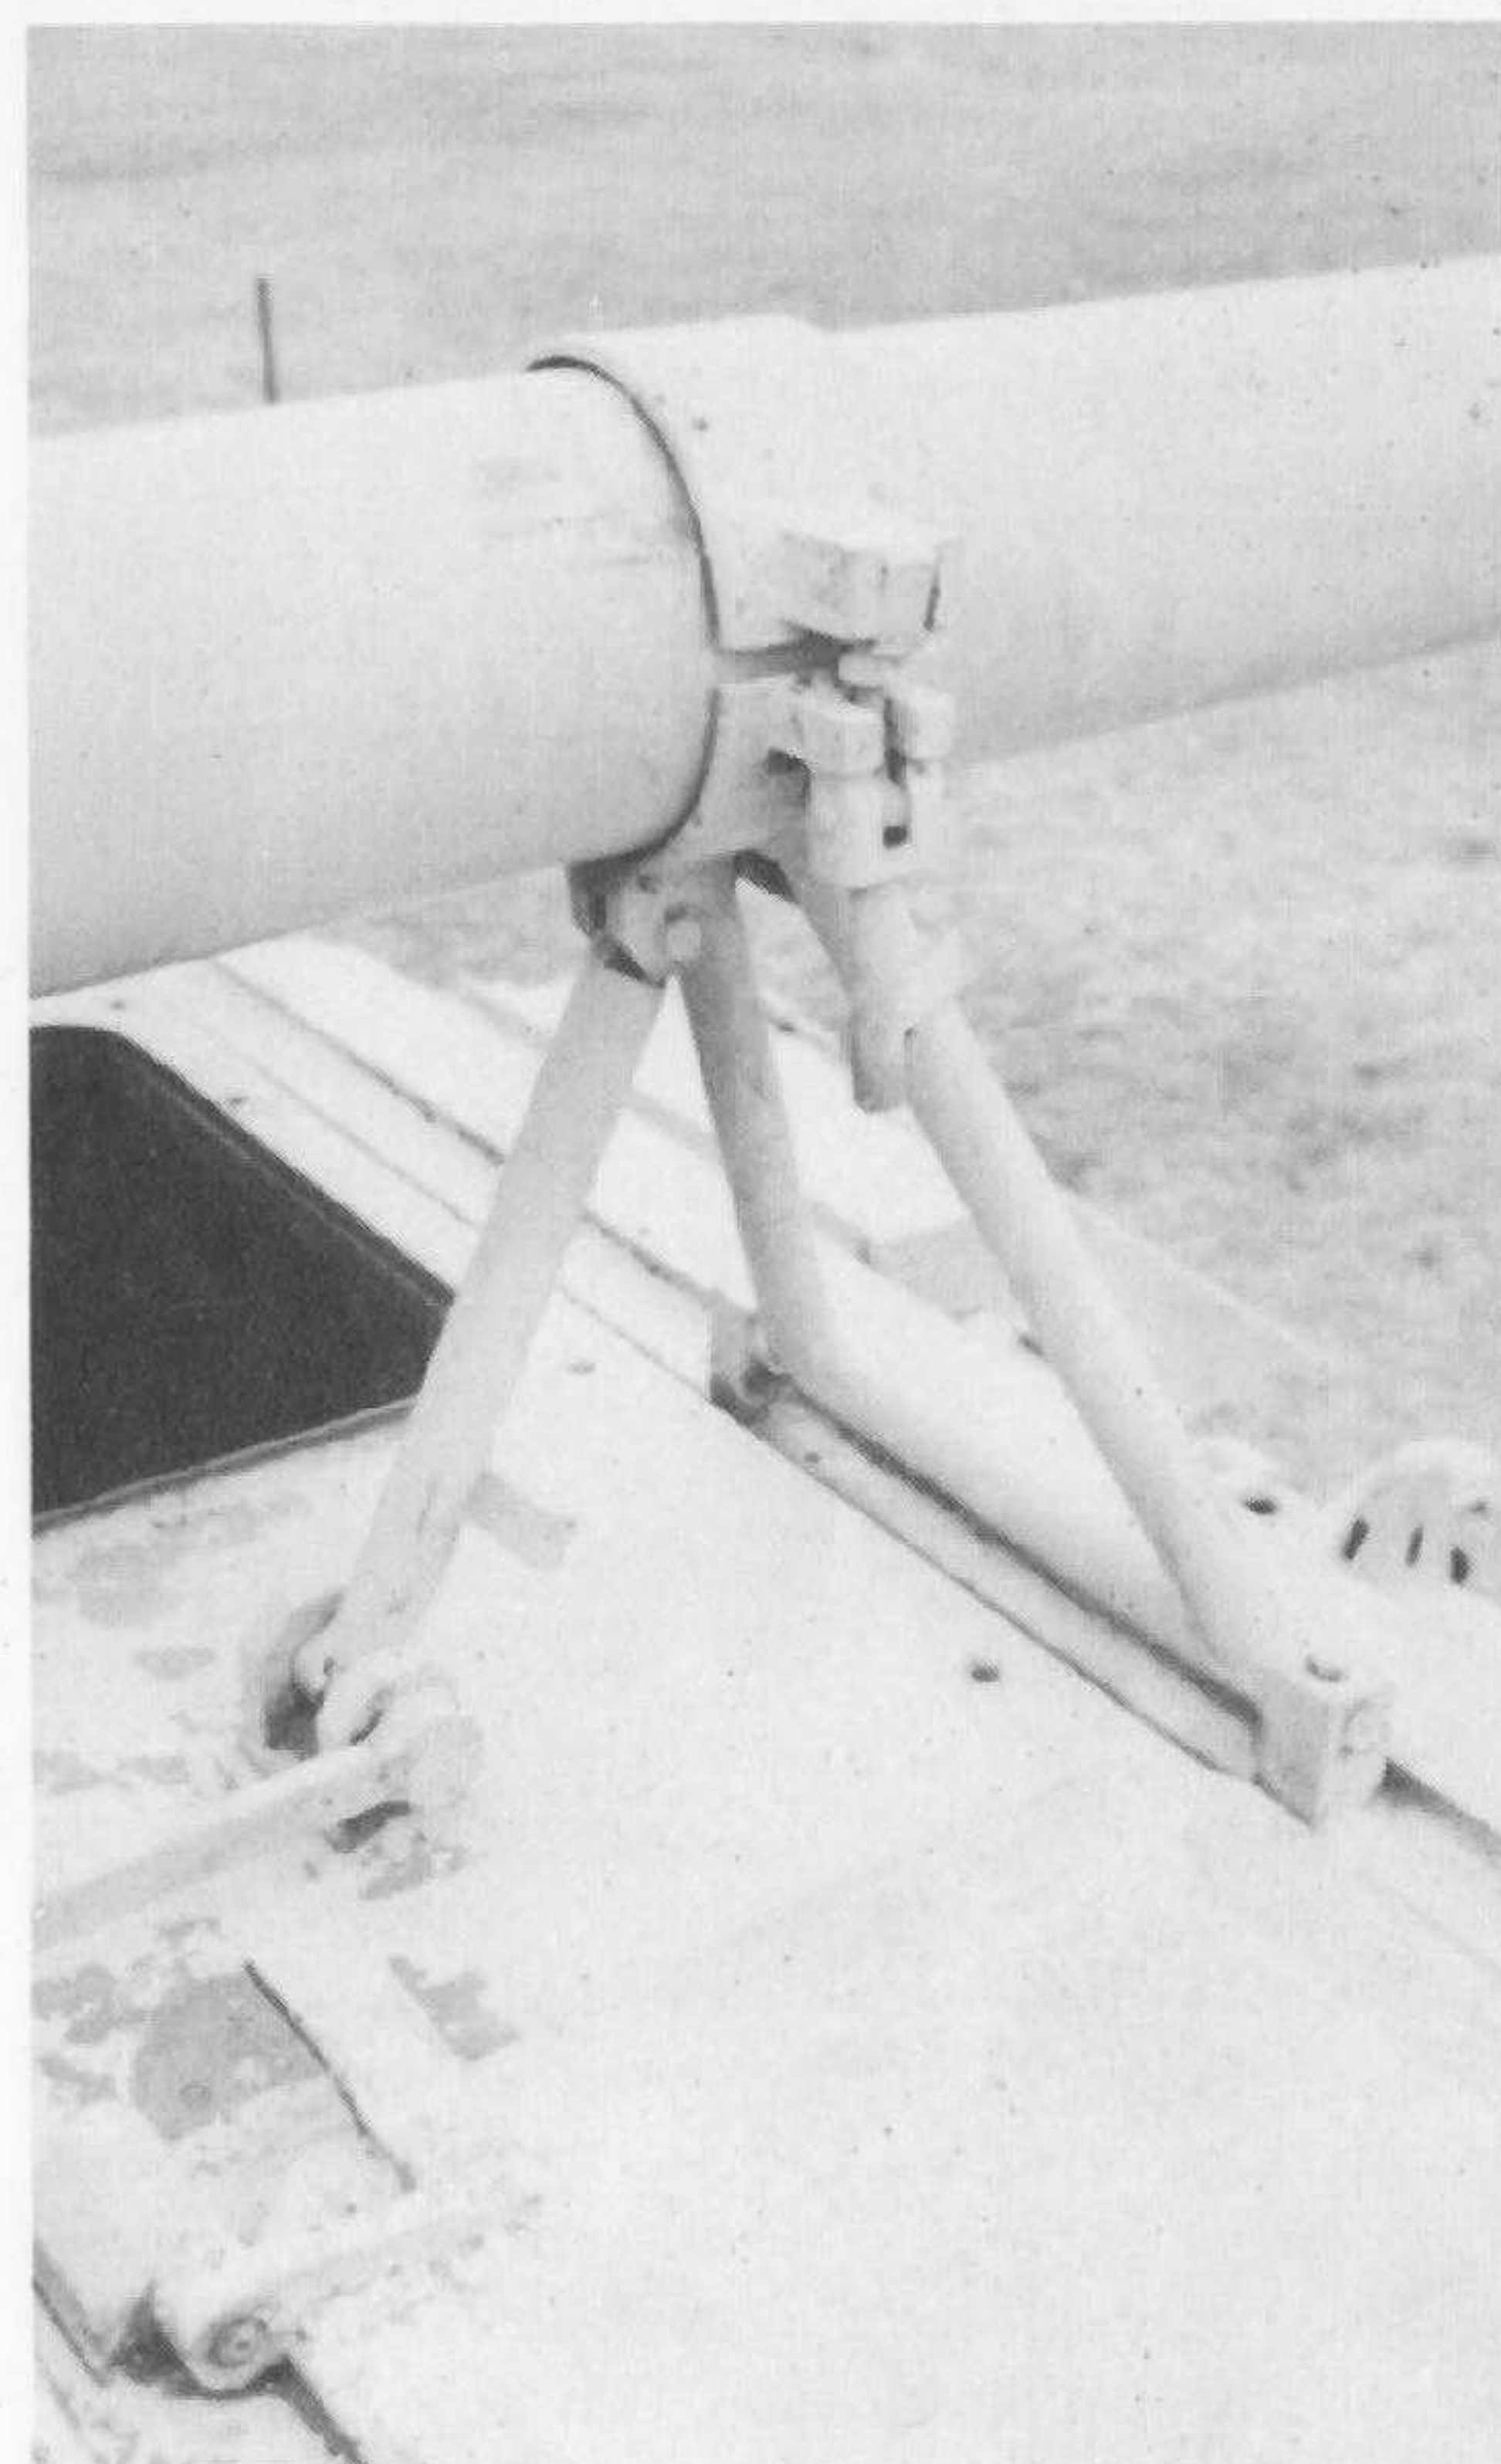
The gun travel lock. There is a nut in the gap between to the two halves that is tighten or loosen as the case may be.
