MUSEUM ORDNANCE SPECIAL NUMBER 4

Elefant Panzerjäger Tiger (P)

Text by Thomas L. Jentz
Photos by Jeffrey D. McKaughan

THE "ELEFANT" AT ABERDEEN

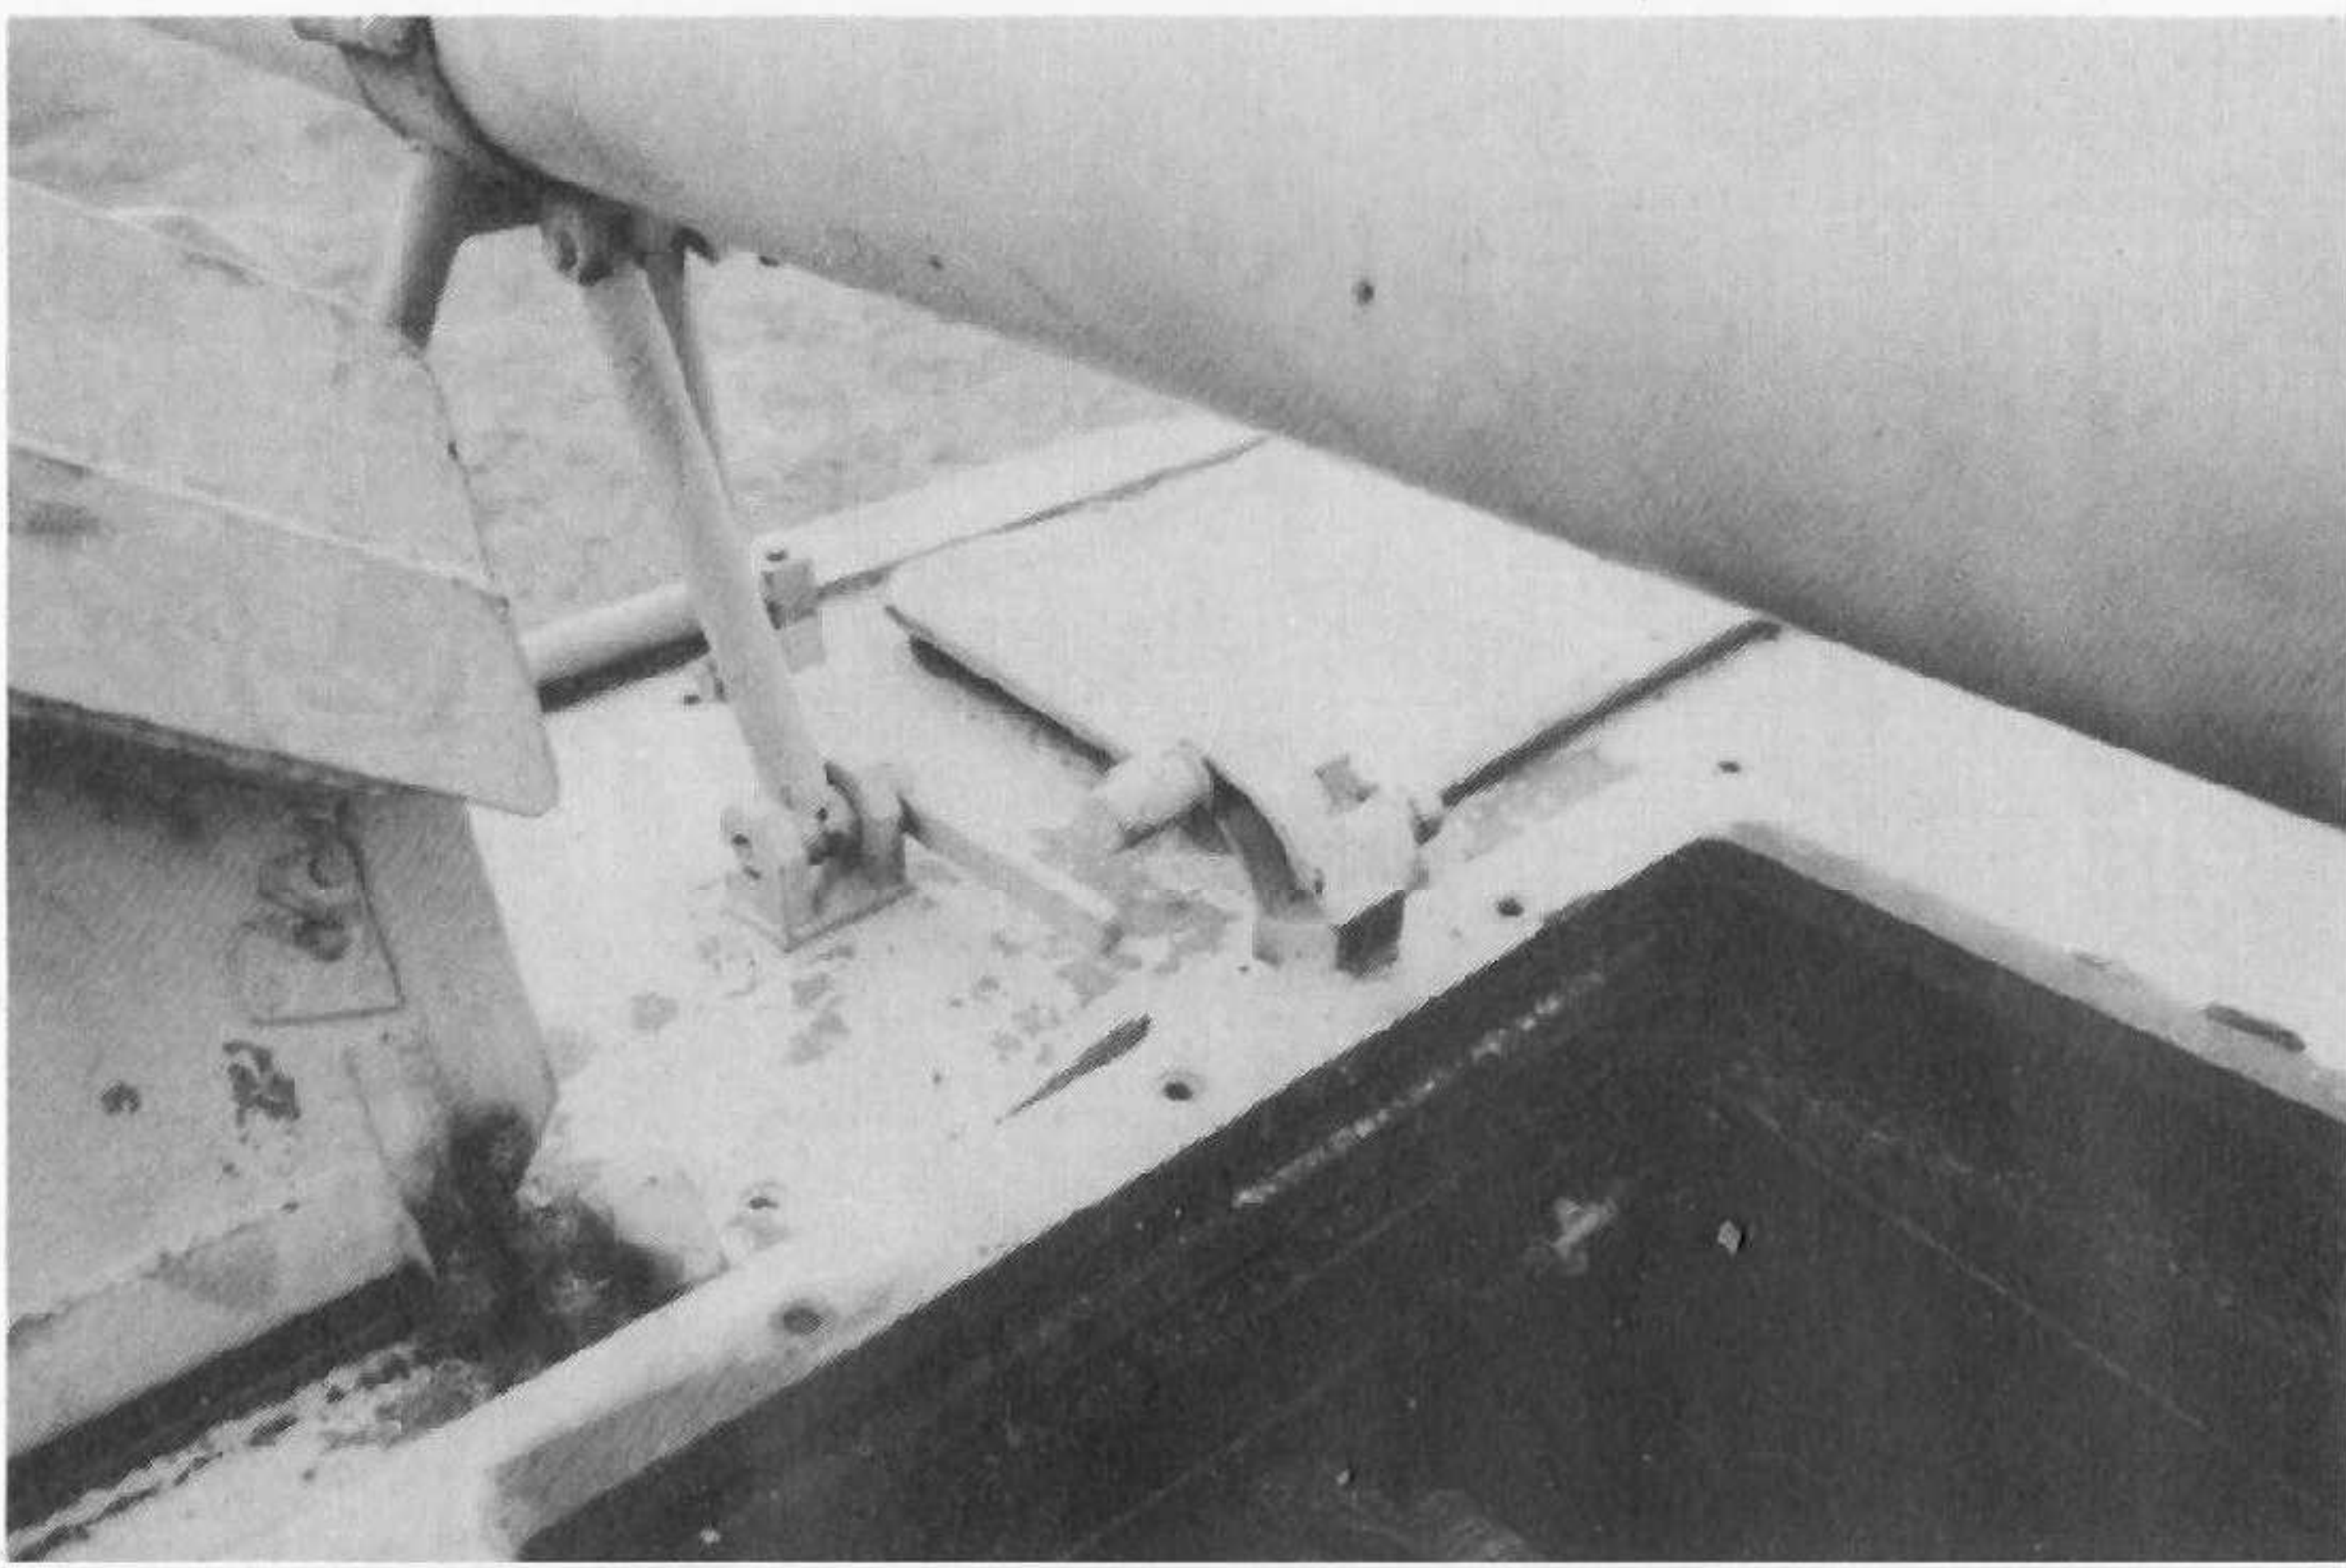
Again looking at the bottom of the gun lock, you can also see the opposite side of the plunger and catch mechanism for the bow gunner's hatch. The driver's catch is in a similar position to the left of the hatch. The small triangular (almost) shape on the driver's hatch is held on by three screws and is part of the driver's locking handle on the underside.

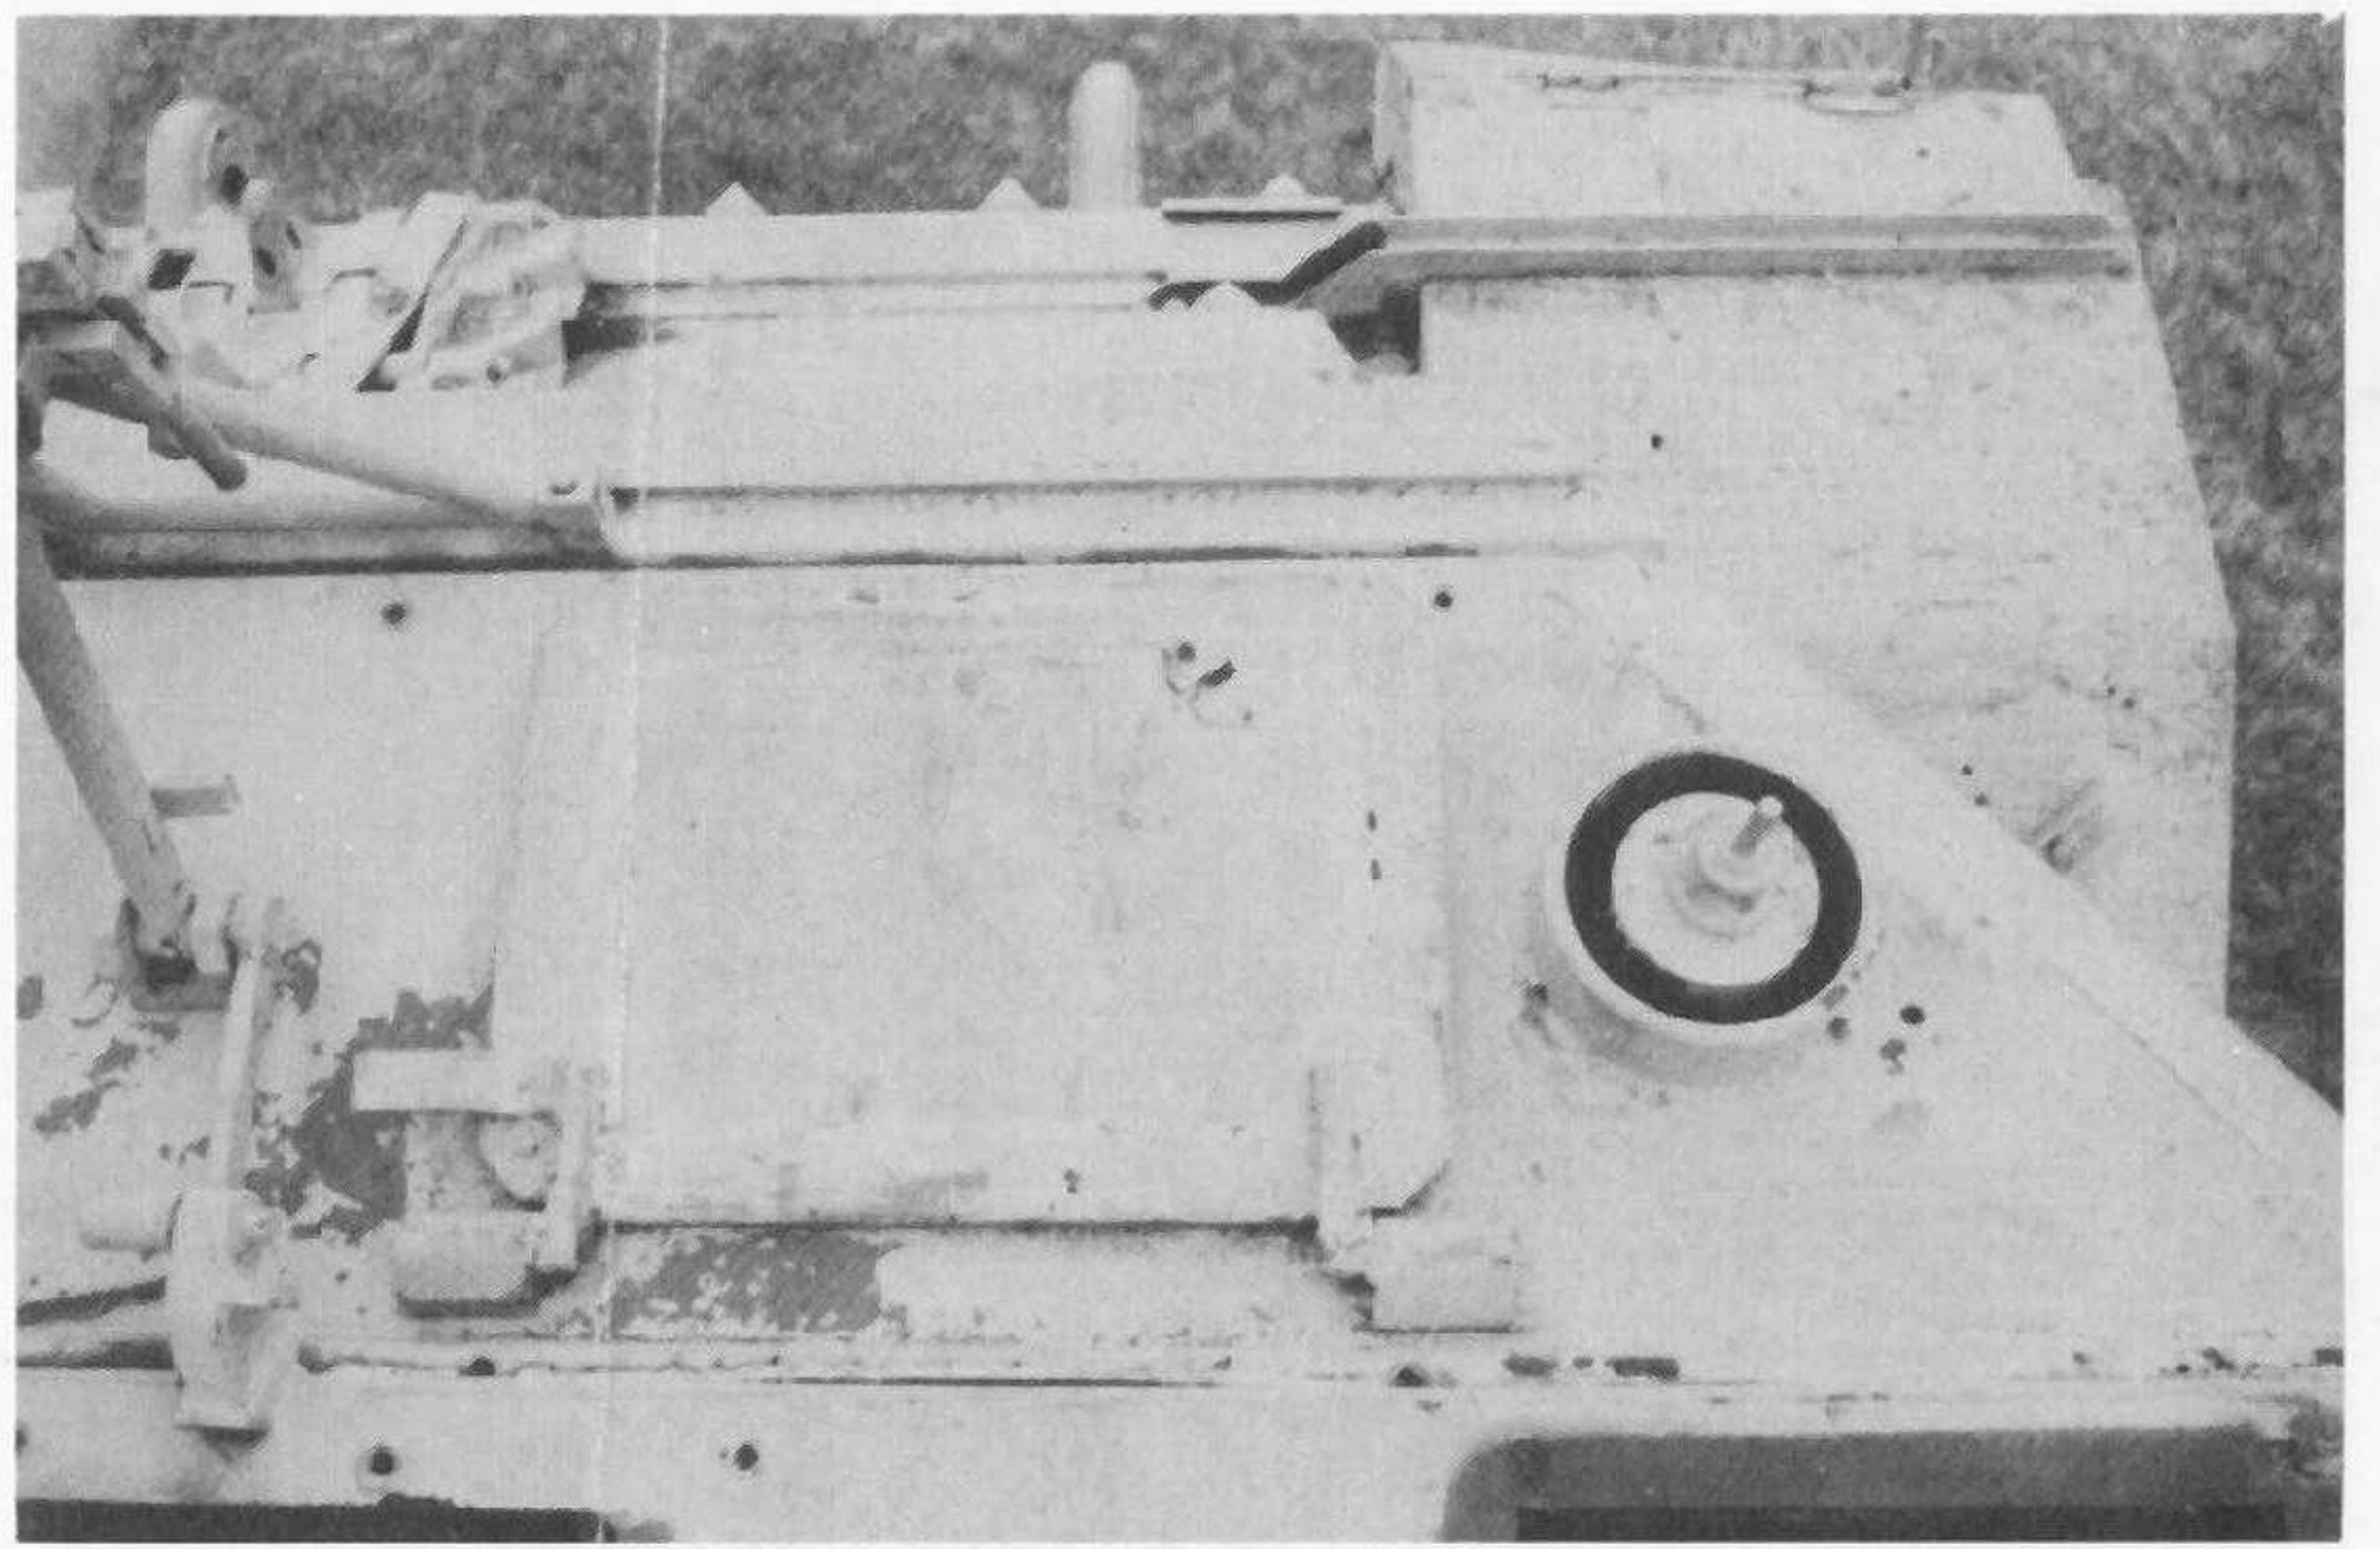
Looking straight down on the bow machine gunner's hatch. To the right is the base for the radio antenna. The triangular shape for the locking mechanism on this hatch is in the upper right.

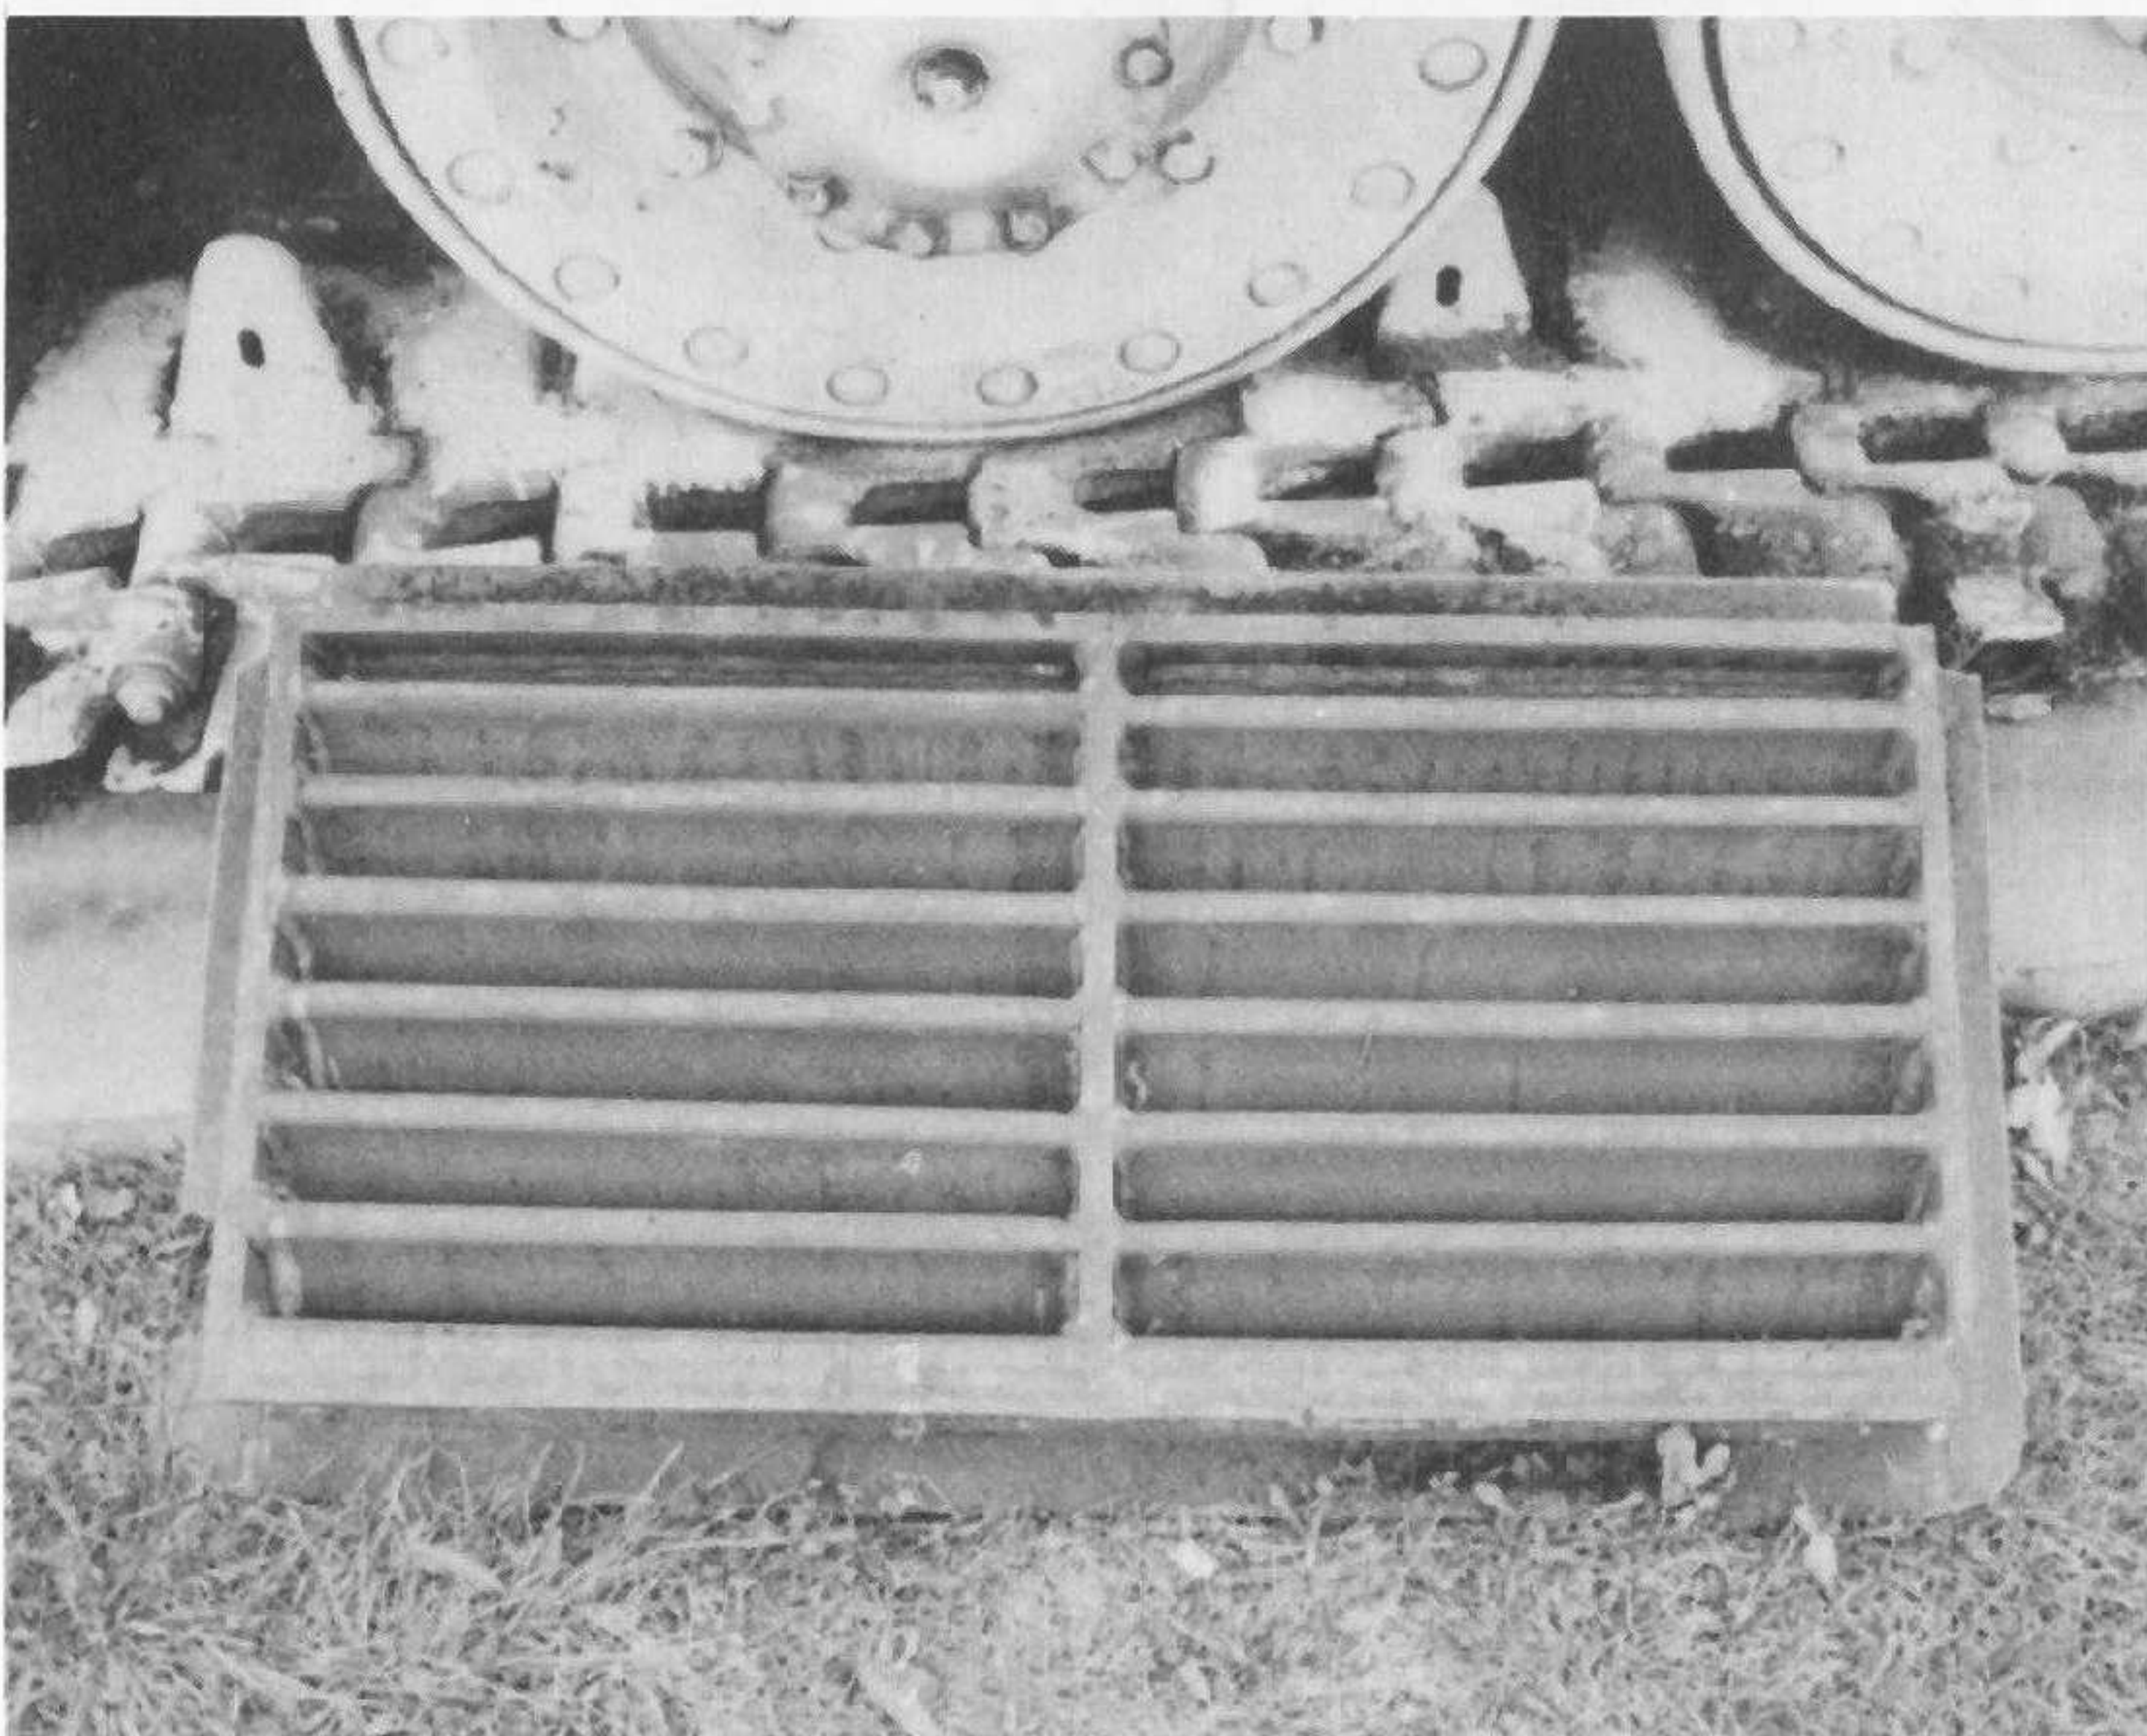
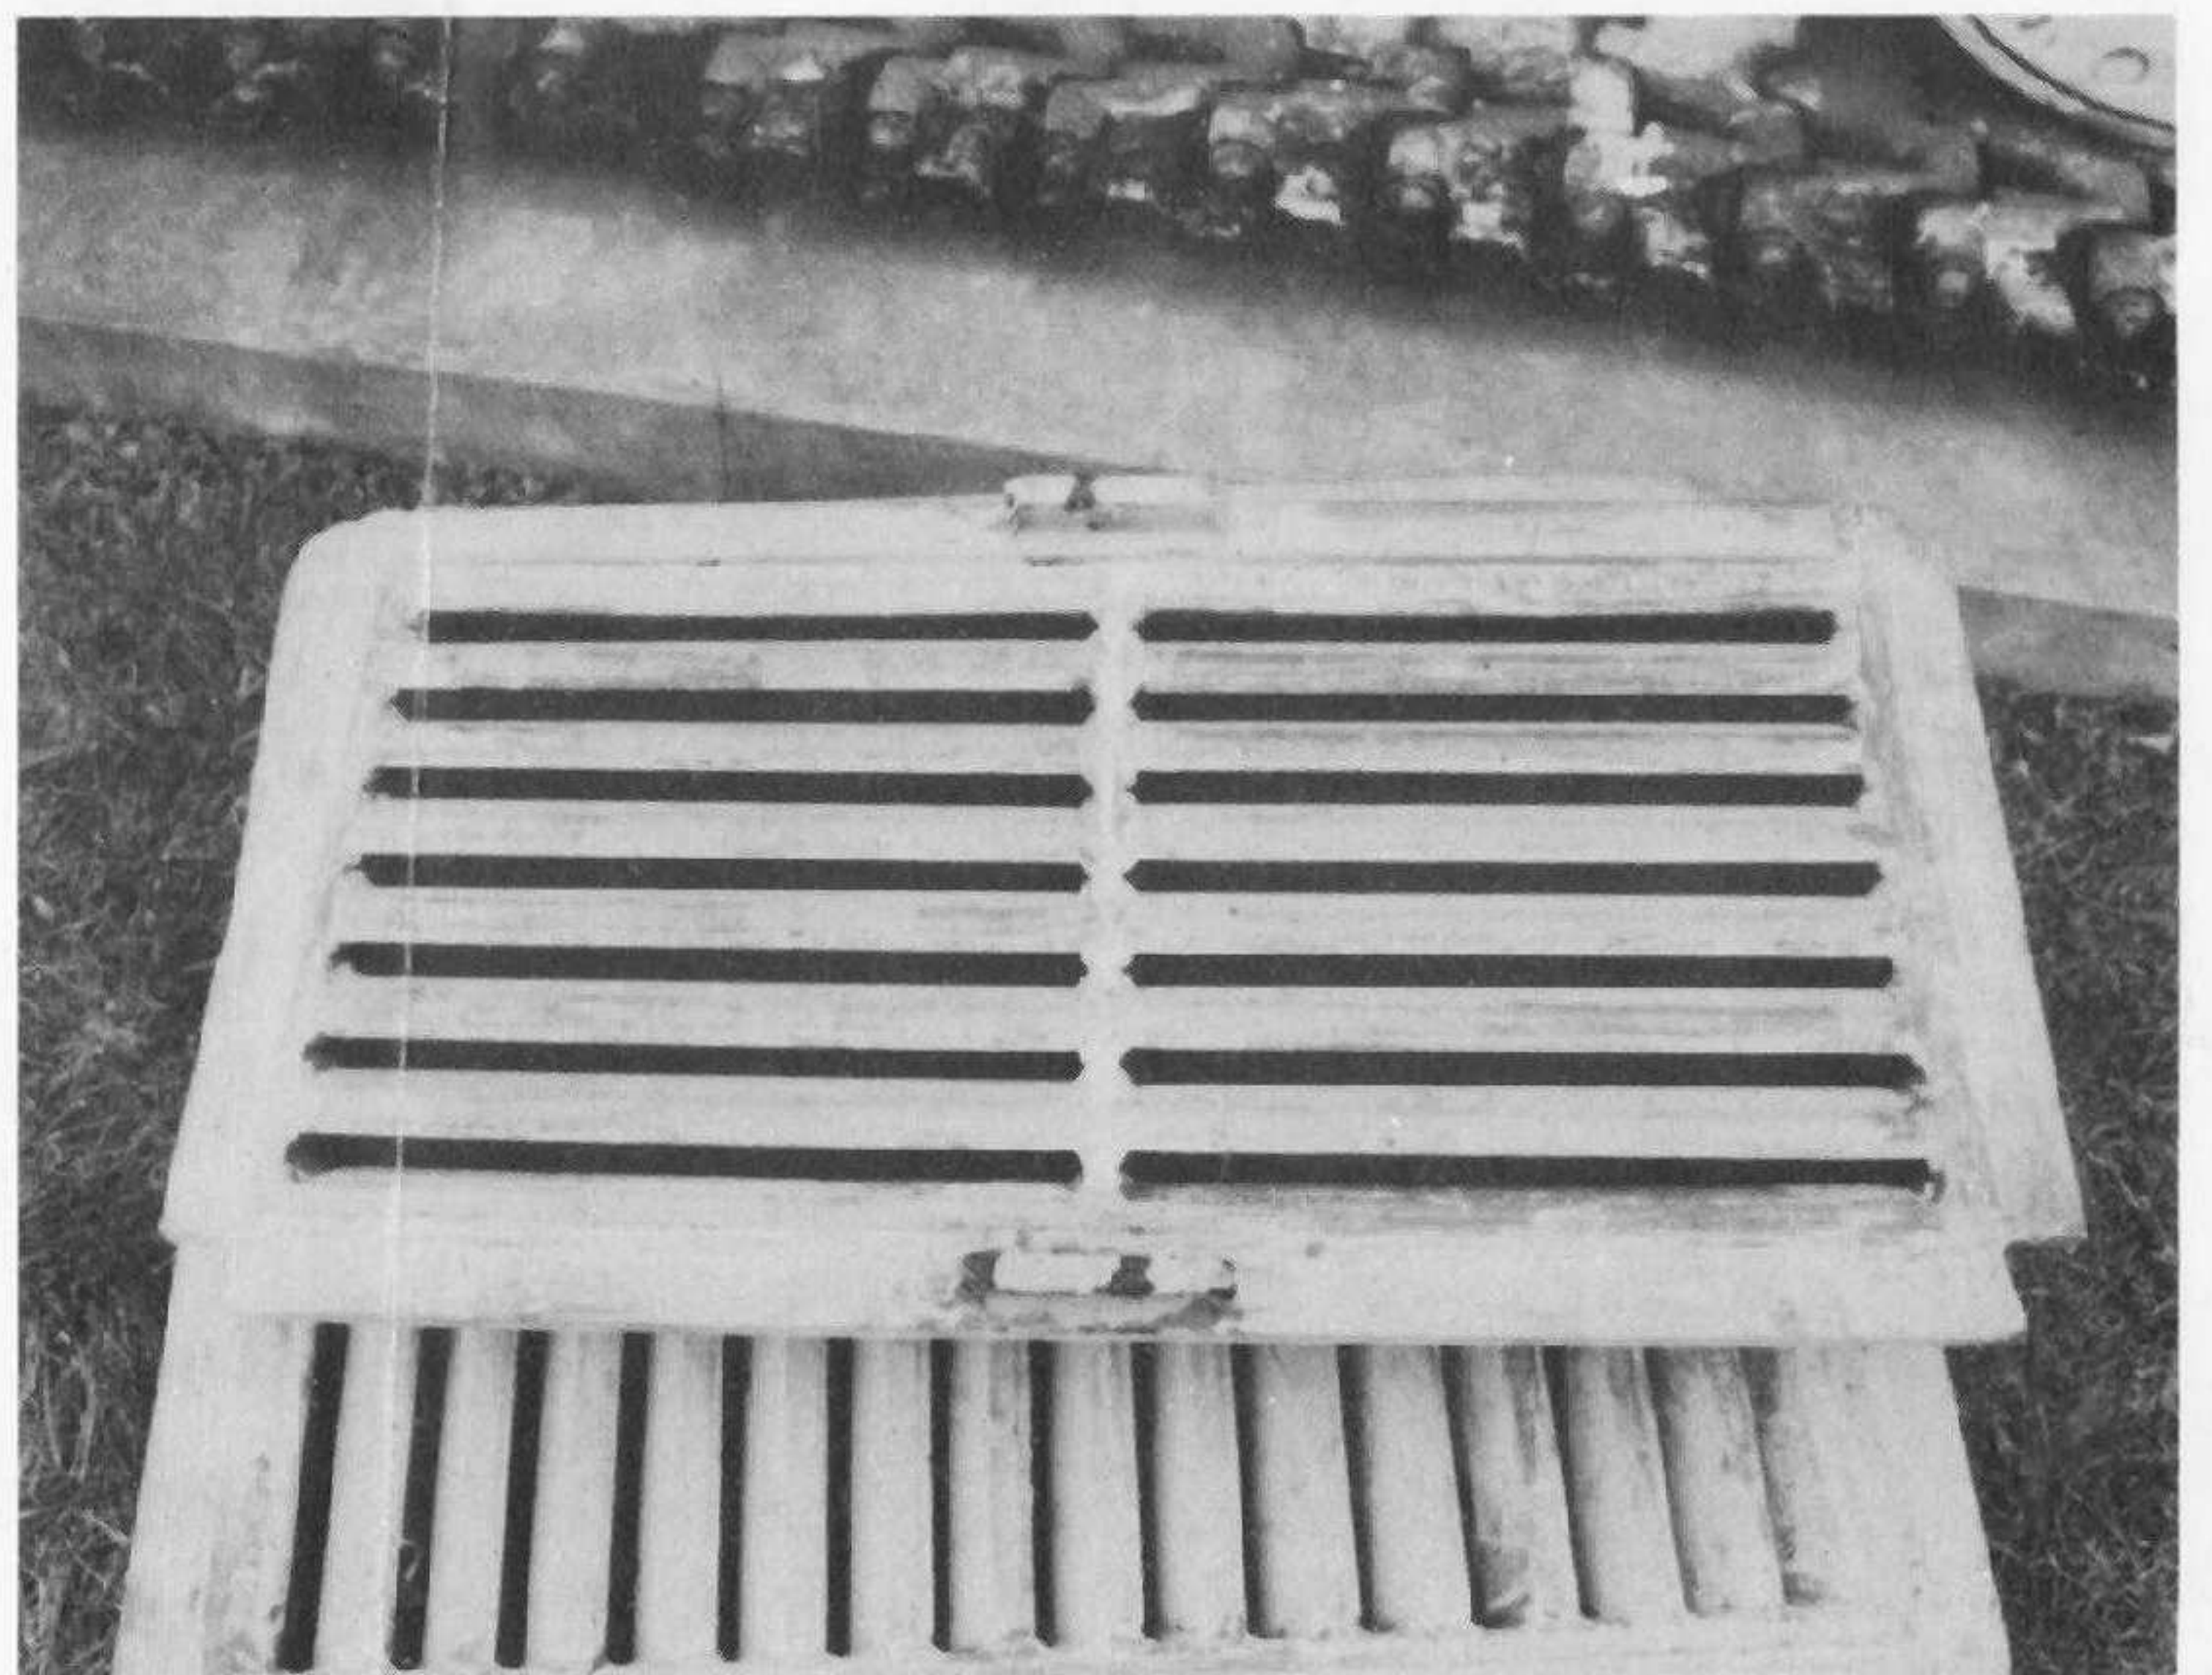
The two photos below are of the grill cover for the radiators. The photo on the left is of the underside while the right hand photo is from the top, note the handles on either side of the cover.

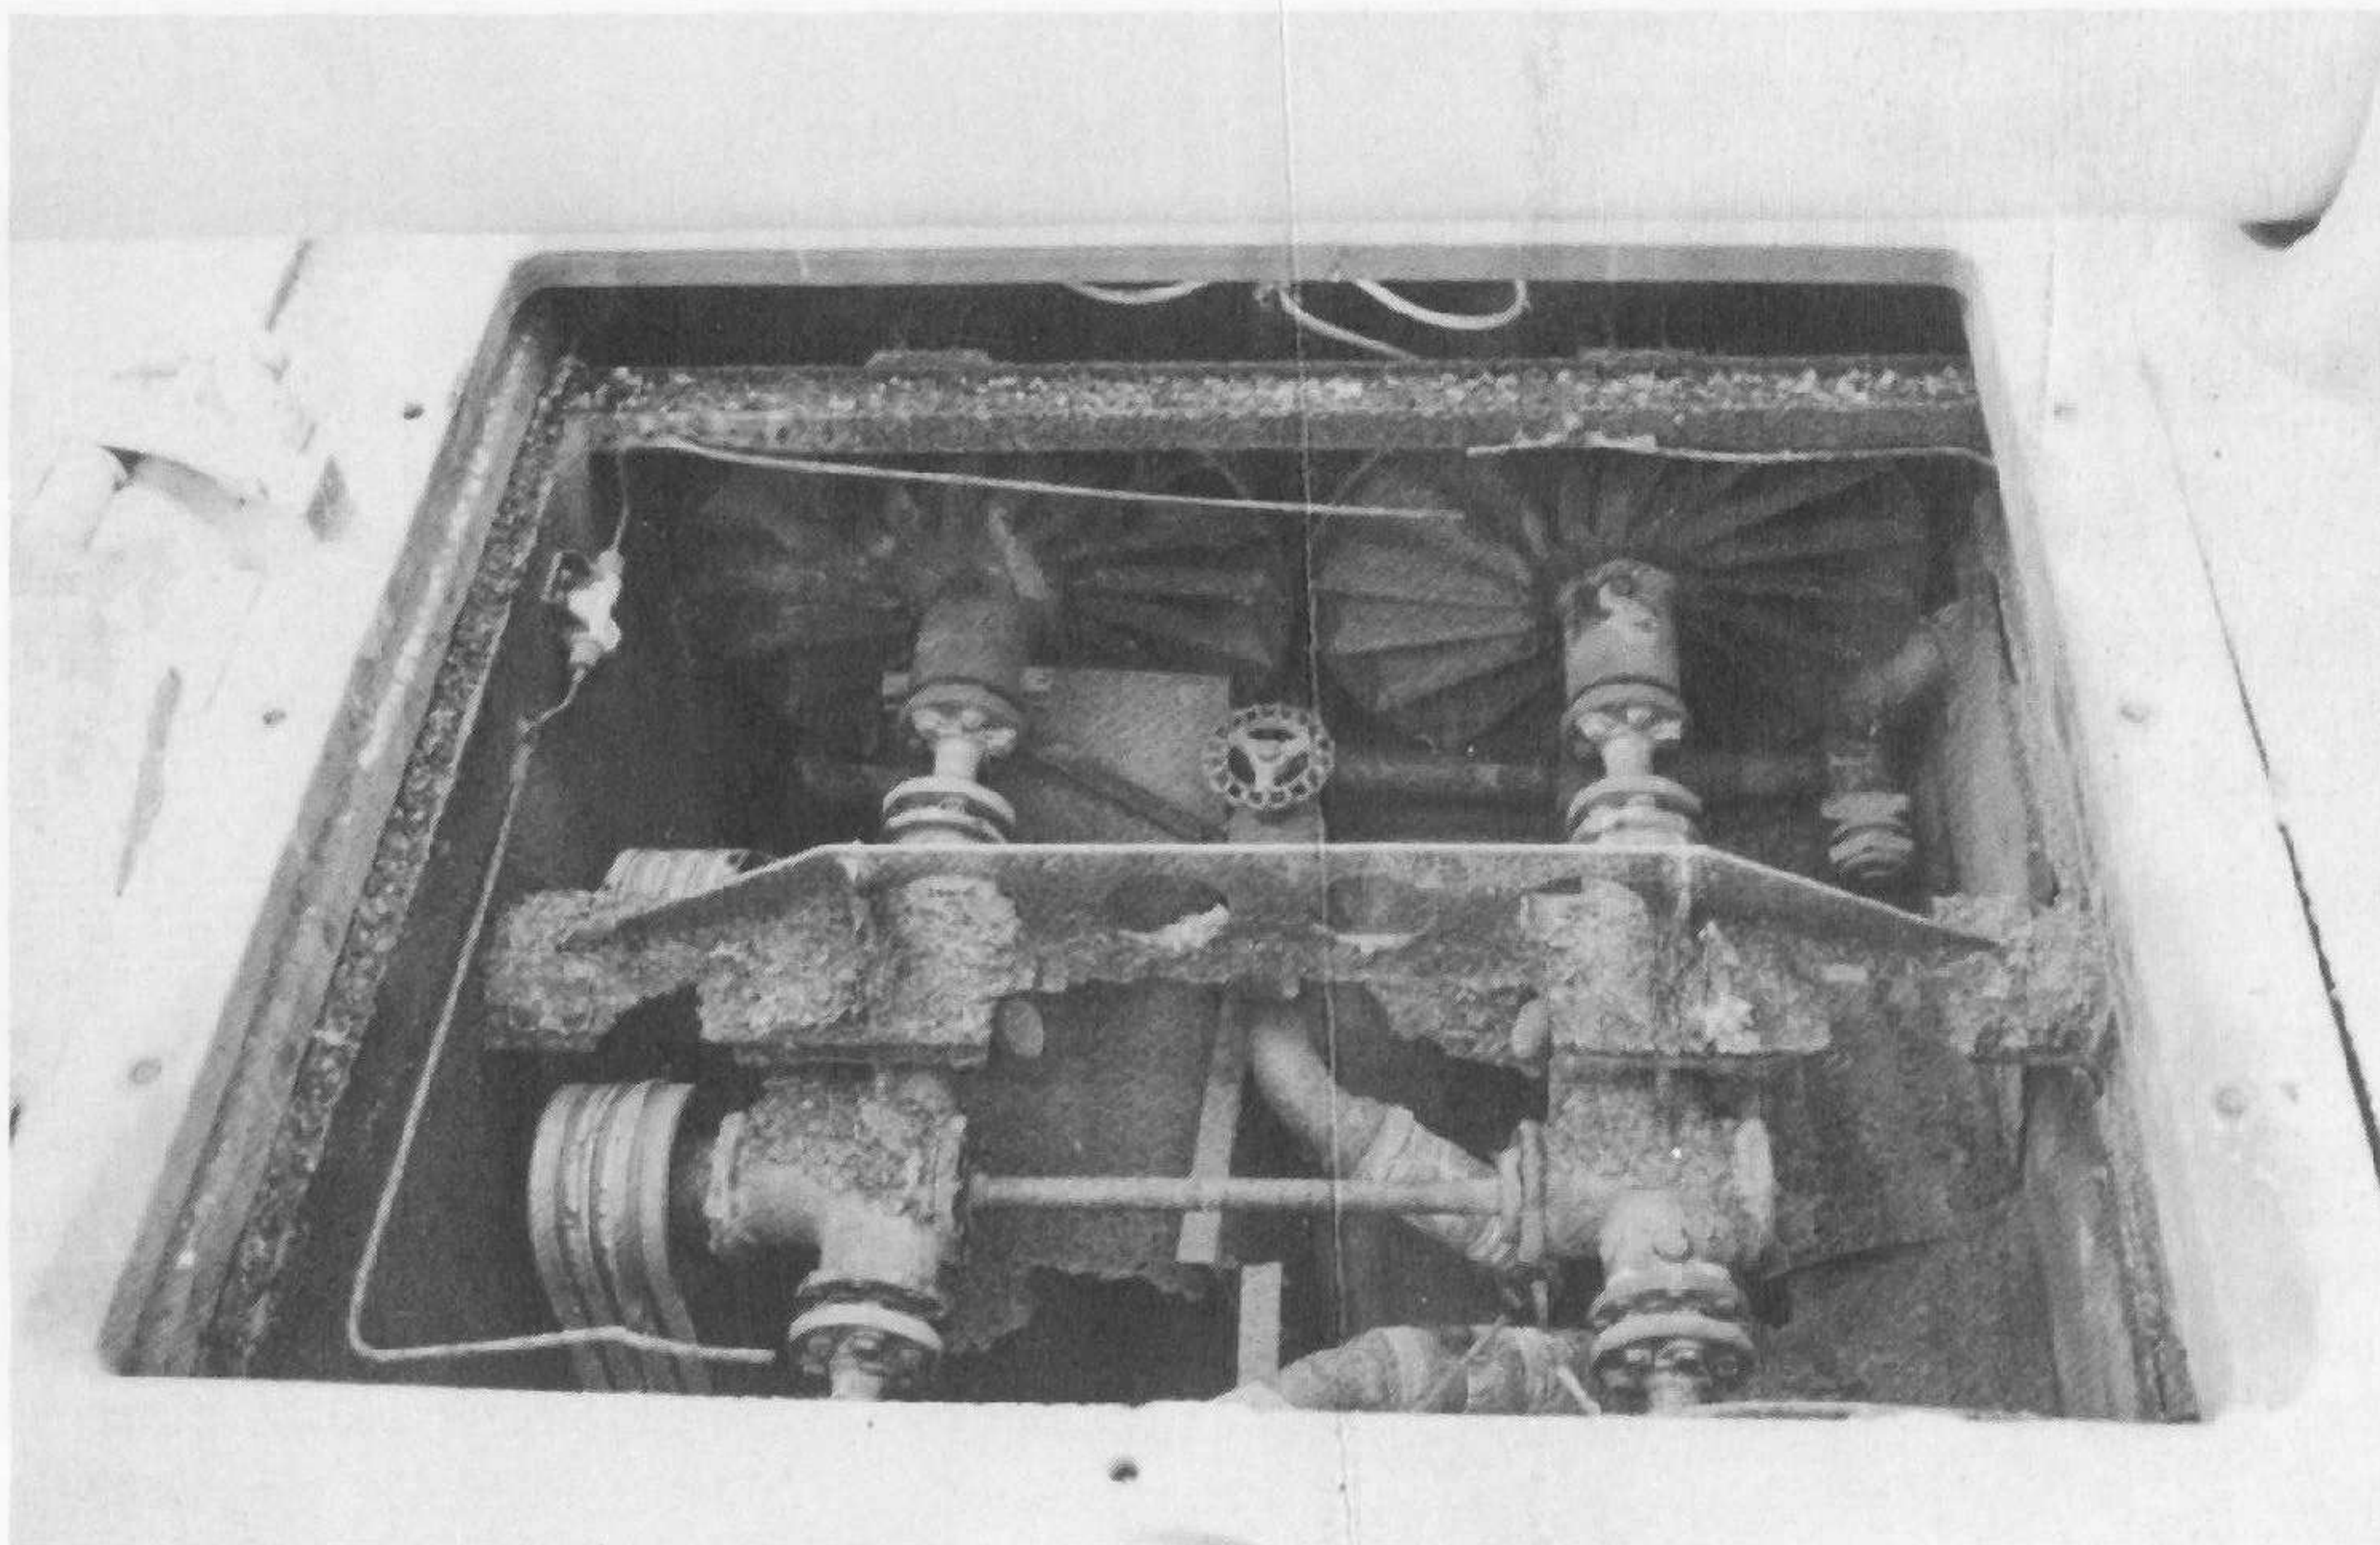
Looking at the twin cooling fans on the Elephant's right side.

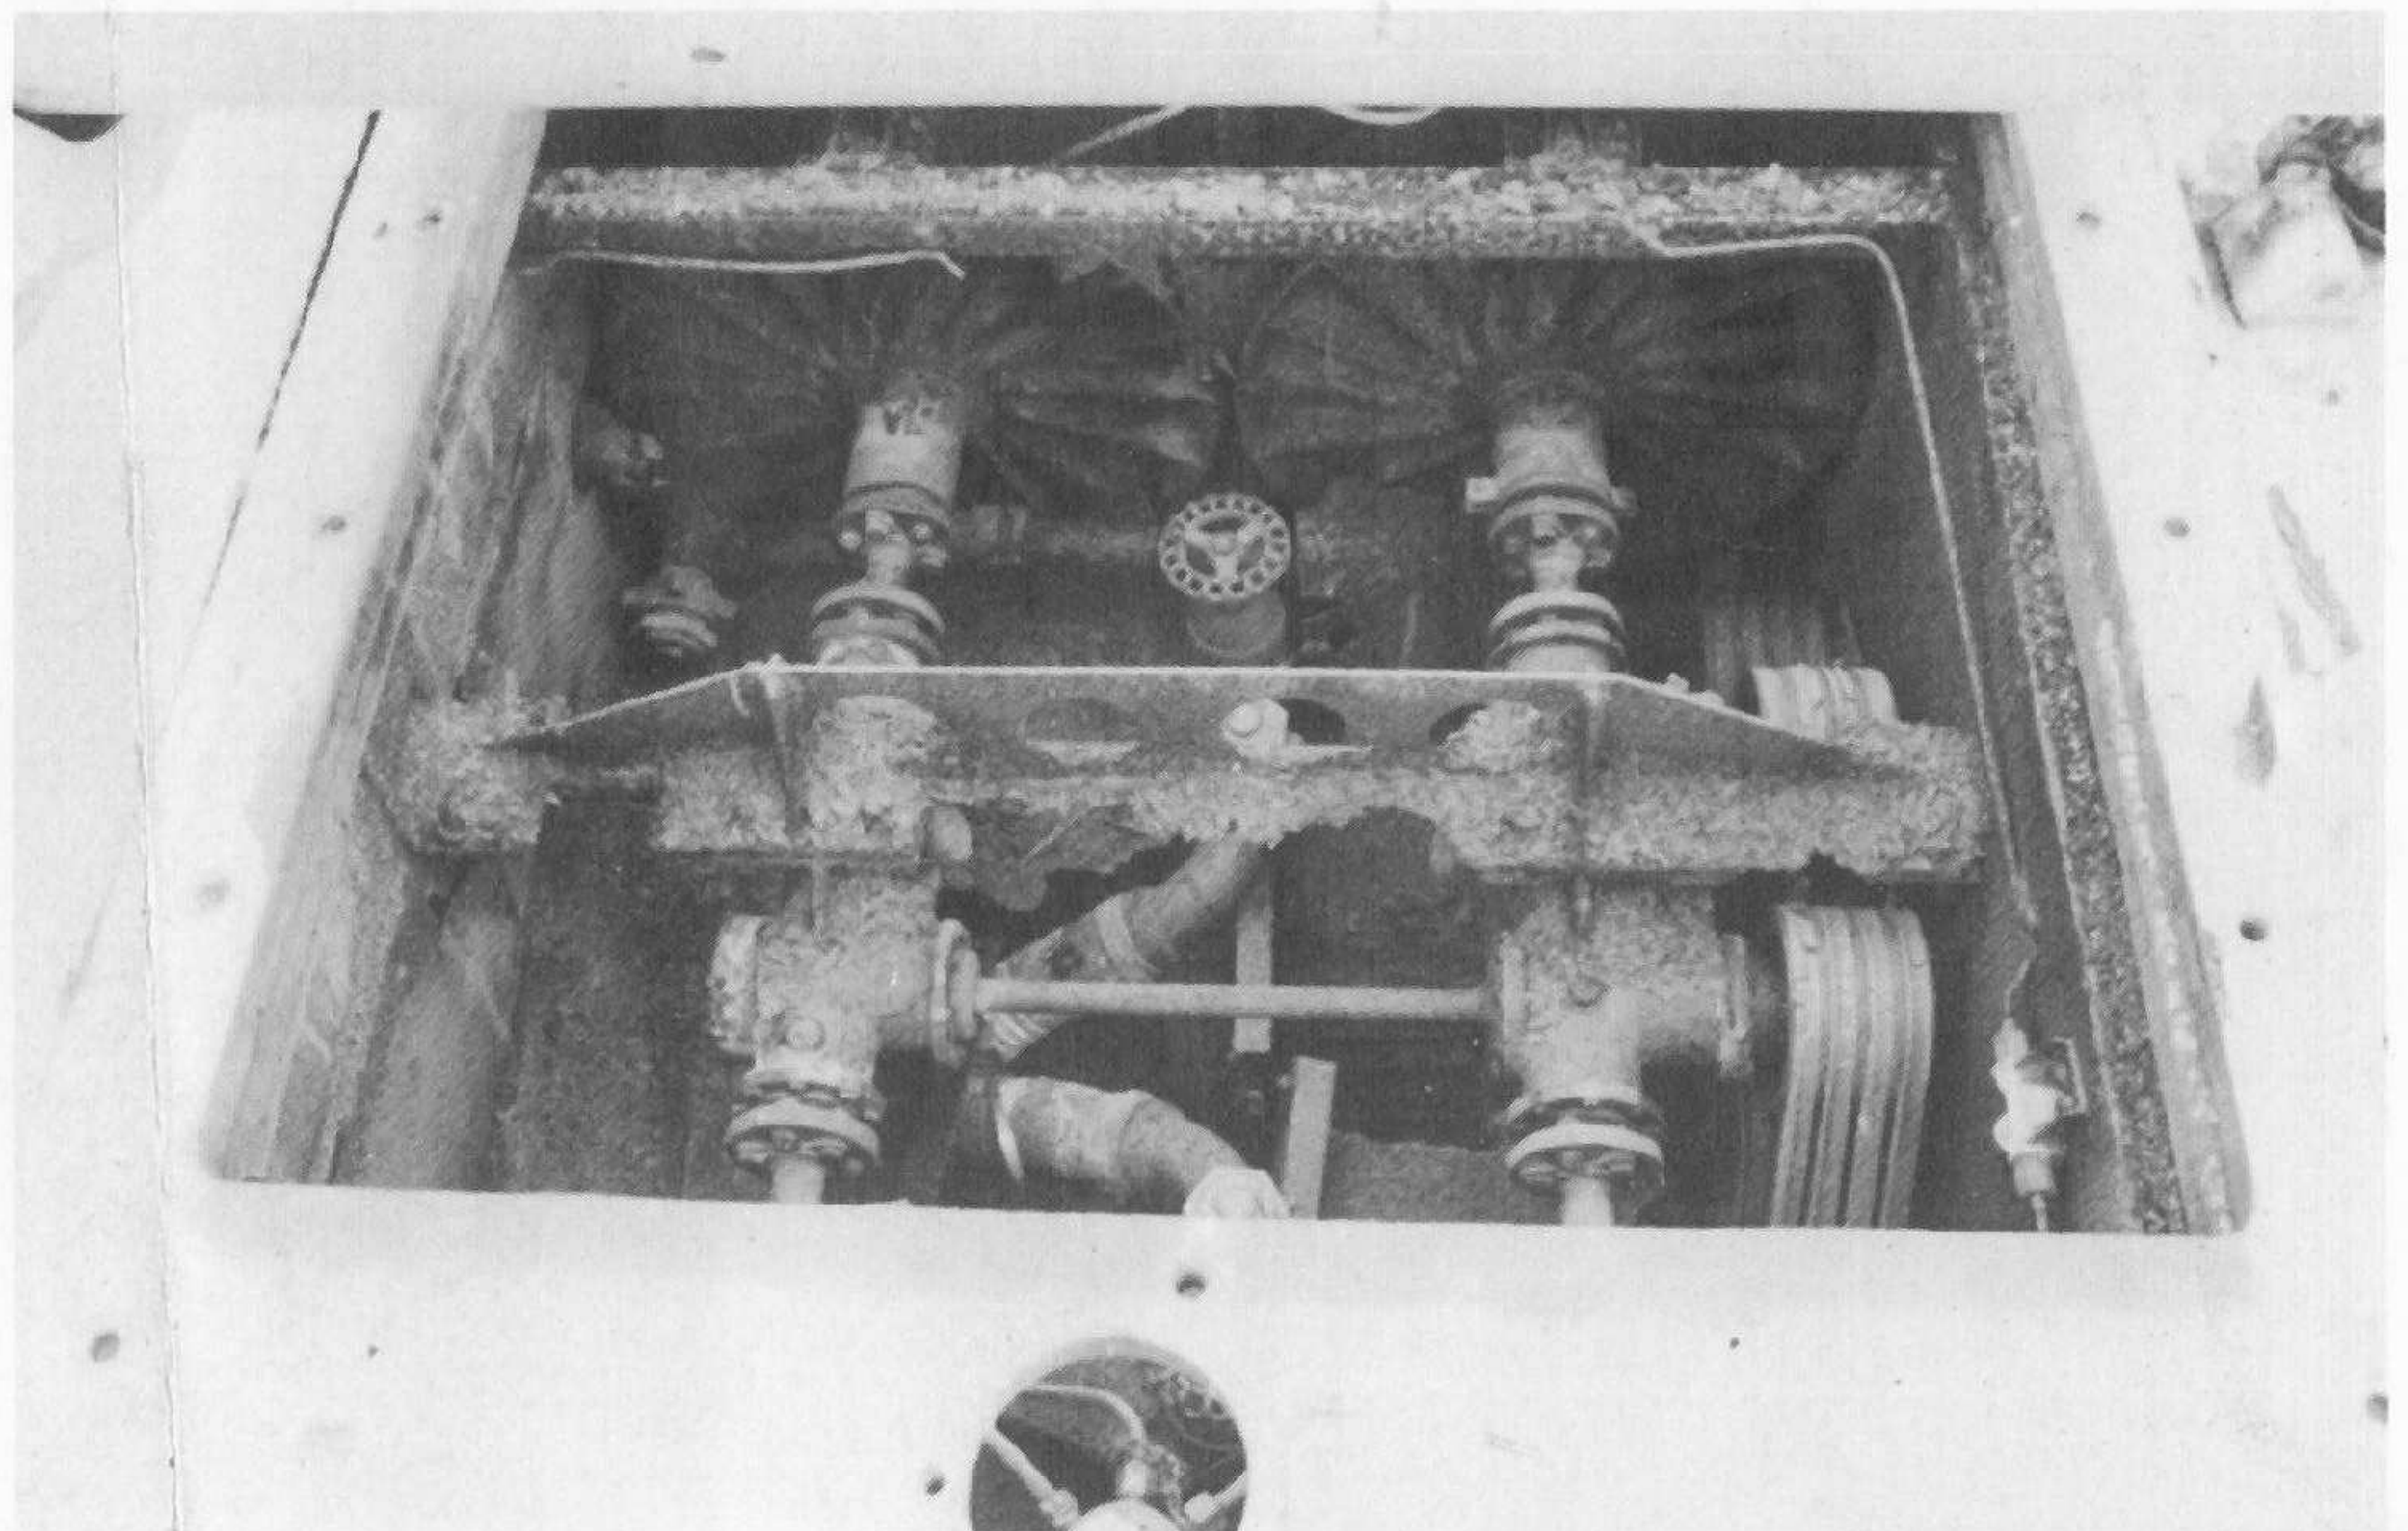
Basically the same photo as above except taken looking at the left side.
