MUSEUM ORDNANCE SPECIAL NUMBER 4

Elefant Panzerjäger Tiger (P)

Text by Thomas L. Jentz
Photos by Jeffrey D. McKaughan

THE "ELEFANT" AT ABERDEEN

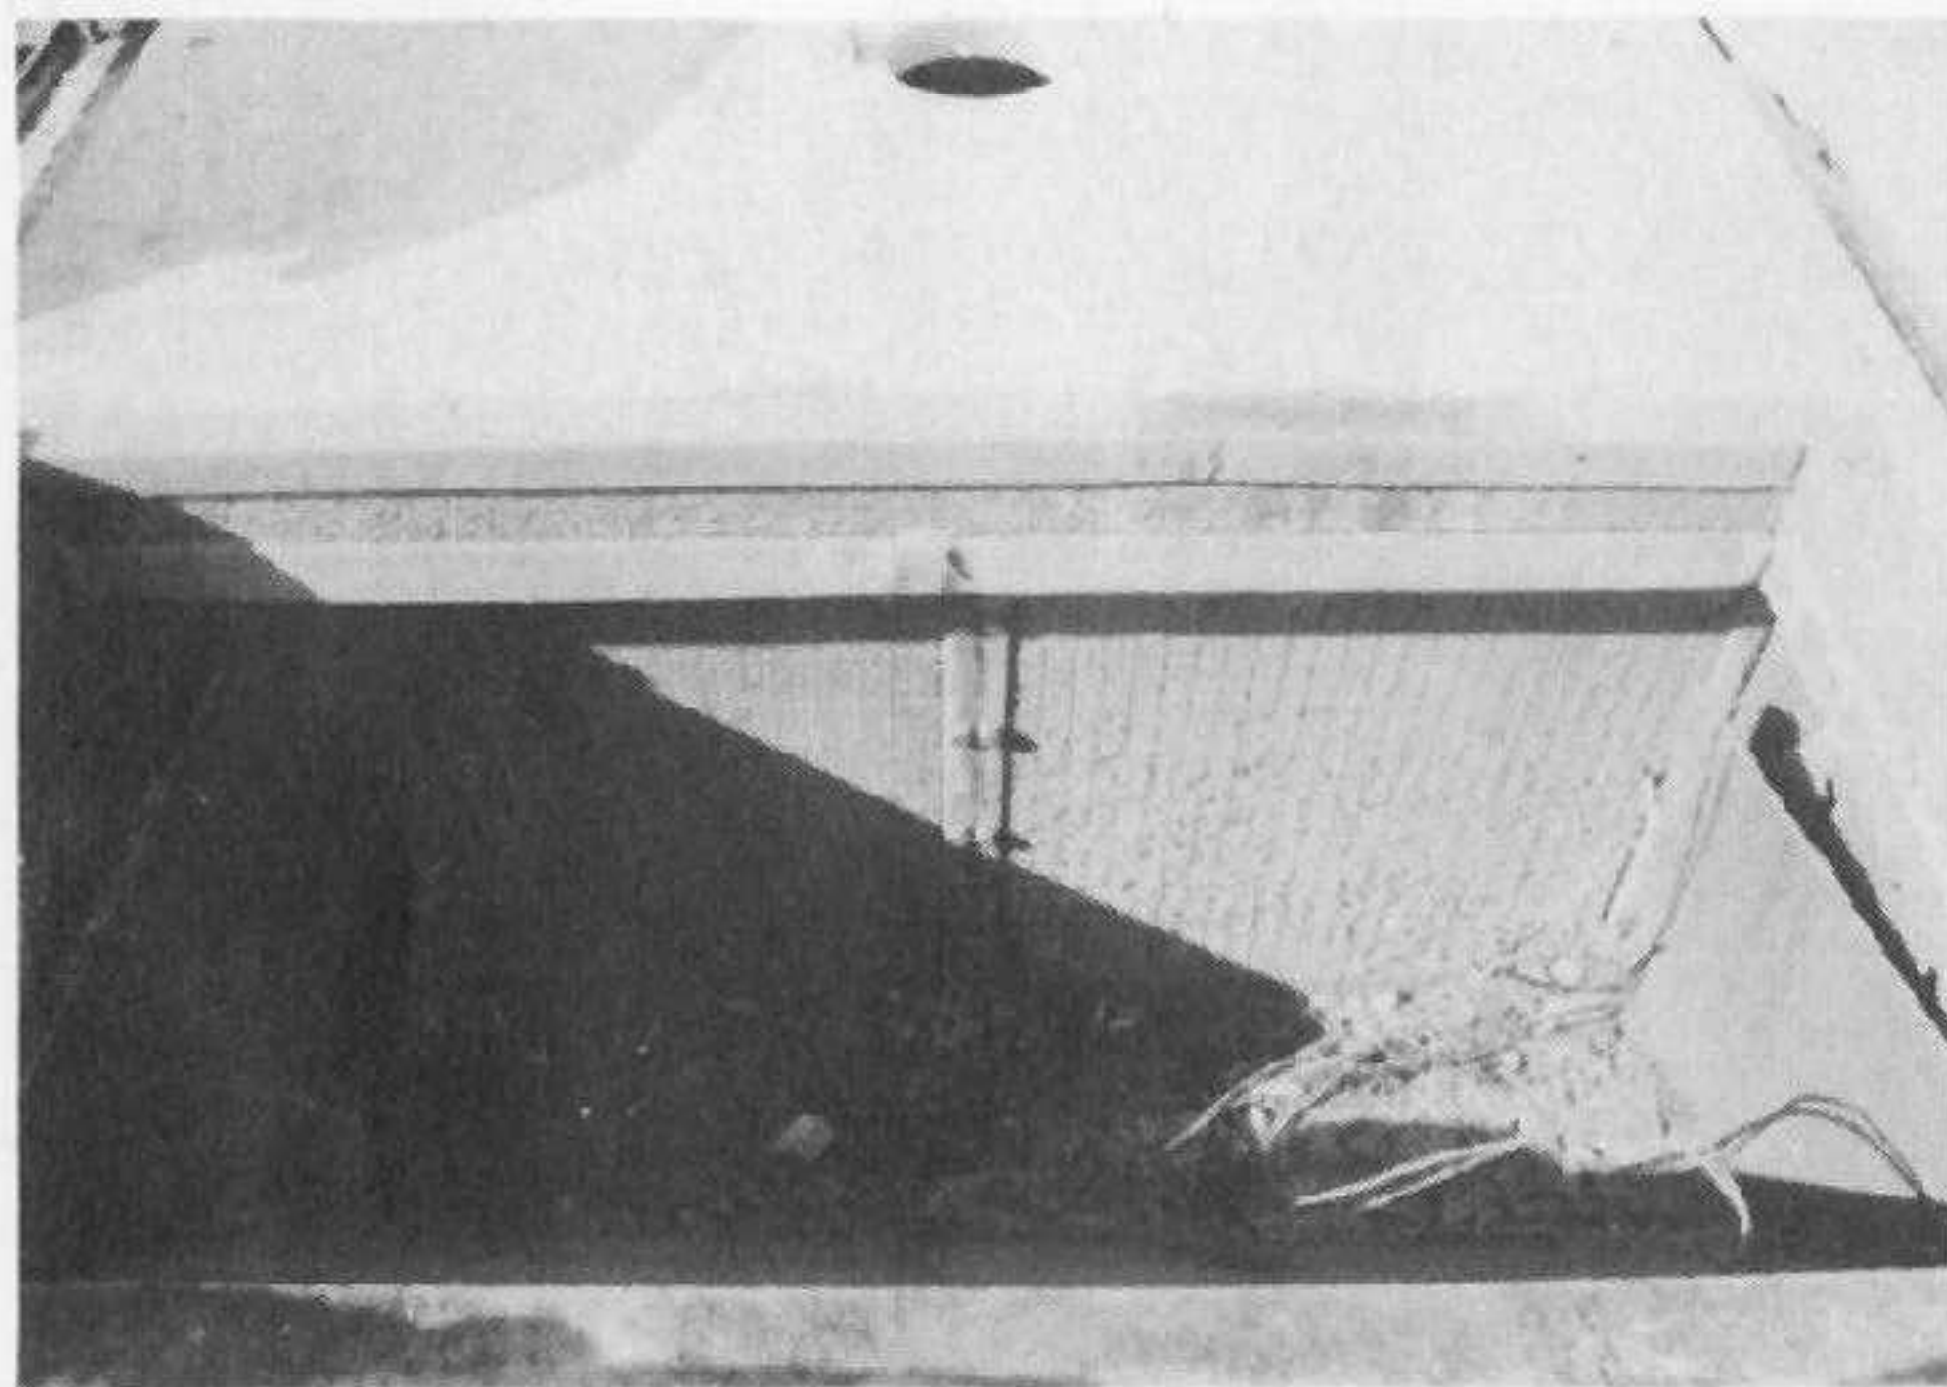
Although a poor photo, it illustrates the cooling fins of the radiator and the division in the middle.

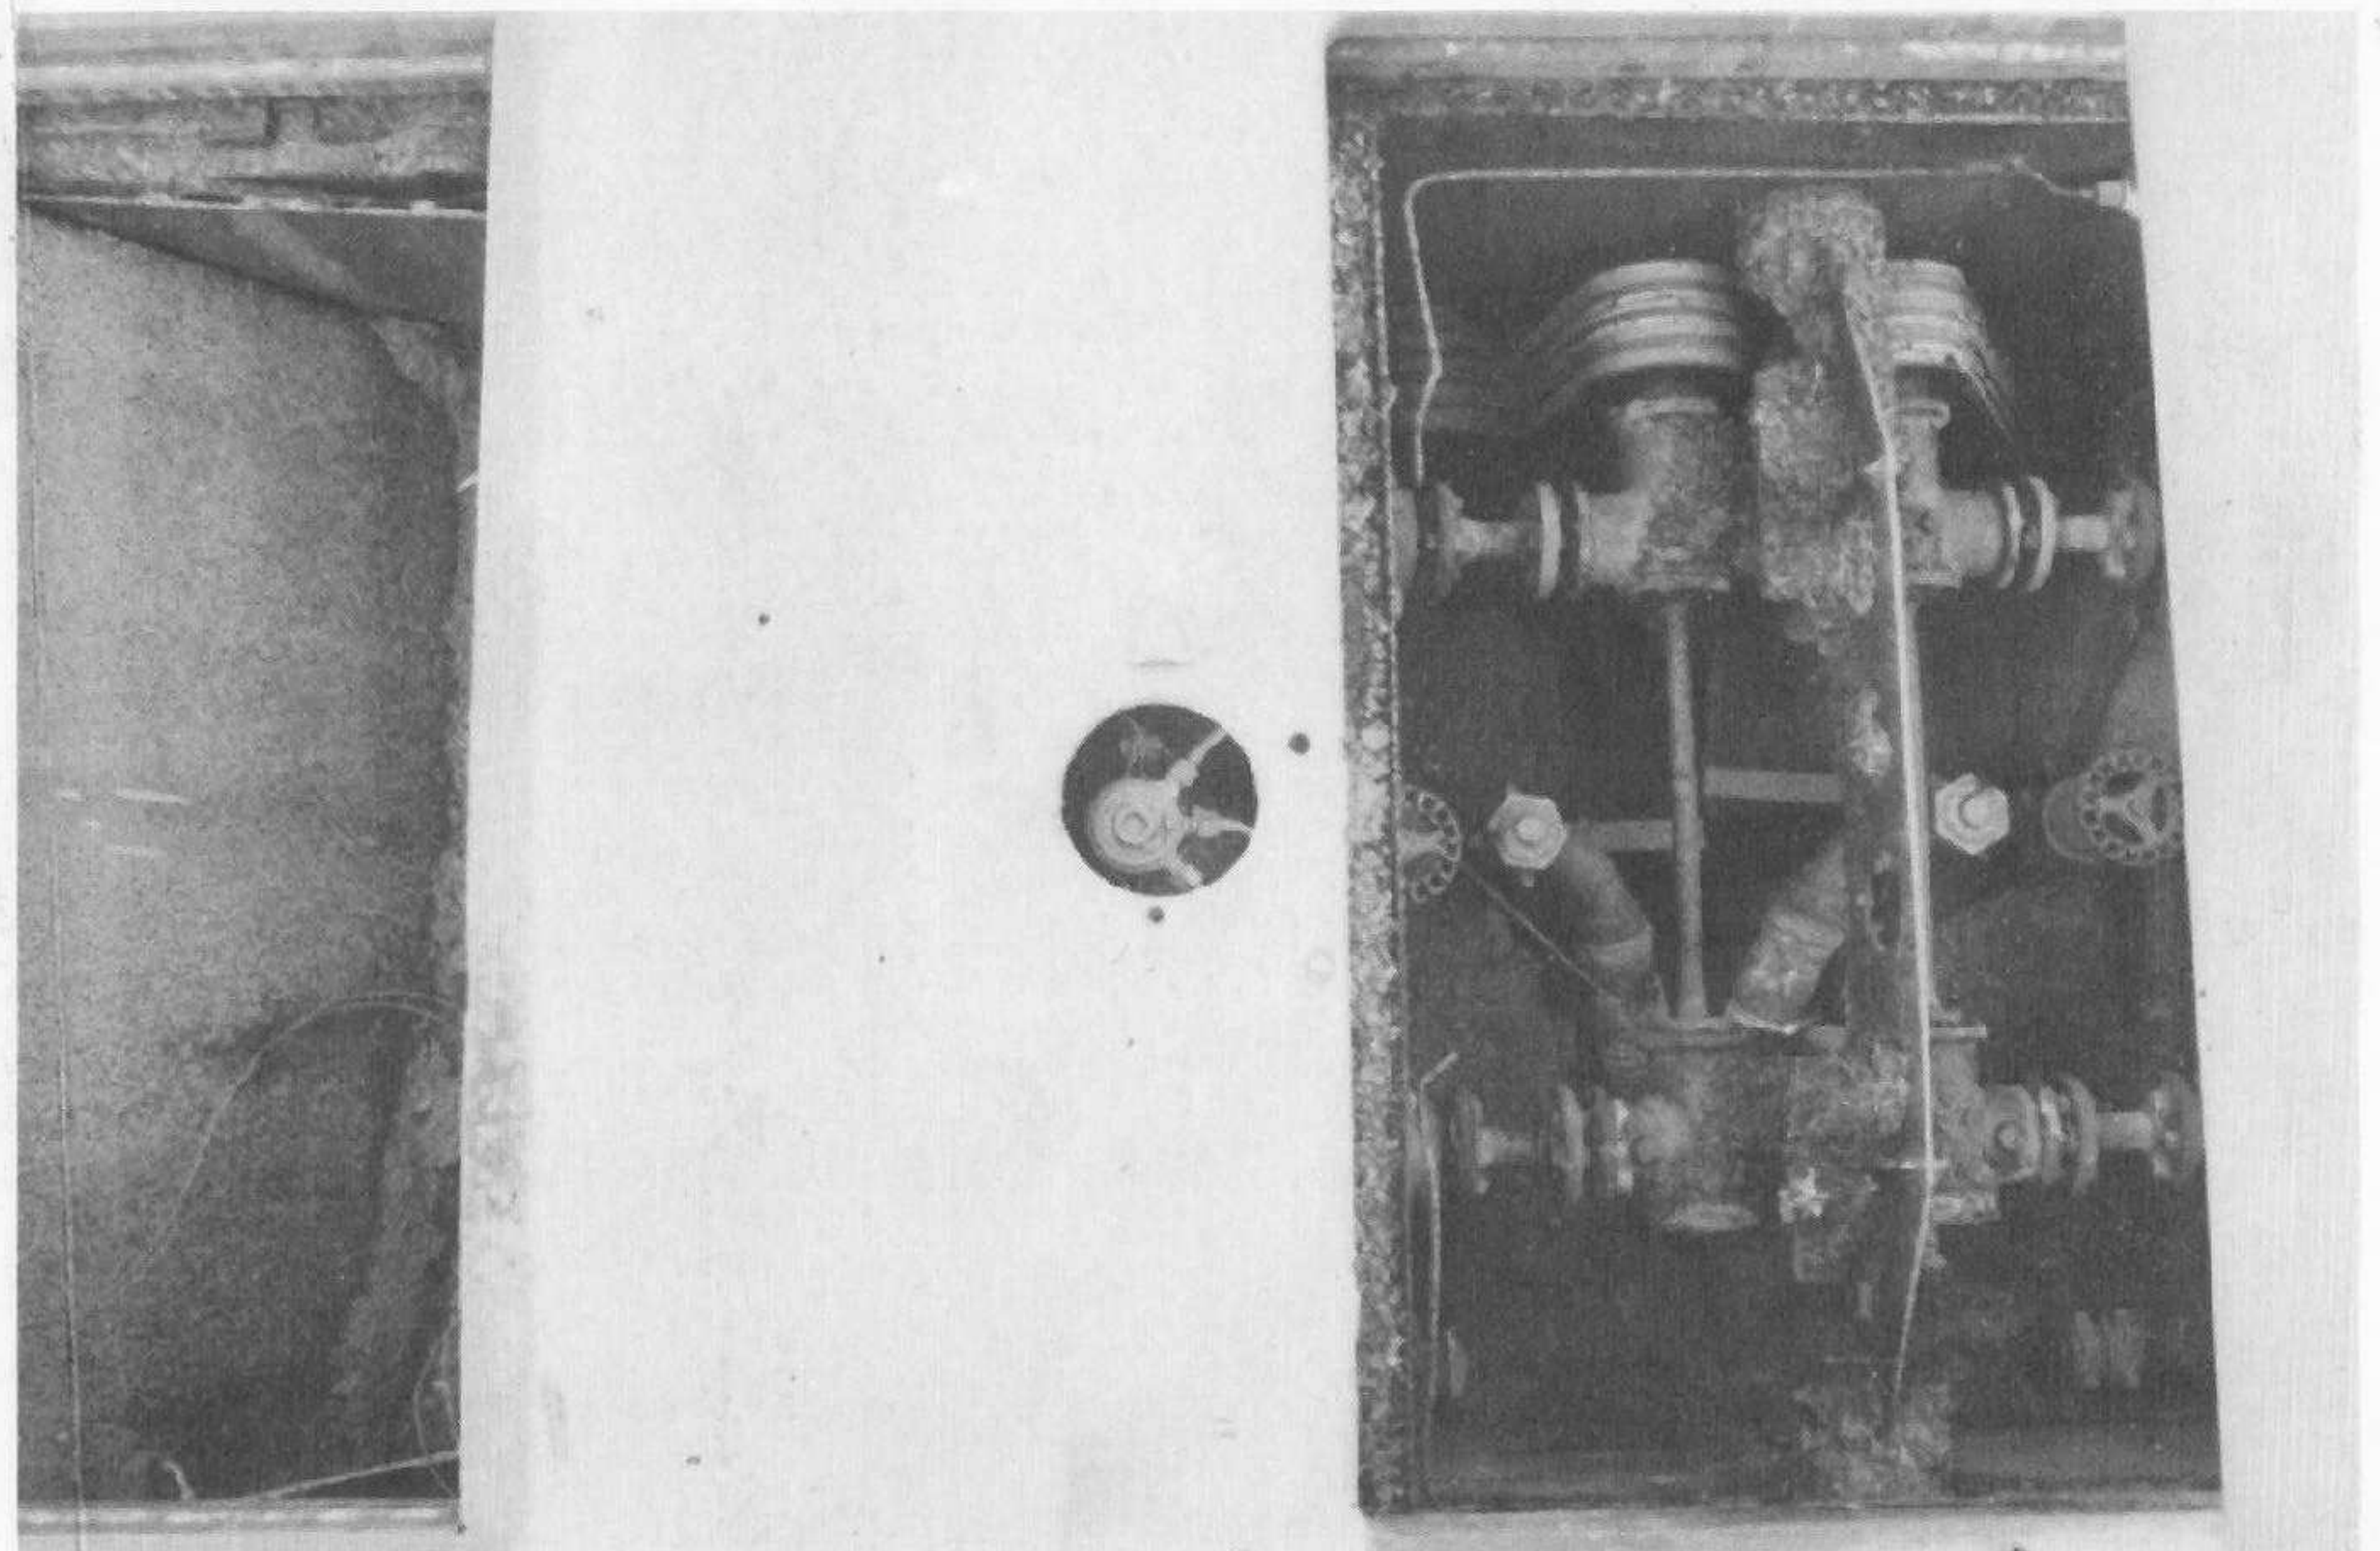
Viewing straight down, the layout in this compartment is basically a mirror image on both sides. The same circular opening is for some type of valve, which is identical to one on the opposite side. To the left in the photo is the opening left by the removal of the grill work over the radiator exhaust.

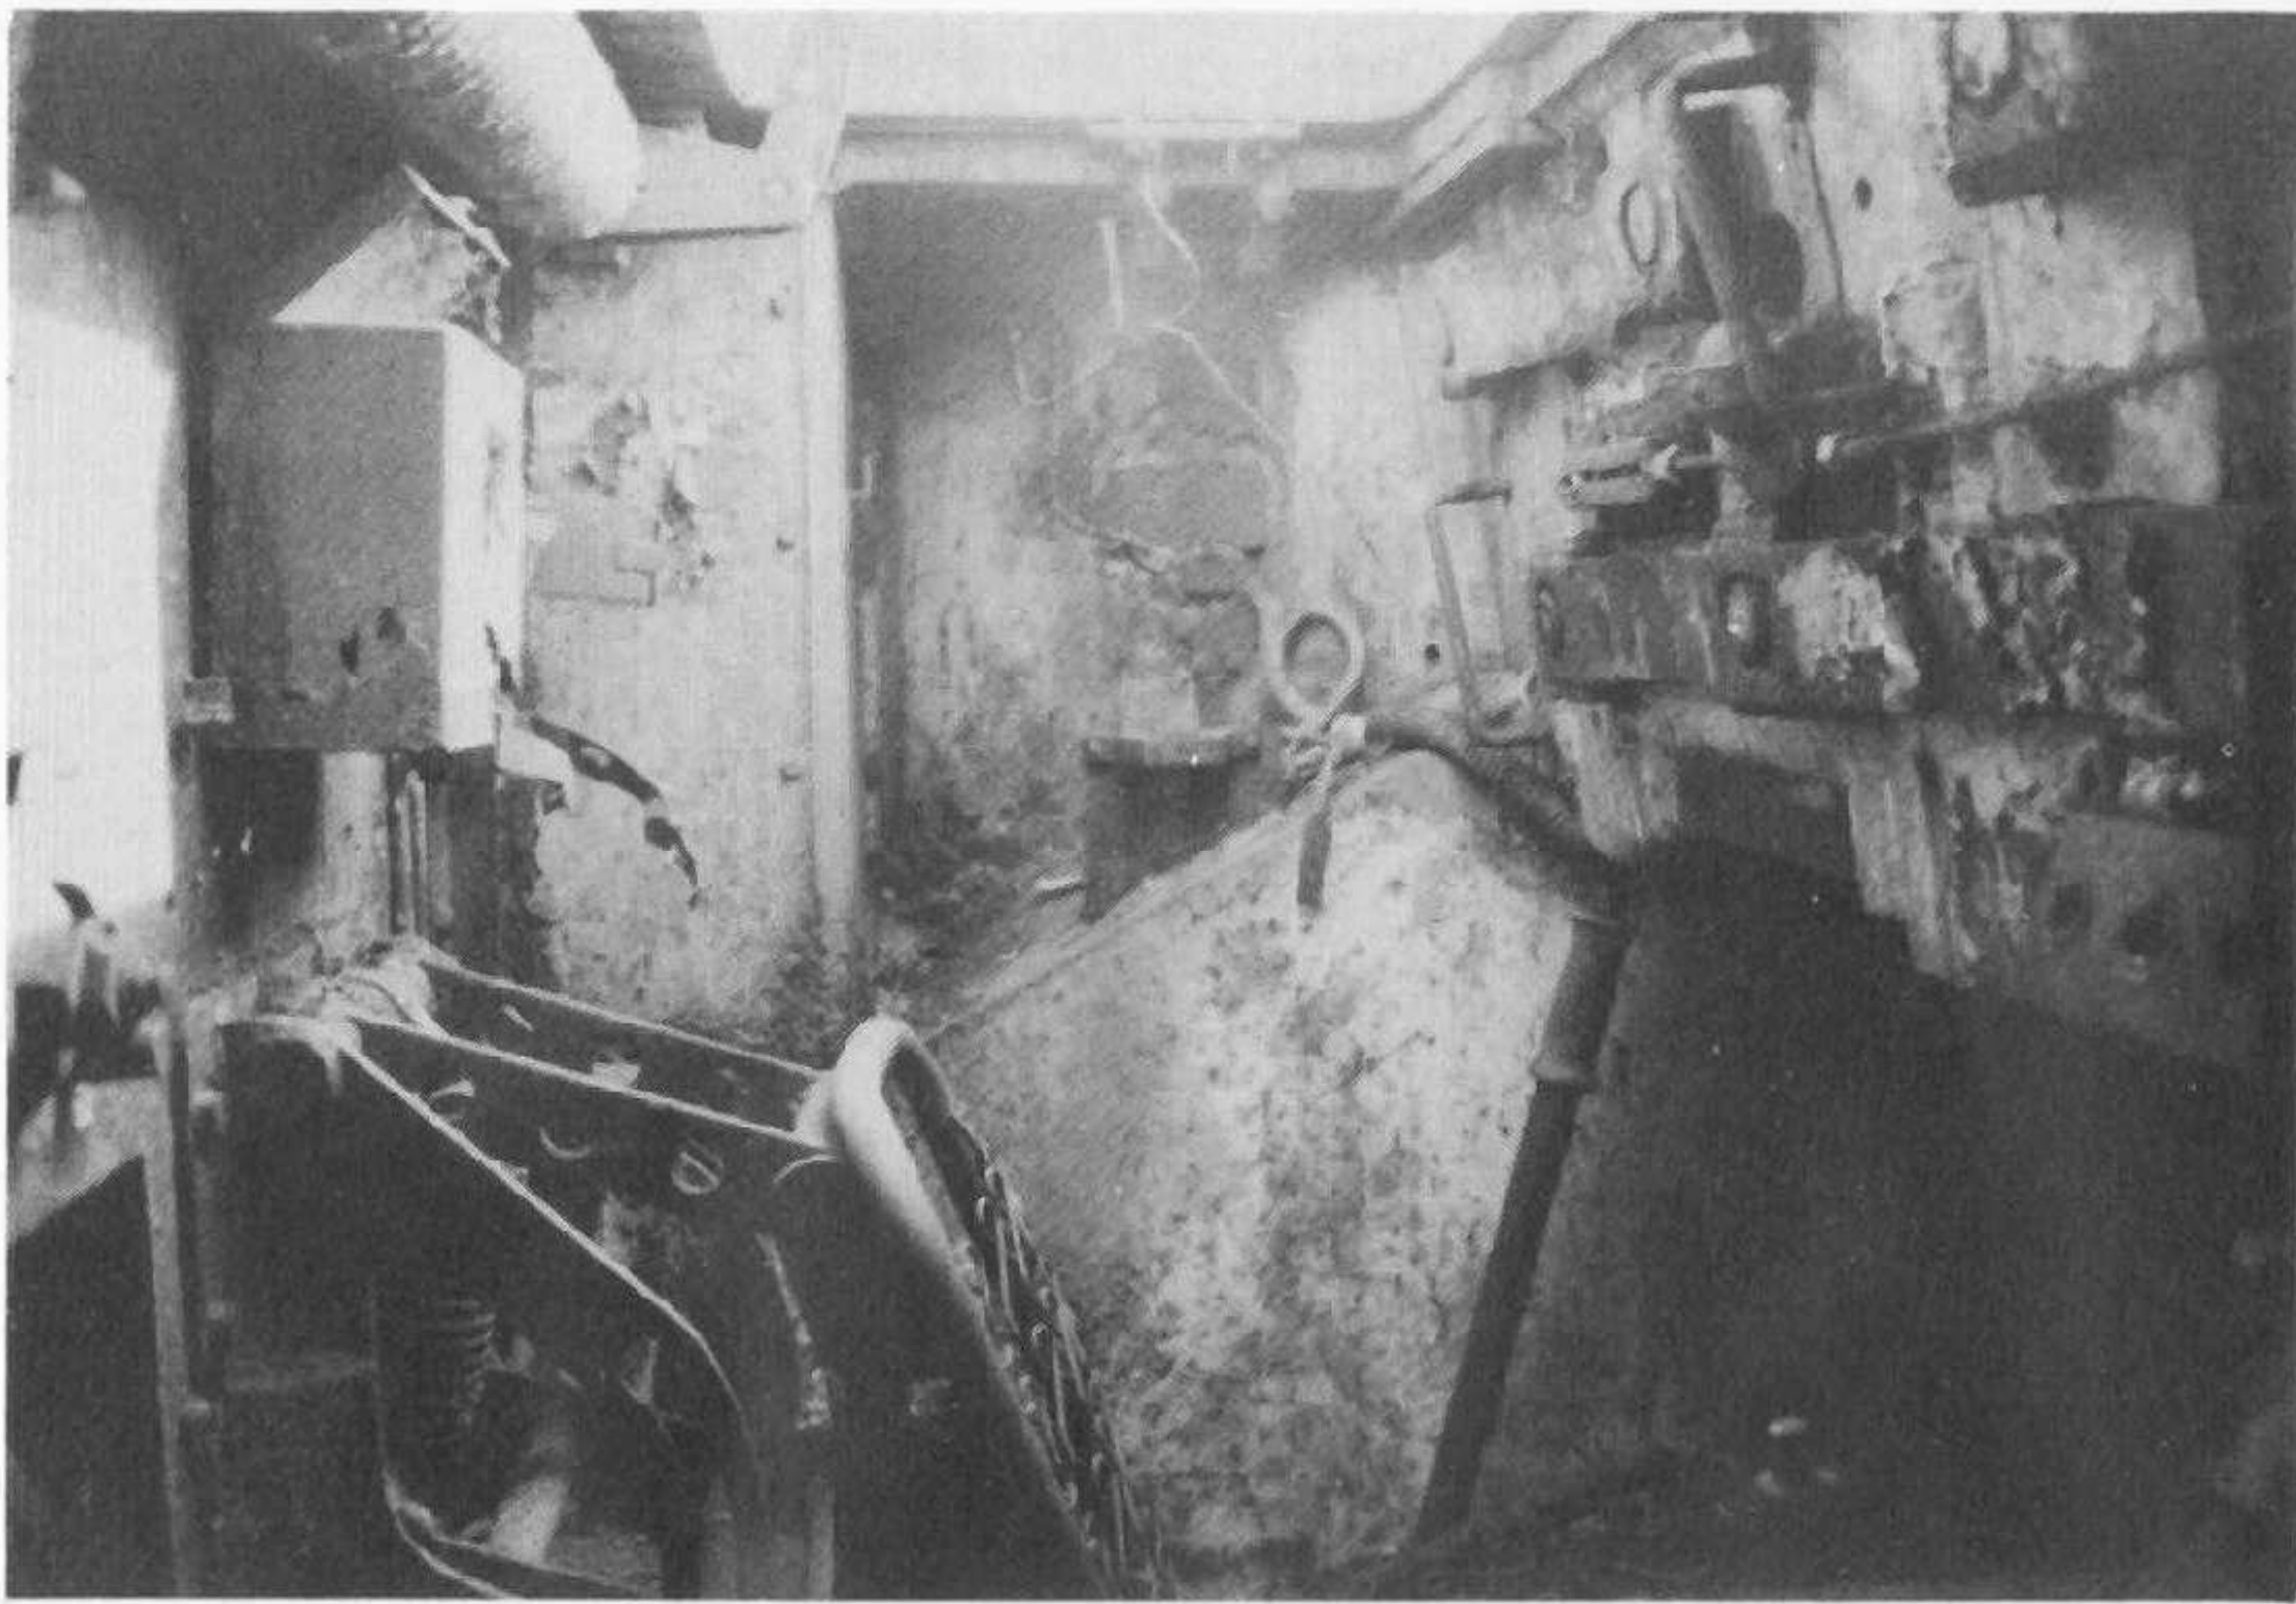
From the bow gunner's position and looking across at the driver's station. Despite the rust you can still see the white color used on the interior.

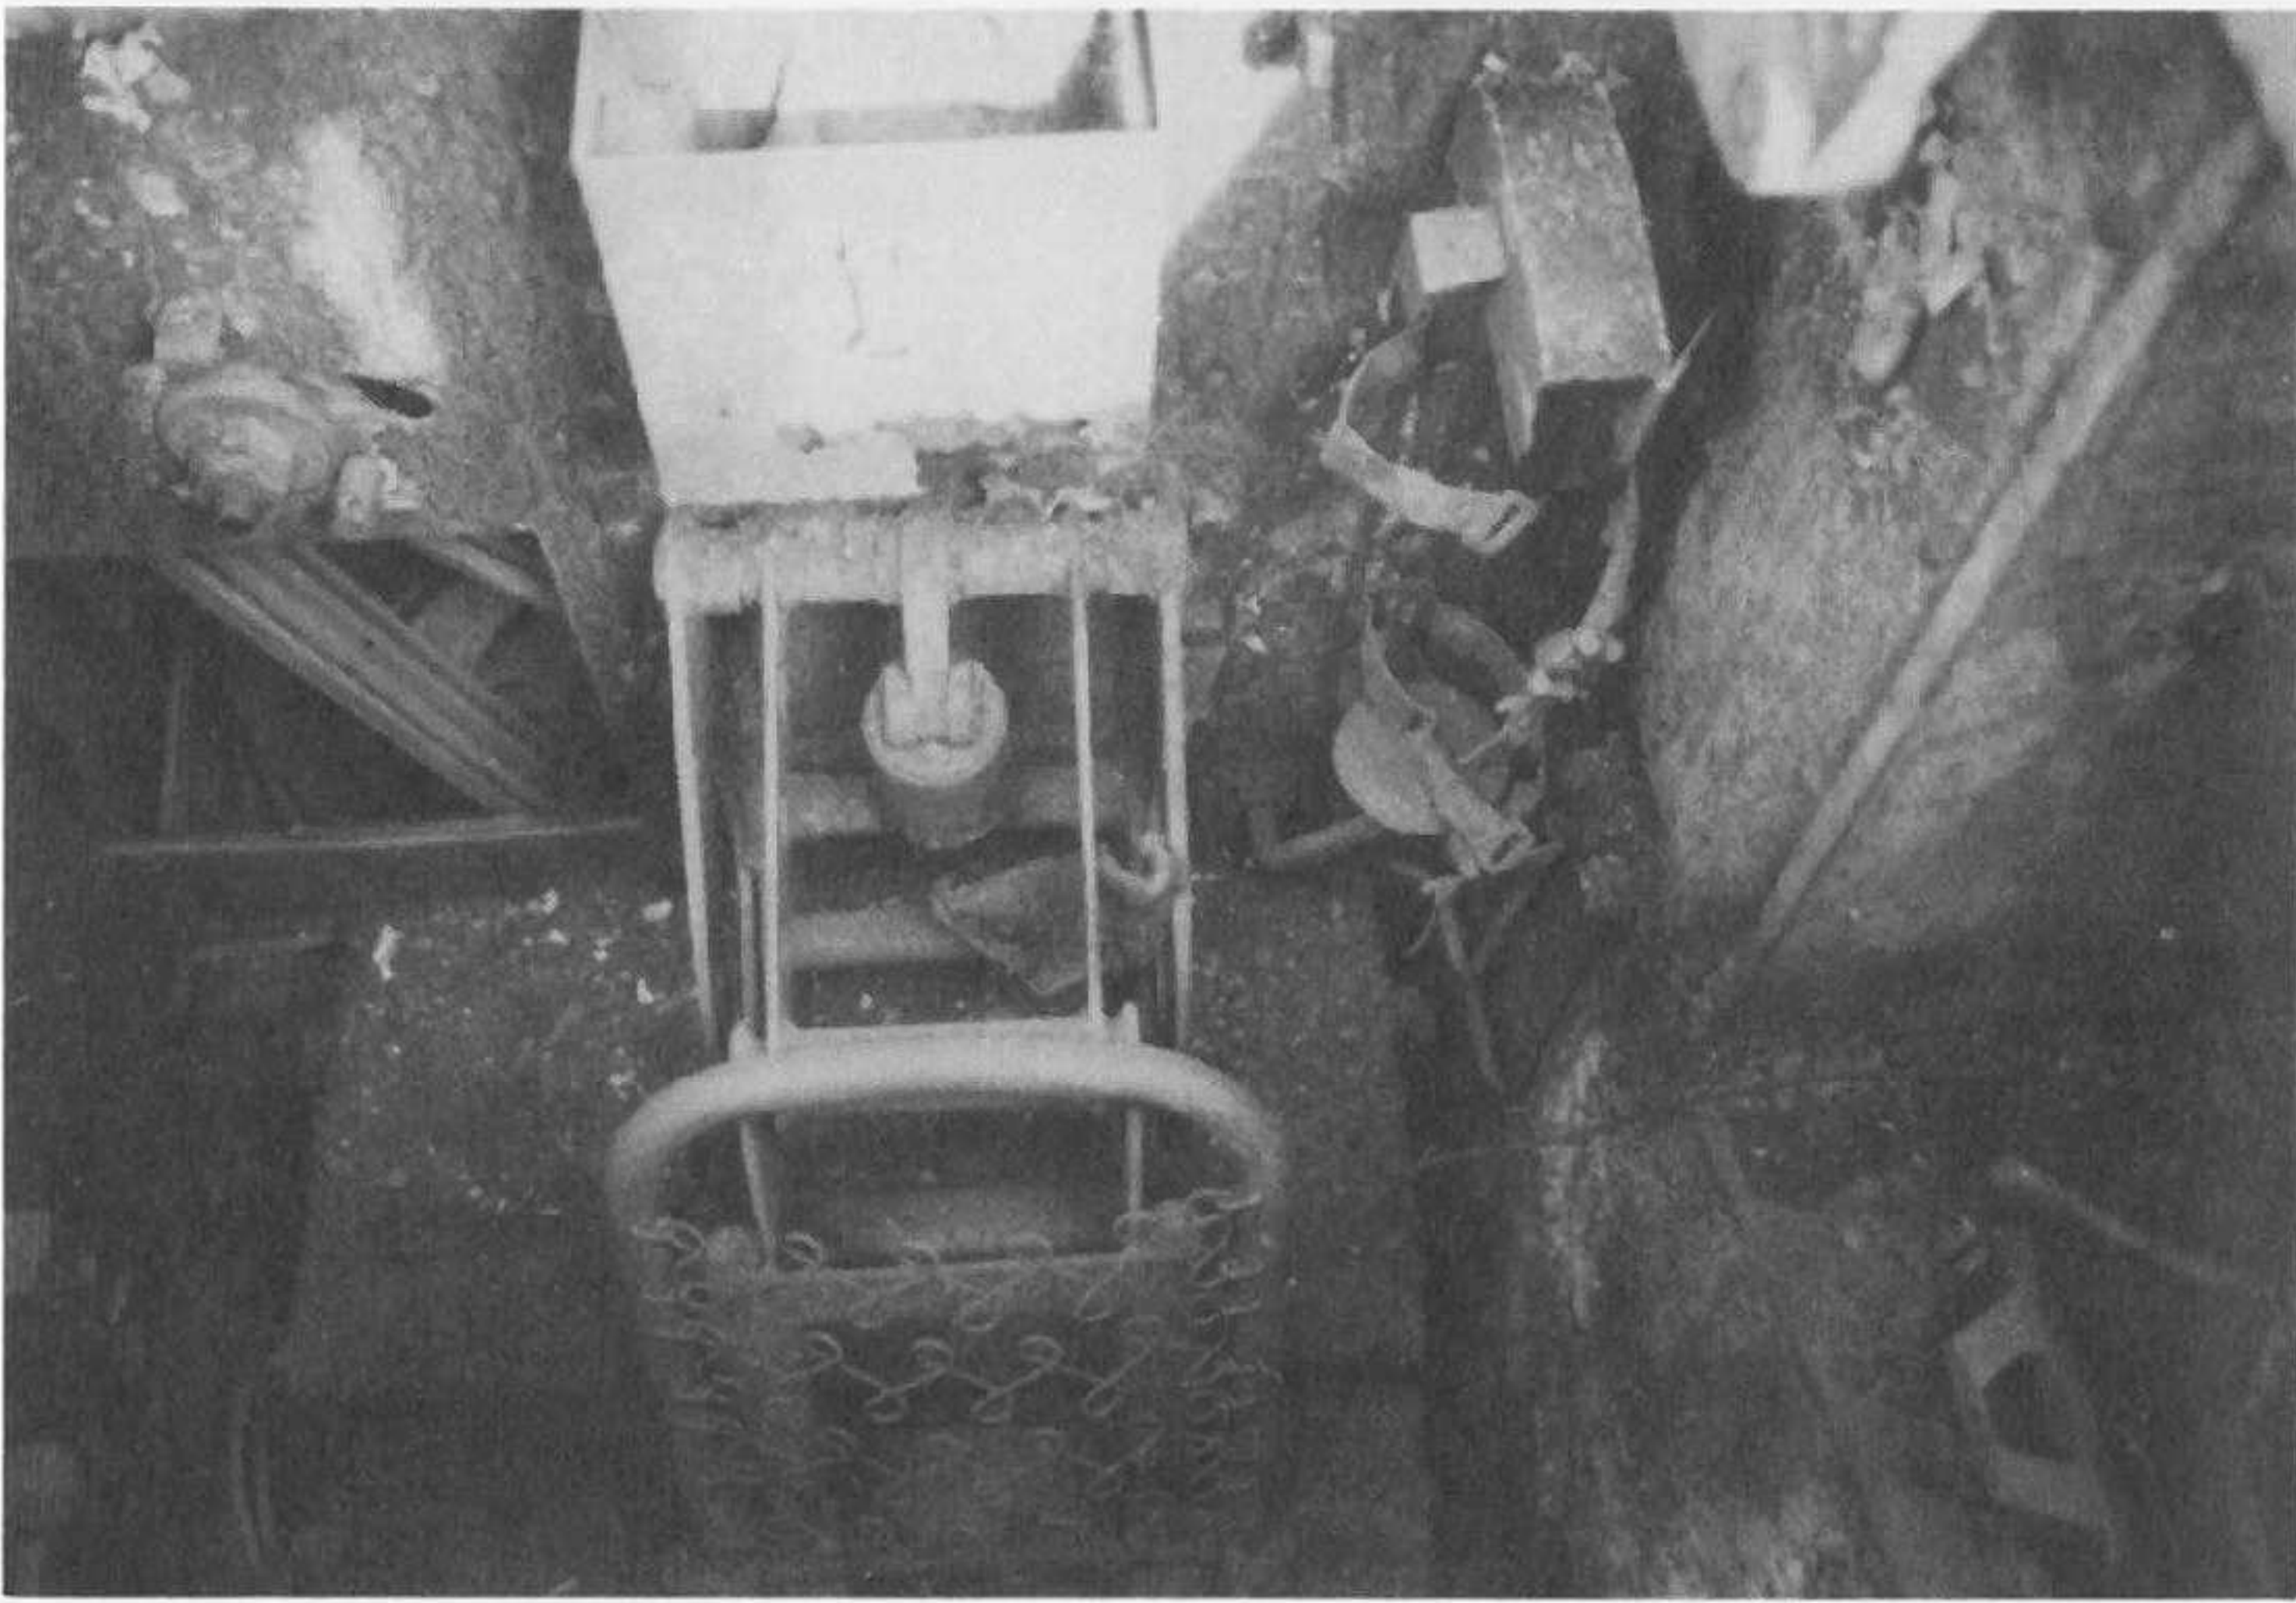
From the top of the driver's hatch and looking down at his seat. What appears to be a fire extinguisher rack is to the right of the seat in this photo.

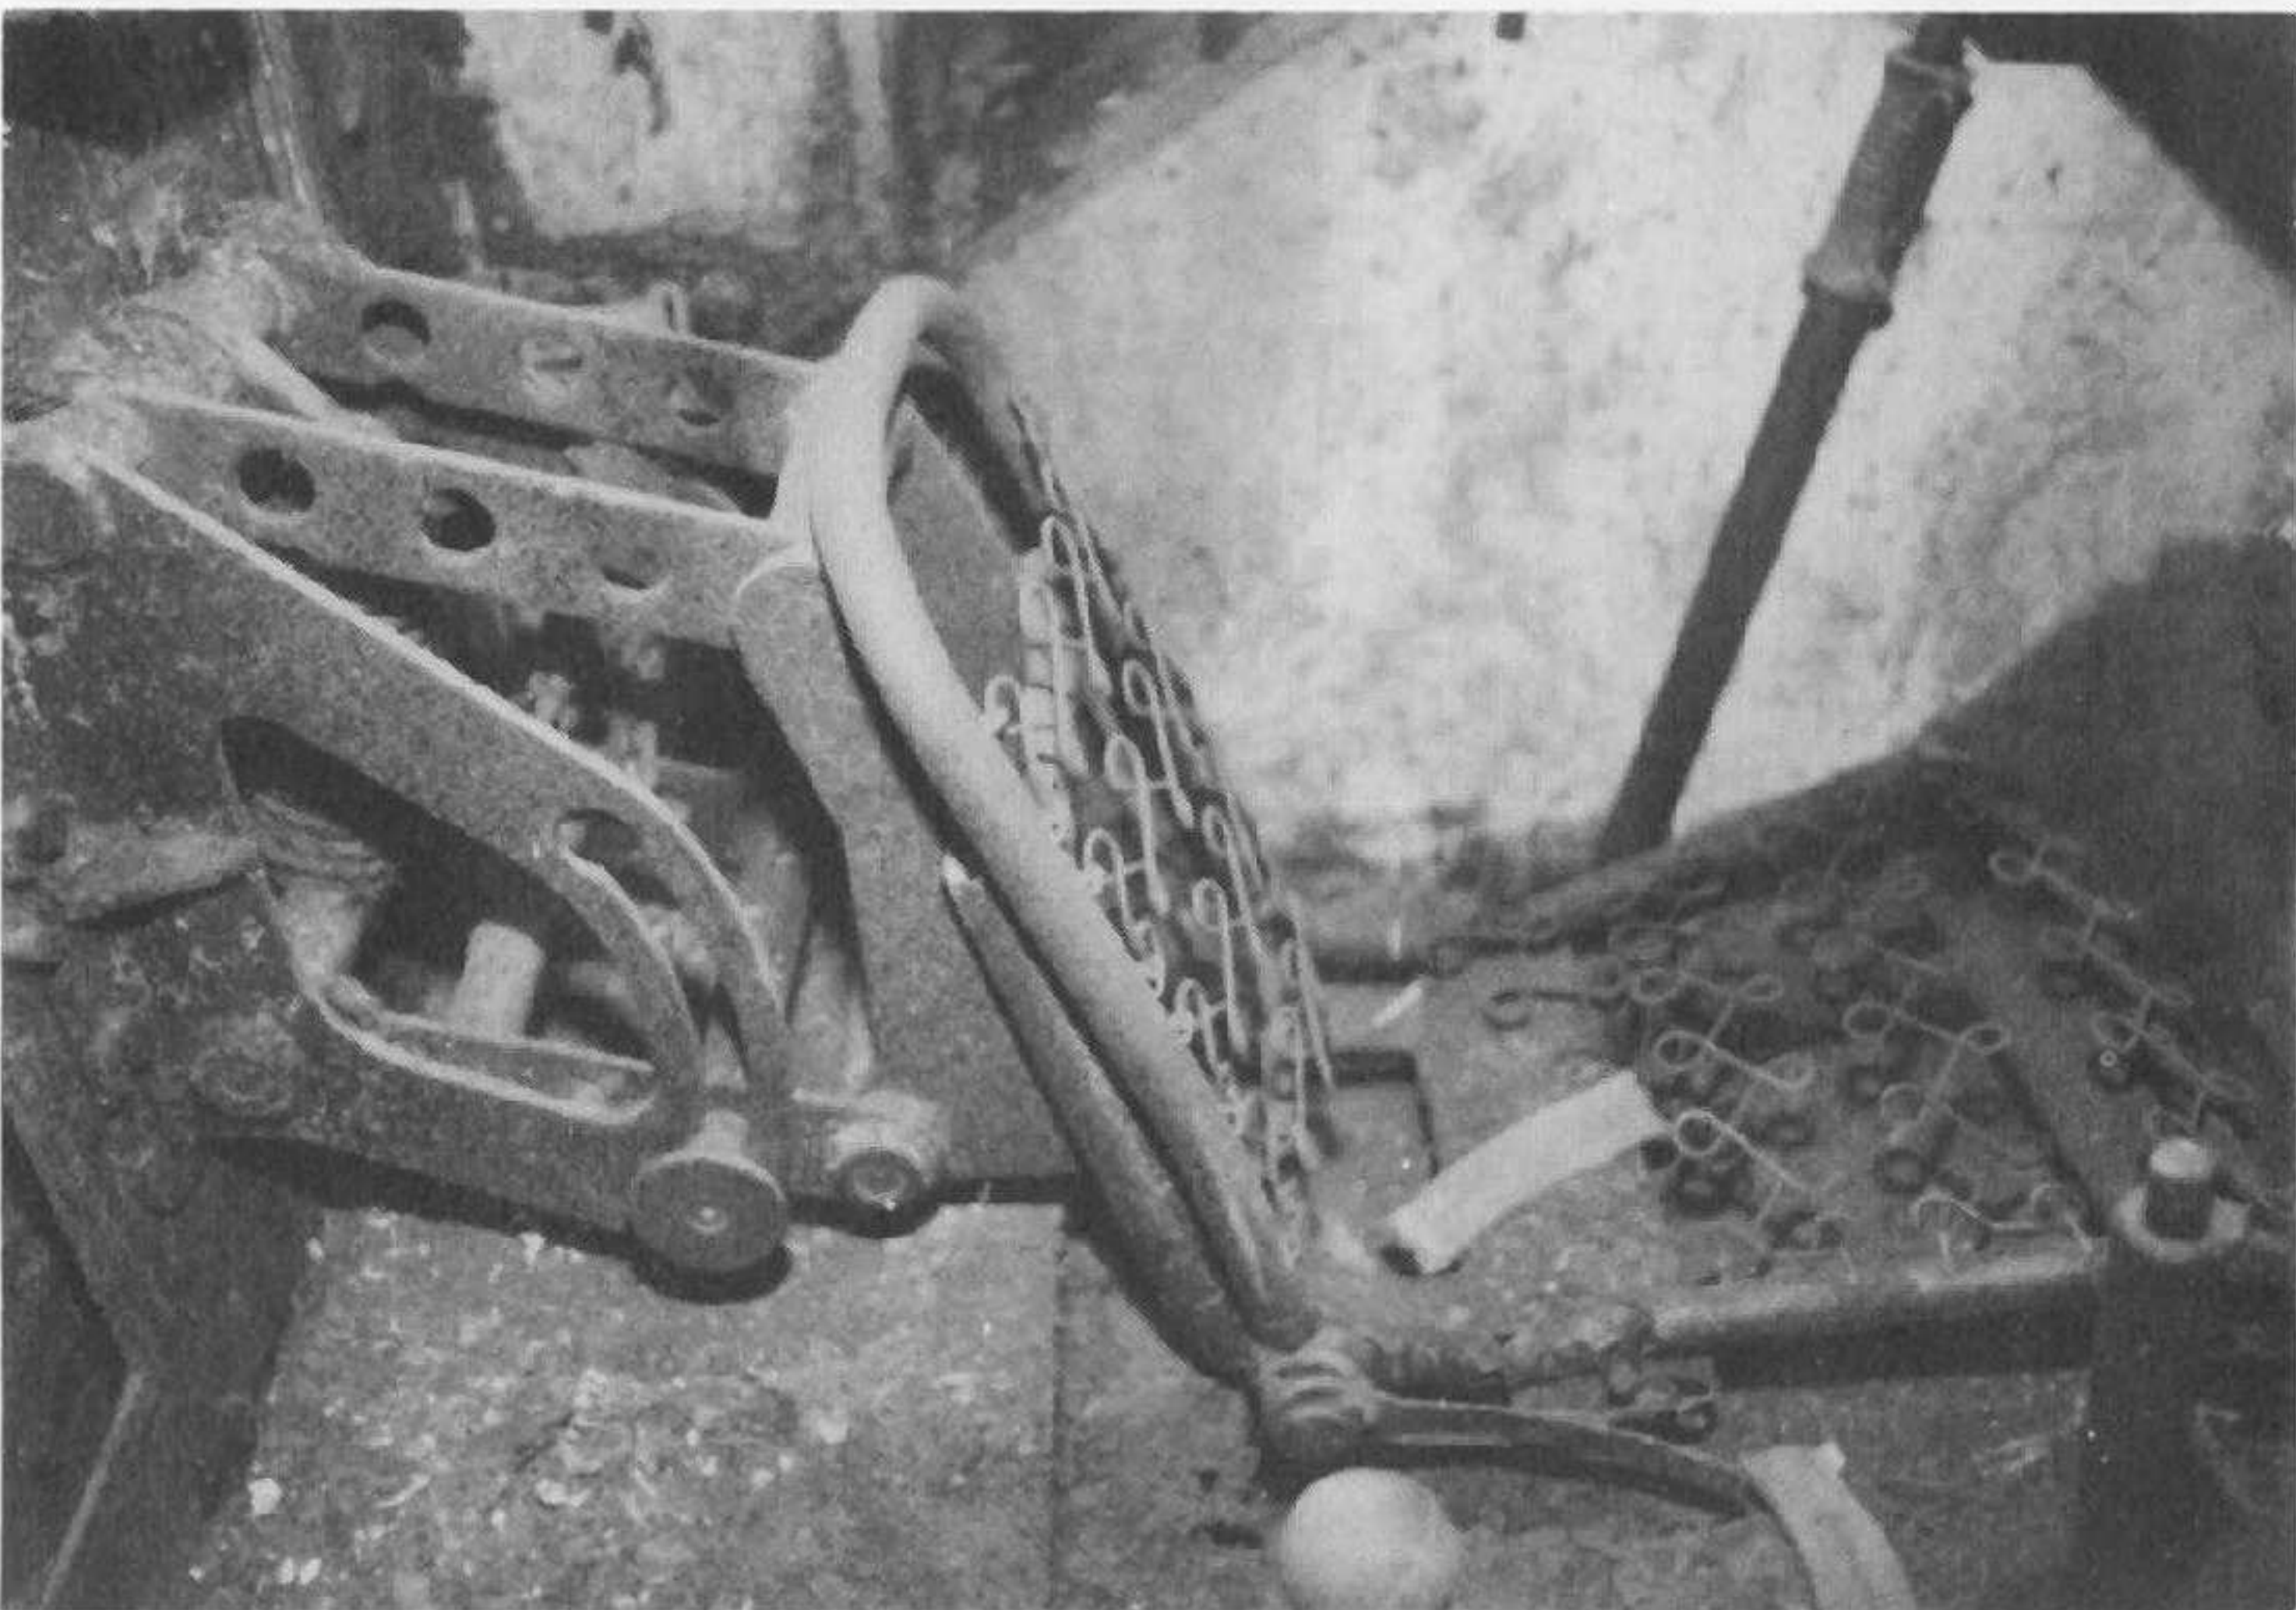
A close look at the operating mechanisms for raising and lowering the crew seat. Although the bow machine gunner's seat is missing I would assume that they would be similar.

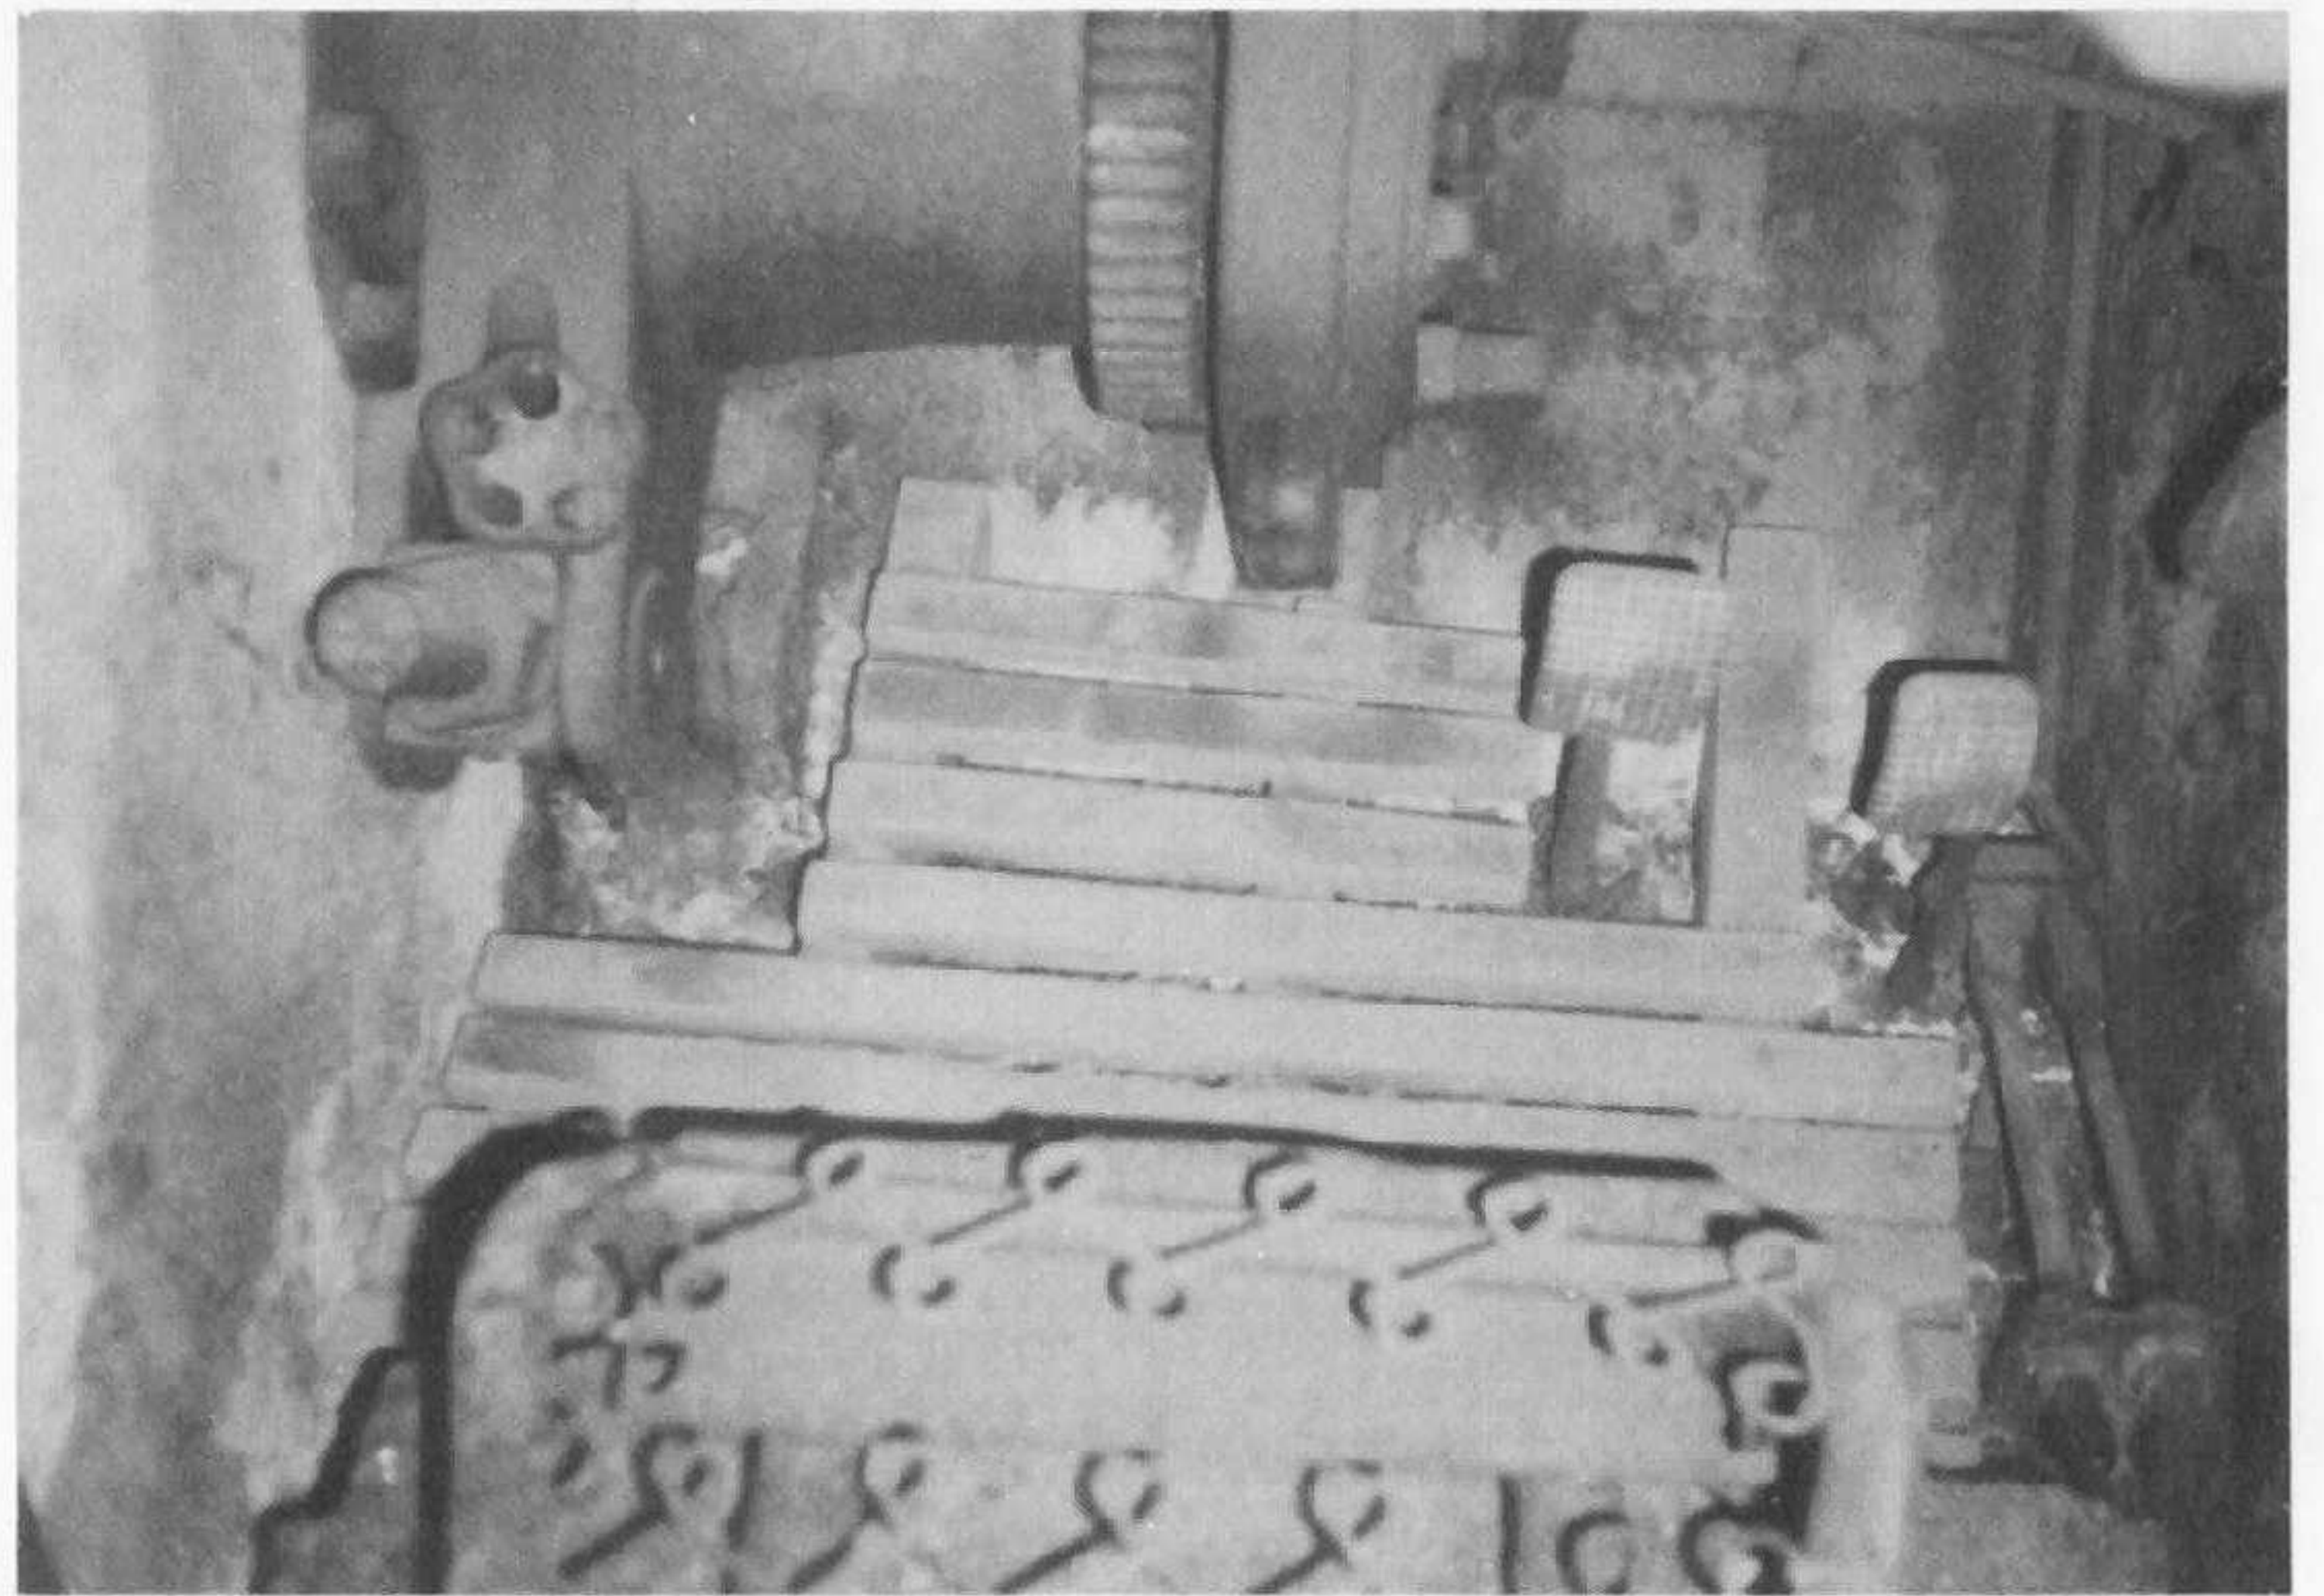
The wooden slats at the driver's feet are still in very good condition.
