MUSEUM ORDNANCE SPECIAL NUMBER 4

Elefant Panzerjäger Tiger (P)

Text by Thomas L. Jentz
Photos by Jeffrey D. McKaughan

THE "ELEFANT" AT ABERDEEN

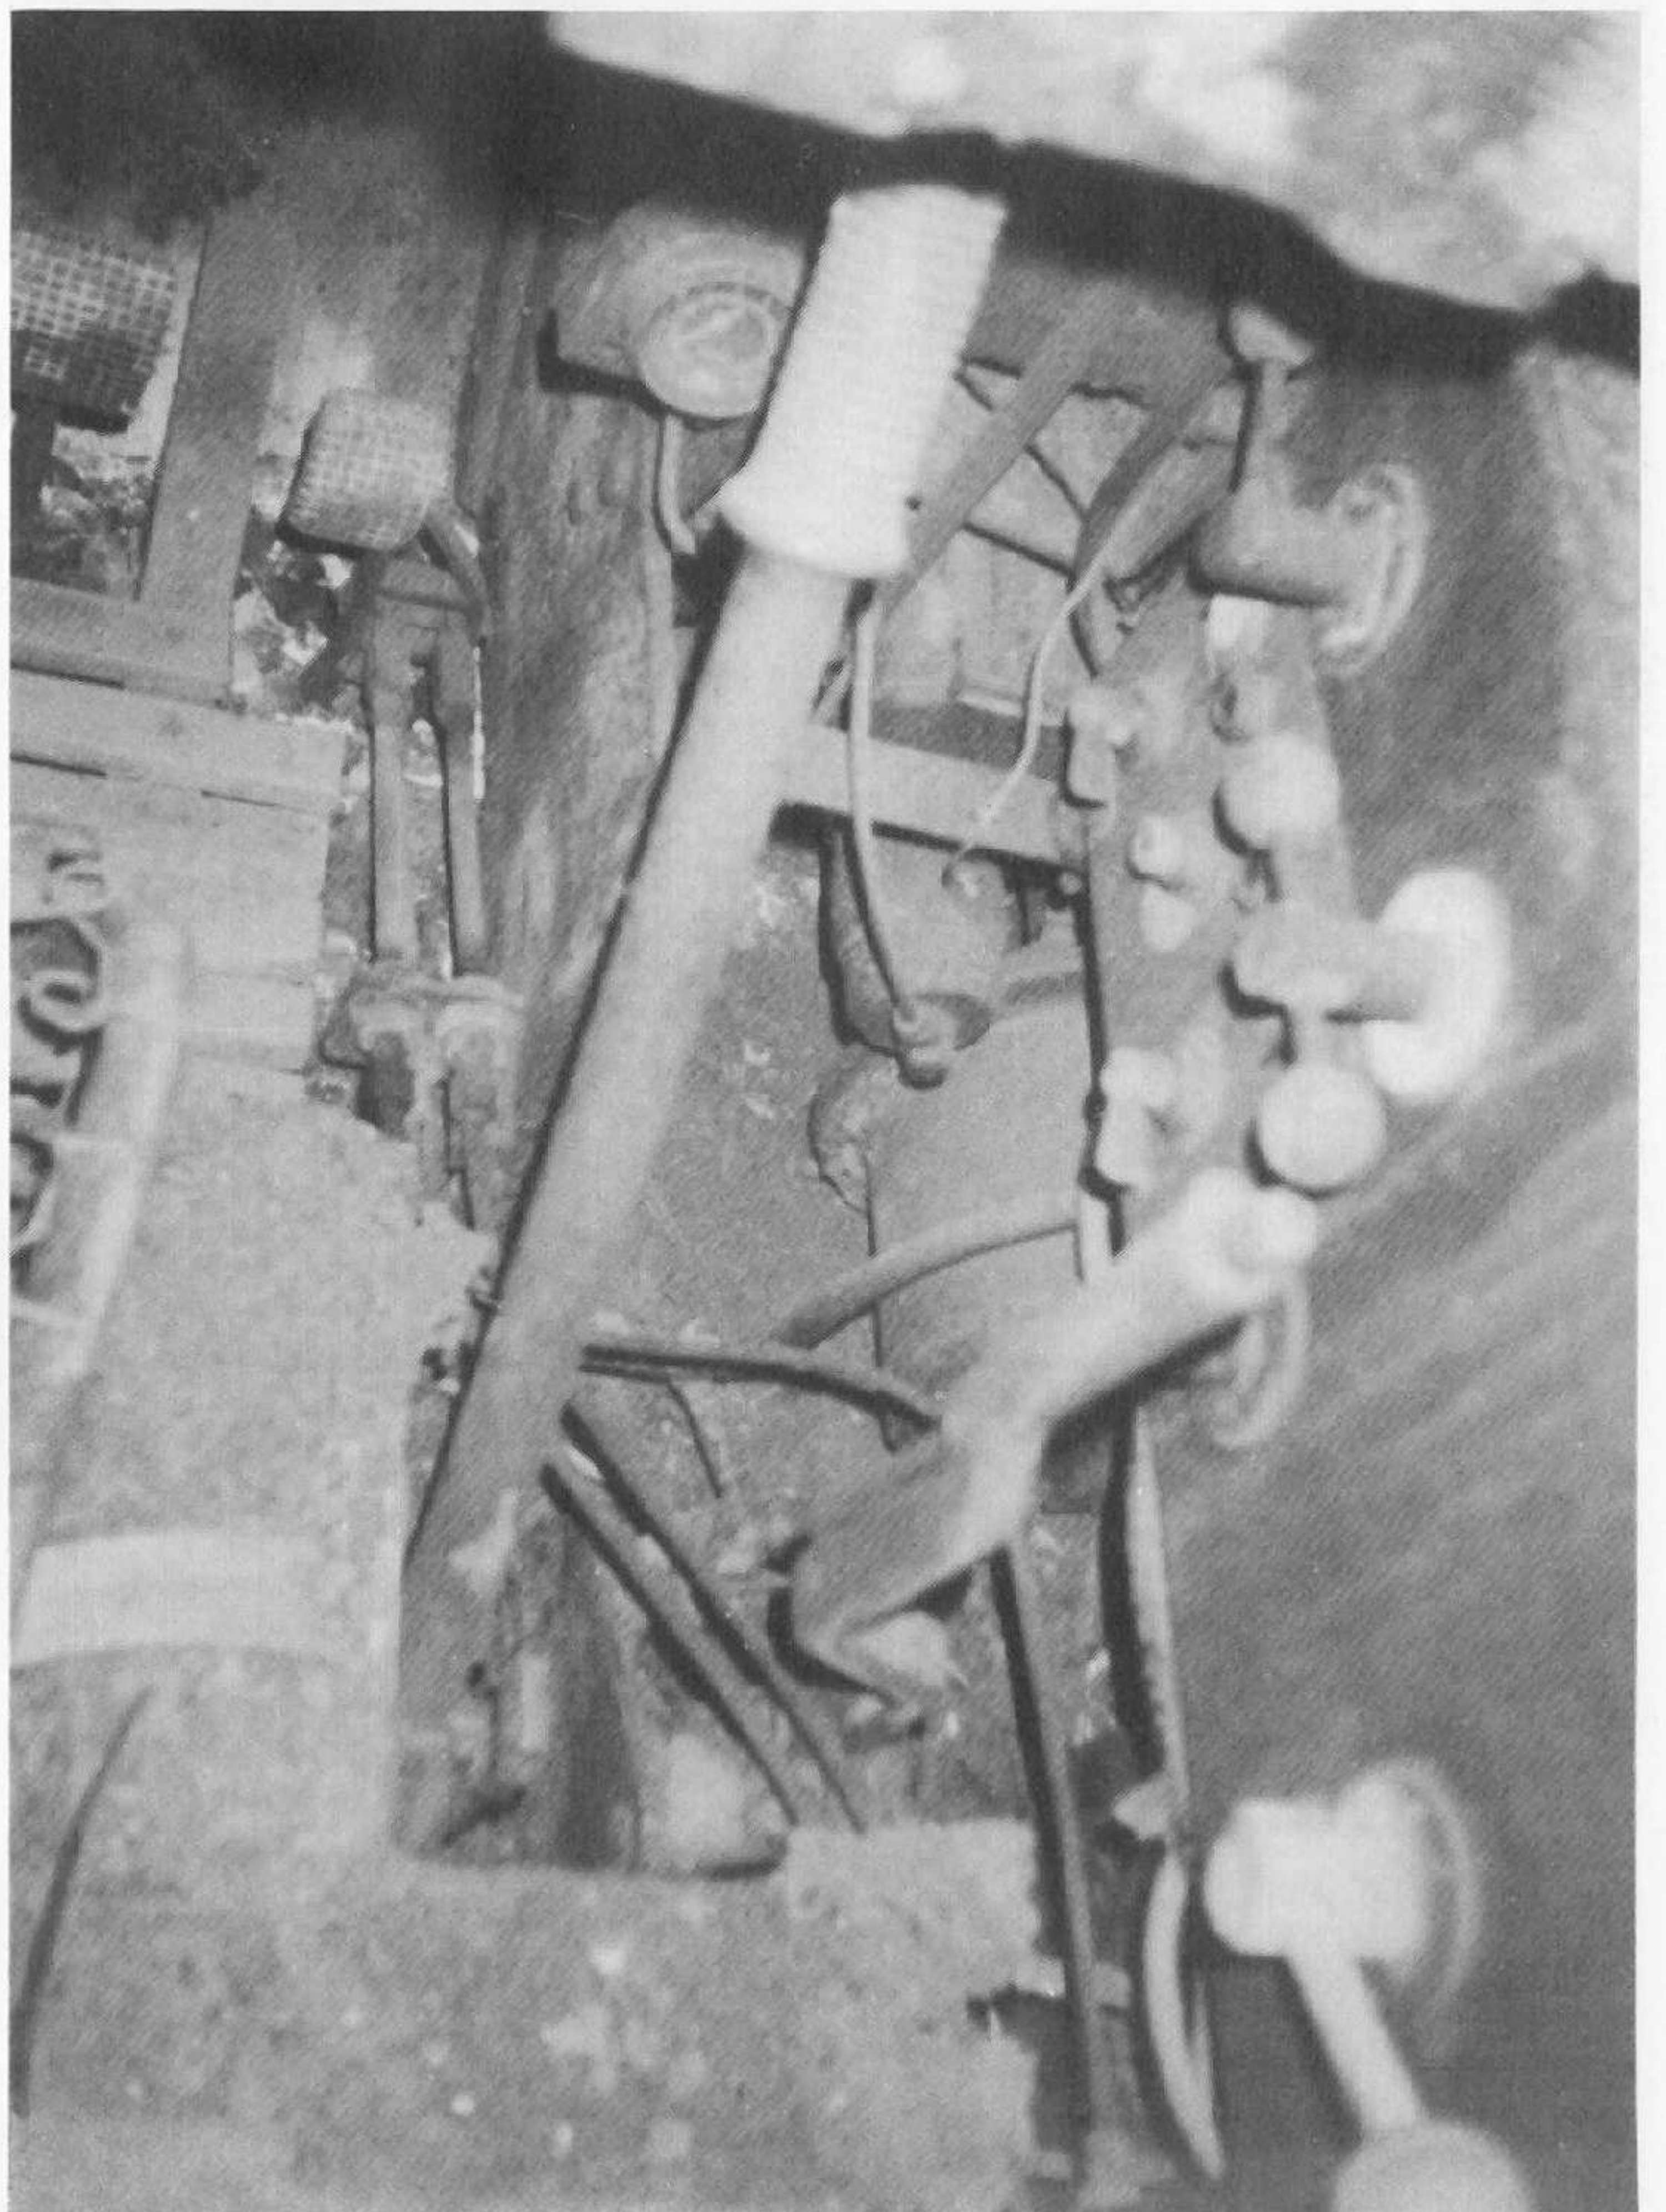
To the driver's right is a number of controls and levers. Many of these are mounted on the side of a raised box that divides the forward compartment in the middle. The center box, or console, enclosed the two air tanks for the hydro-pneumatic steering.

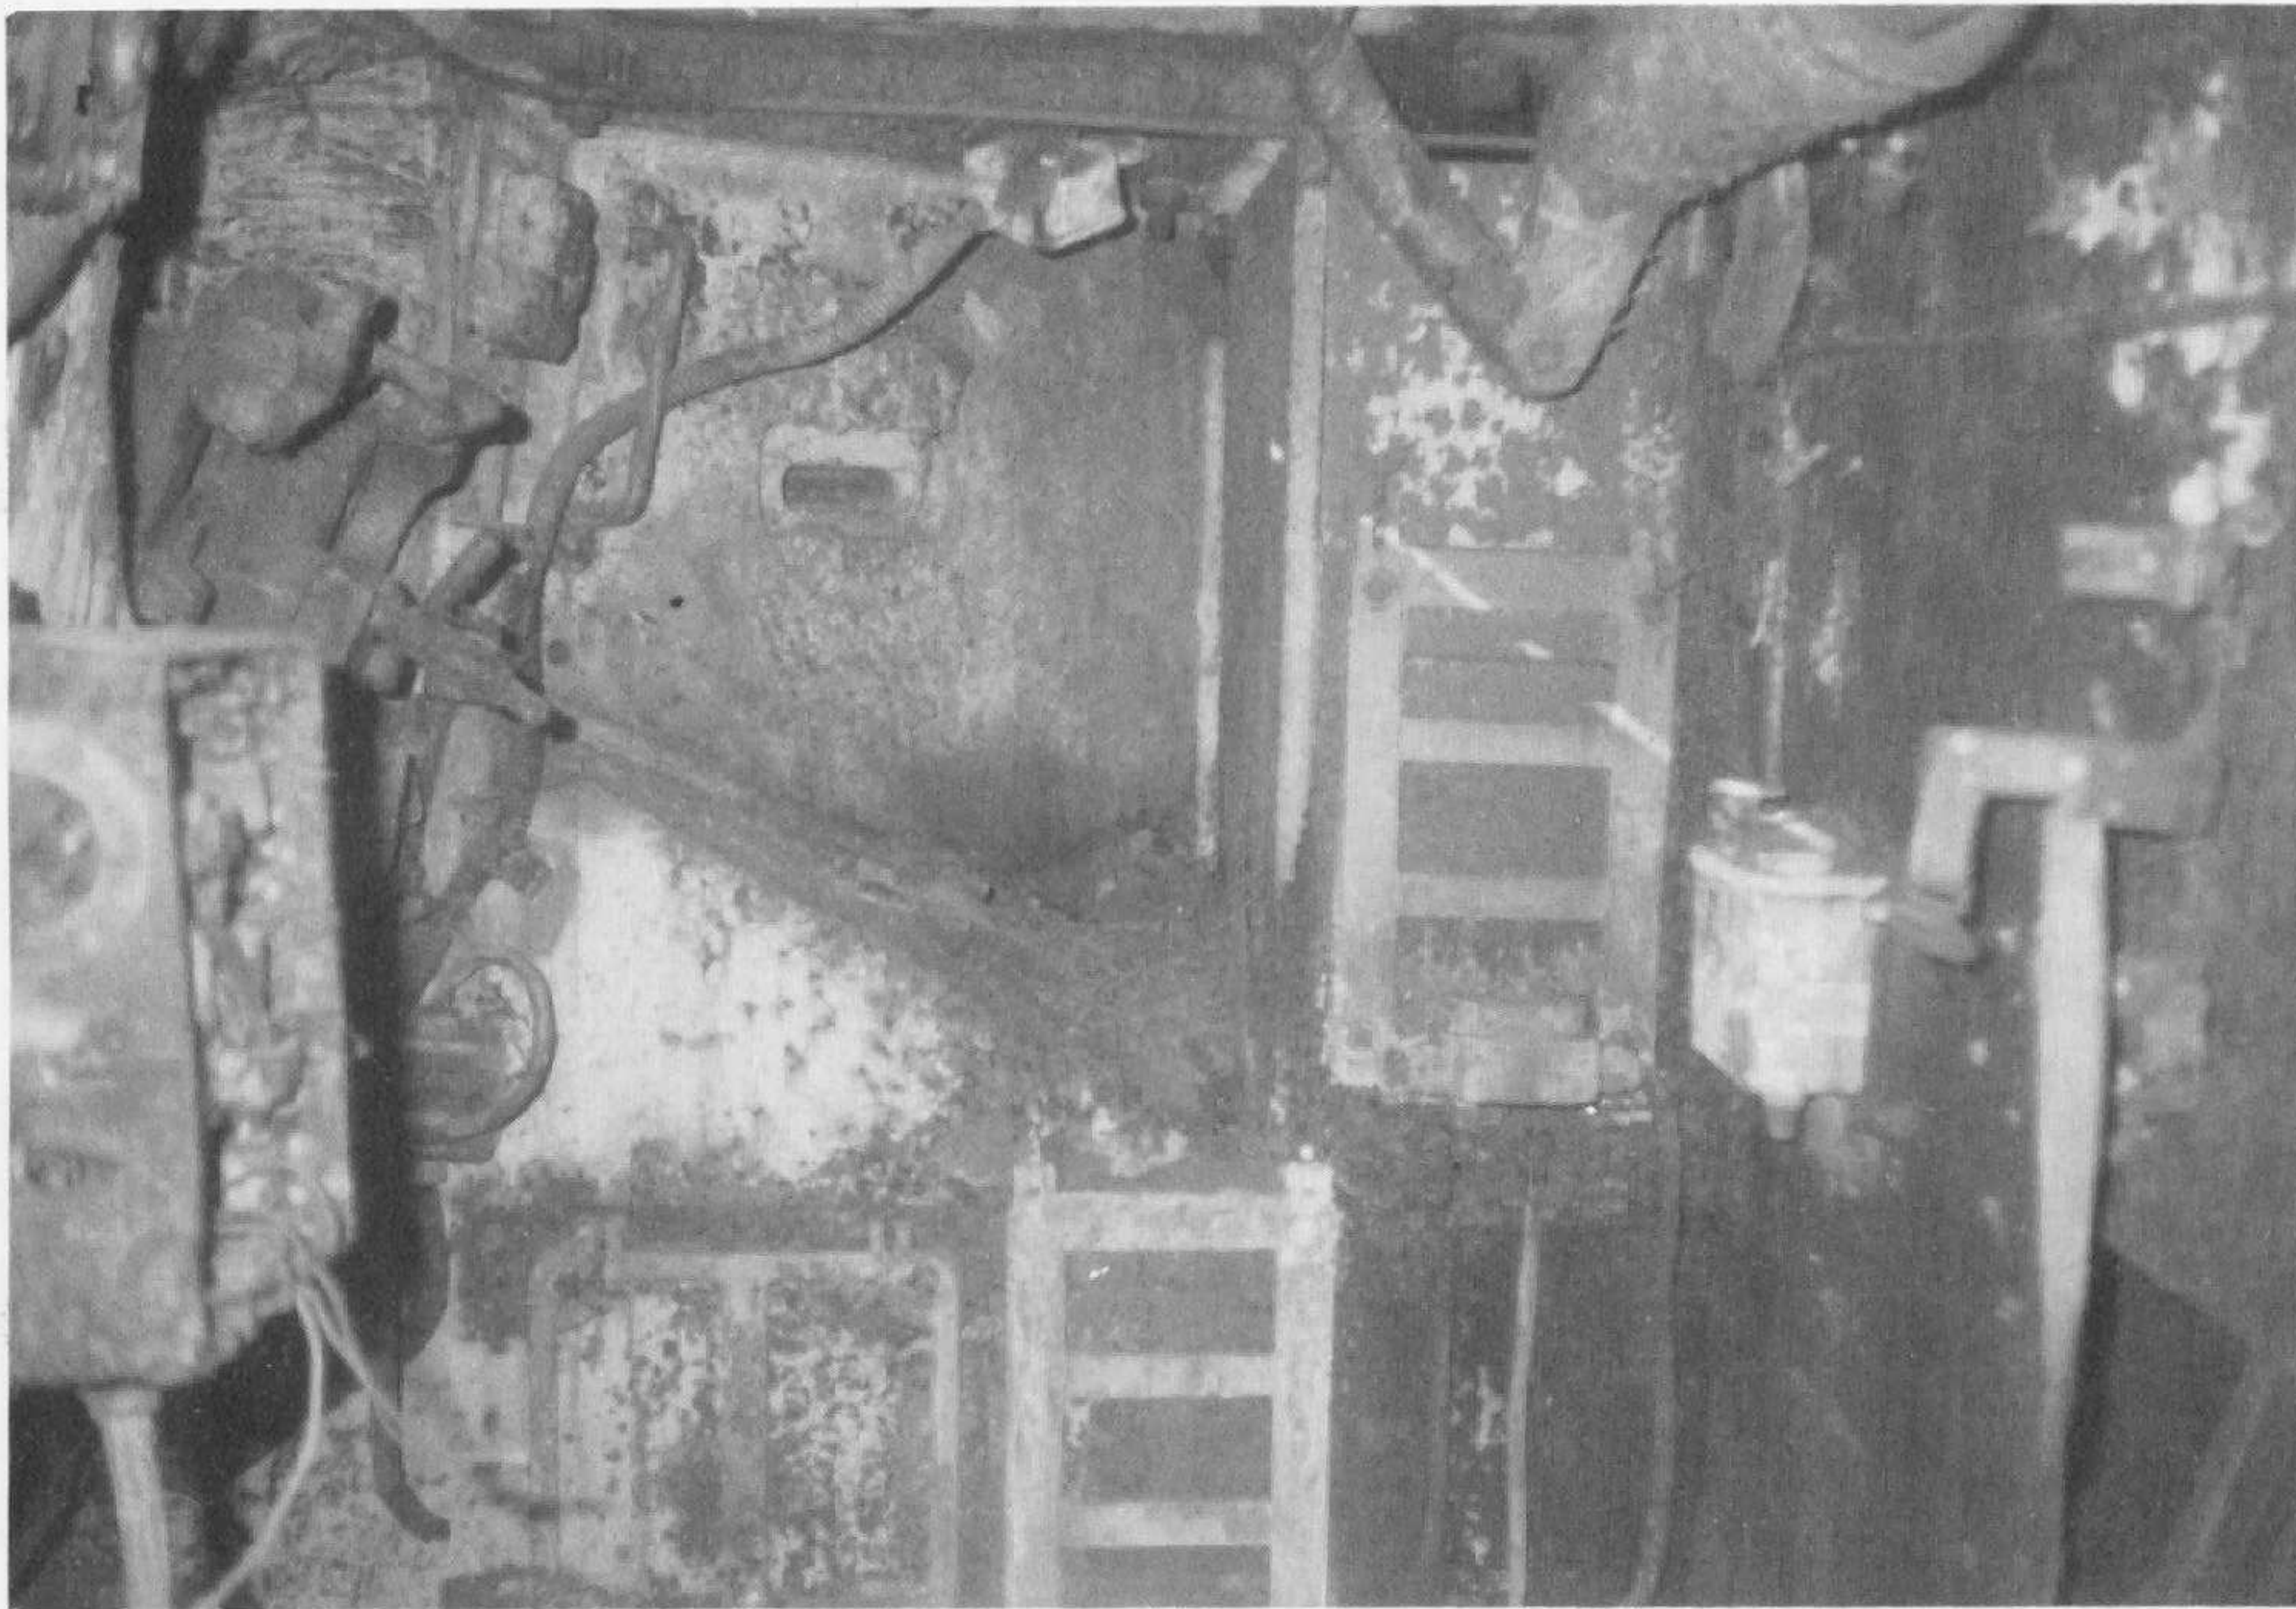
From the driver's position looking across at the bow machine gunner's area. Of note is the large spring and hatch arm in the upper right, the side vision slit near the center and the radio racks. You can also see the radio lead cable snaking up to the roof along the side wall.

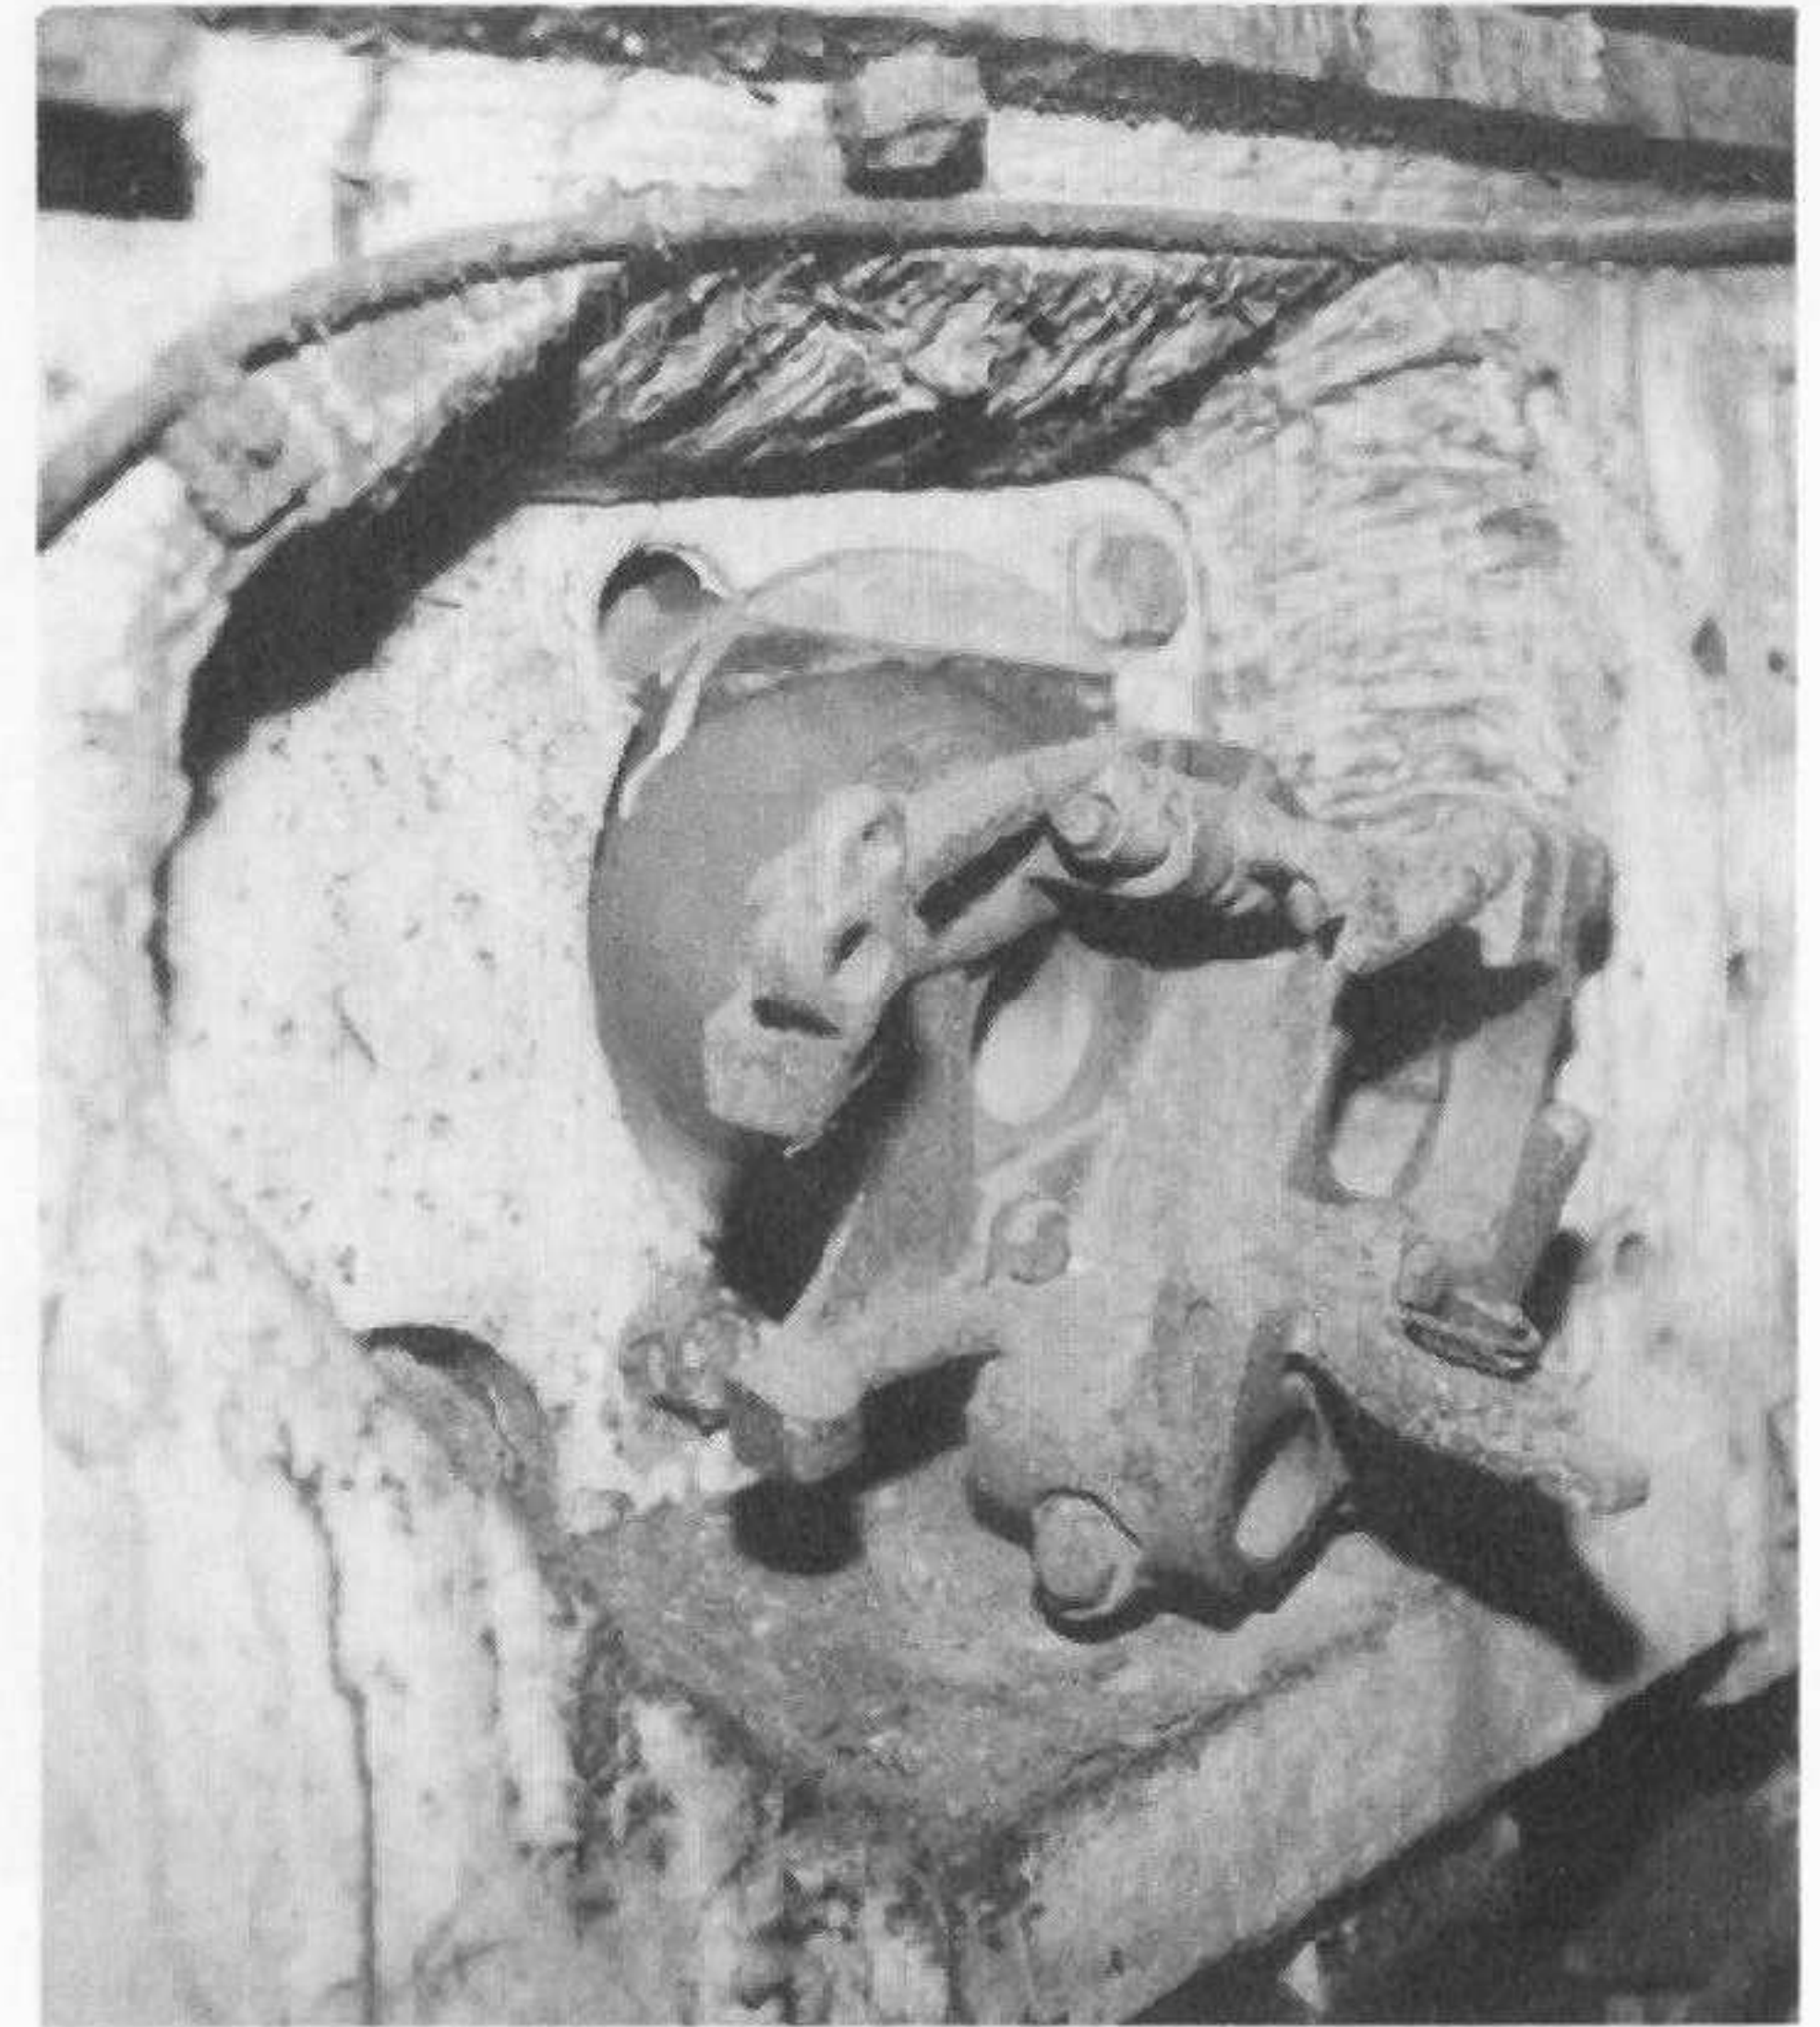
As proof that the addition of a bow machine gun was an afterthought, look at how crude the cut is around the machine gun aperture. Although part of the ball mount is missing, you can see how it fit into place.

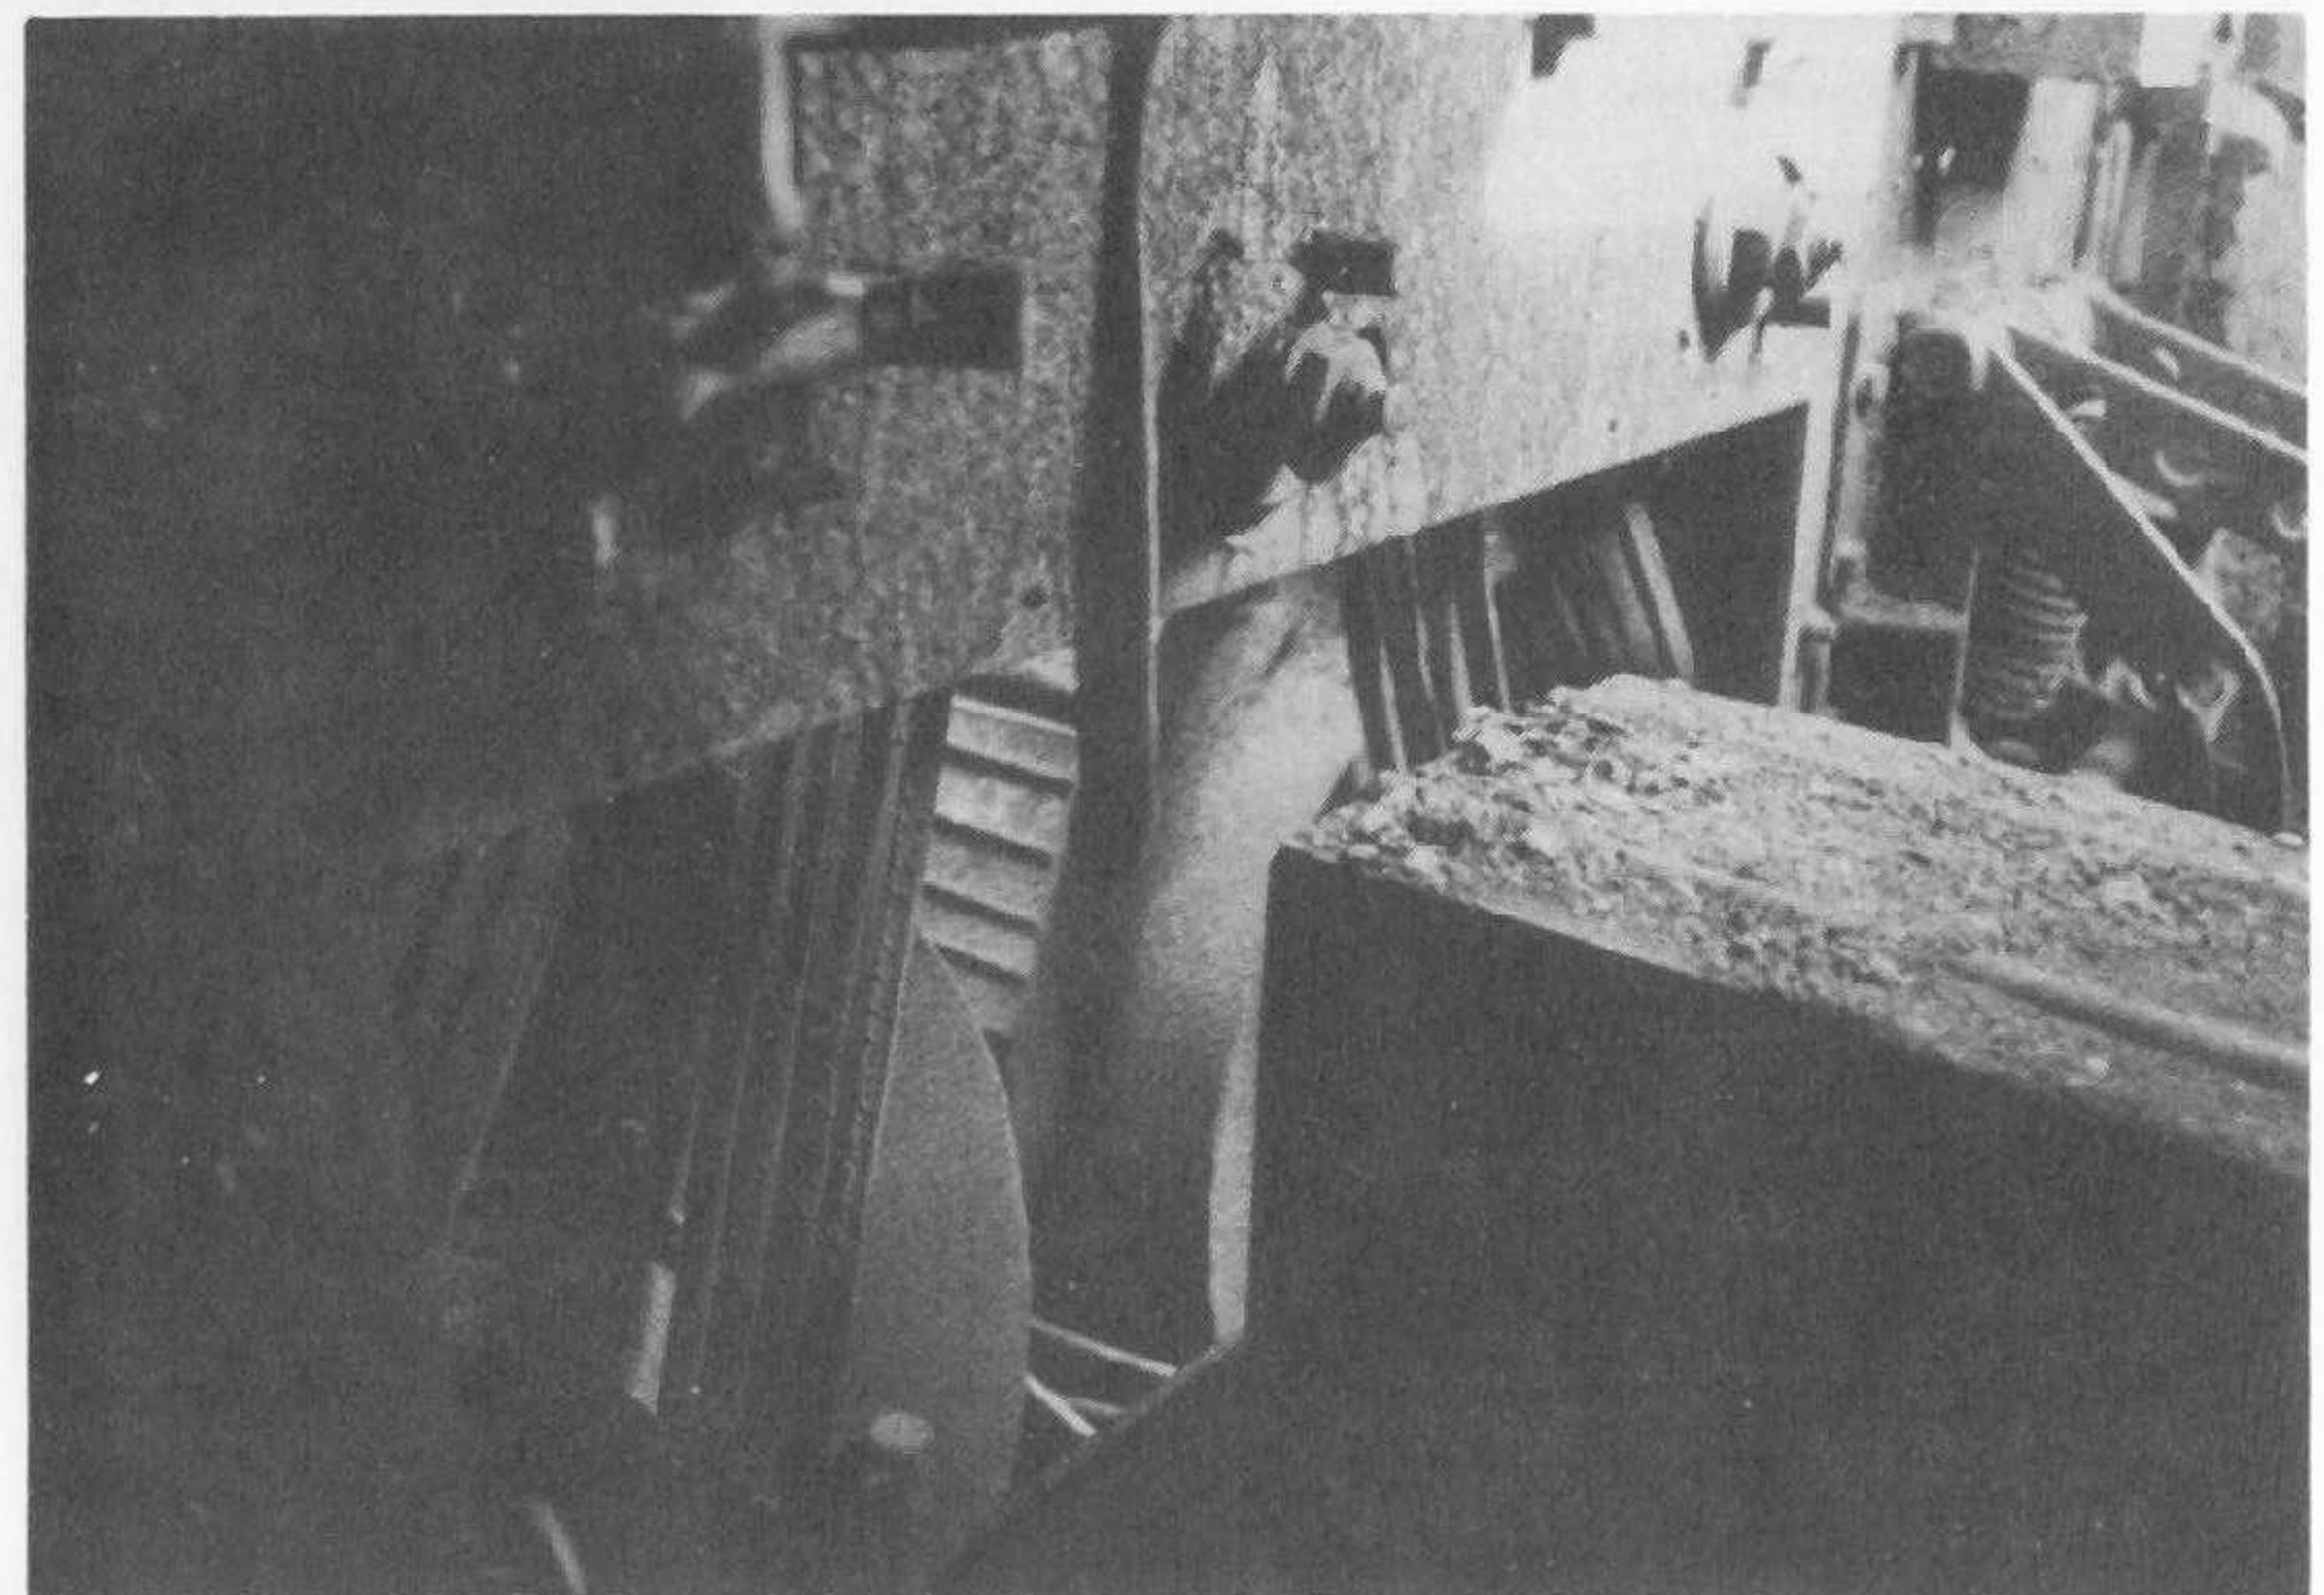
With the cover missing from this access panel, you can see into part of the engine compartment. Also note the center box that divides the compartment.

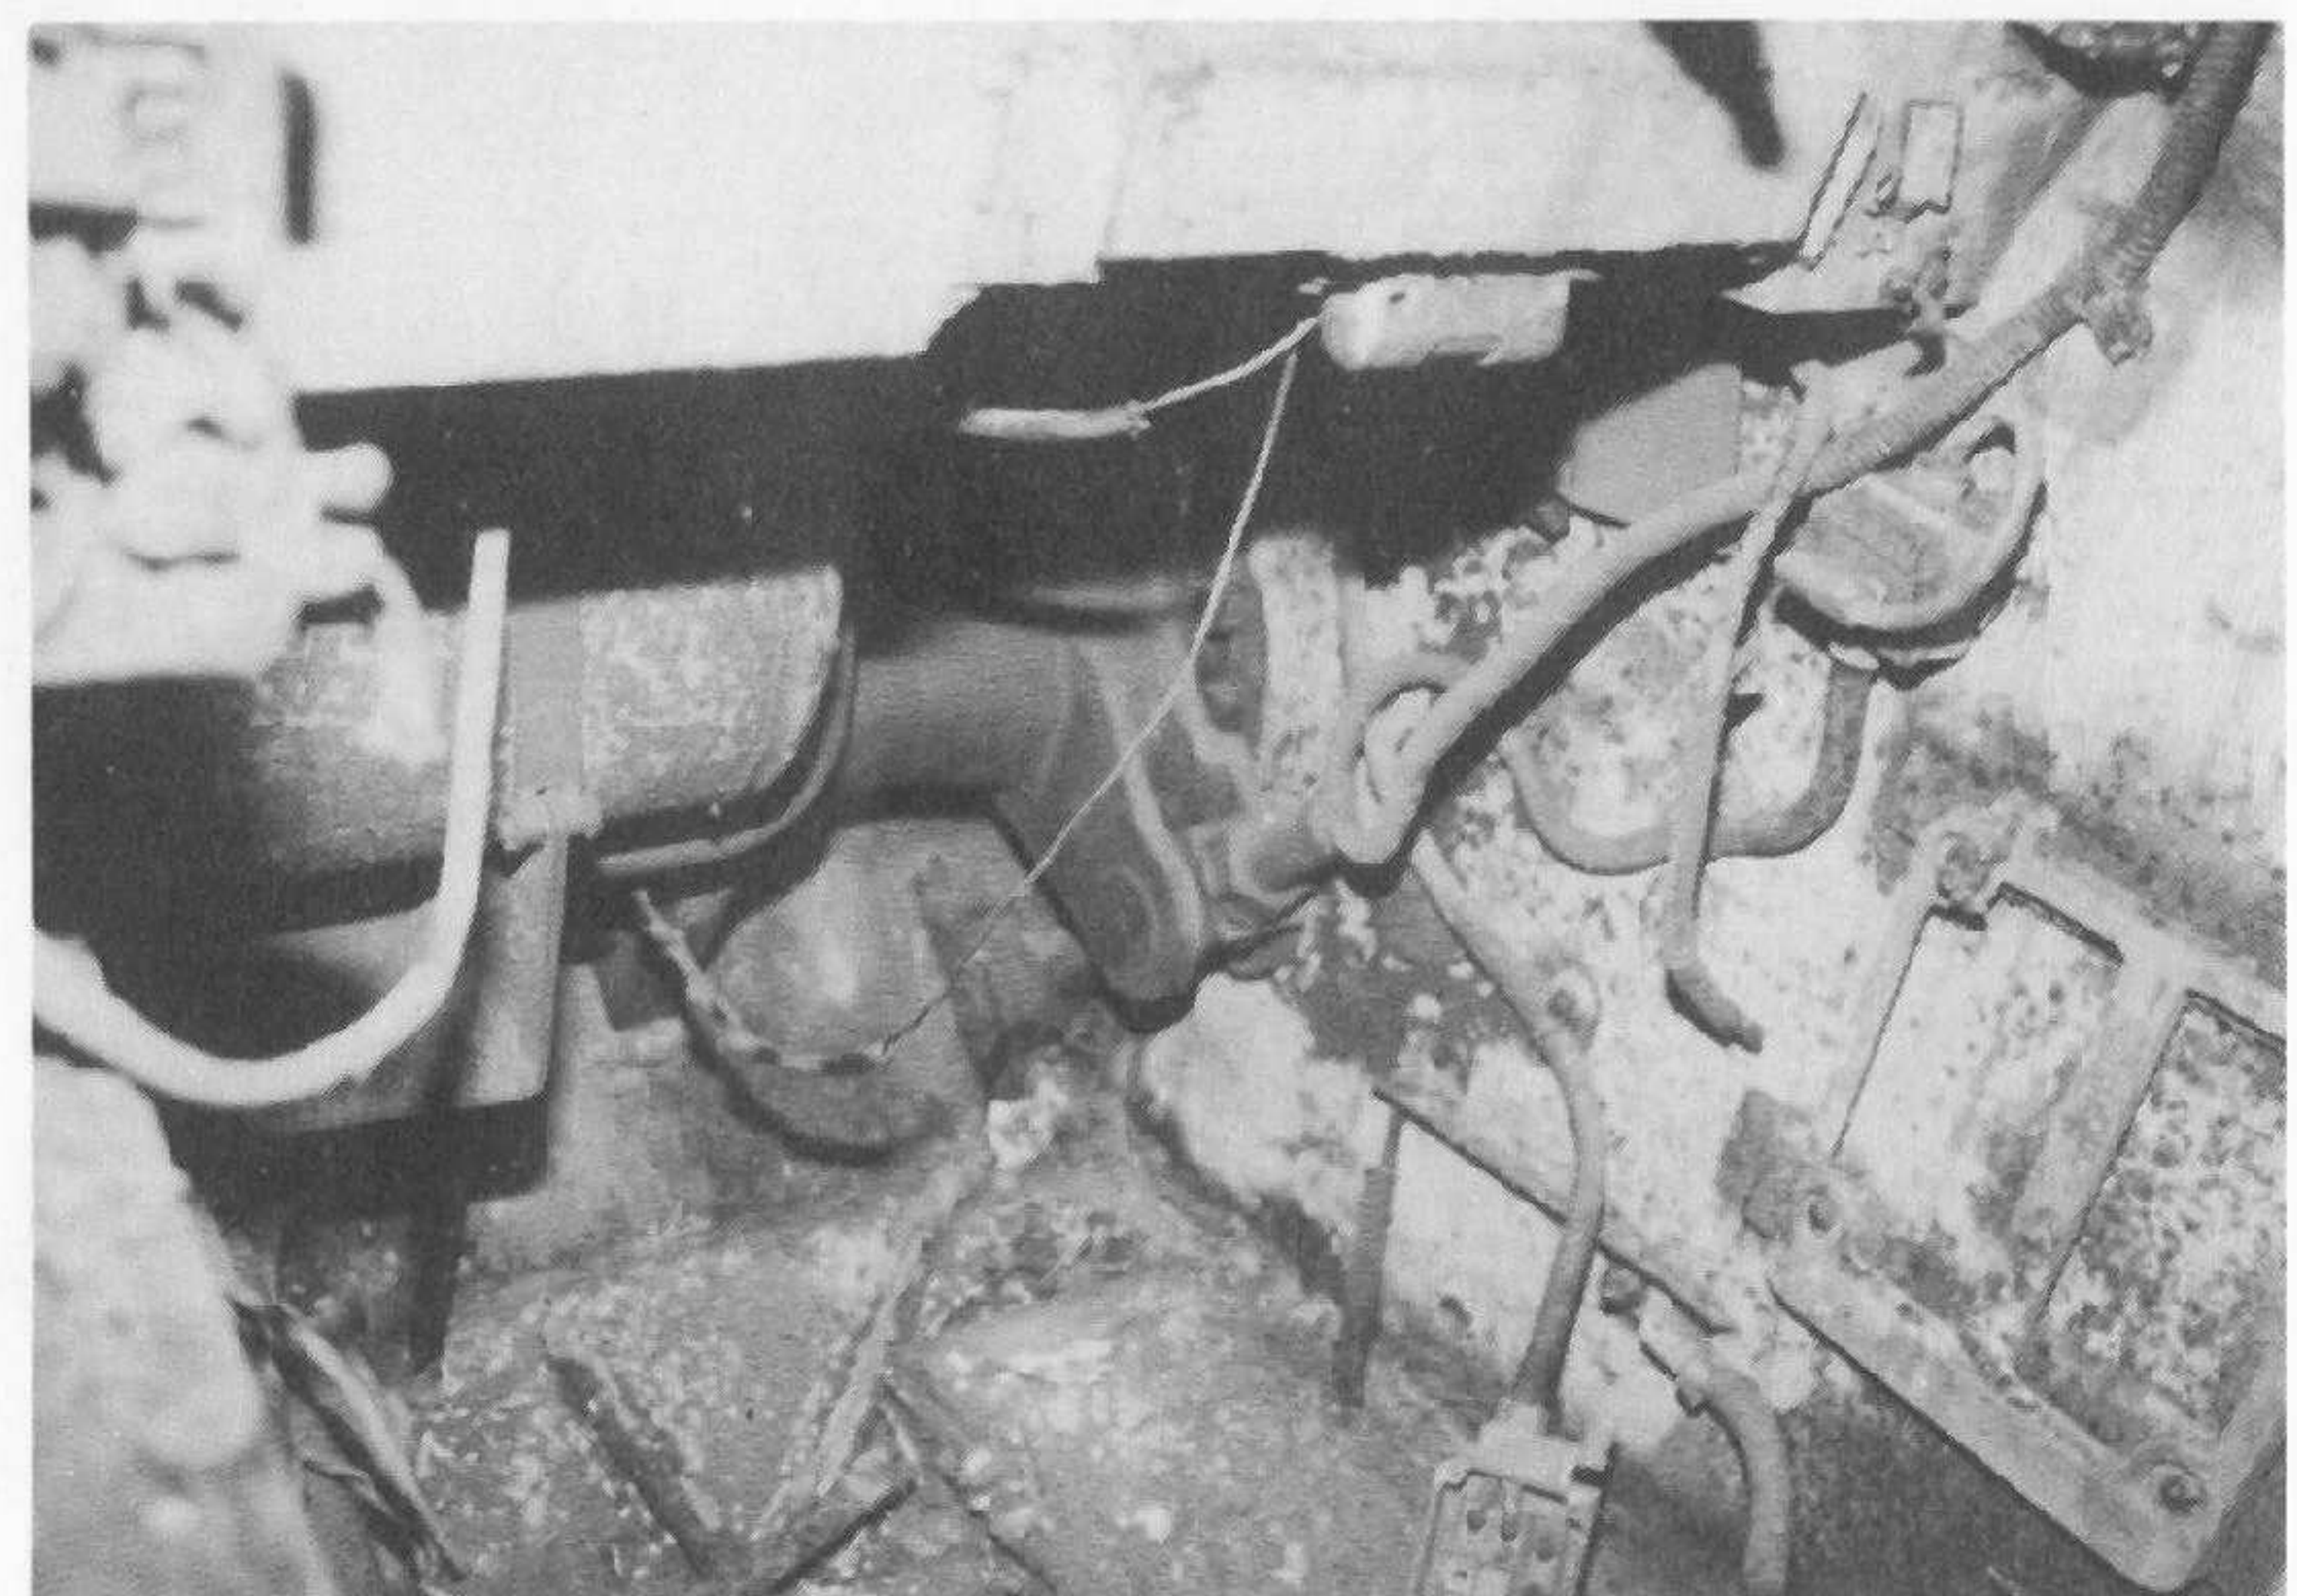
Another look at the gunner's side wall and floor. In the upper center of the photo, mounted below the front panel is the interior light for the gunner. The Elephant was equipped with a standard FuG 5, 10-watt sender "c" (20 W.S.c.) and ultra short wave receiver "e" (UKw.E.e). The aerial for this set was supposed to be 2 meters.

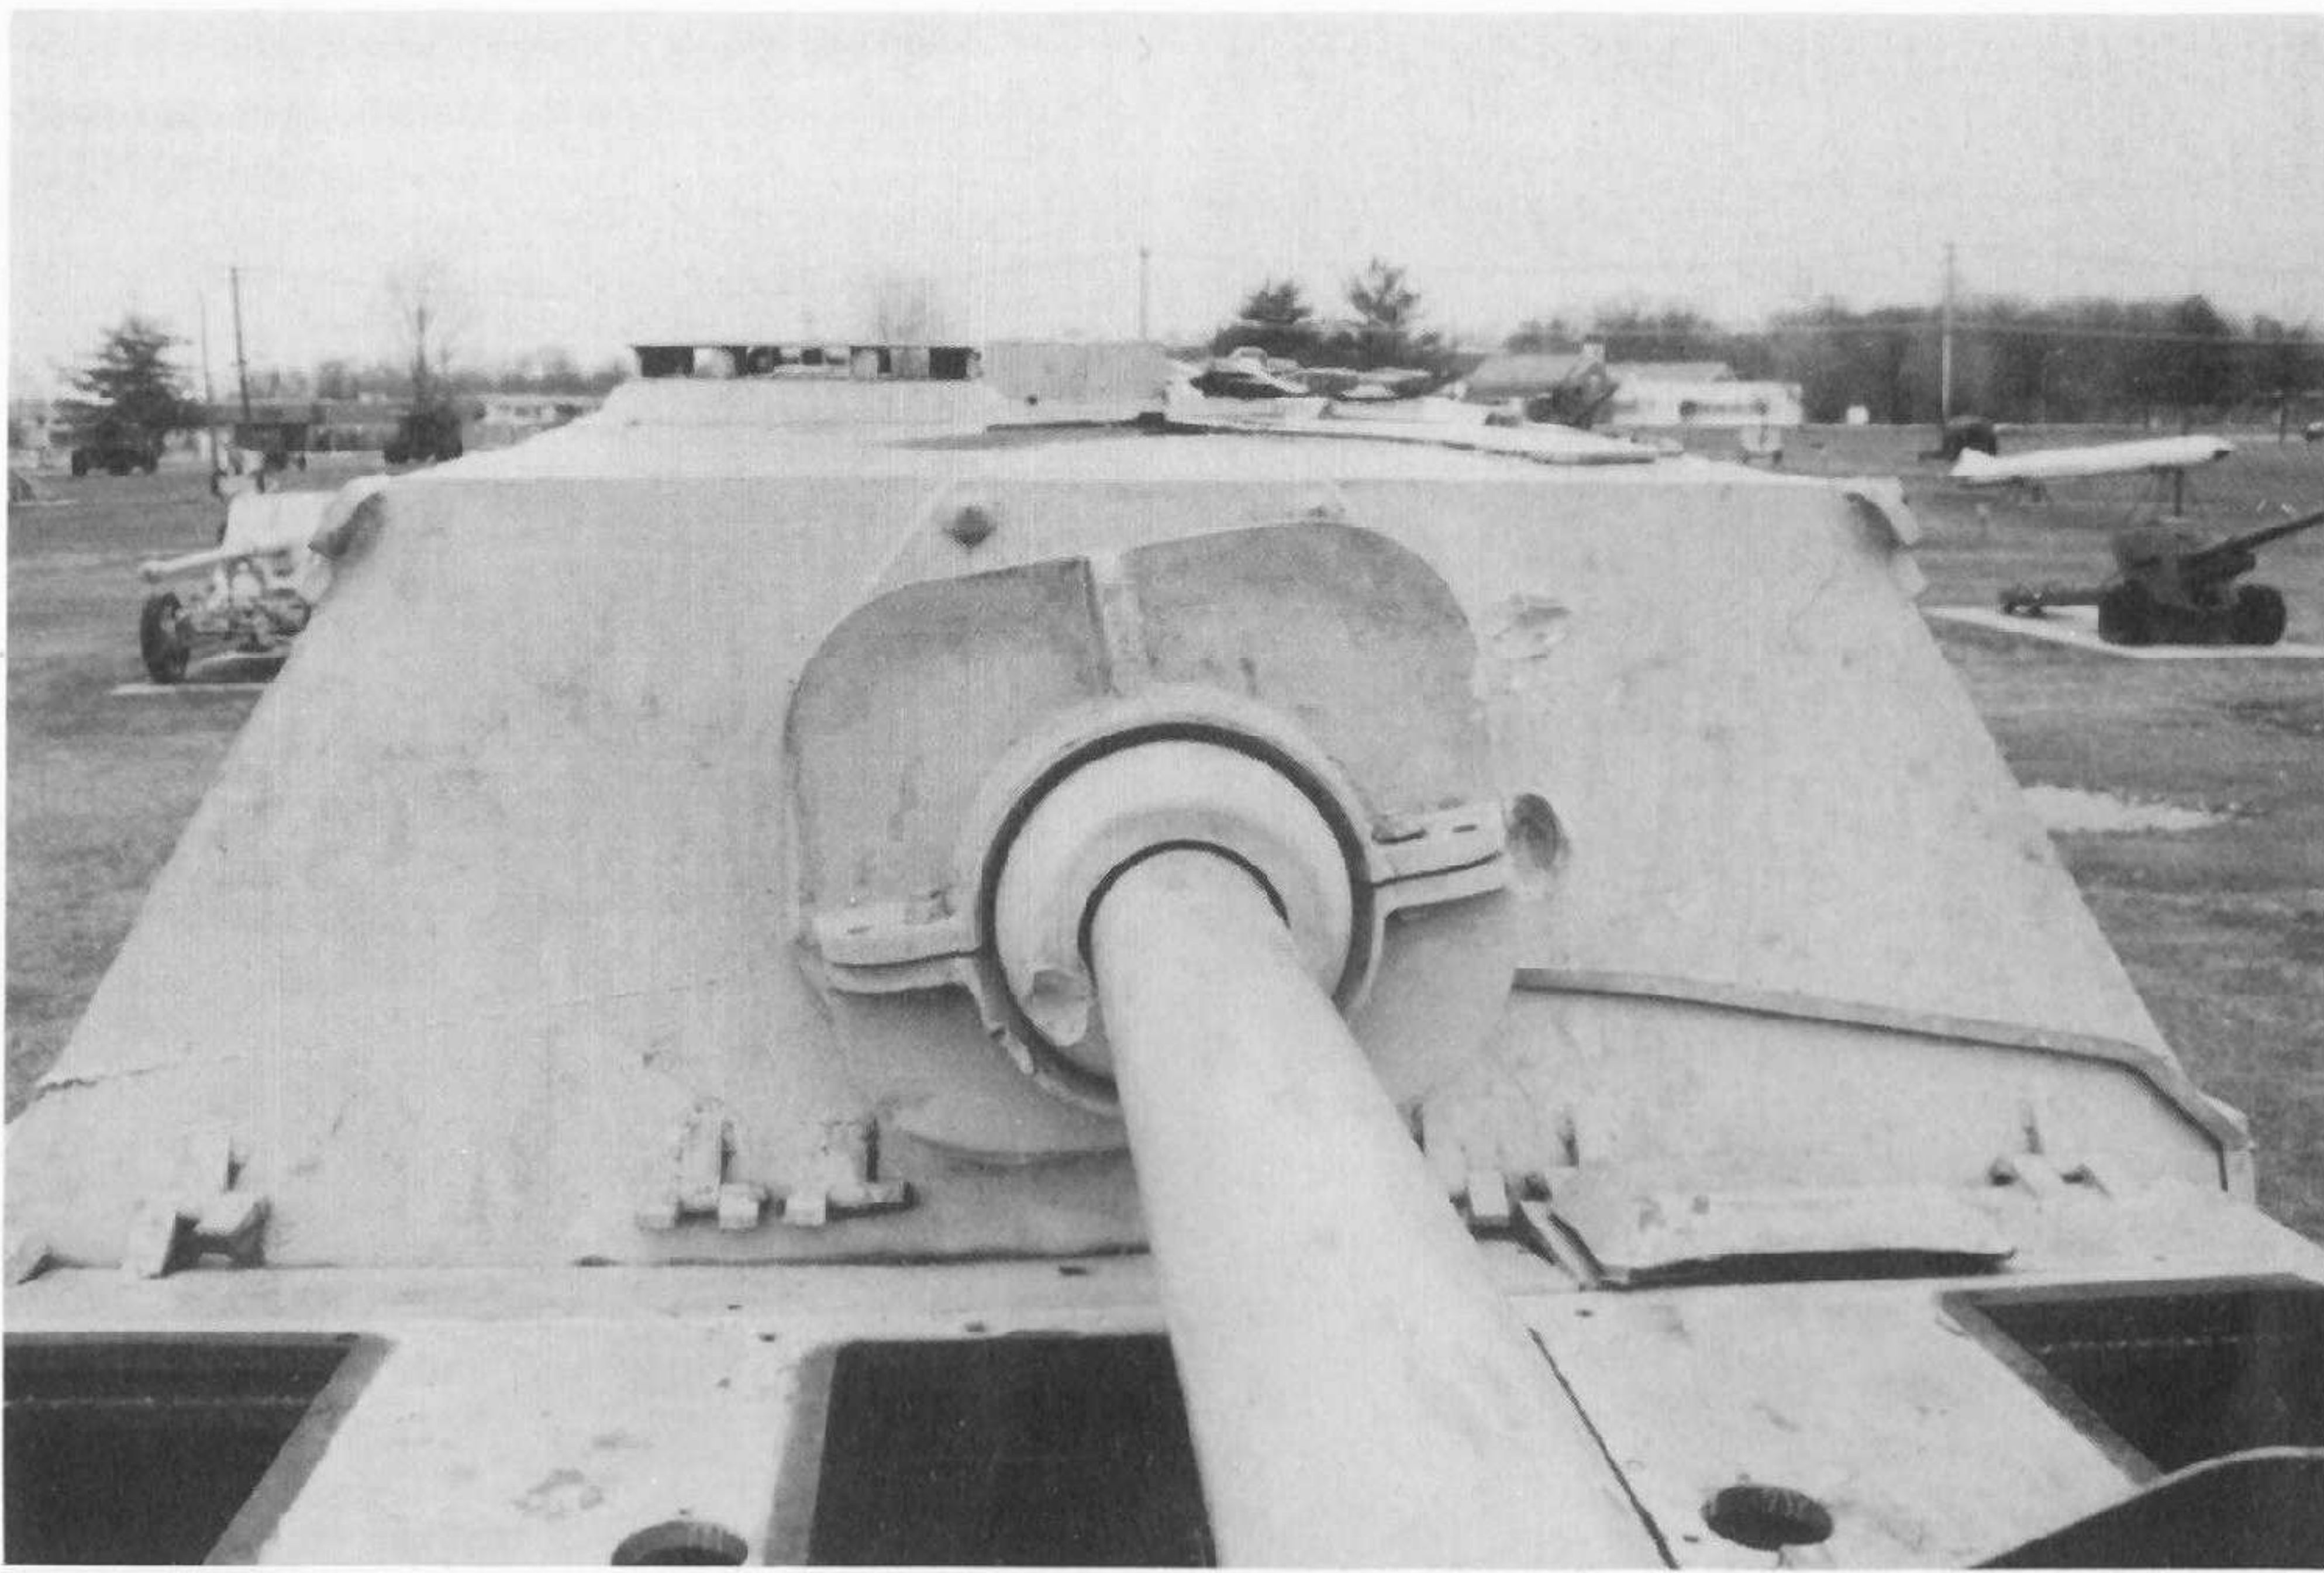
Aberdeen's Elephant came in with a small amount of shell damage, including the frontal shell shots that can be seen on the add-on collar (which is flat on the backside) and the front plate: Perhaps less noticeable at first is the missing rain guard missing from the right side (left in the photo) and the broken welds on the brackets that hold the back plate of the engine deck to the front armor slope. In this photo all but the two brackets on the right are broken. The result has been that the rear engine deck plate has settled down at an angle and rests below where it should be. The plate should be welded to the four brackets that are shown on the front plate, this in turn would bring the plate up level with the rest of the deck.
