MUSEUM ORDNANCE SPECIAL NUMBER 4

Elefant Panzerjäger Tiger (P)

Text by Thomas L. Jentz
Photos by Jeffrey D. McKaughan

THE "ELEFANT" AT ABERDEEN

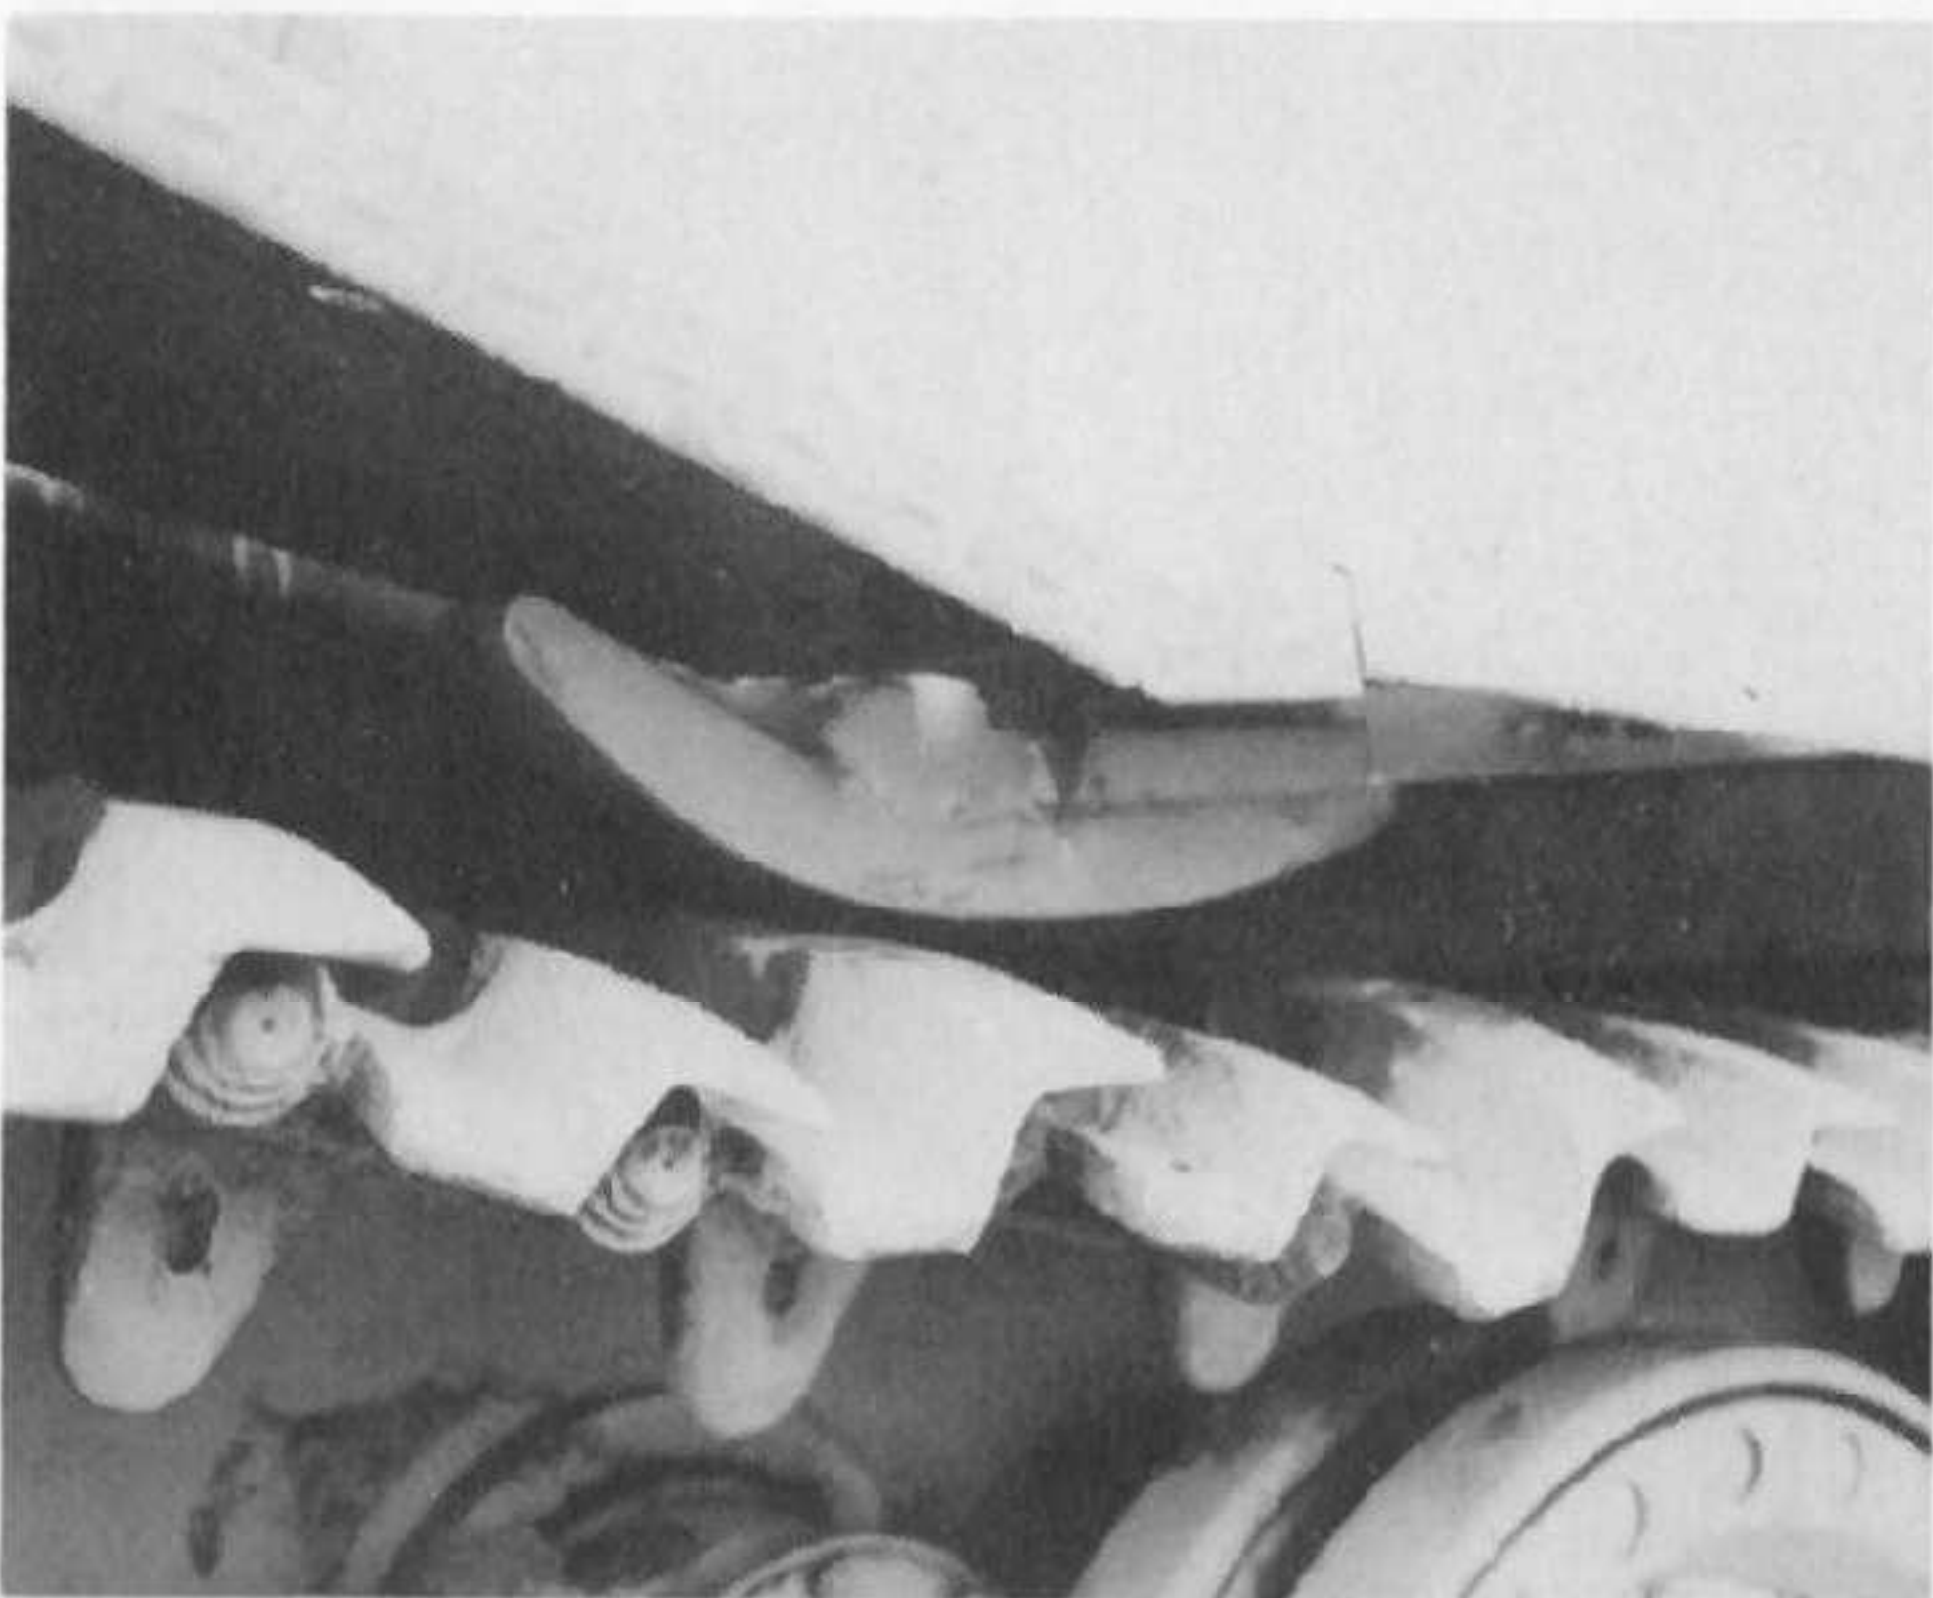
Because the fenders were so close to the top of the tracks near each of the sprockets, protective "horns" were fitted to the underside of the hull to help guide the tracks.

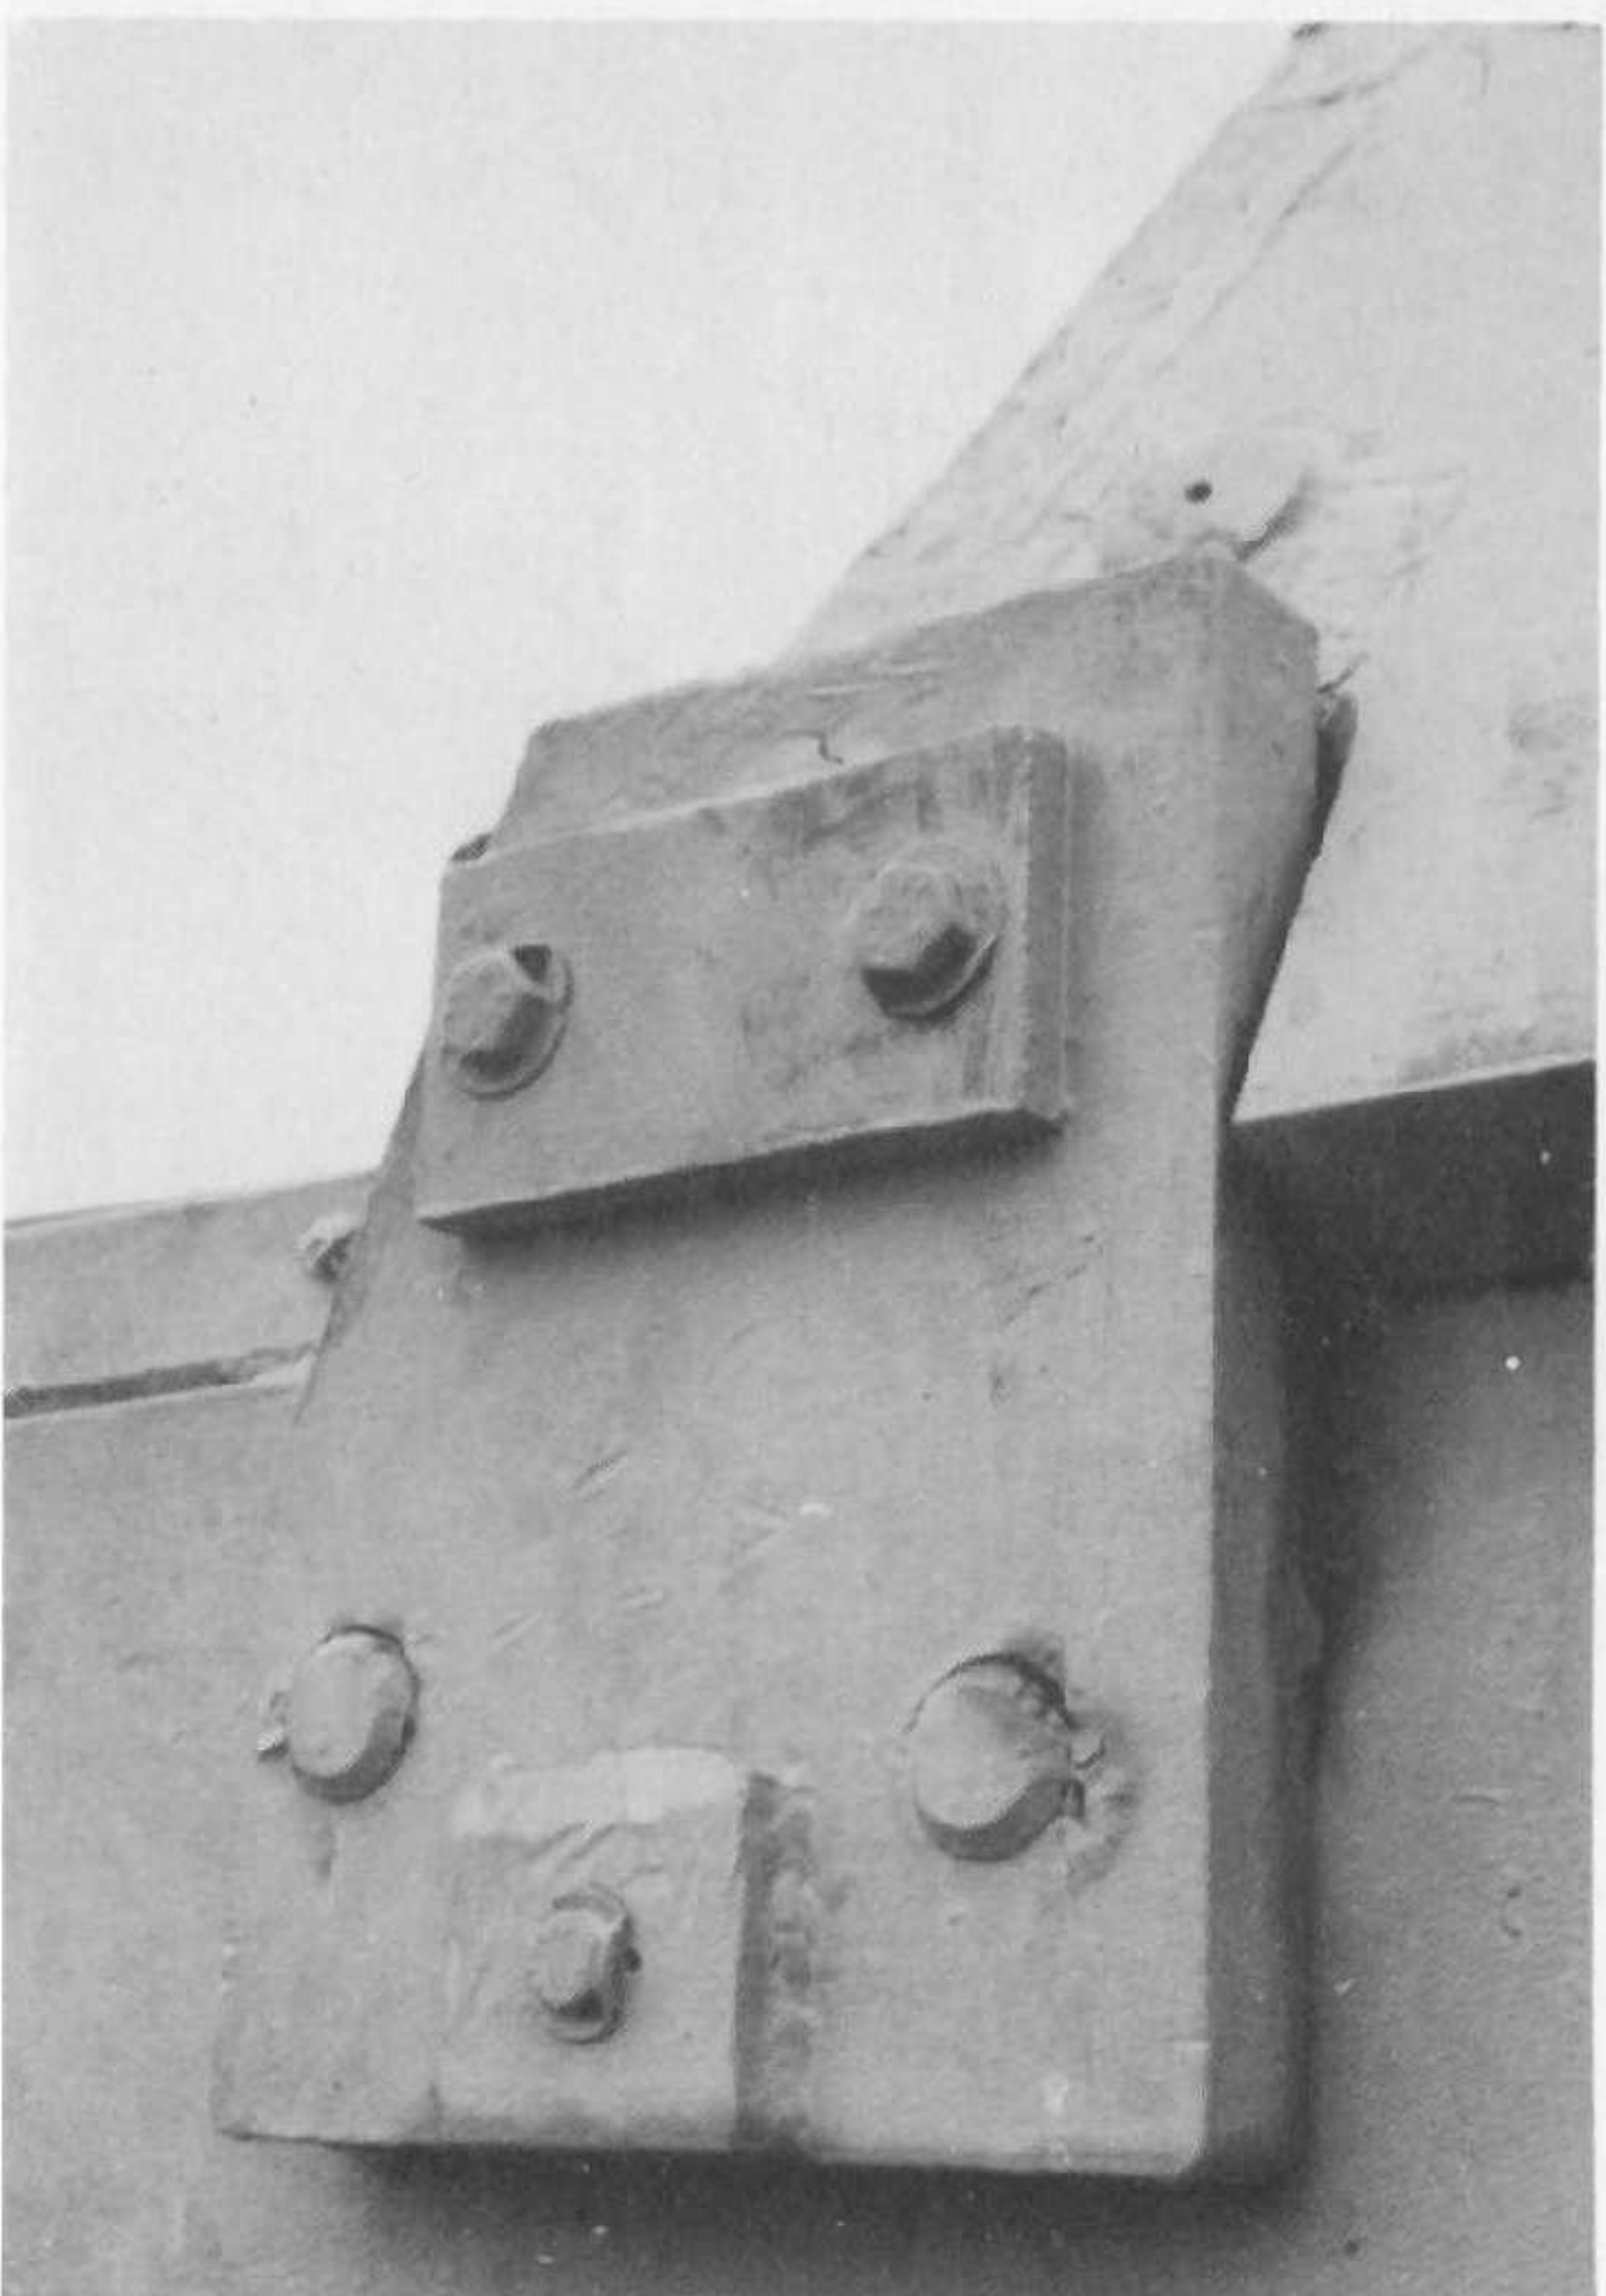
The forward exterior attachment plate securing the fighting compartment to the hull.

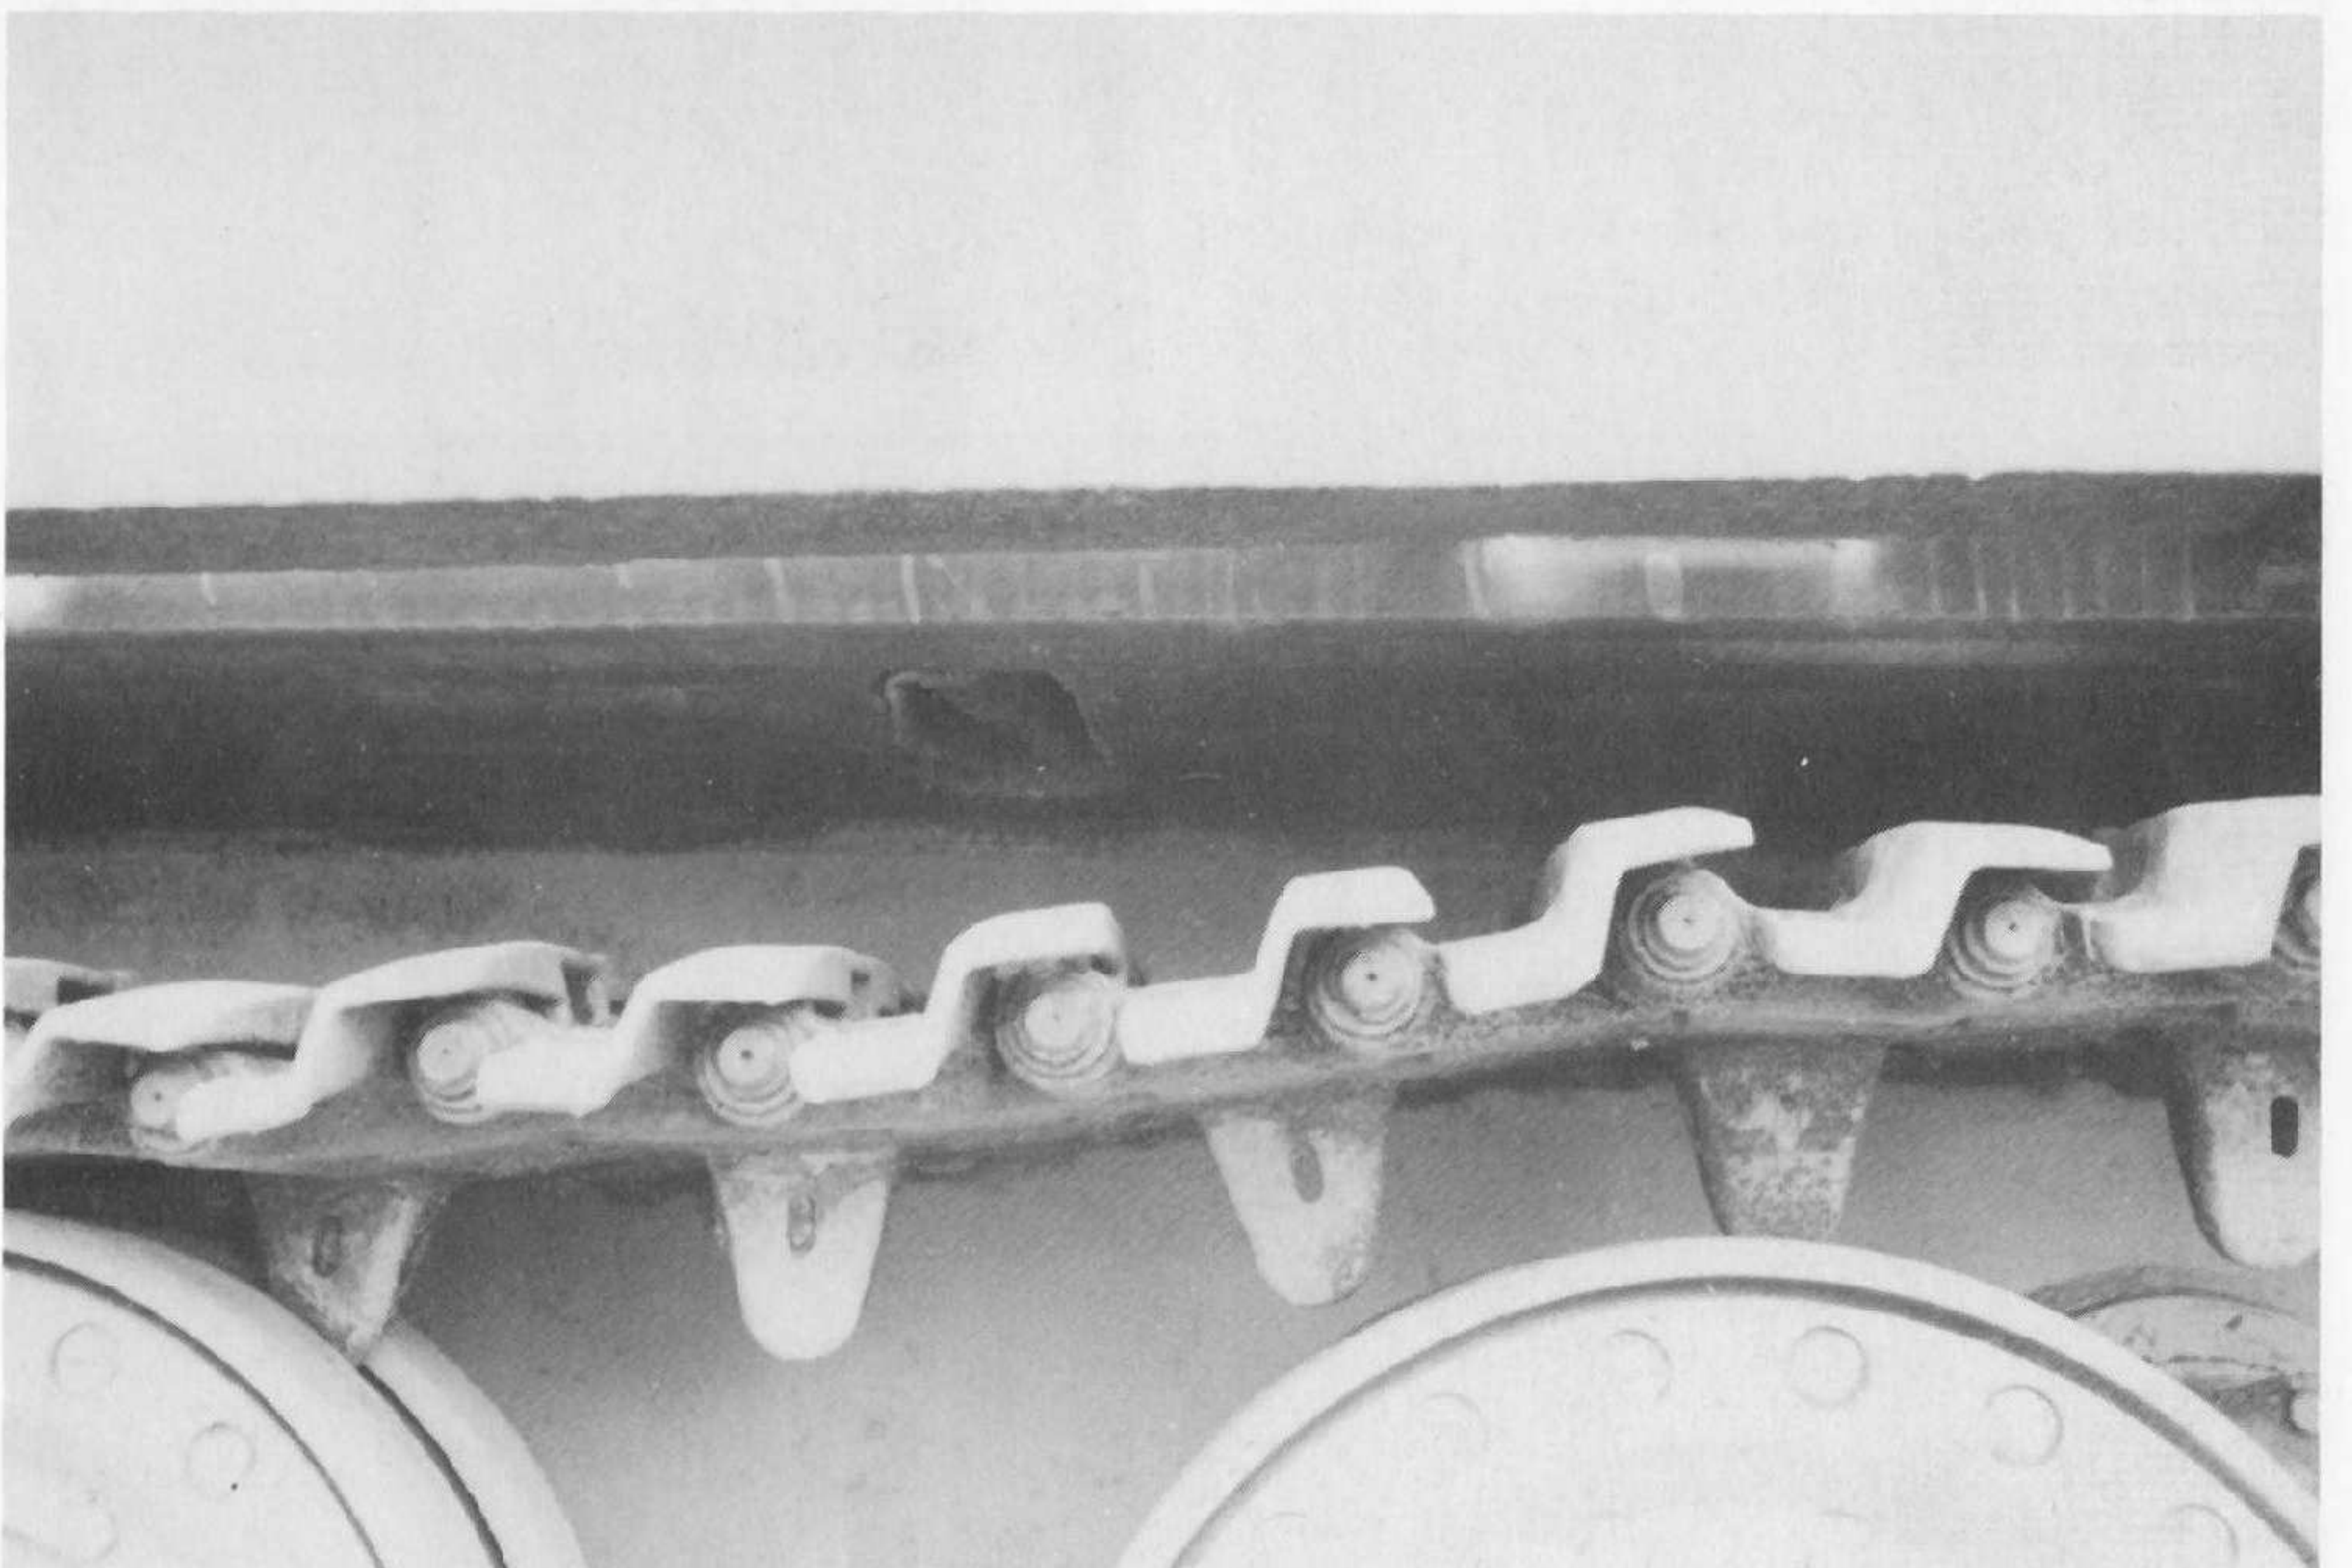
Venting for the electric motors was located under the hull overhang of the tracks between the middle and last bogie assembly.

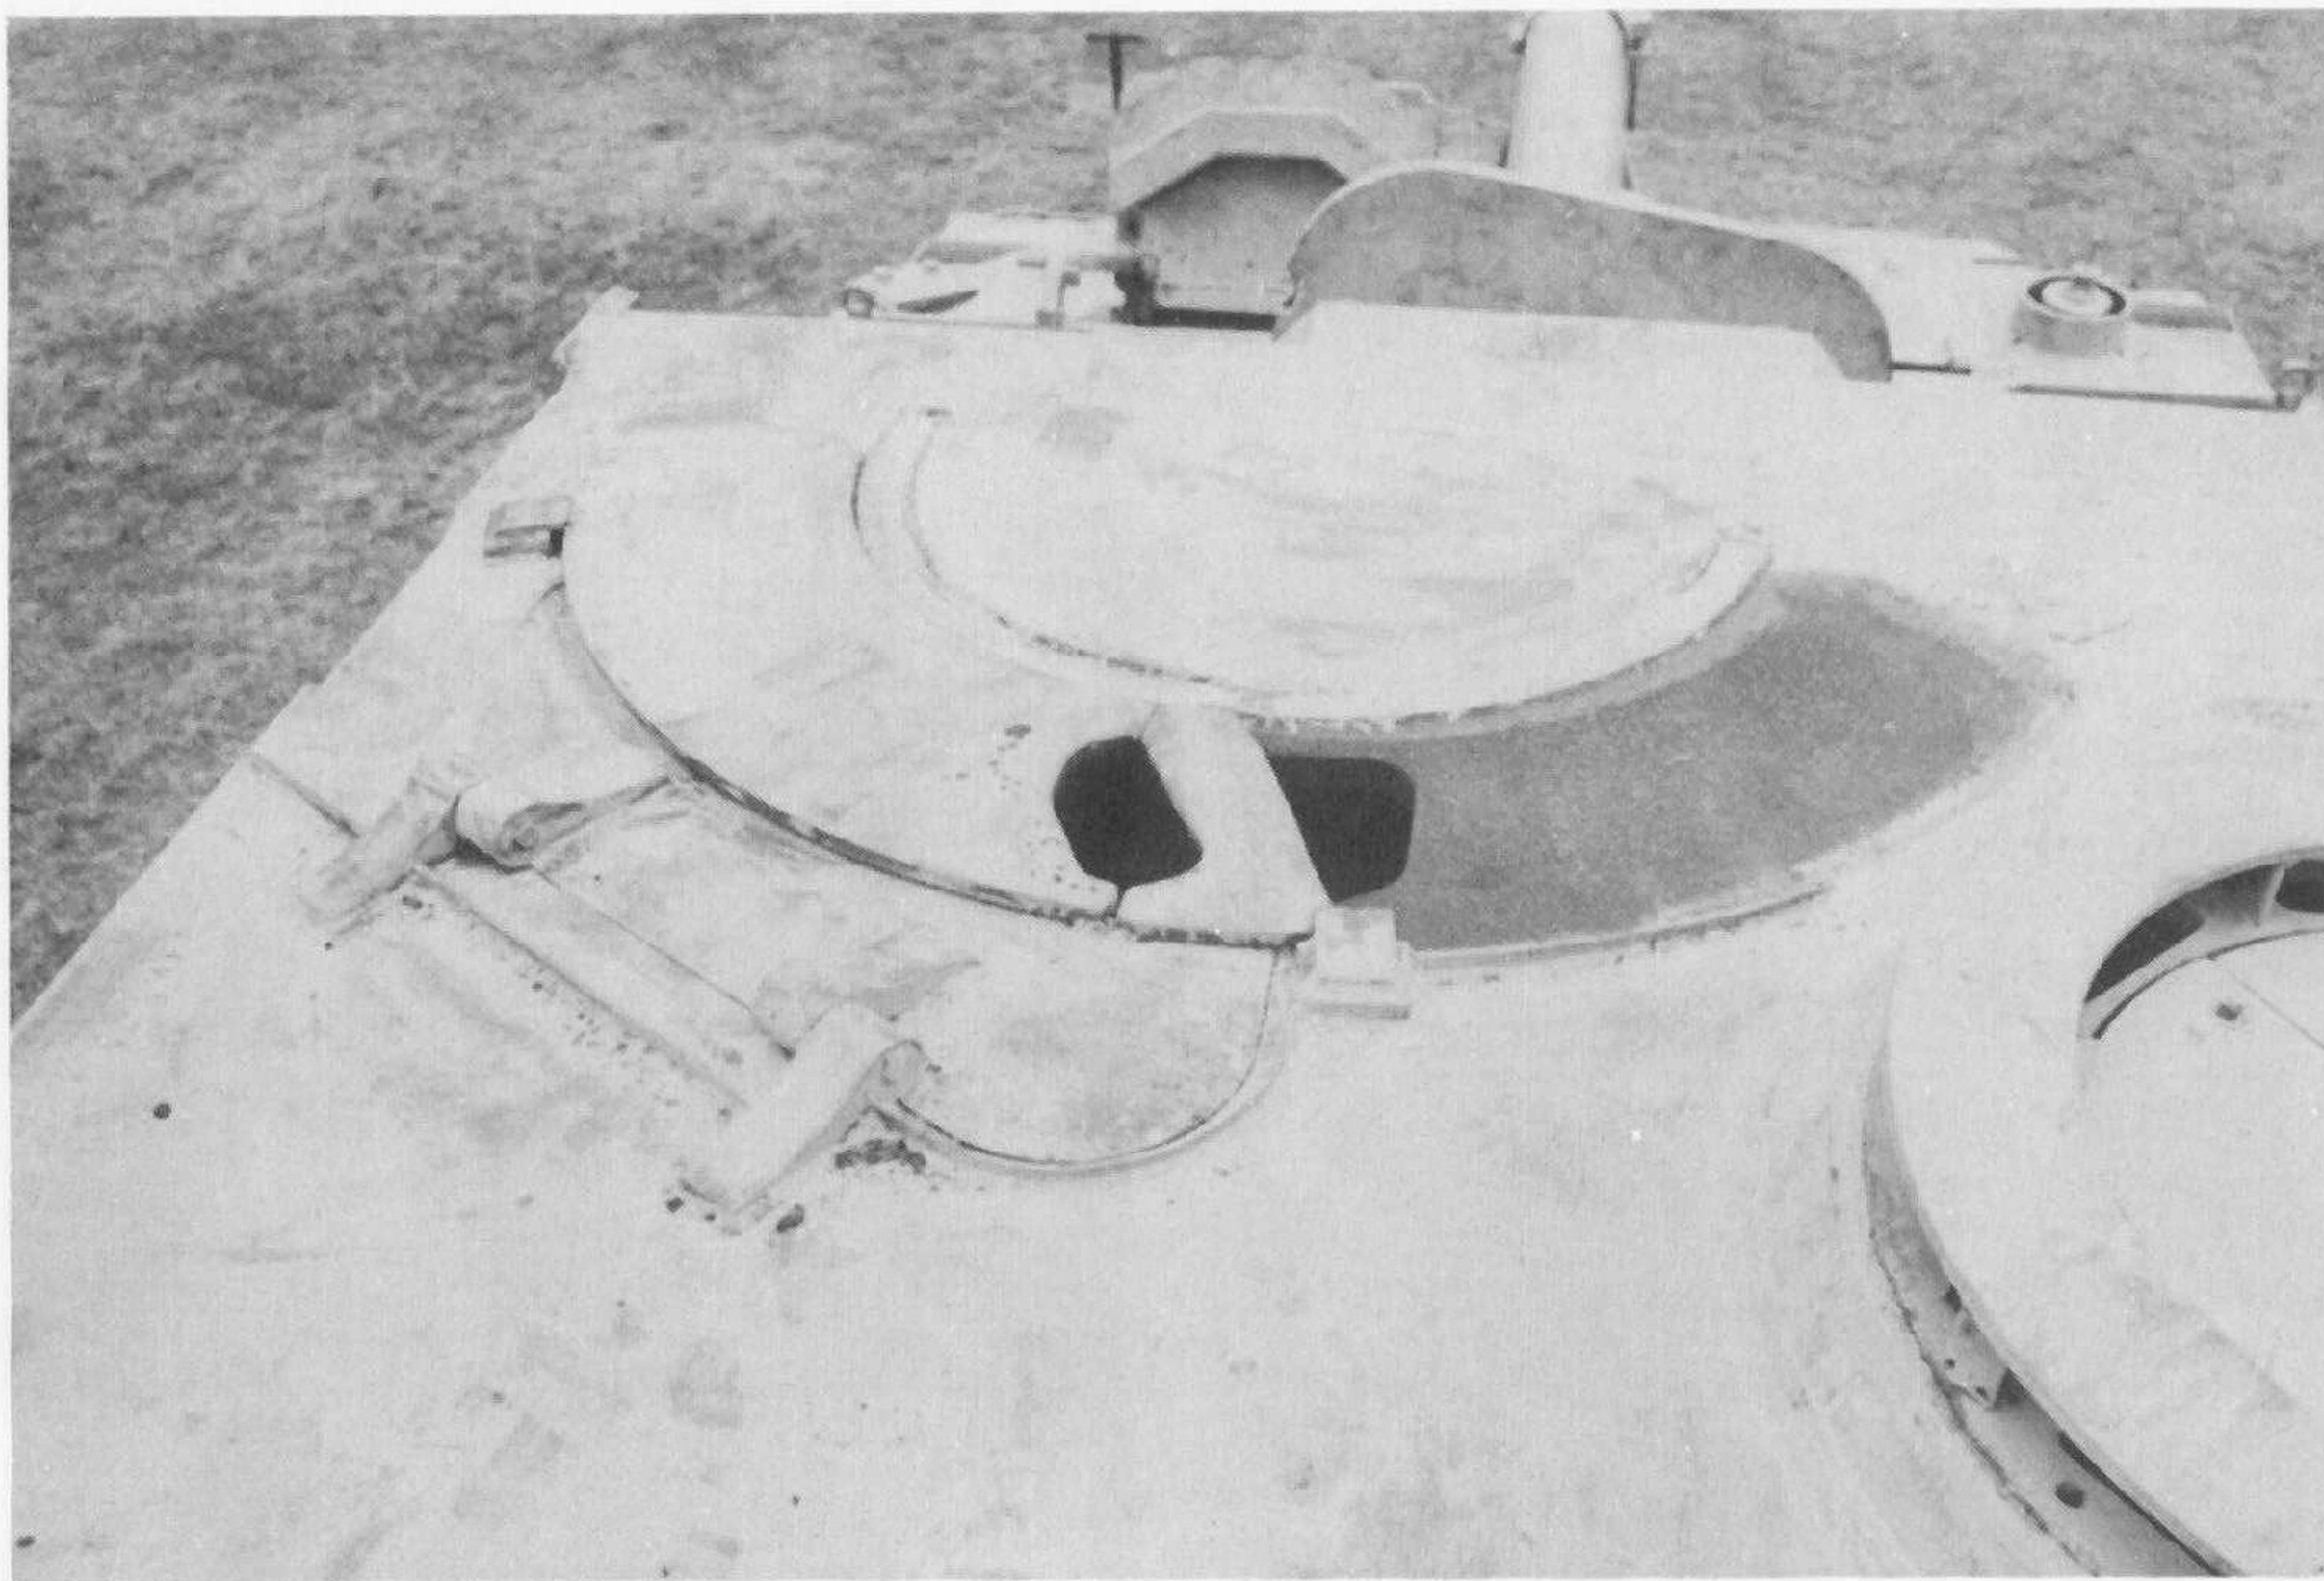
In the center is the roof vent surrounded with an armored box. The commander's cupola is in the upper right.

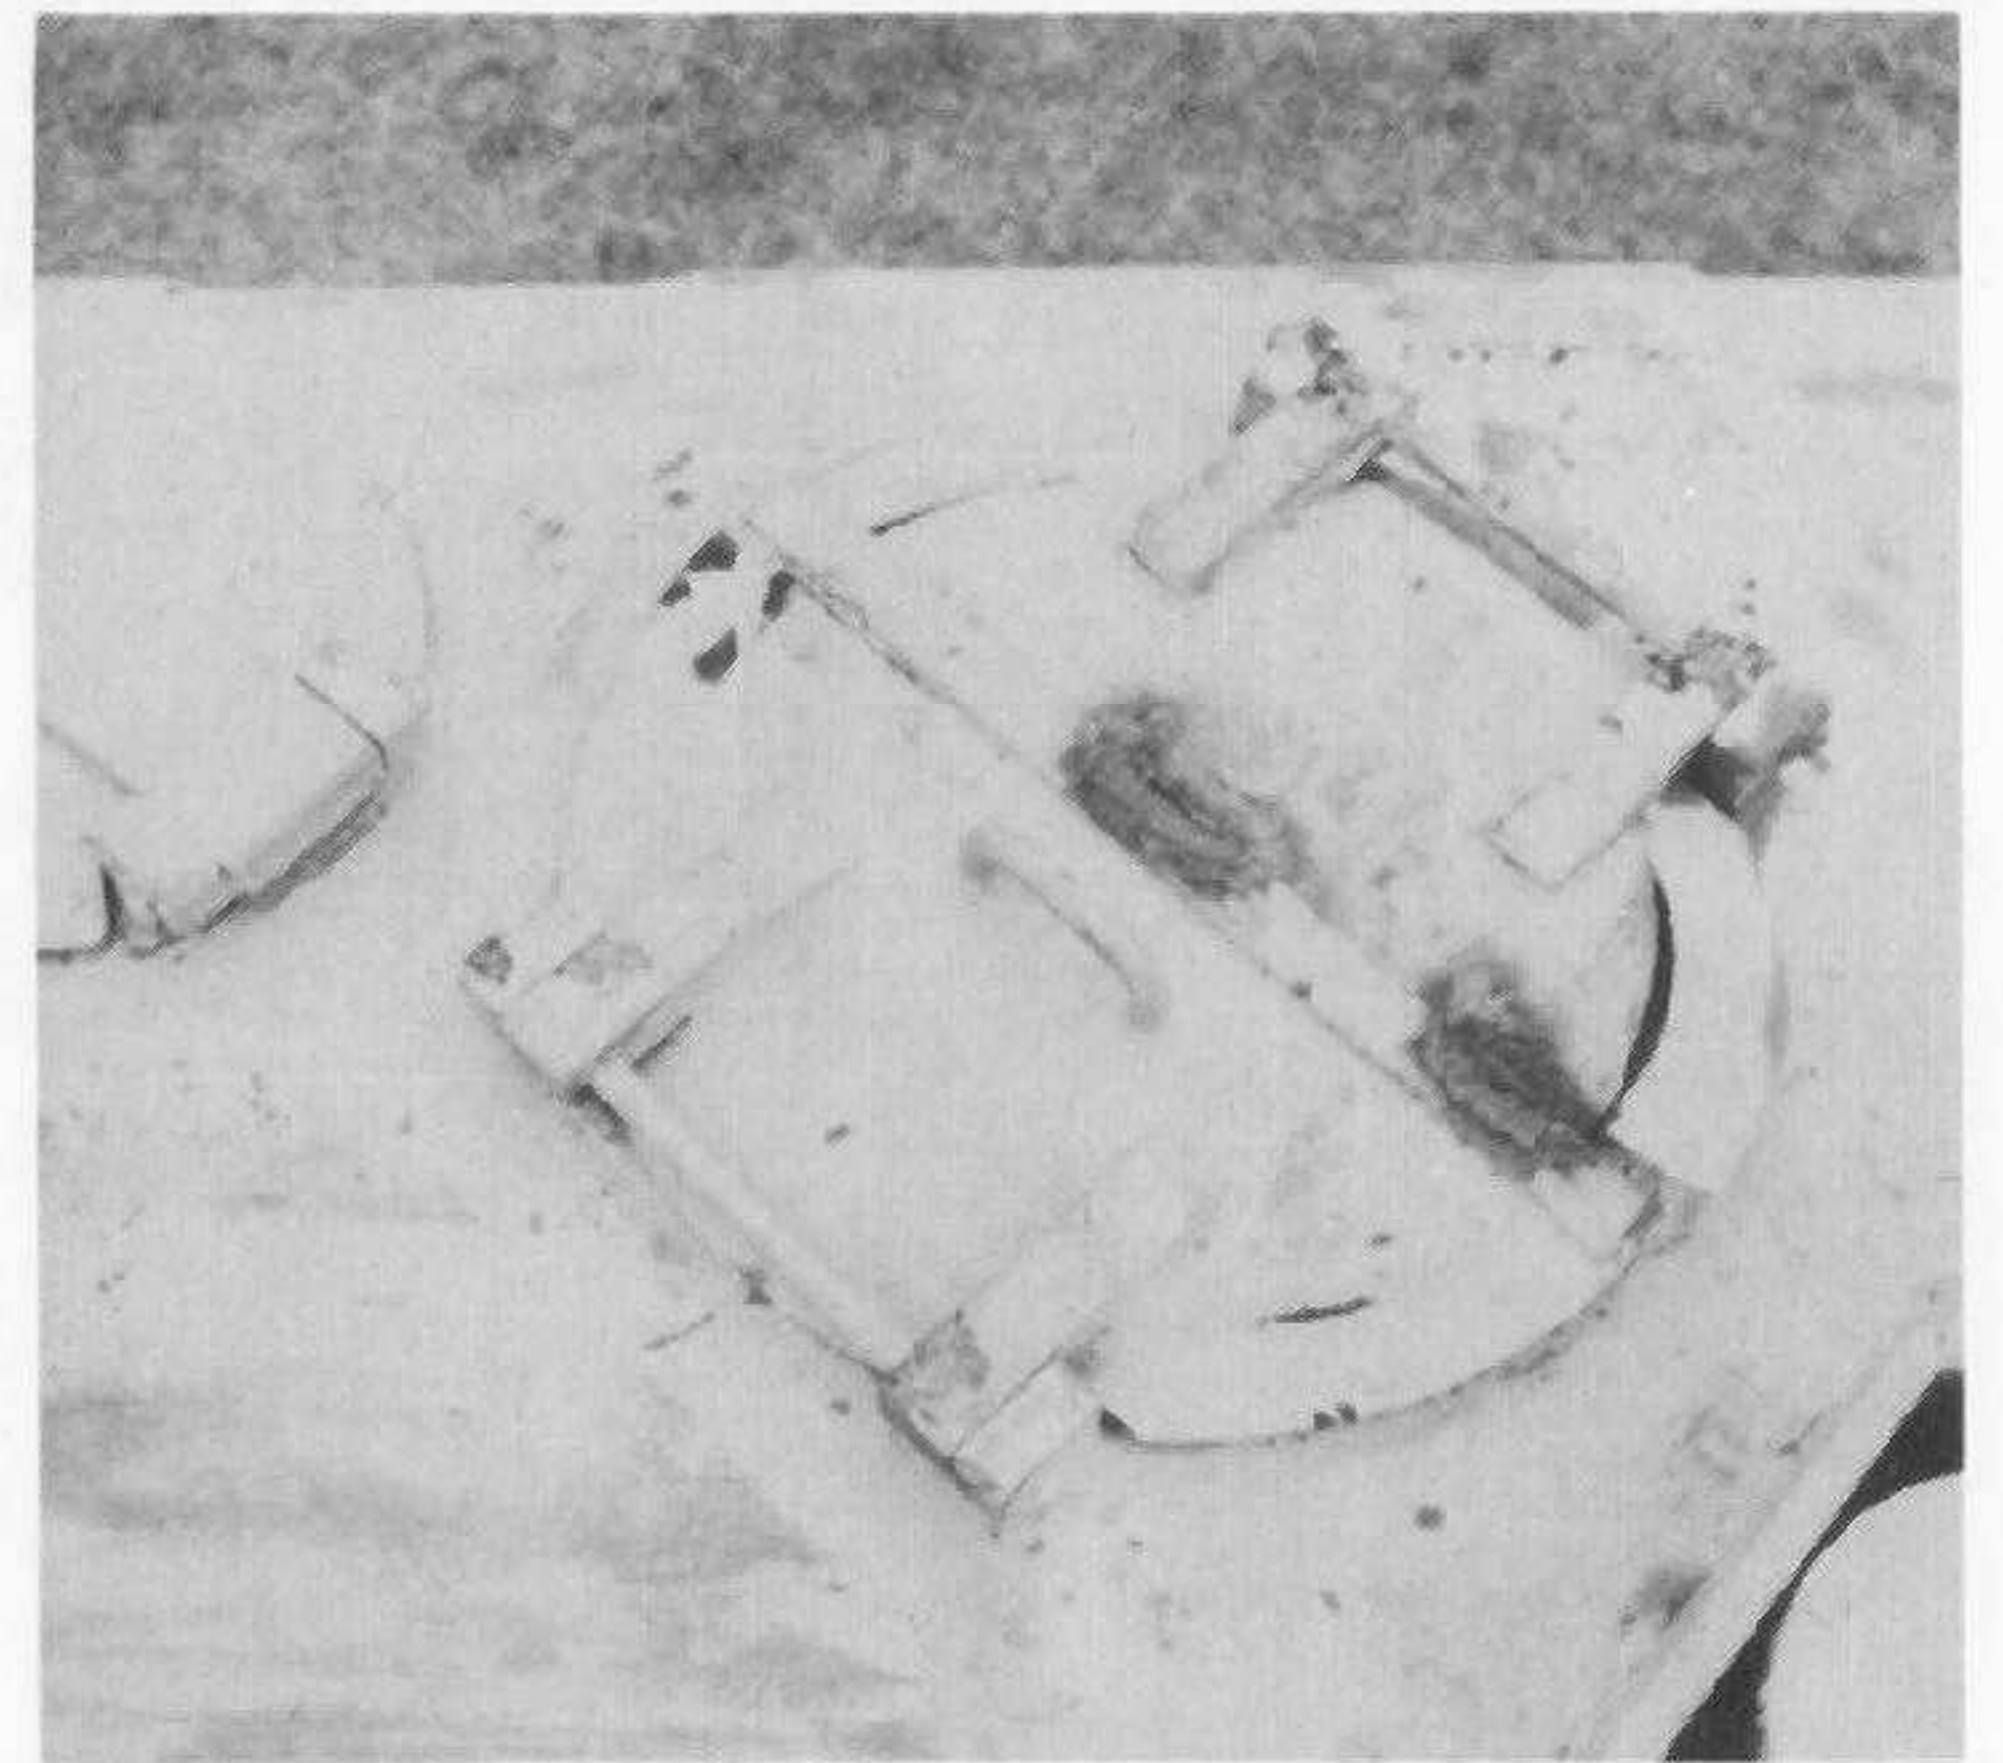
The crew hatch near the back left corner of the fighting compartment was one of three hinged openings on top. This two piece hatch did not have any vision devices mounted and did not rotate.

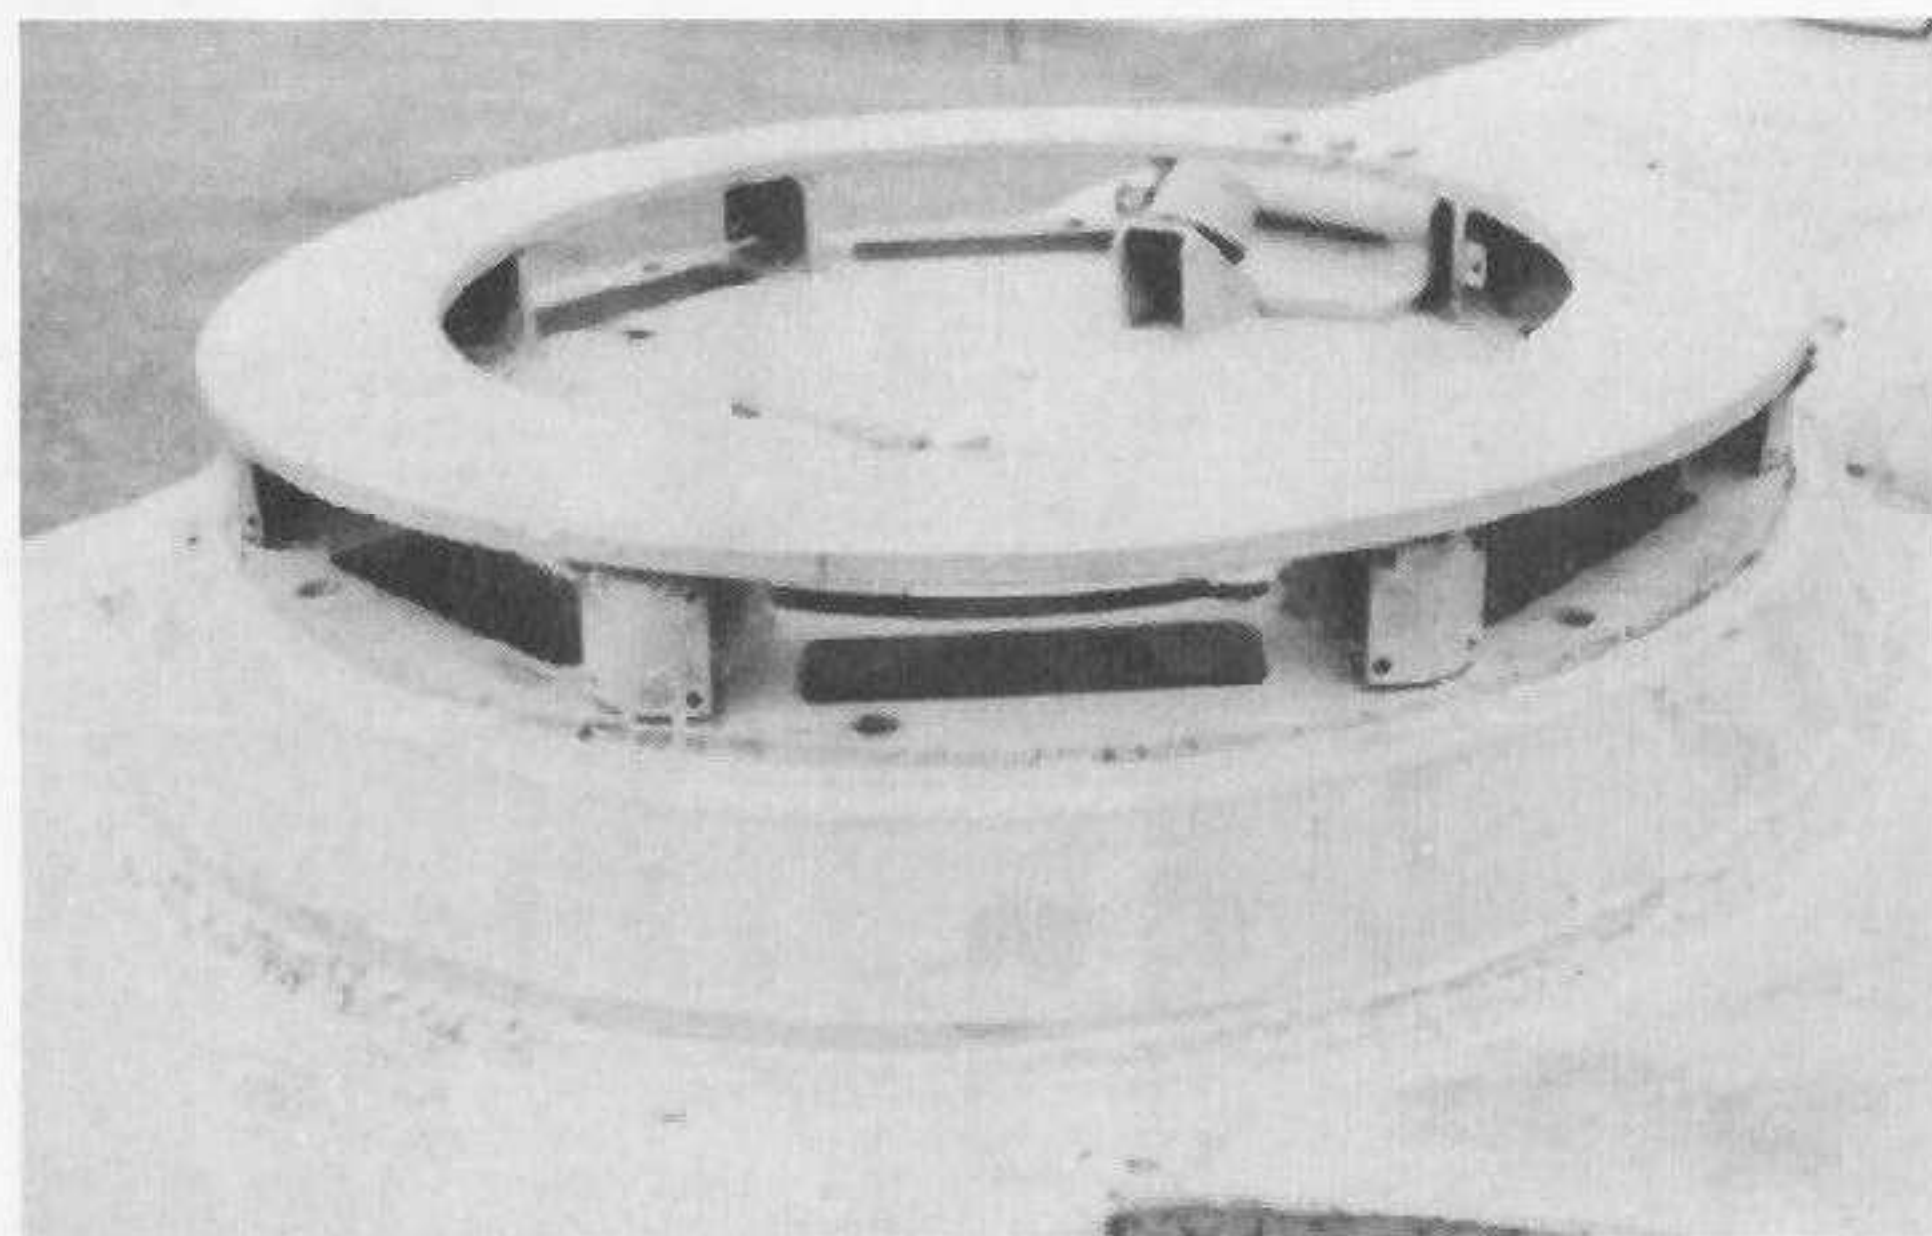
RIGHT: The forward sliding periscope aperture. There was also a hinged hatch that could be used for the gunner's escape should it be necessary in an emergency.
