MUSEUM ORDNANCE SPECIAL NUMBER 4

Elefant Panzerjäger Tiger (P)

Text by Thomas L. Jentz
Photos by Jeffrey D. McKaughan

THE "ELEFANT" AT ABERDEEN

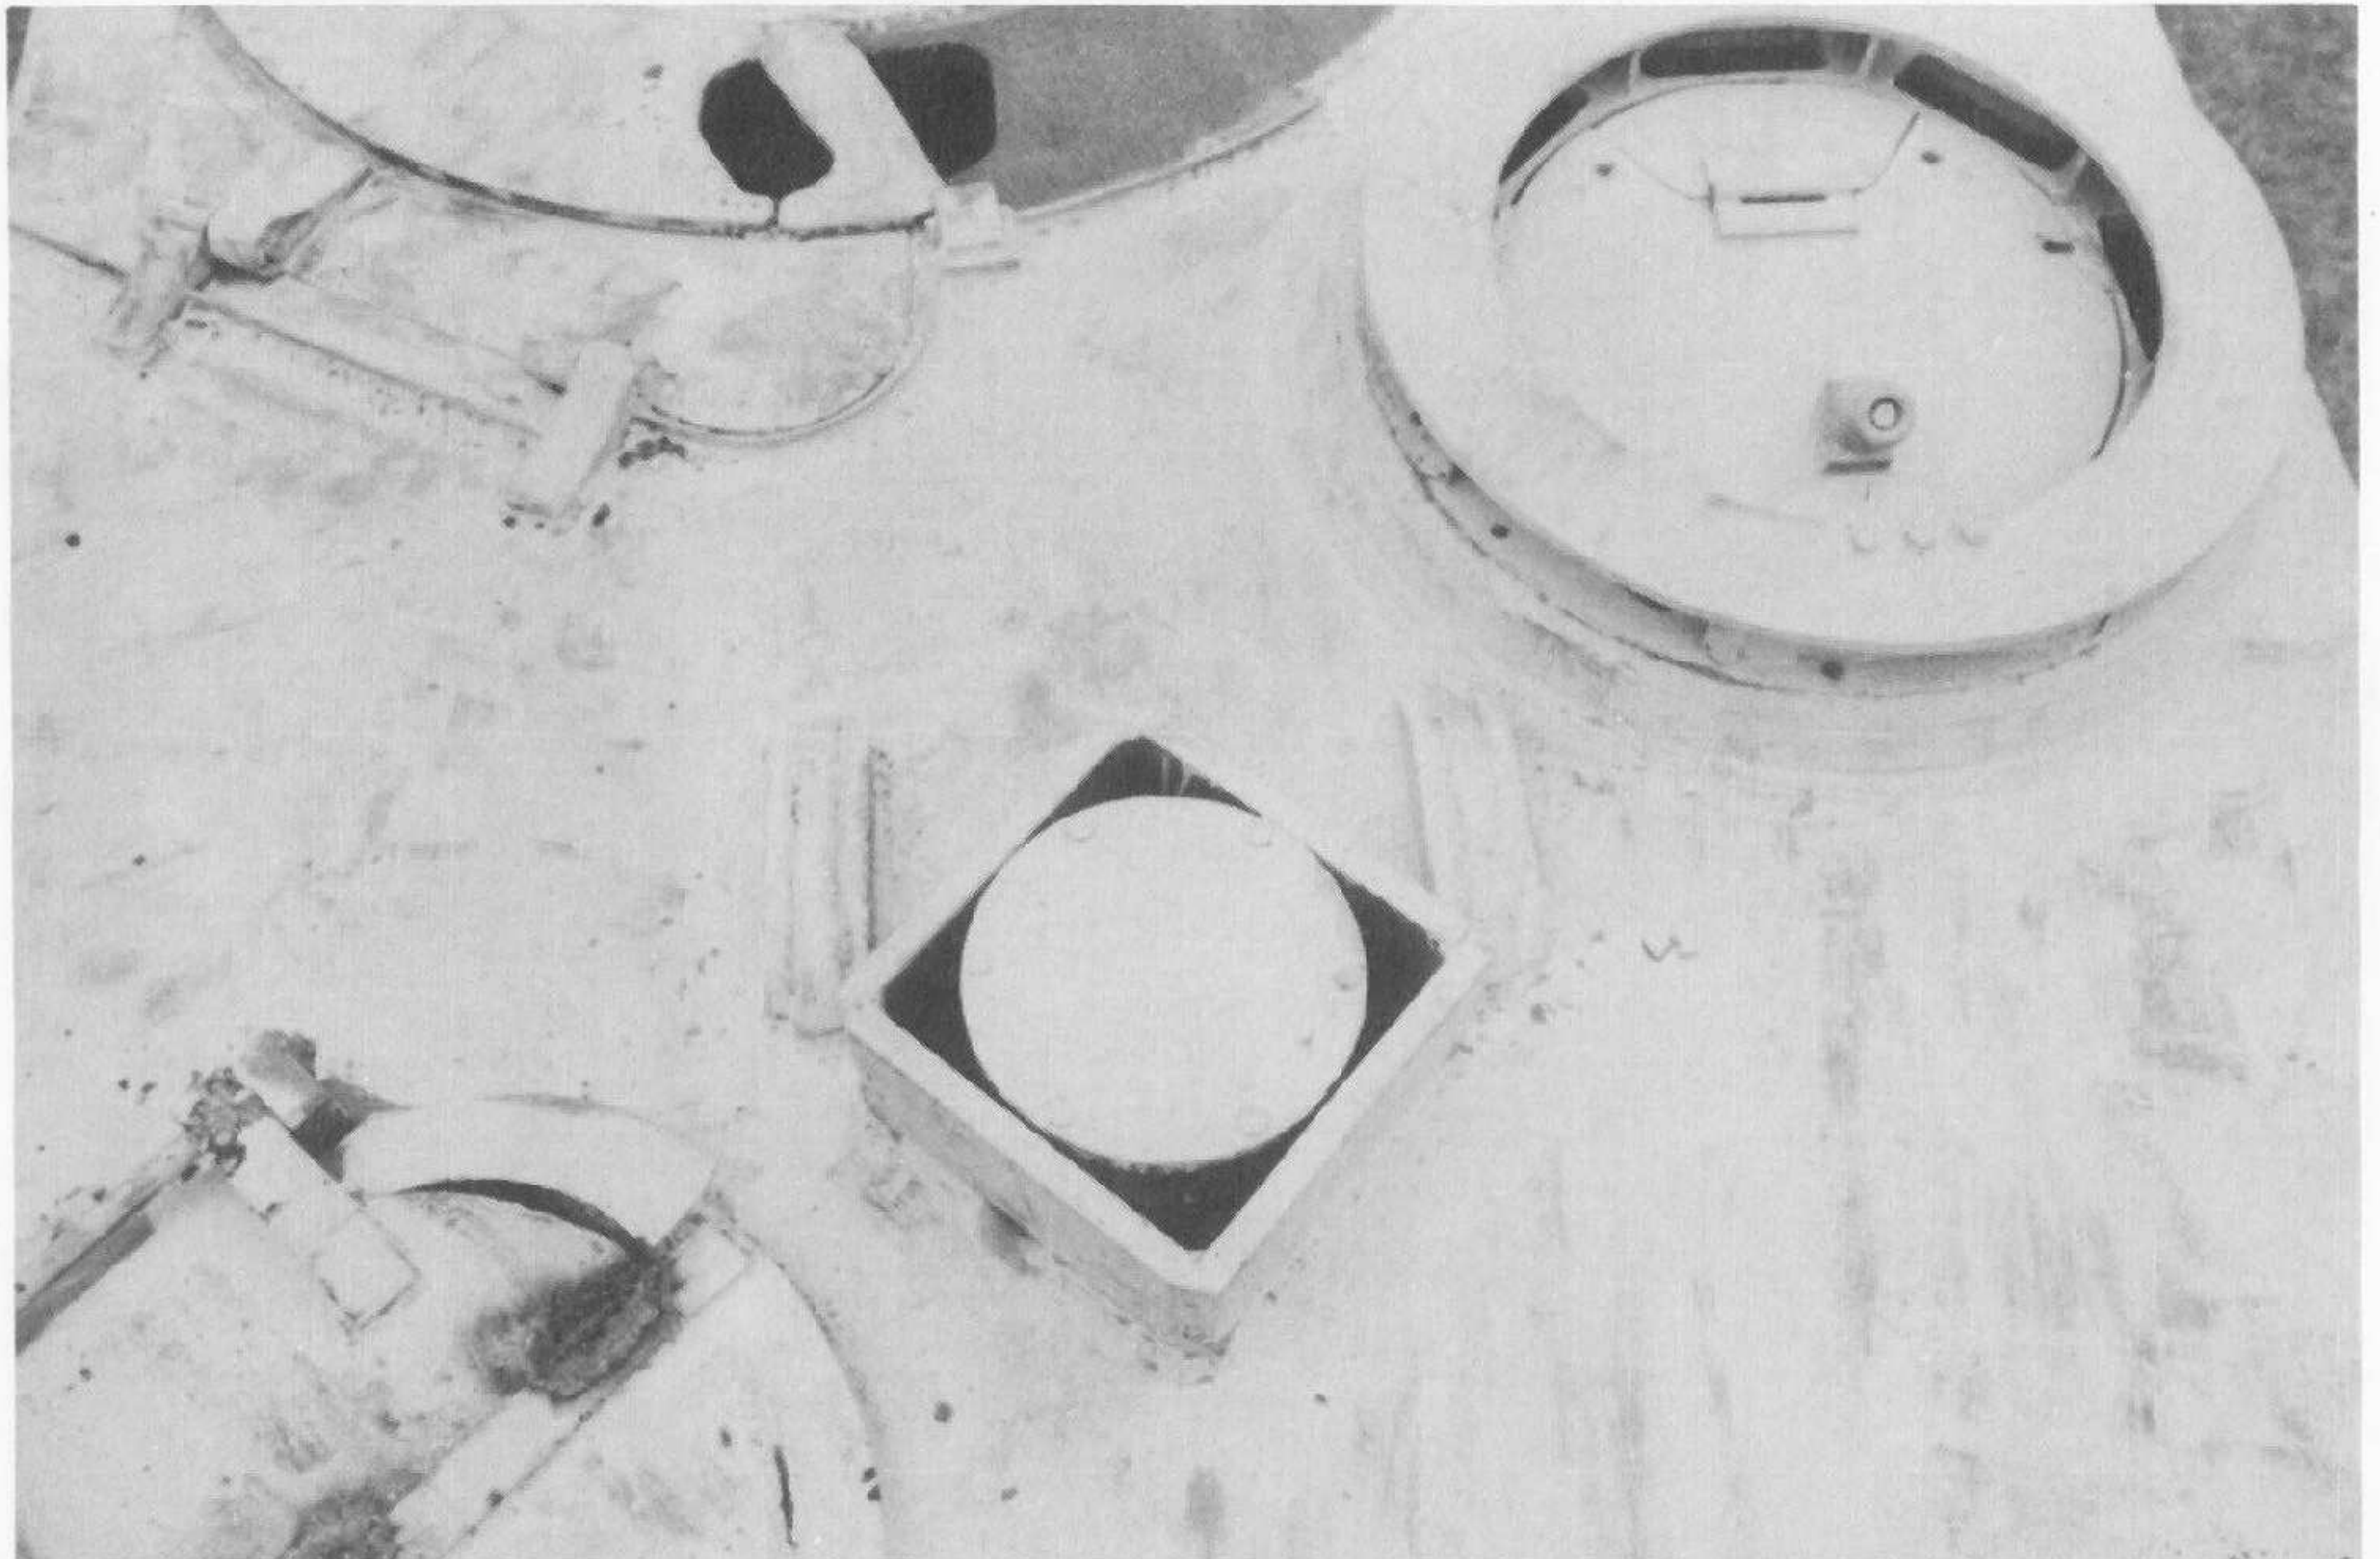
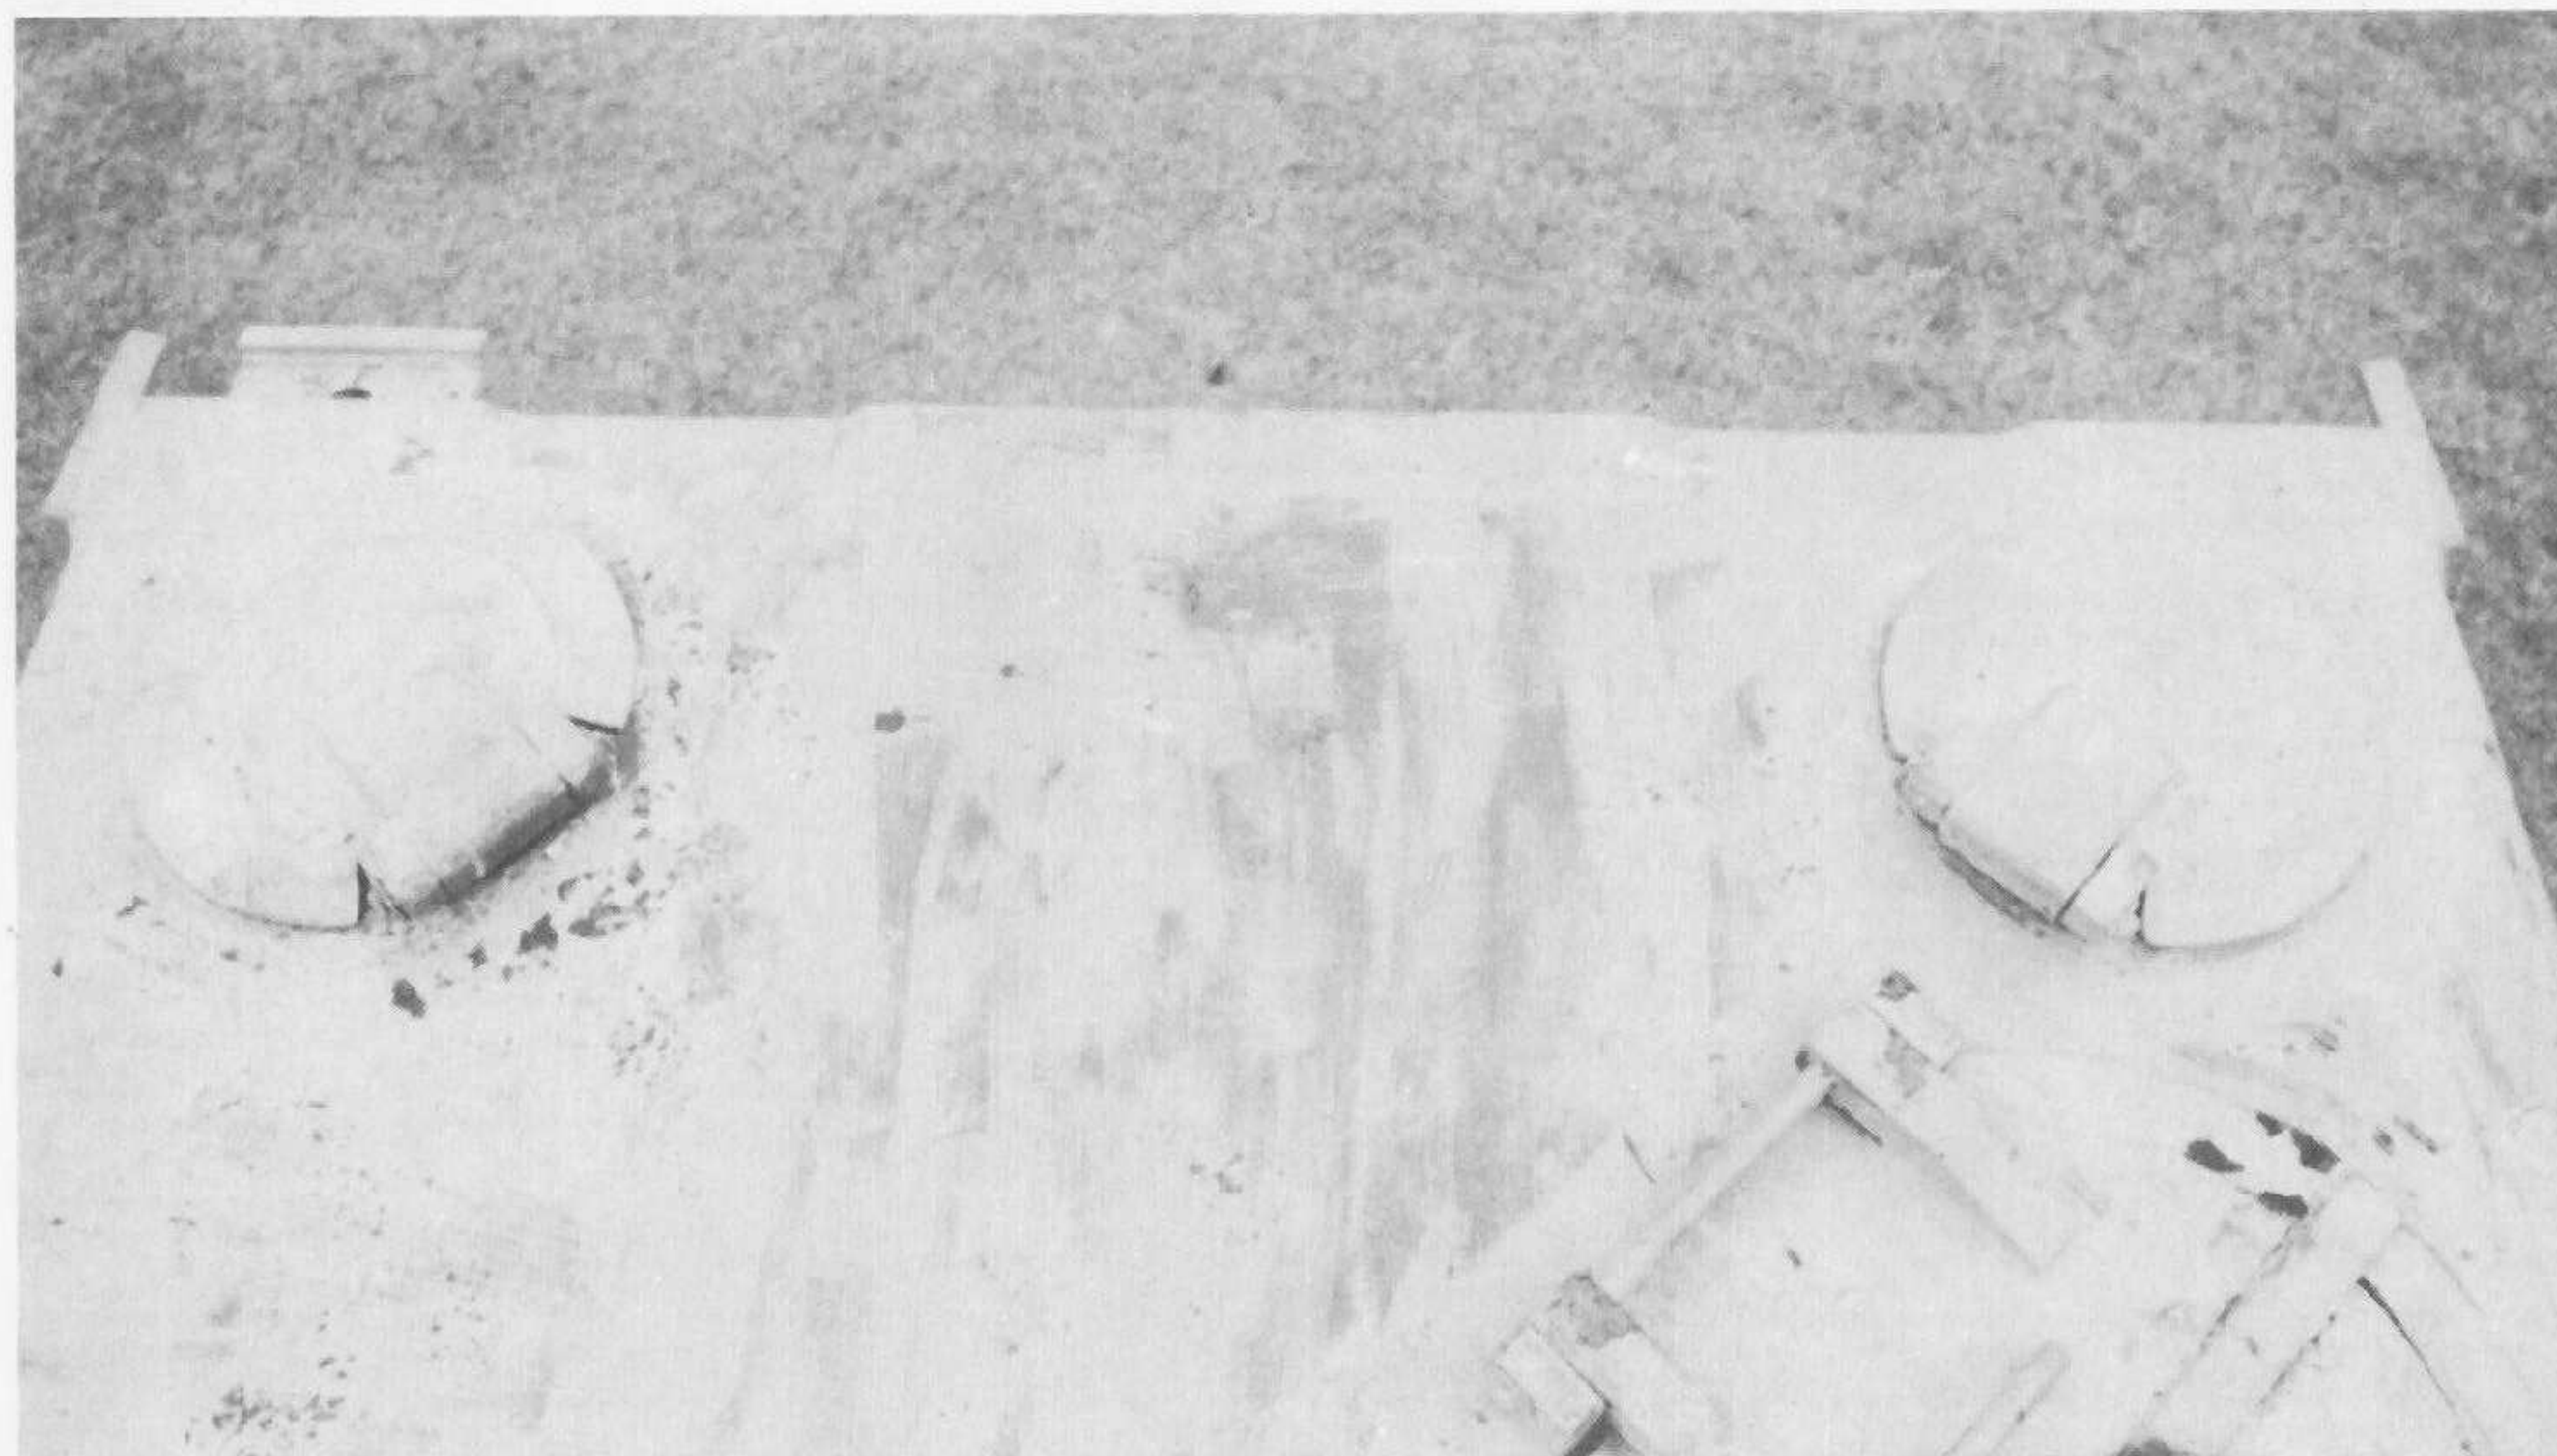
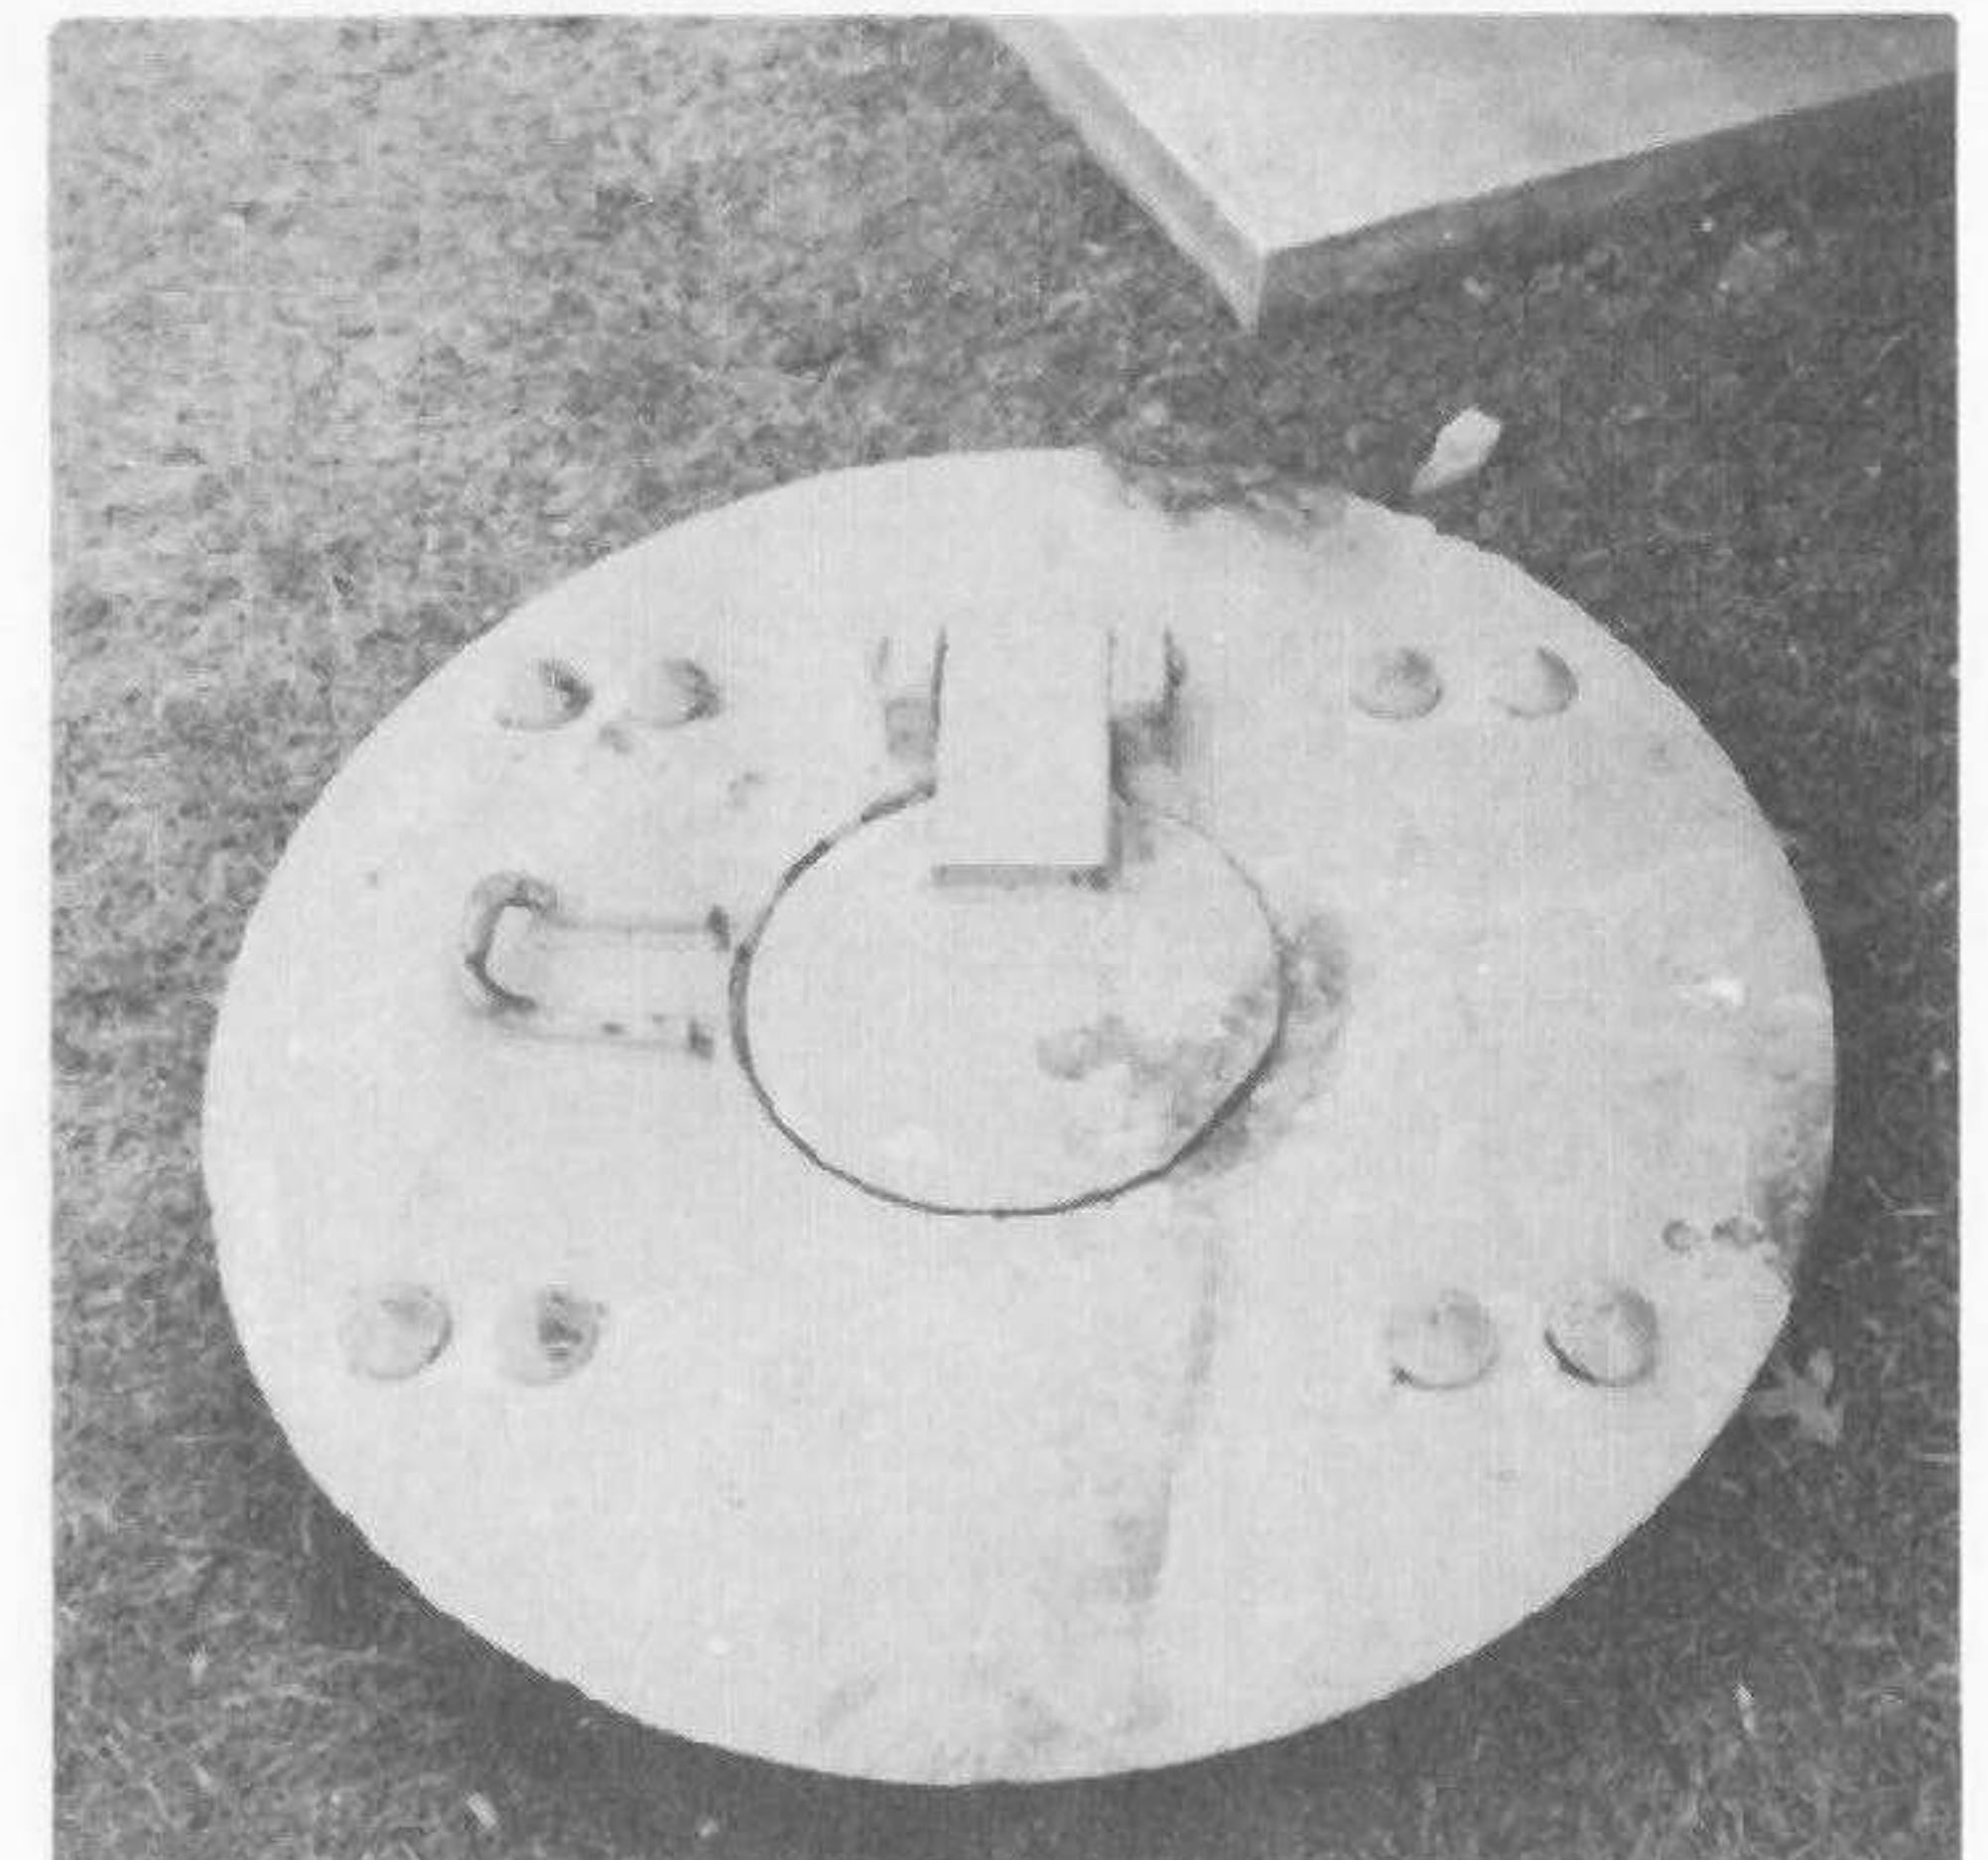
The commander's cupola with seven vision blocks covering all directions except straight back.

Small periscope ports for the loader's use, both identical and located in the back corners on top of the fighting compartment.

The rear access hatch was held in place by eight conical bolts fastened to plates.

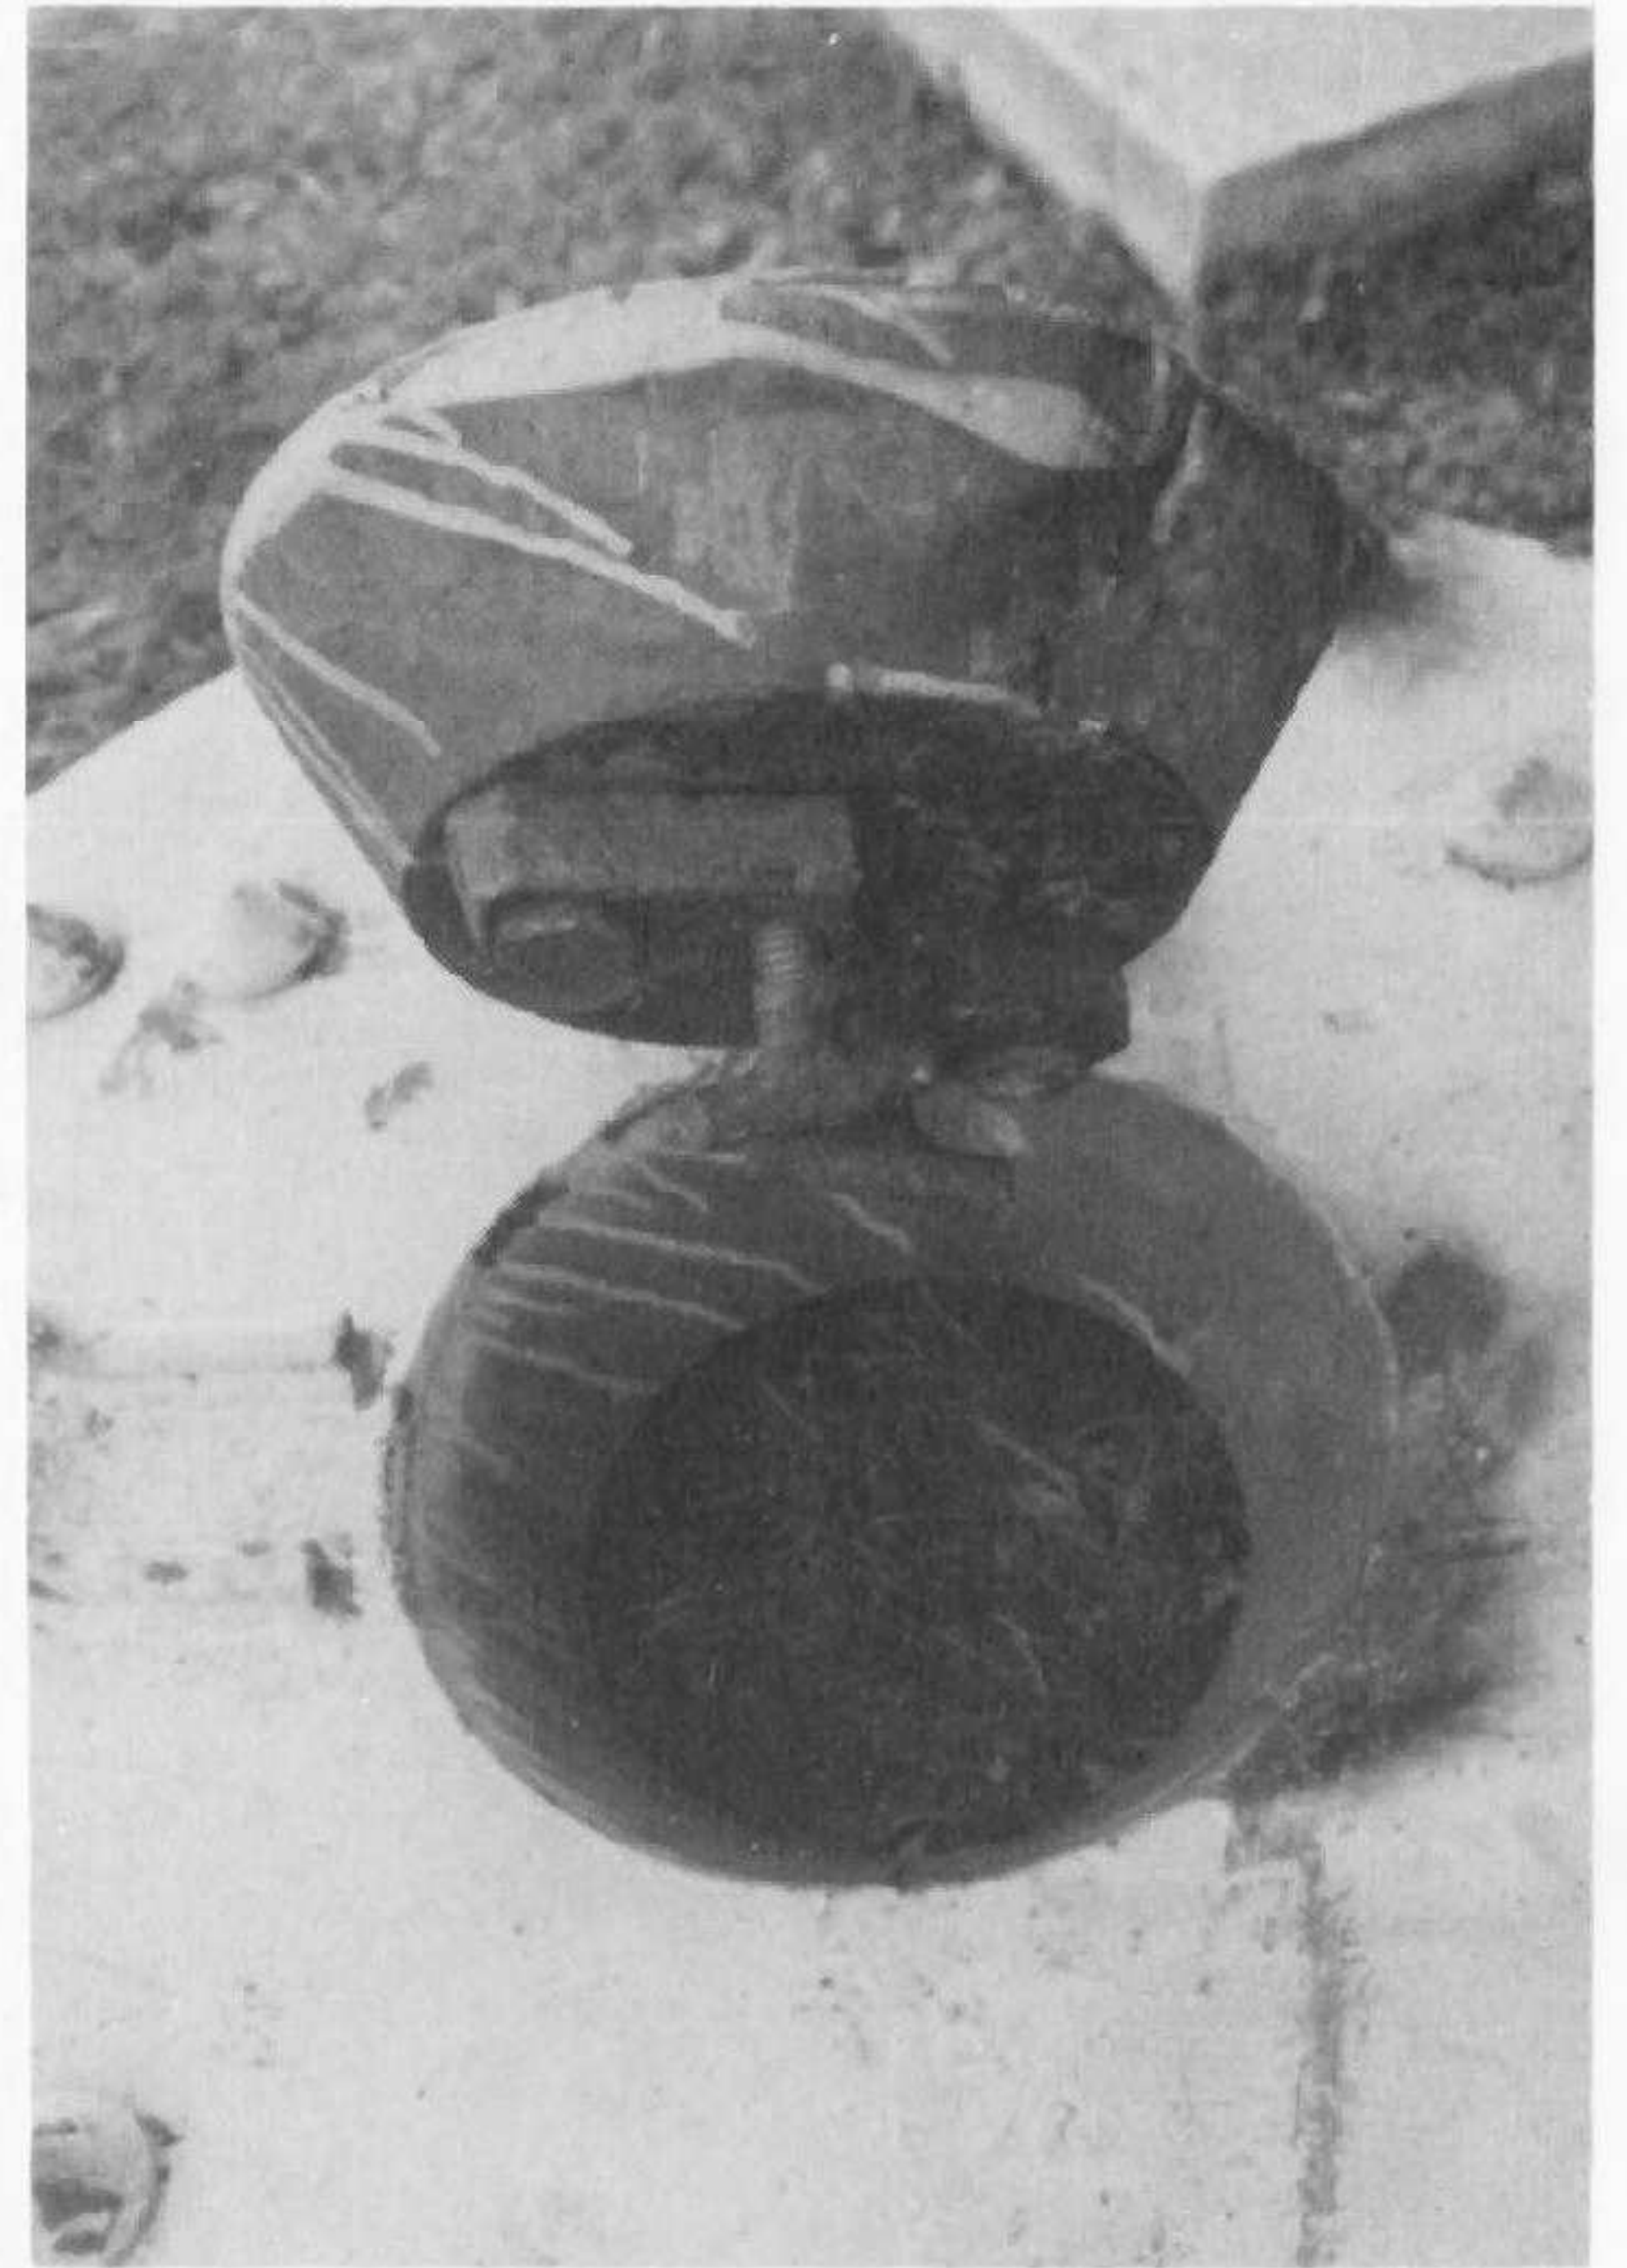
The shell ejection port was located in the center of the large rear hatch. The port was hinged with a locking screw mechanism on the inside. This port was approximately 10 1/2 ins. in diameter.

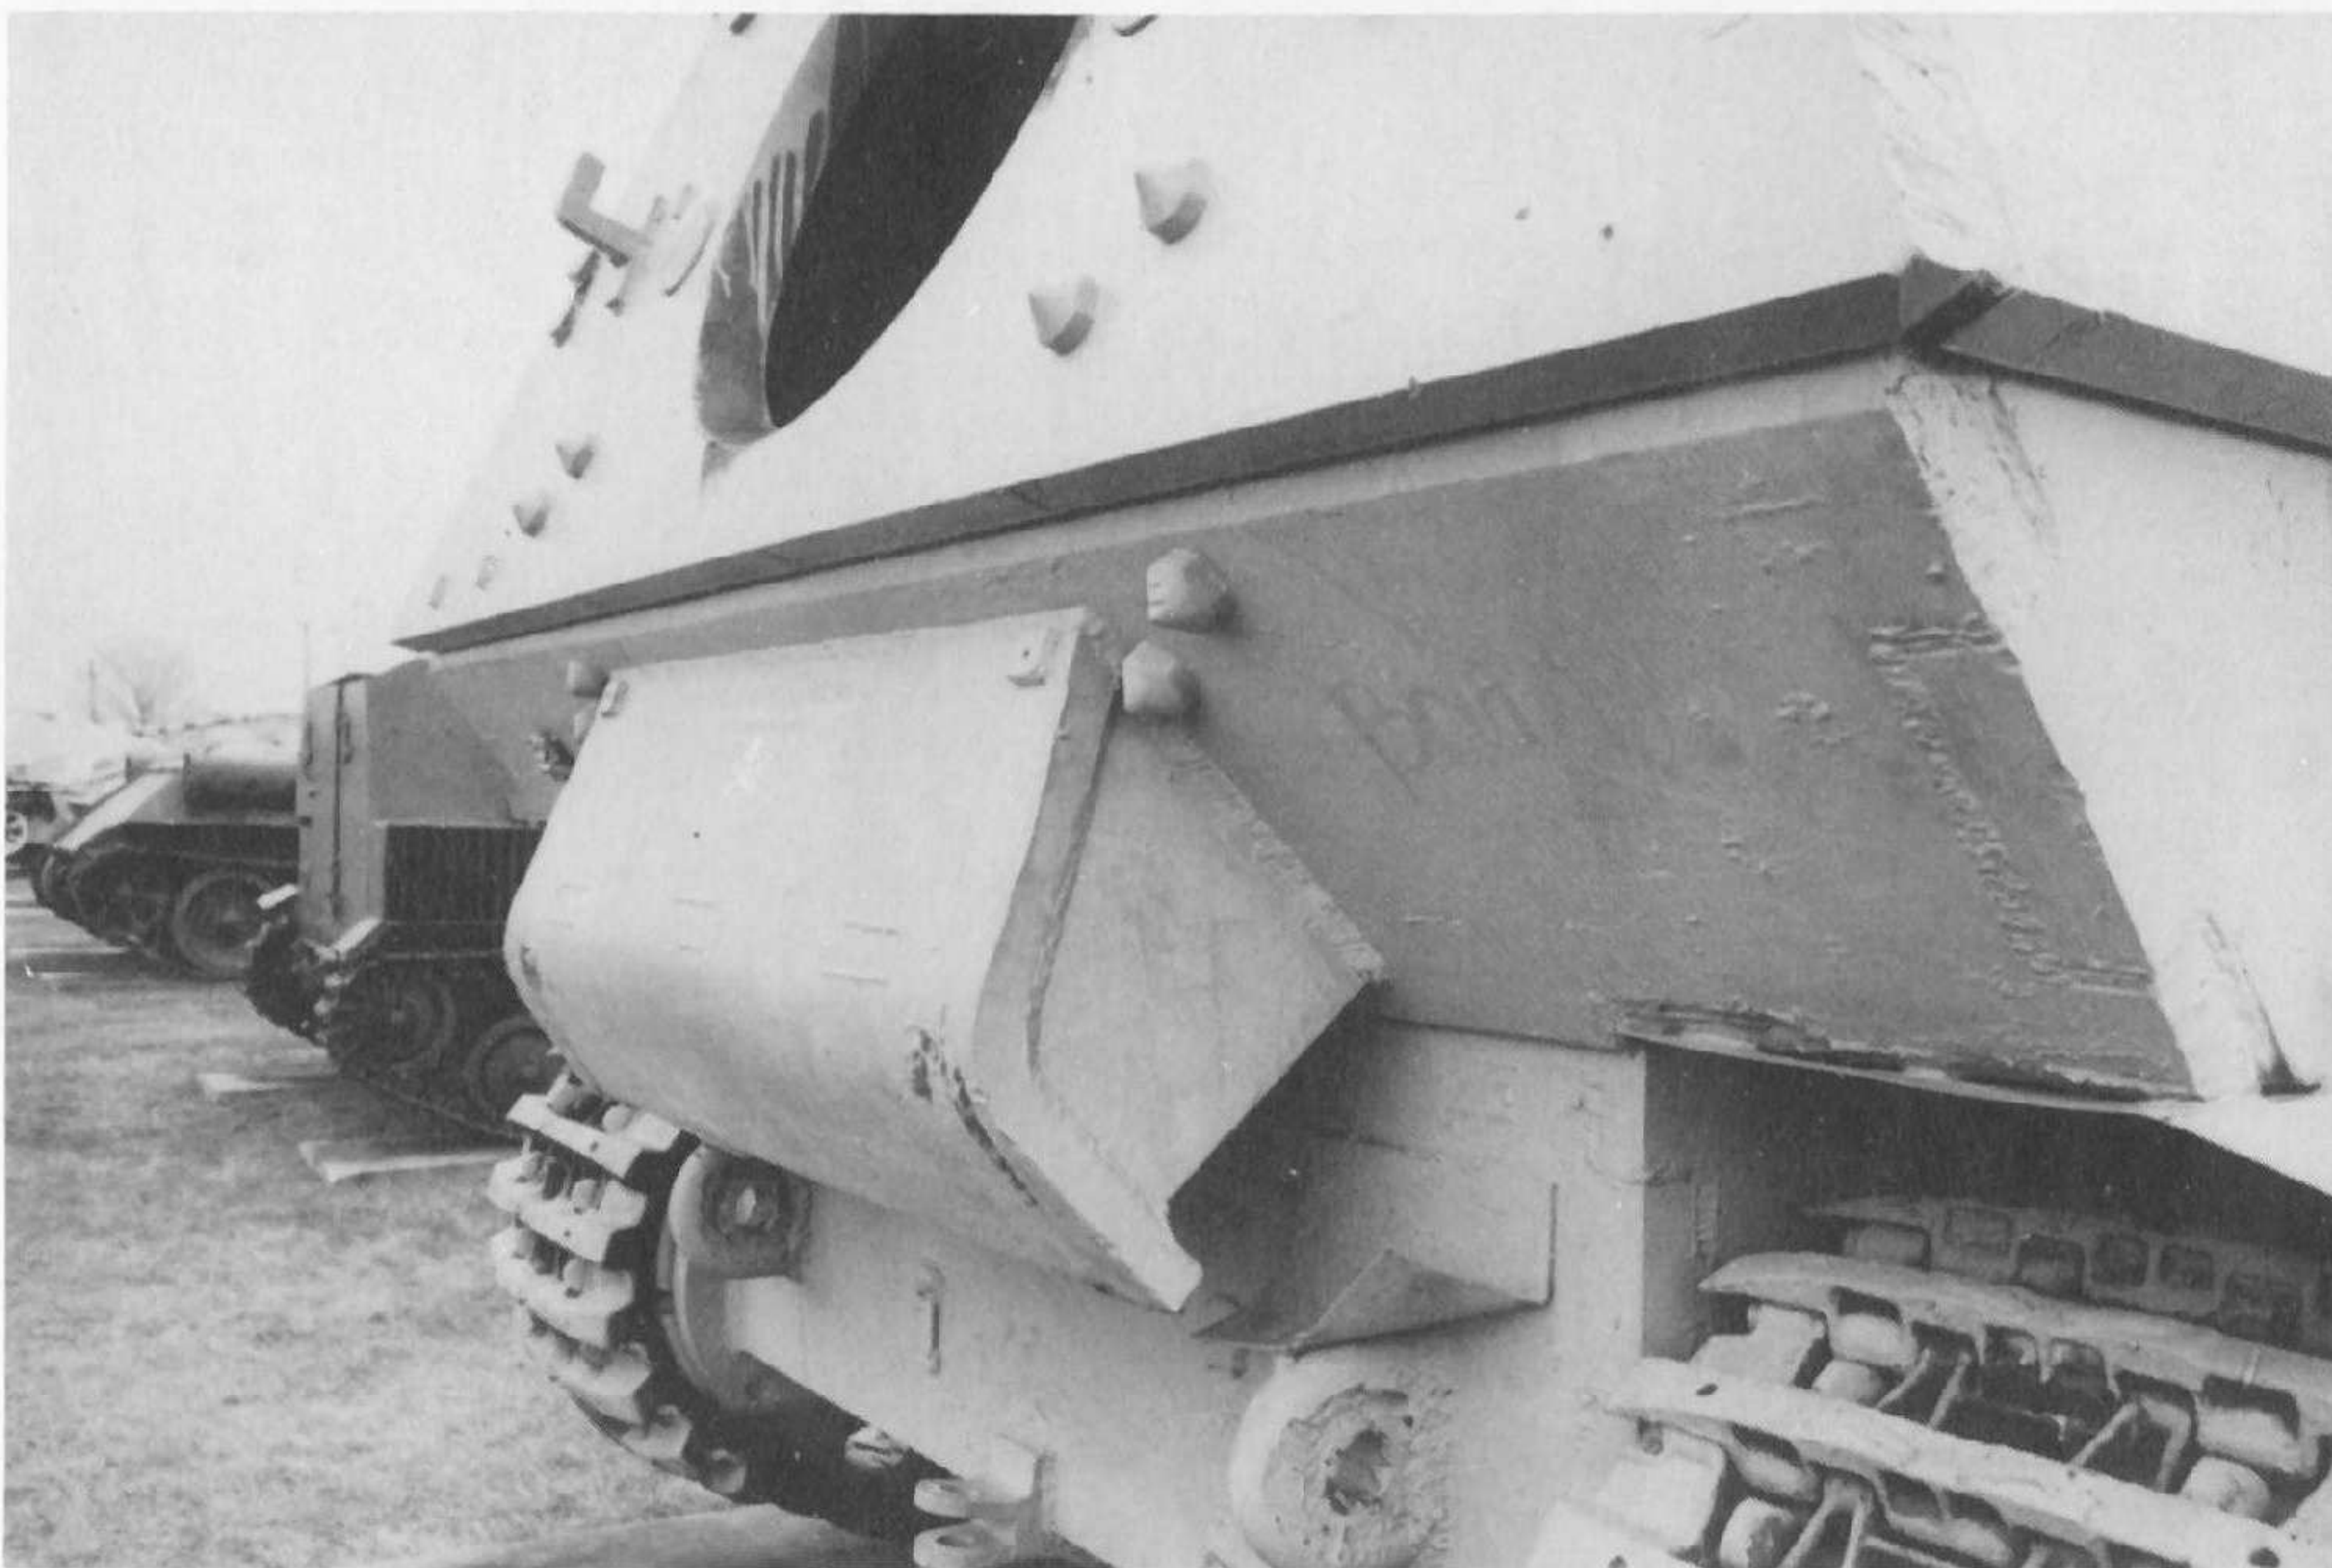
LEFT: The armored shroud covered the vent for the Siemen electric motors that powered the drive sprockets. Also note the interlocking of the welded portions of the vehicle.

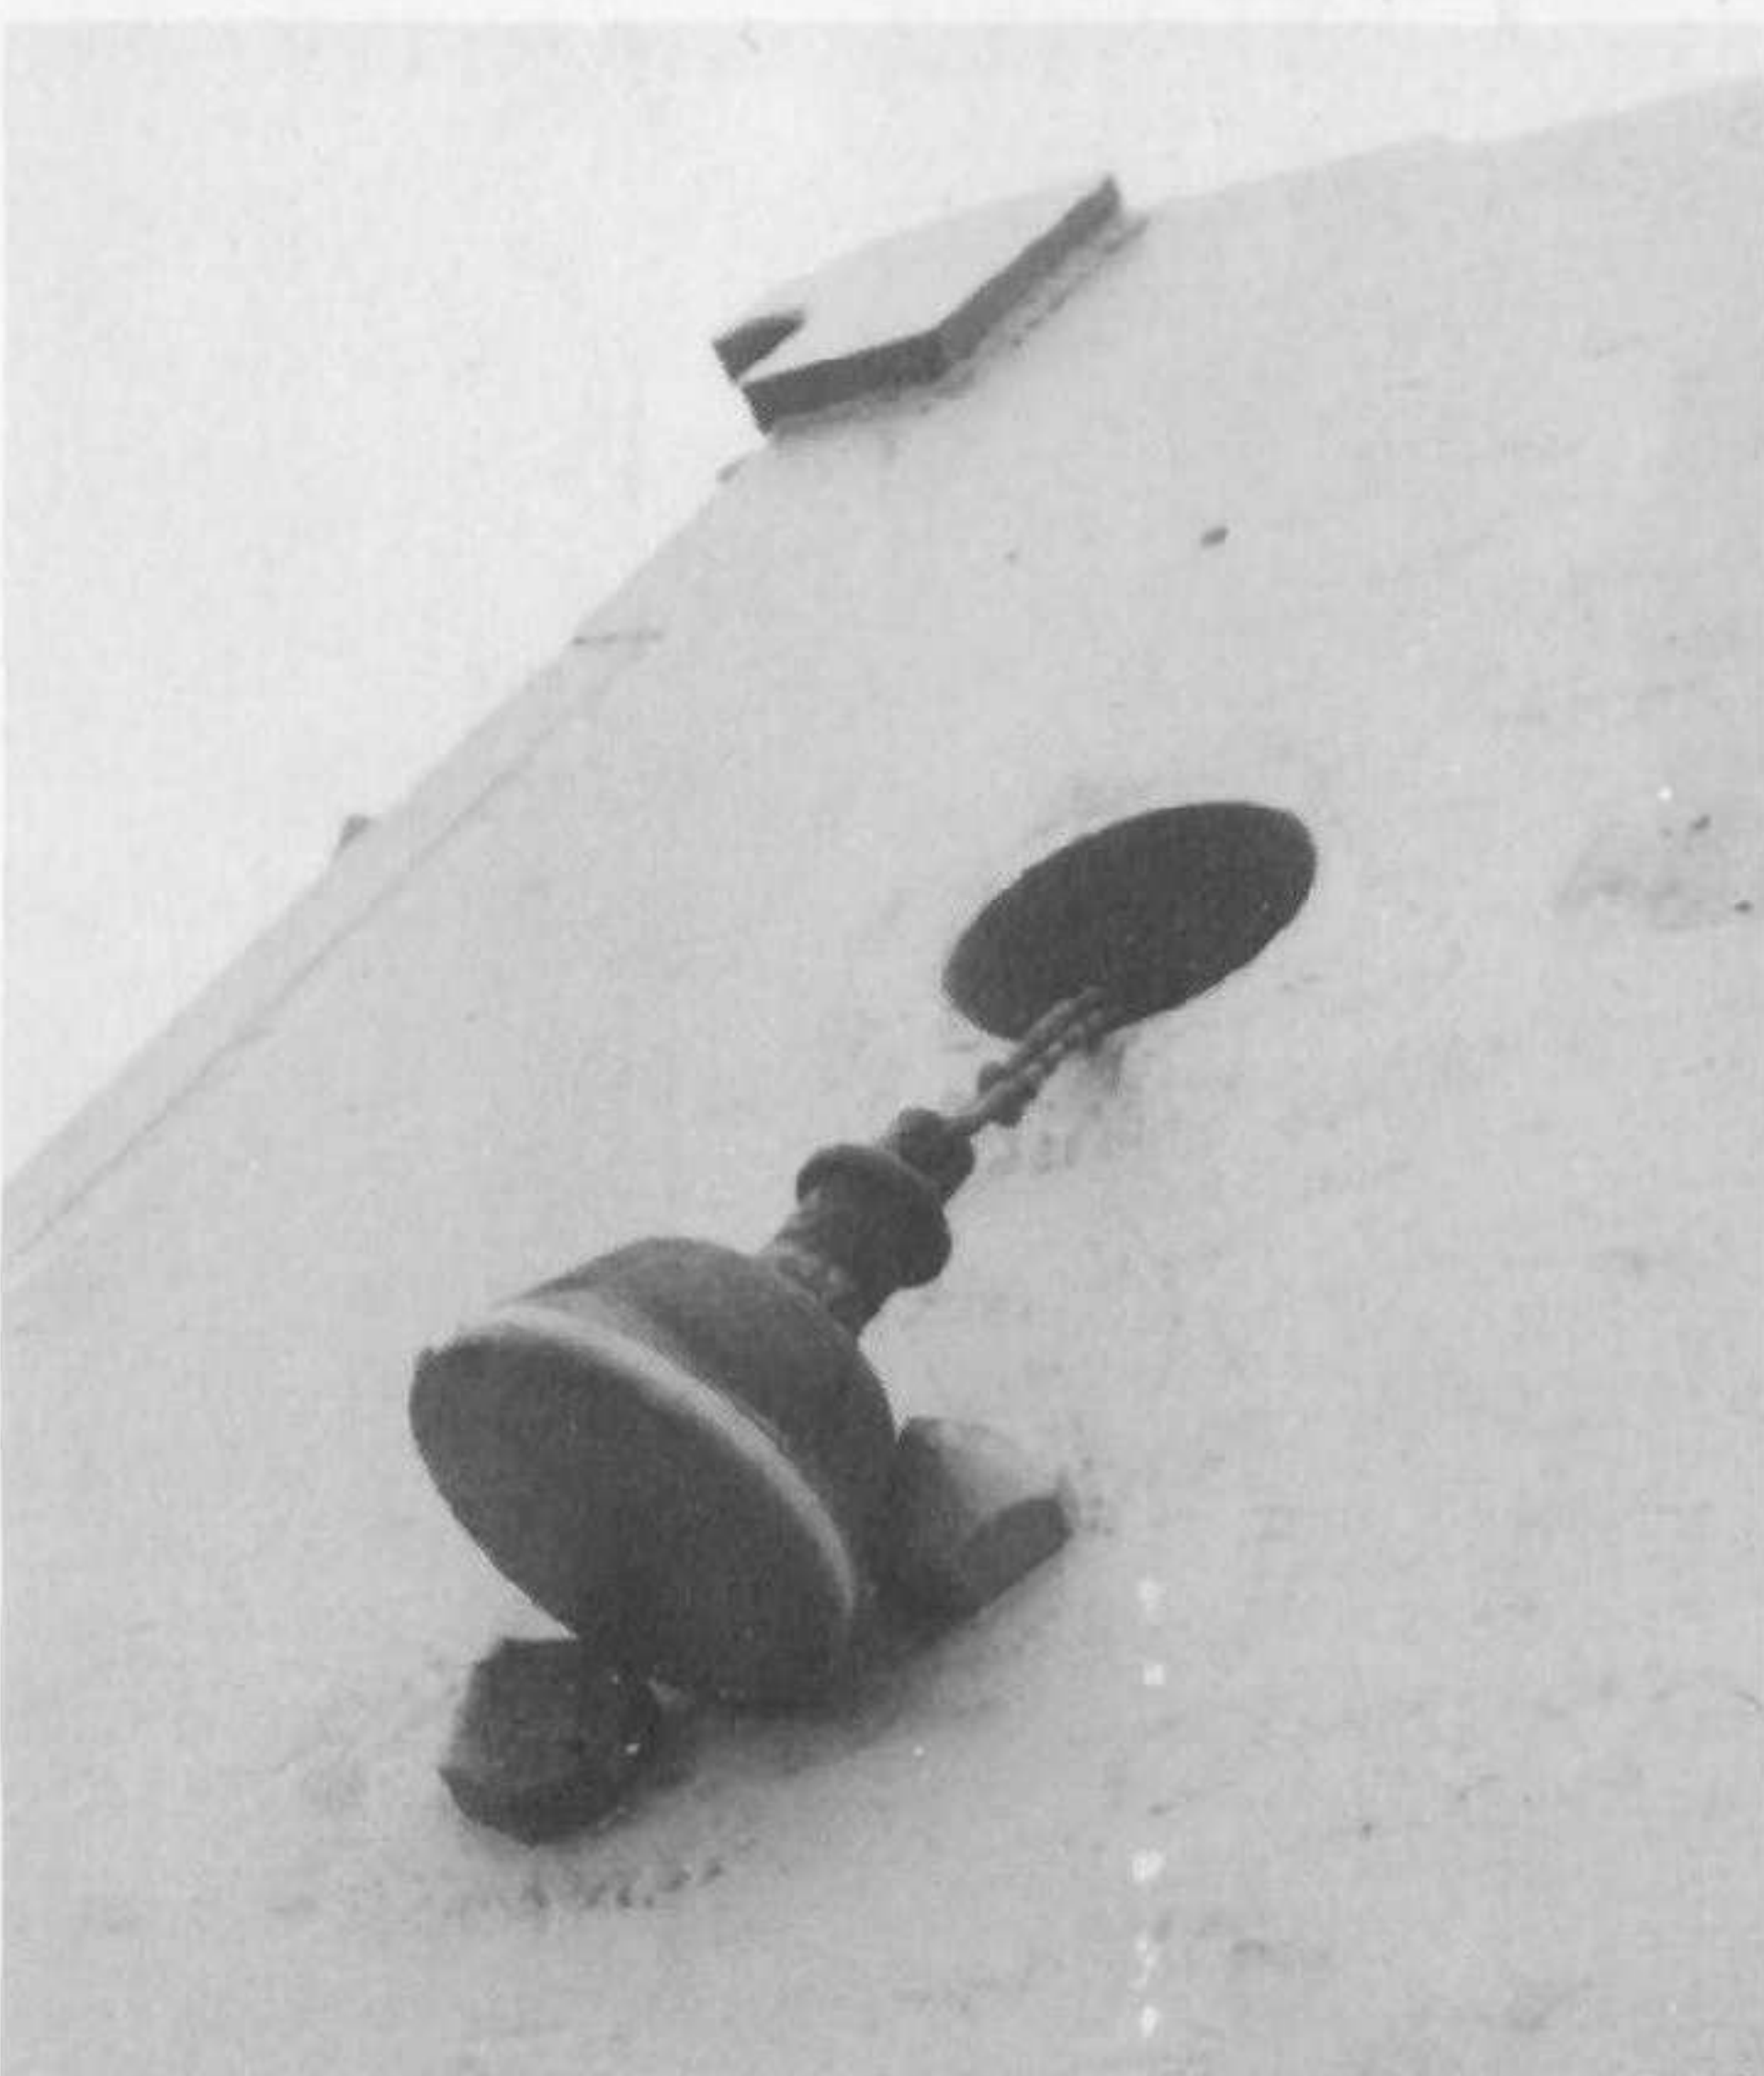
The right side pistol port has been punched out and allowed to hang at the full extension of the retrieval chain. Note the cone-shape to the pistol and the corresponding shape in the hull plate. This photo also clearly shows the rough cut to the interlocking plates. After testing in the US and years of being stored outside, little is left of the zimmerit that covered the Elephant at the time of its capture.
