MUSEUM ORDNANCE SPECIAL NUMBER 4

Elefant Panzerjäger Tiger (P)

Text by Thomas L. Jentz
Photos by Jeffrey D. McKaughan

THE "ELEFANT" AT ABERDEEN

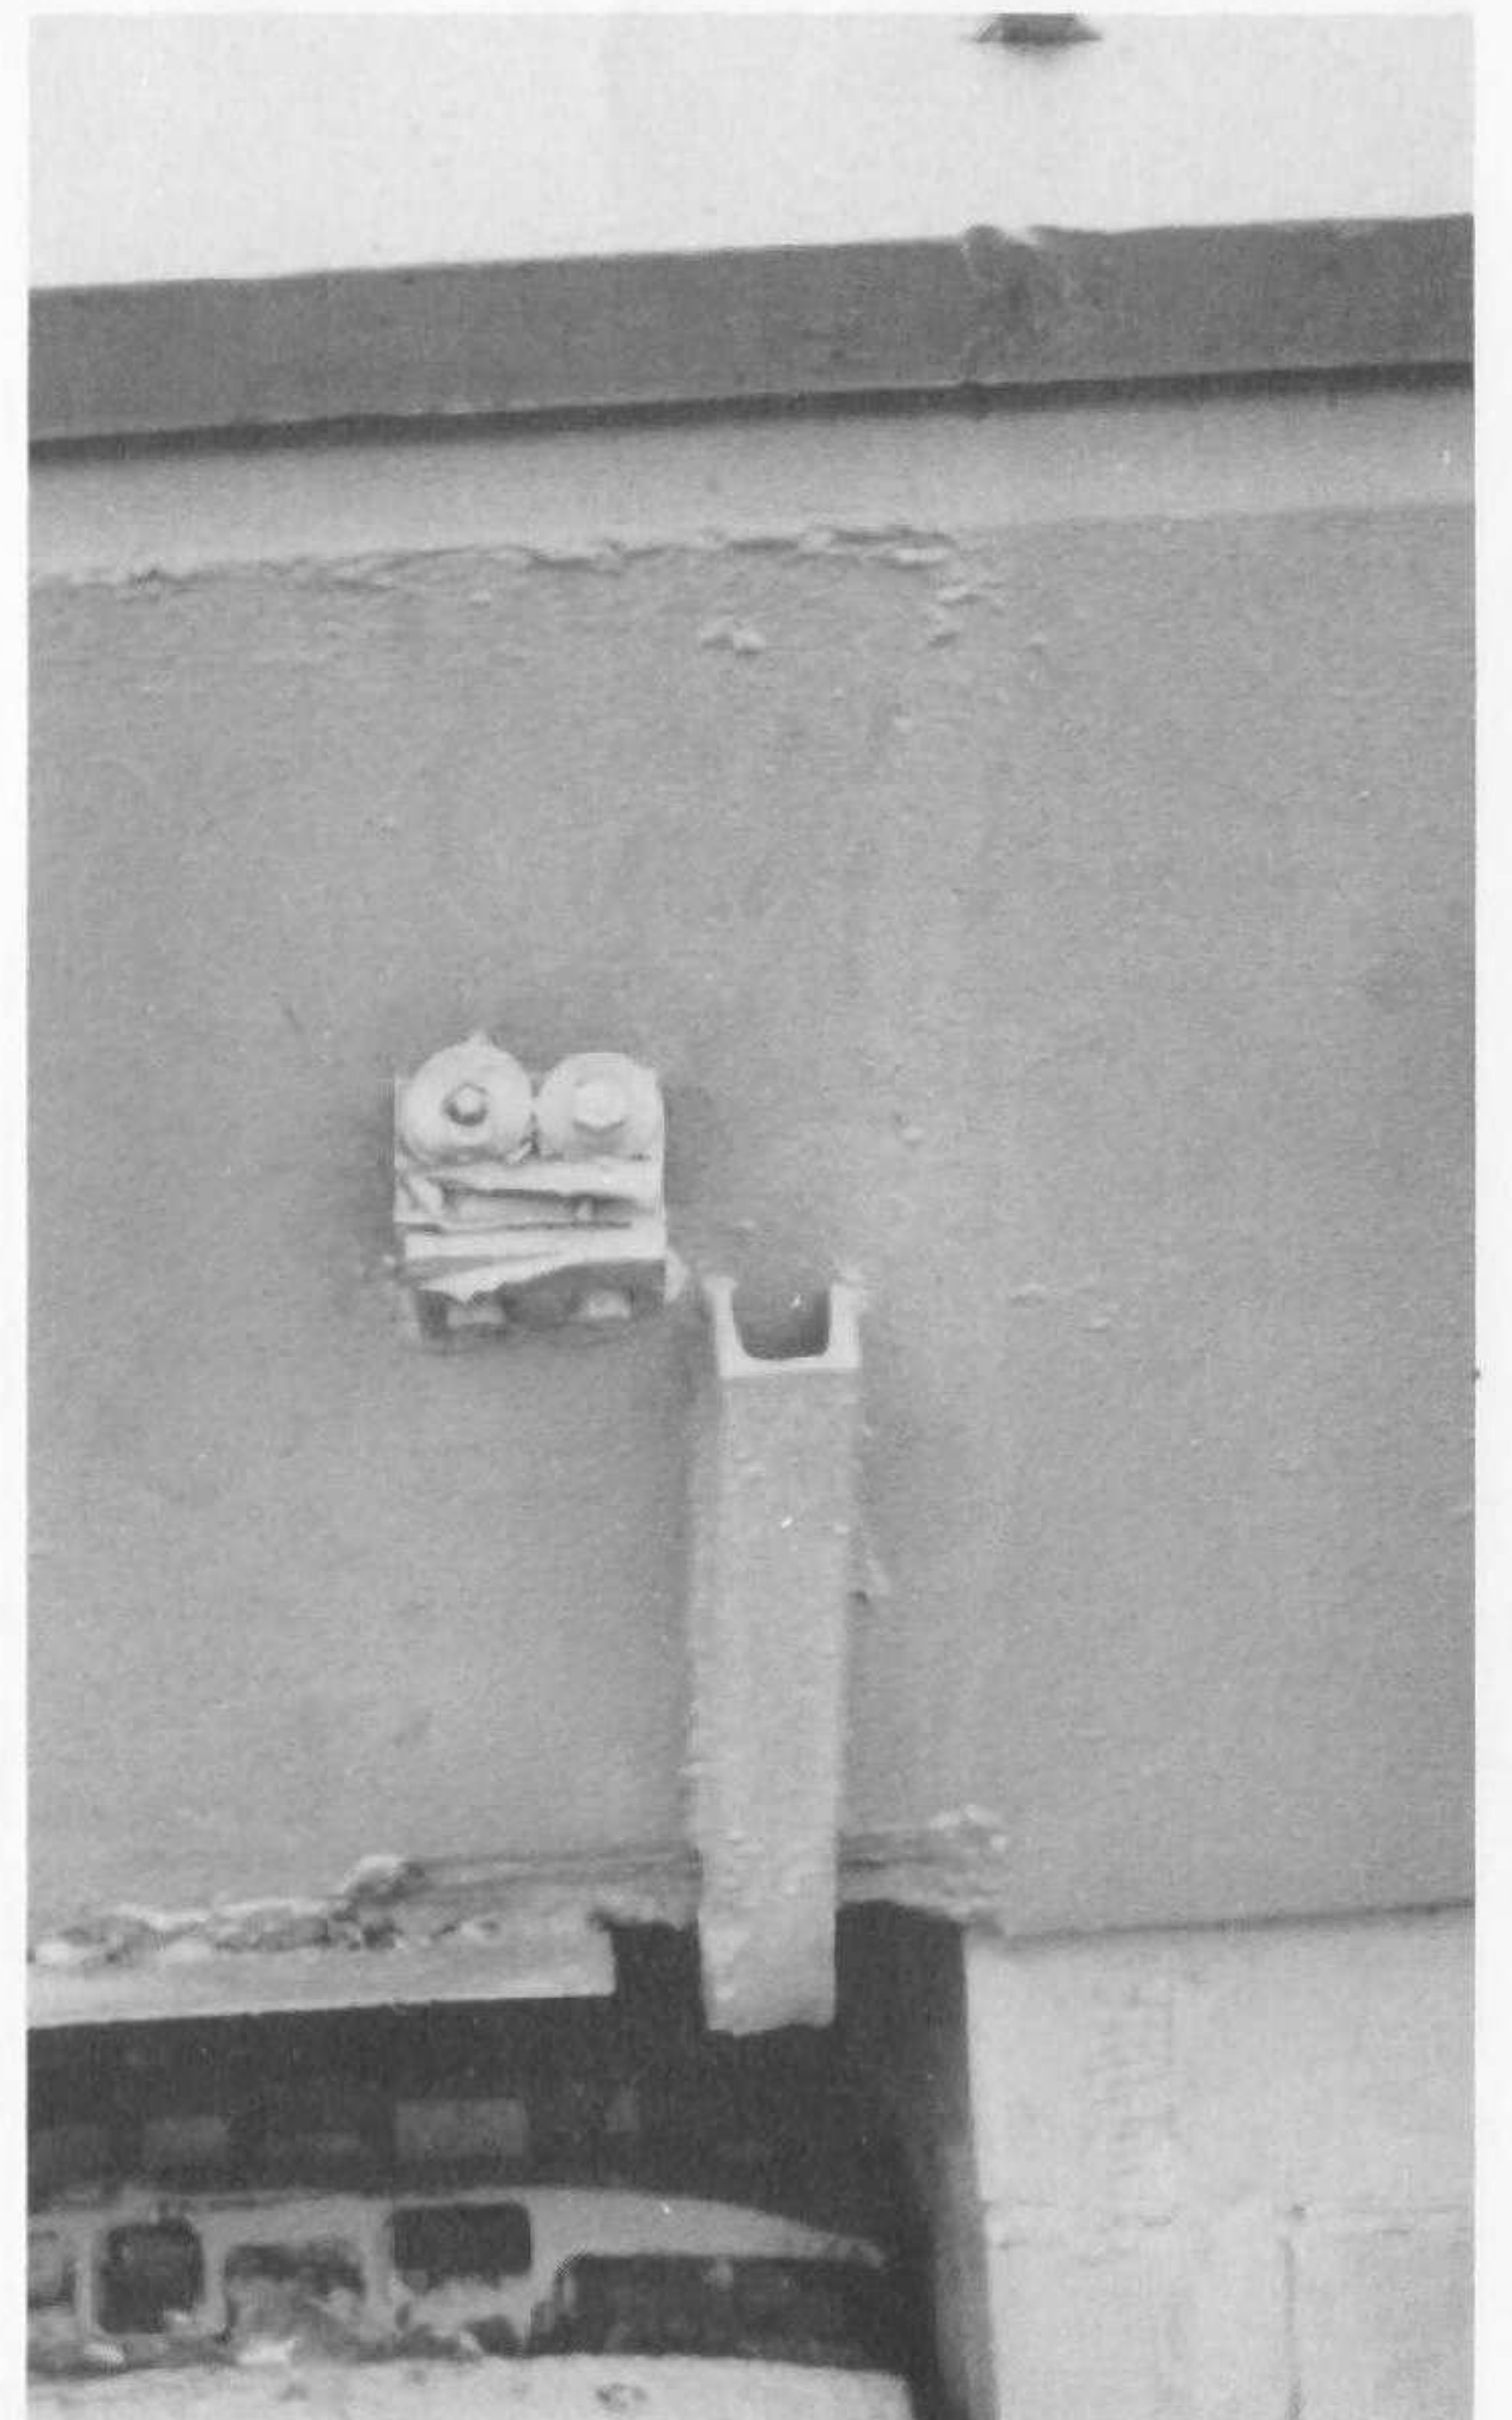
Small rear hull fixtures. It appears that the small double fixture on top is for rear blackout and marker lights and the purpose of the small rectangular bracket is unknown.

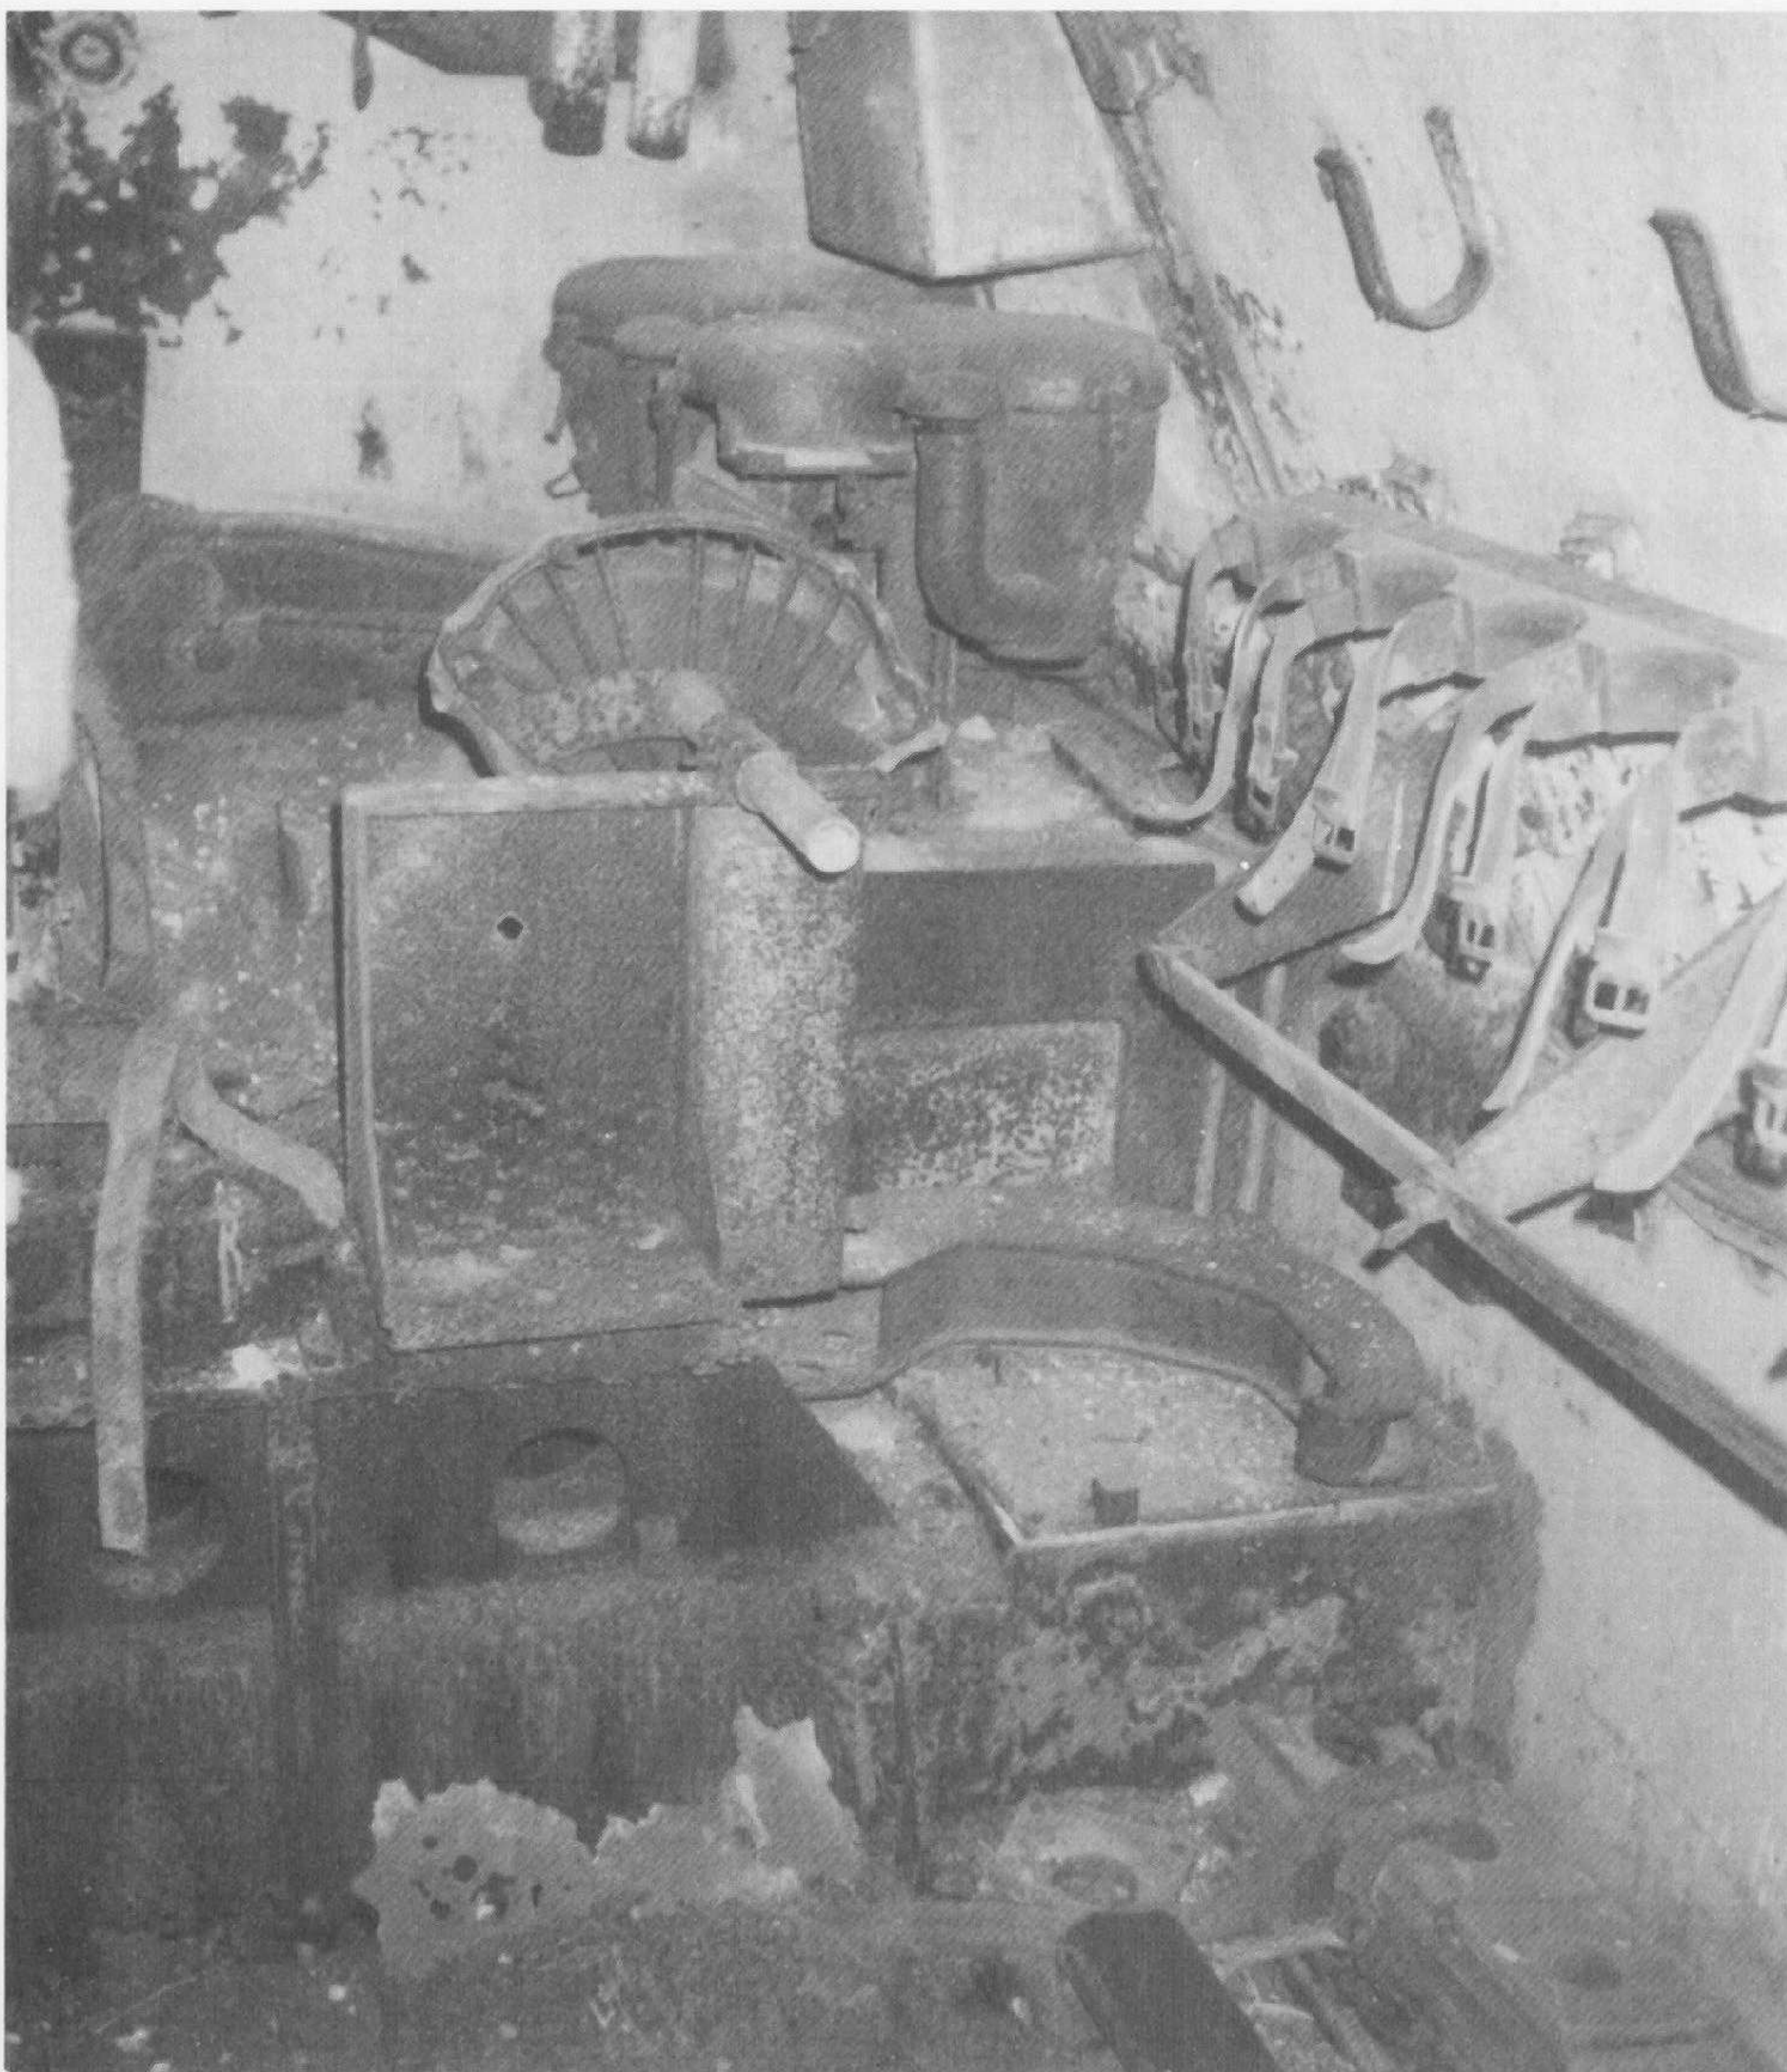
An overall look at the fighting compartment to the right side of the main gun. The commander's seat is folded forward. Except for the floor, the inside of the vehicle is in better condition than might be expected. Of interest is the color of the interior. The walls of the fighting compartment were painted a shade of white while the walls of the hull (seen in the lower right of this photo) appear to be a green/gray color.

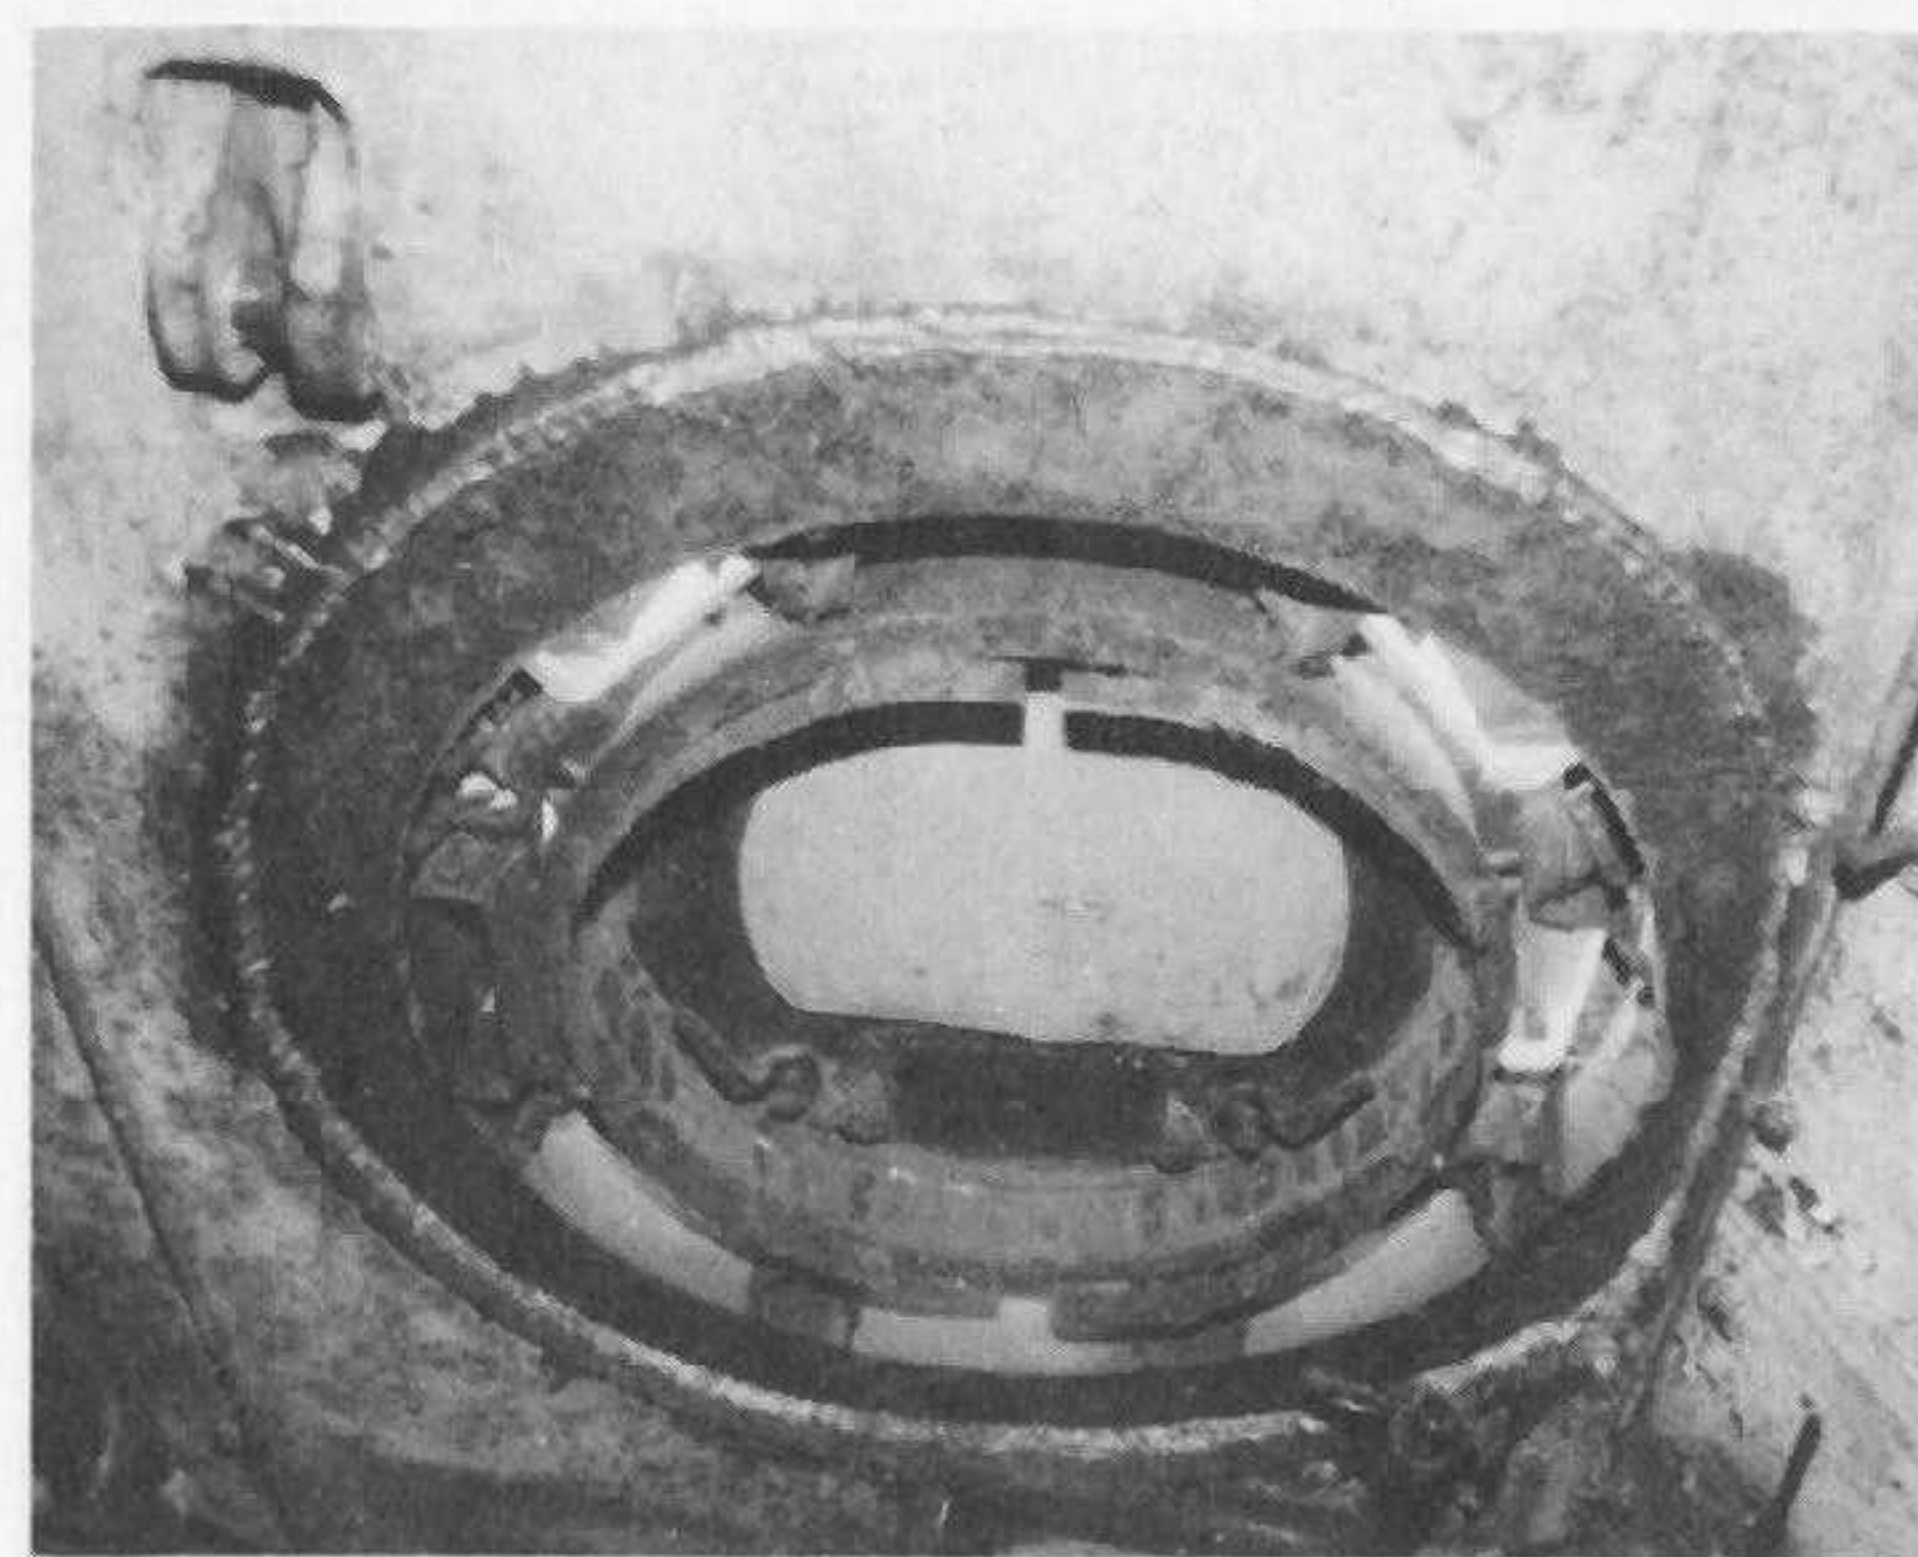
The underside of the commander's cupola. Note the two locking handles directly in front of the padded hatch bottom.

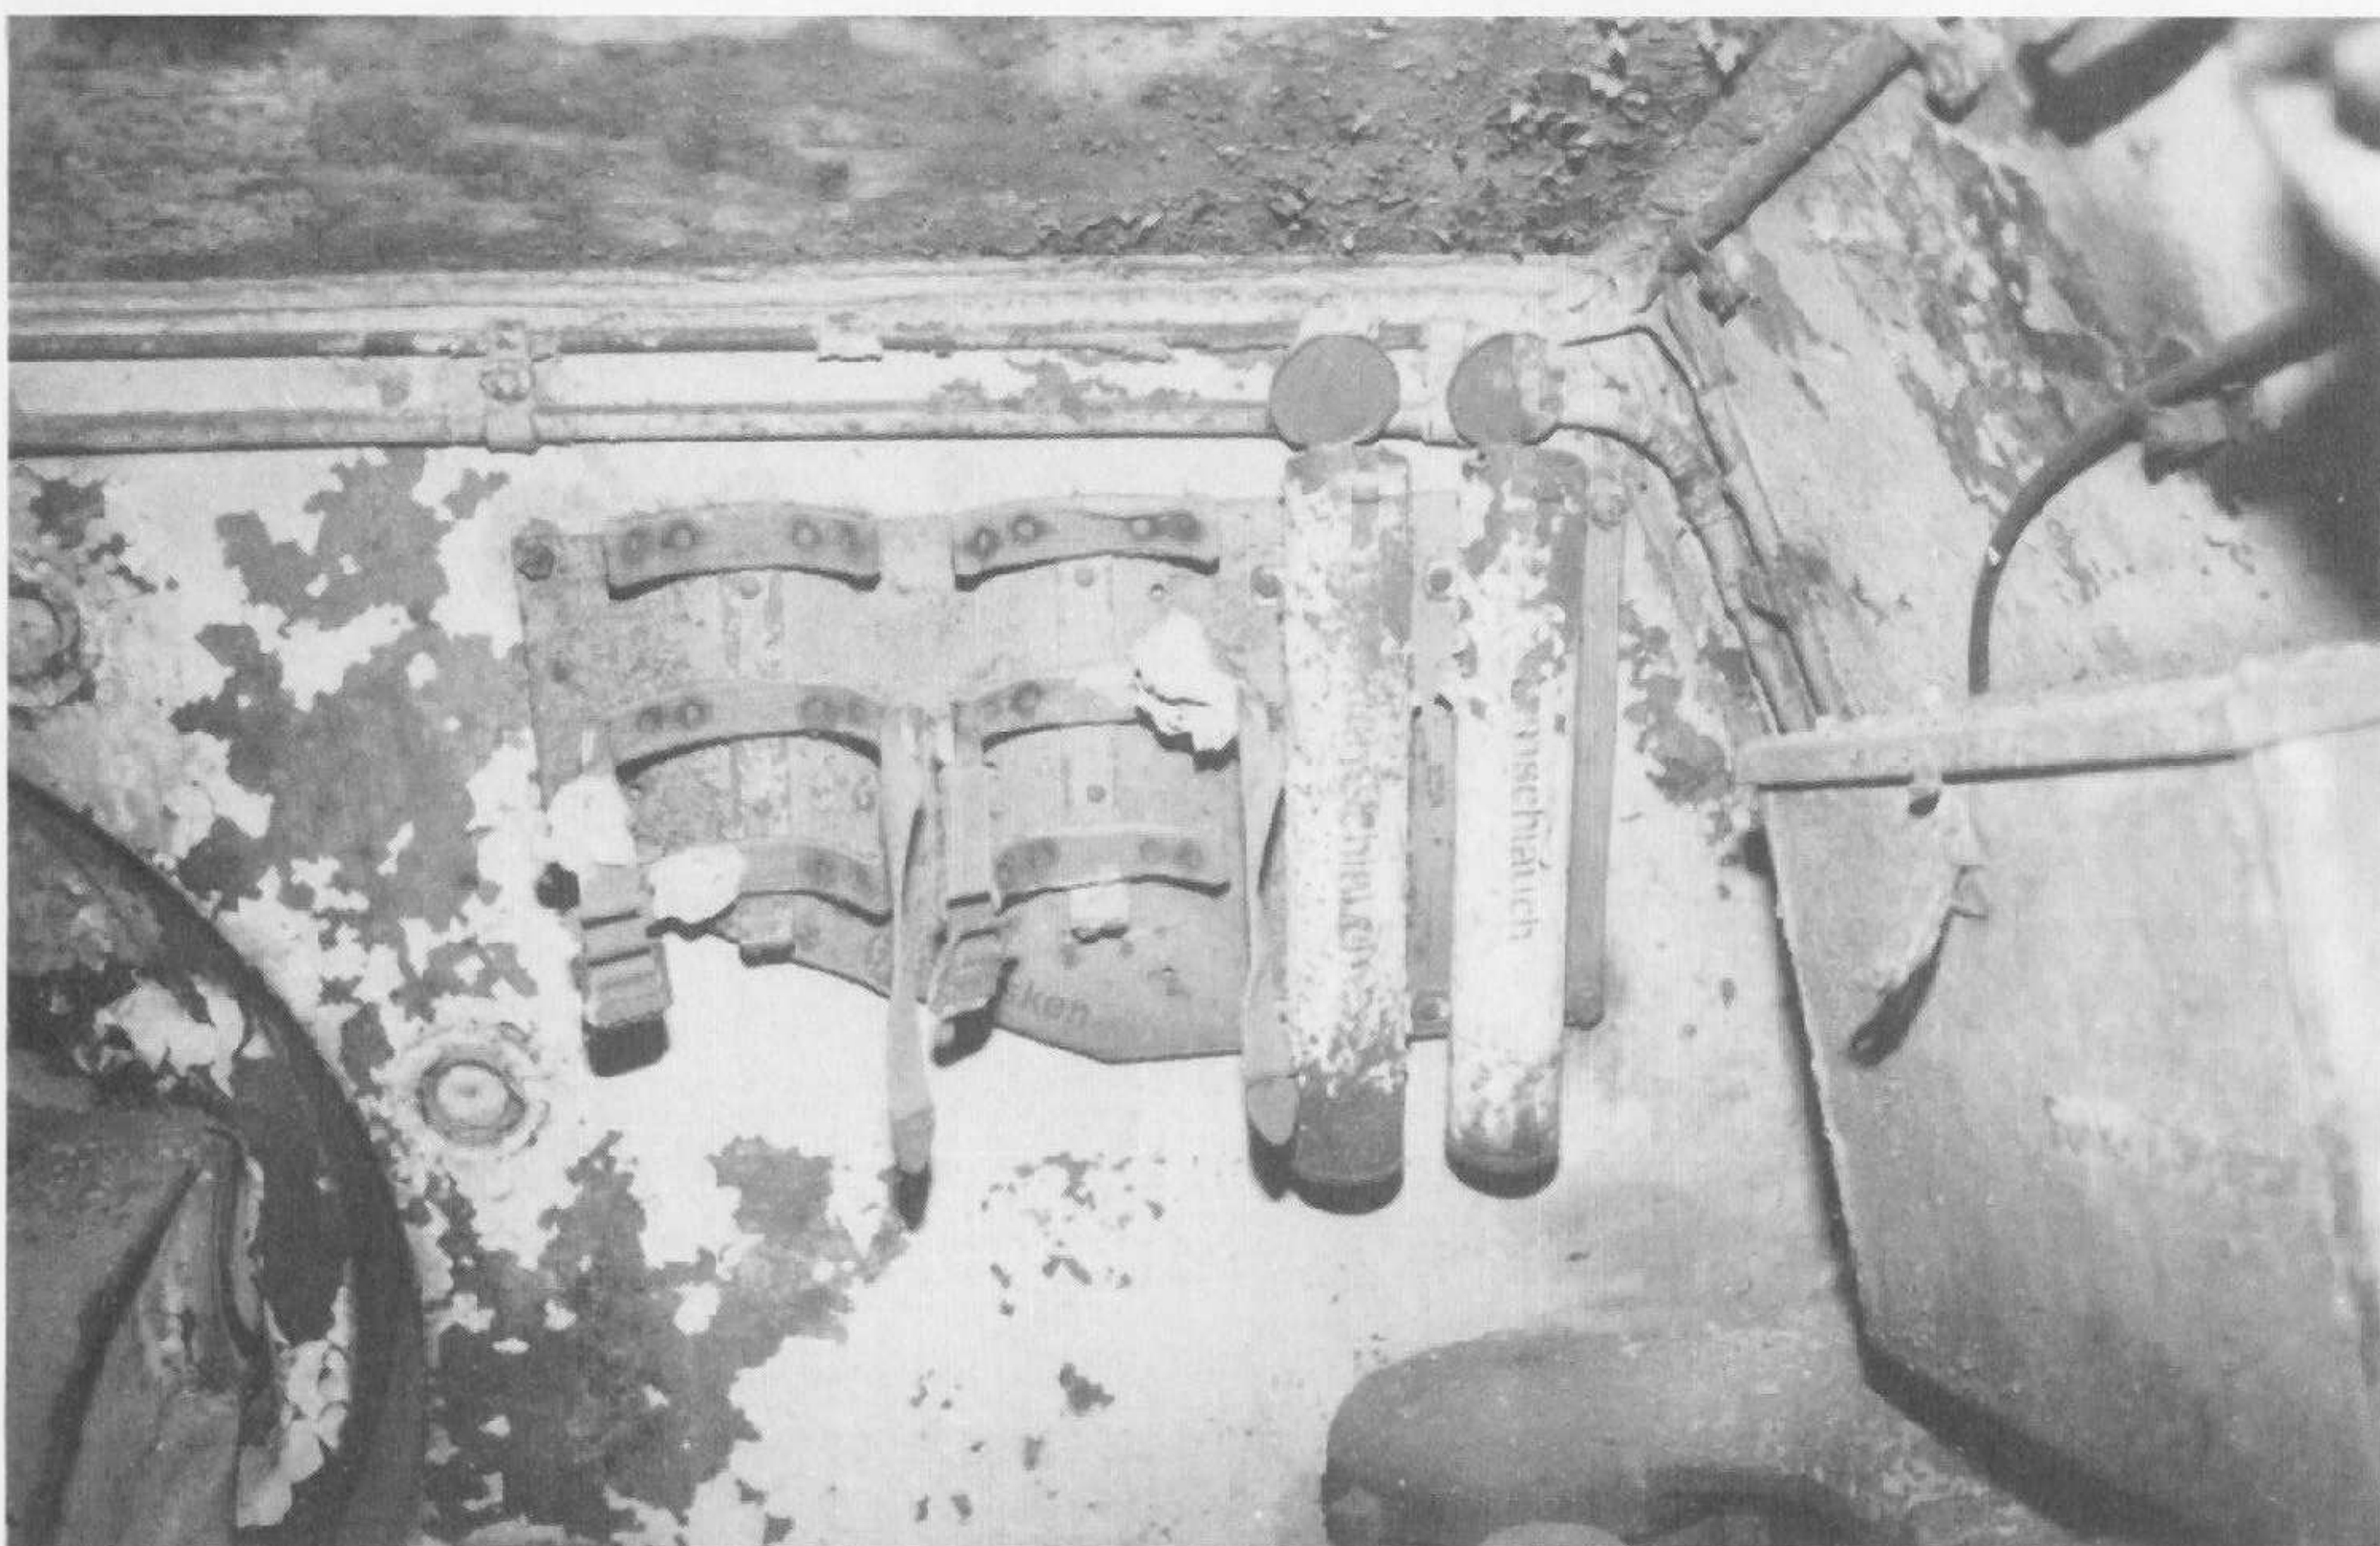
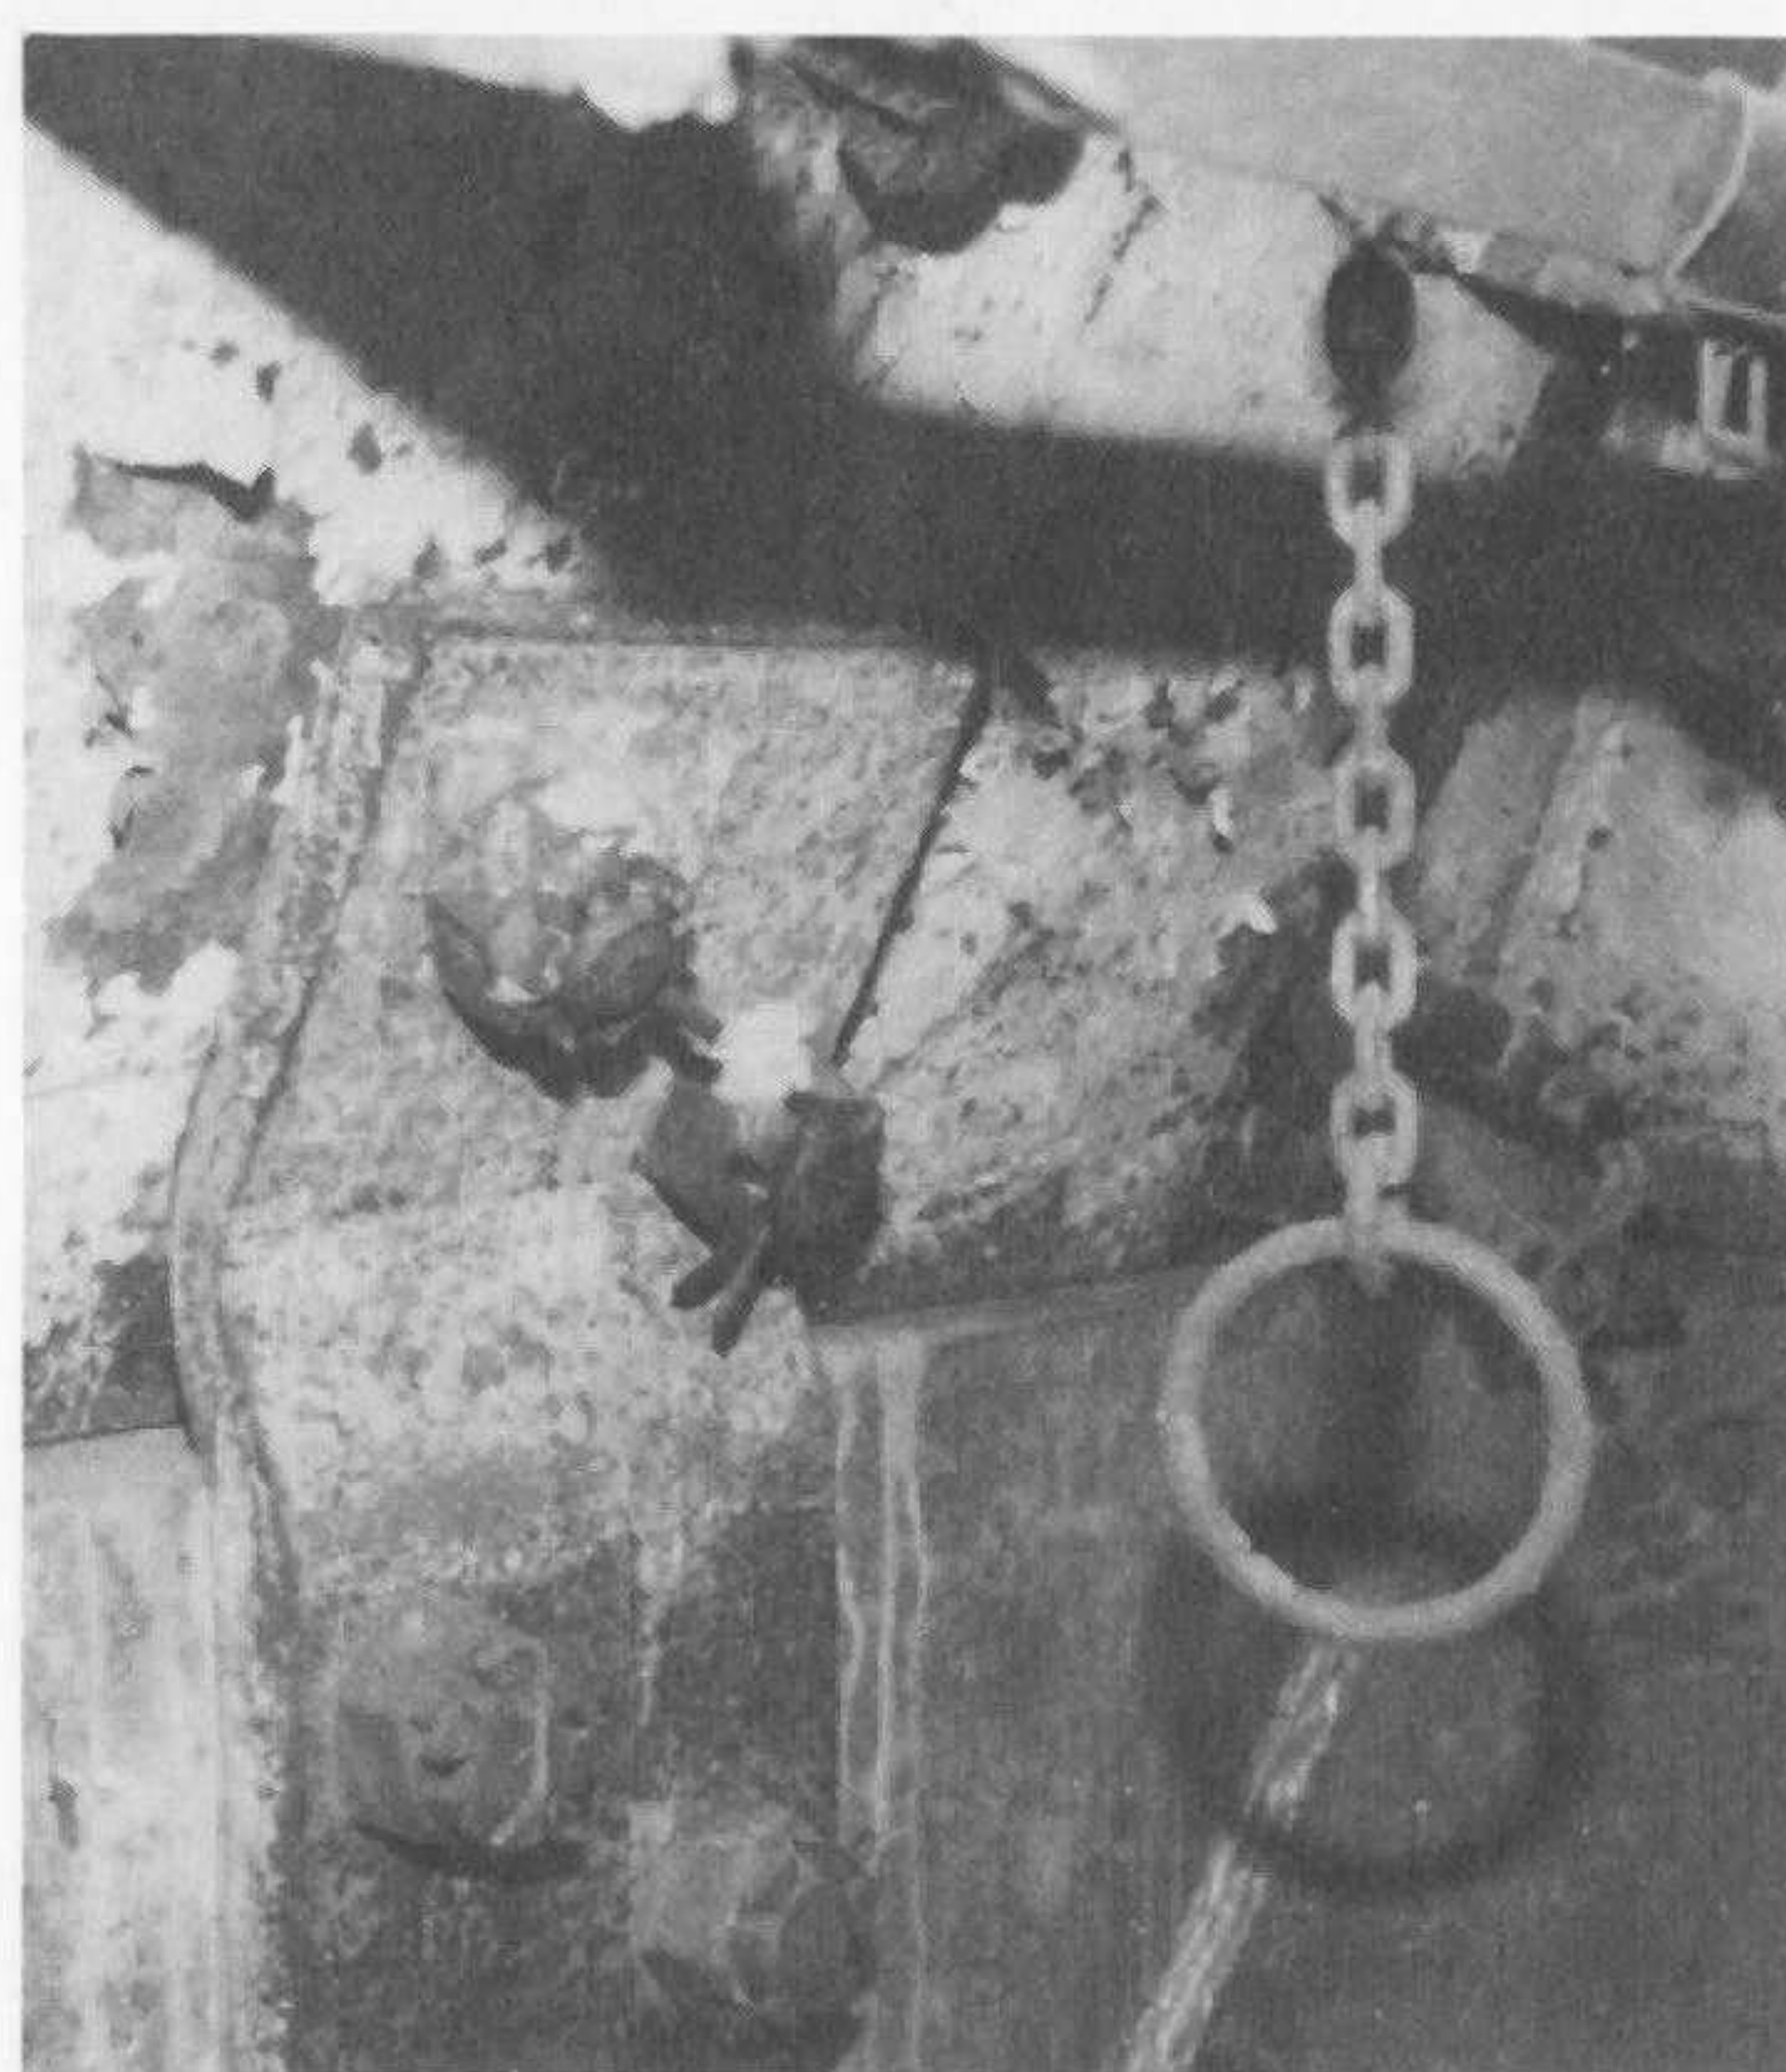
The connecting plate and backside of the conical bolts that hold the fighting compartment to the hull. Each bolt is also secured with a cotter pin.

In mirror image design, there were gas mask racks on the front plate on either side of the main gun.

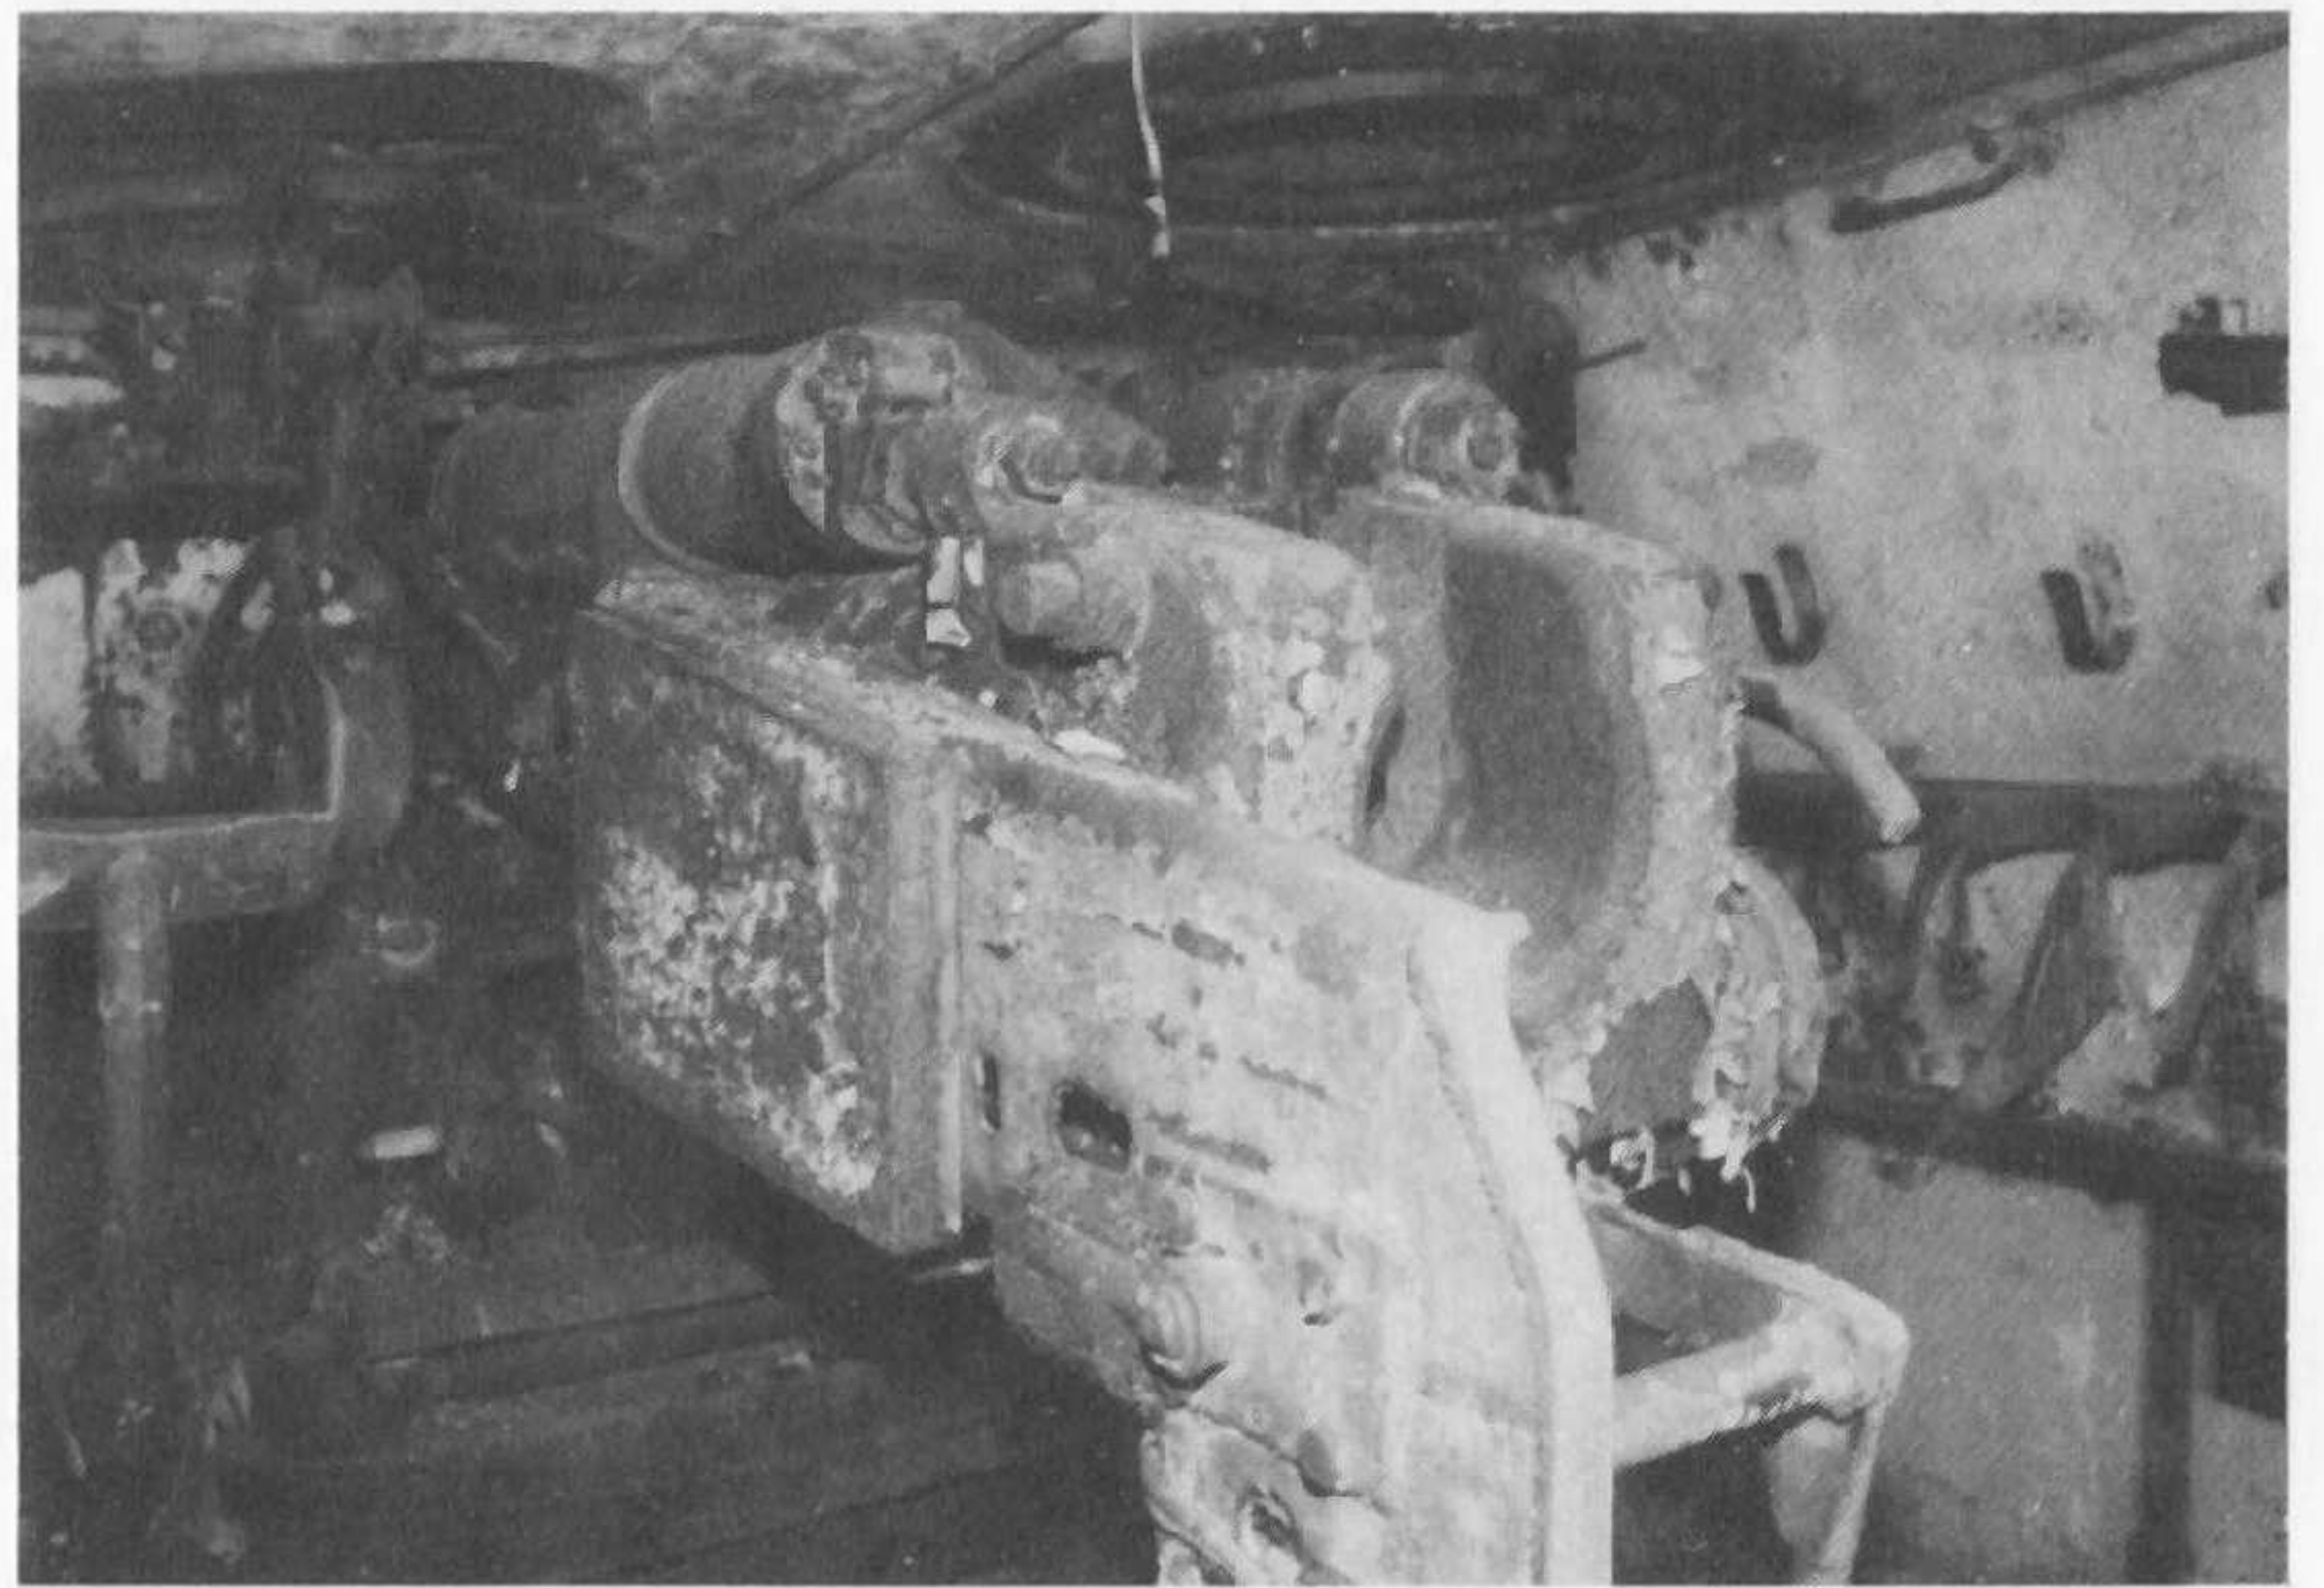
Although very rusted, this is the platform that the main gun rests on.
