MUSEUM ORDNANCE SPECIAL NUMBER 4

Elefant Panzerjäger Tiger (P)

Text by Thomas L. Jentz
Photos by Jeffrey D. McKaughan

THE "ELEFANT" AT ABERDEEN

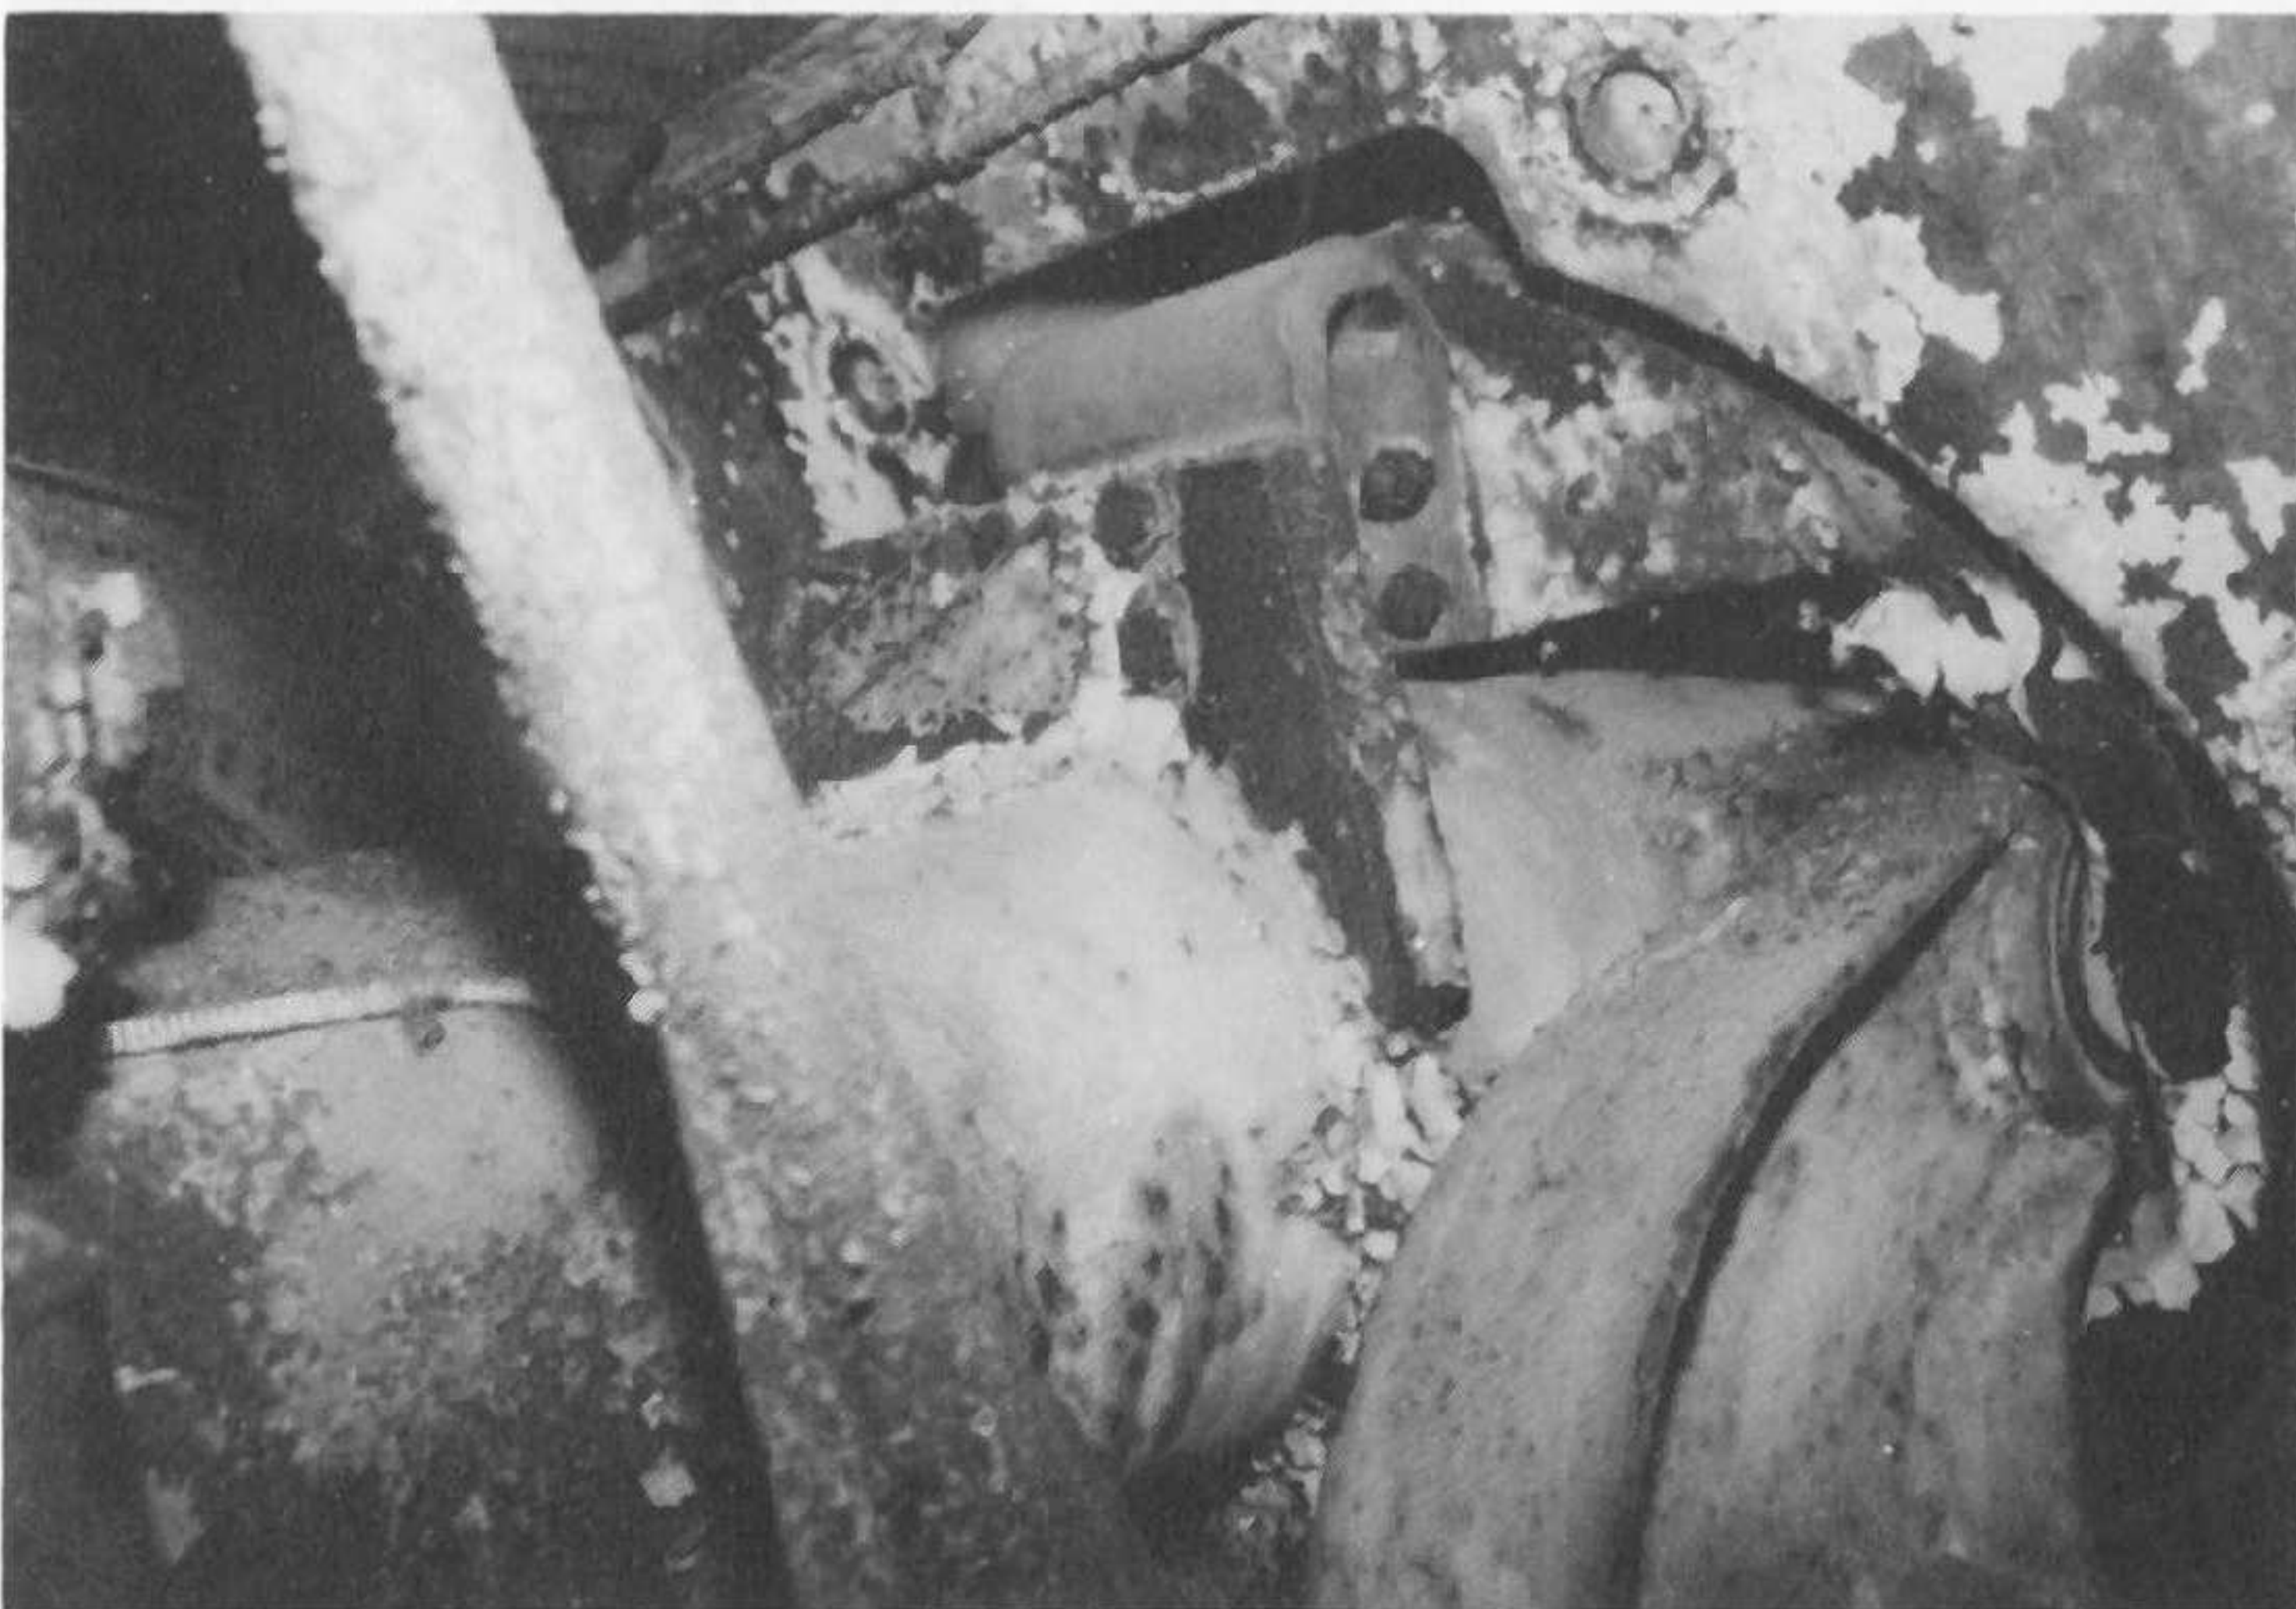
The left side of the main gun with the breech guard in the down position.

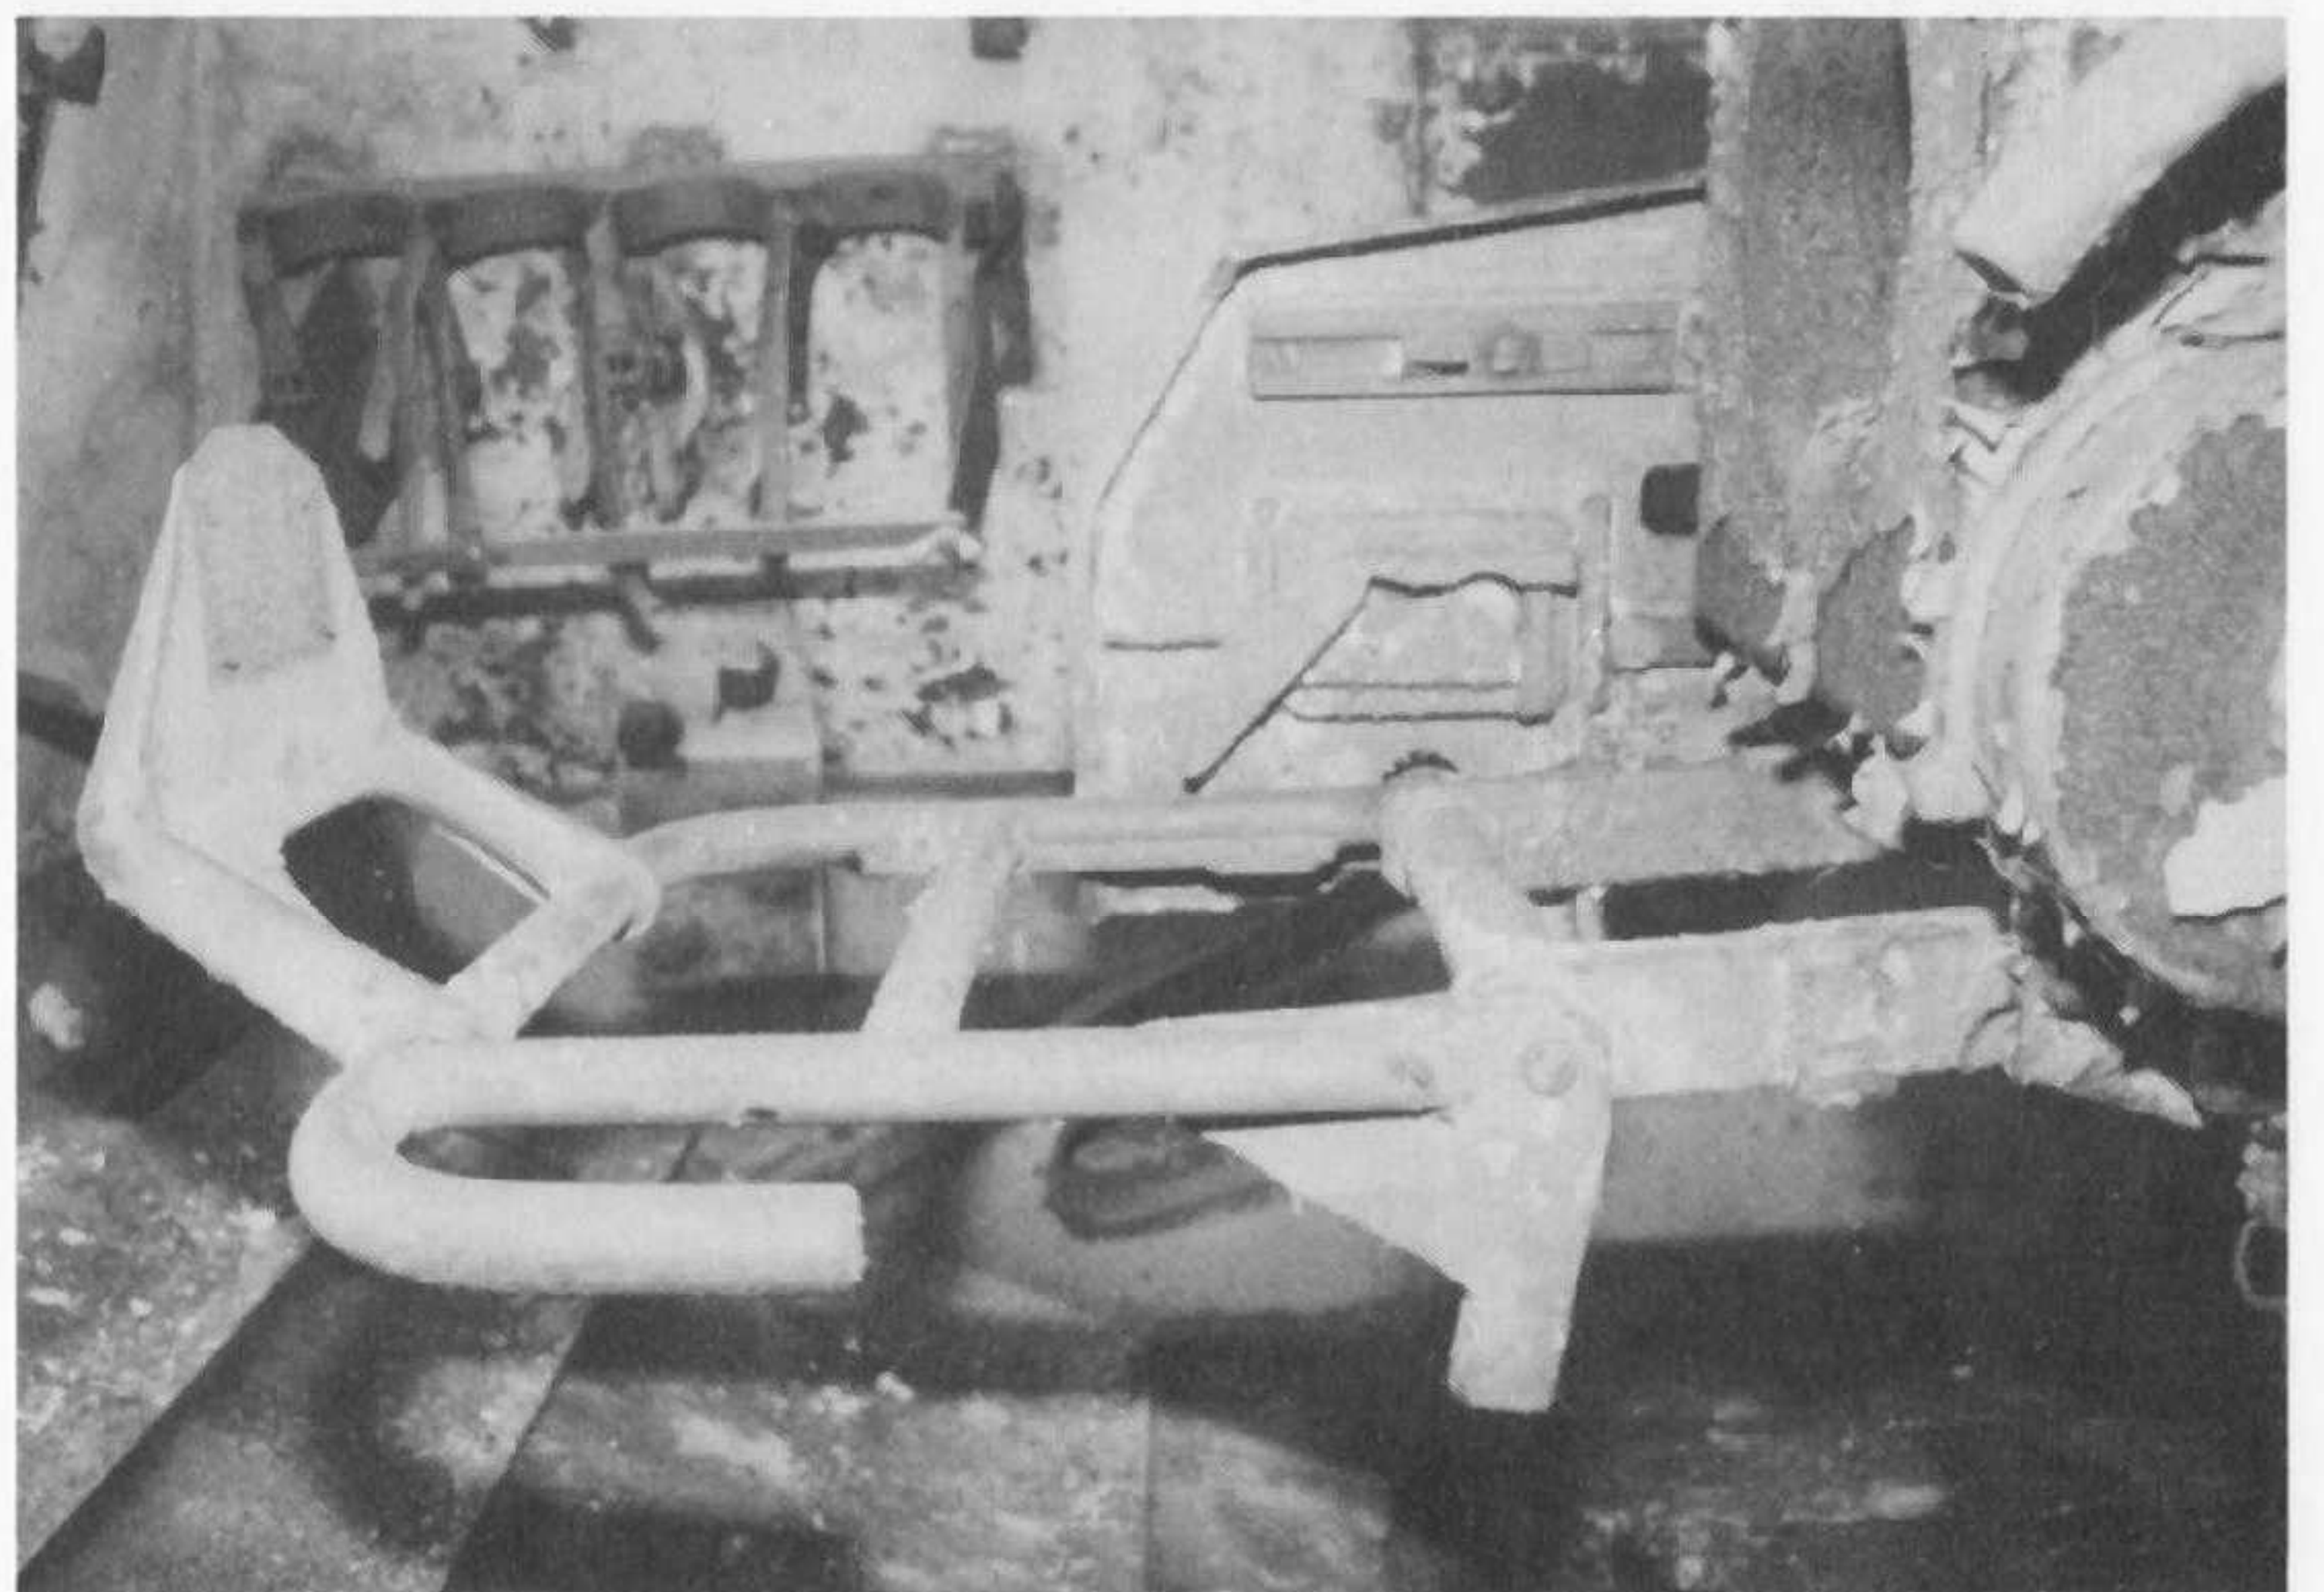
The main gun trunnions at the front armor plate.

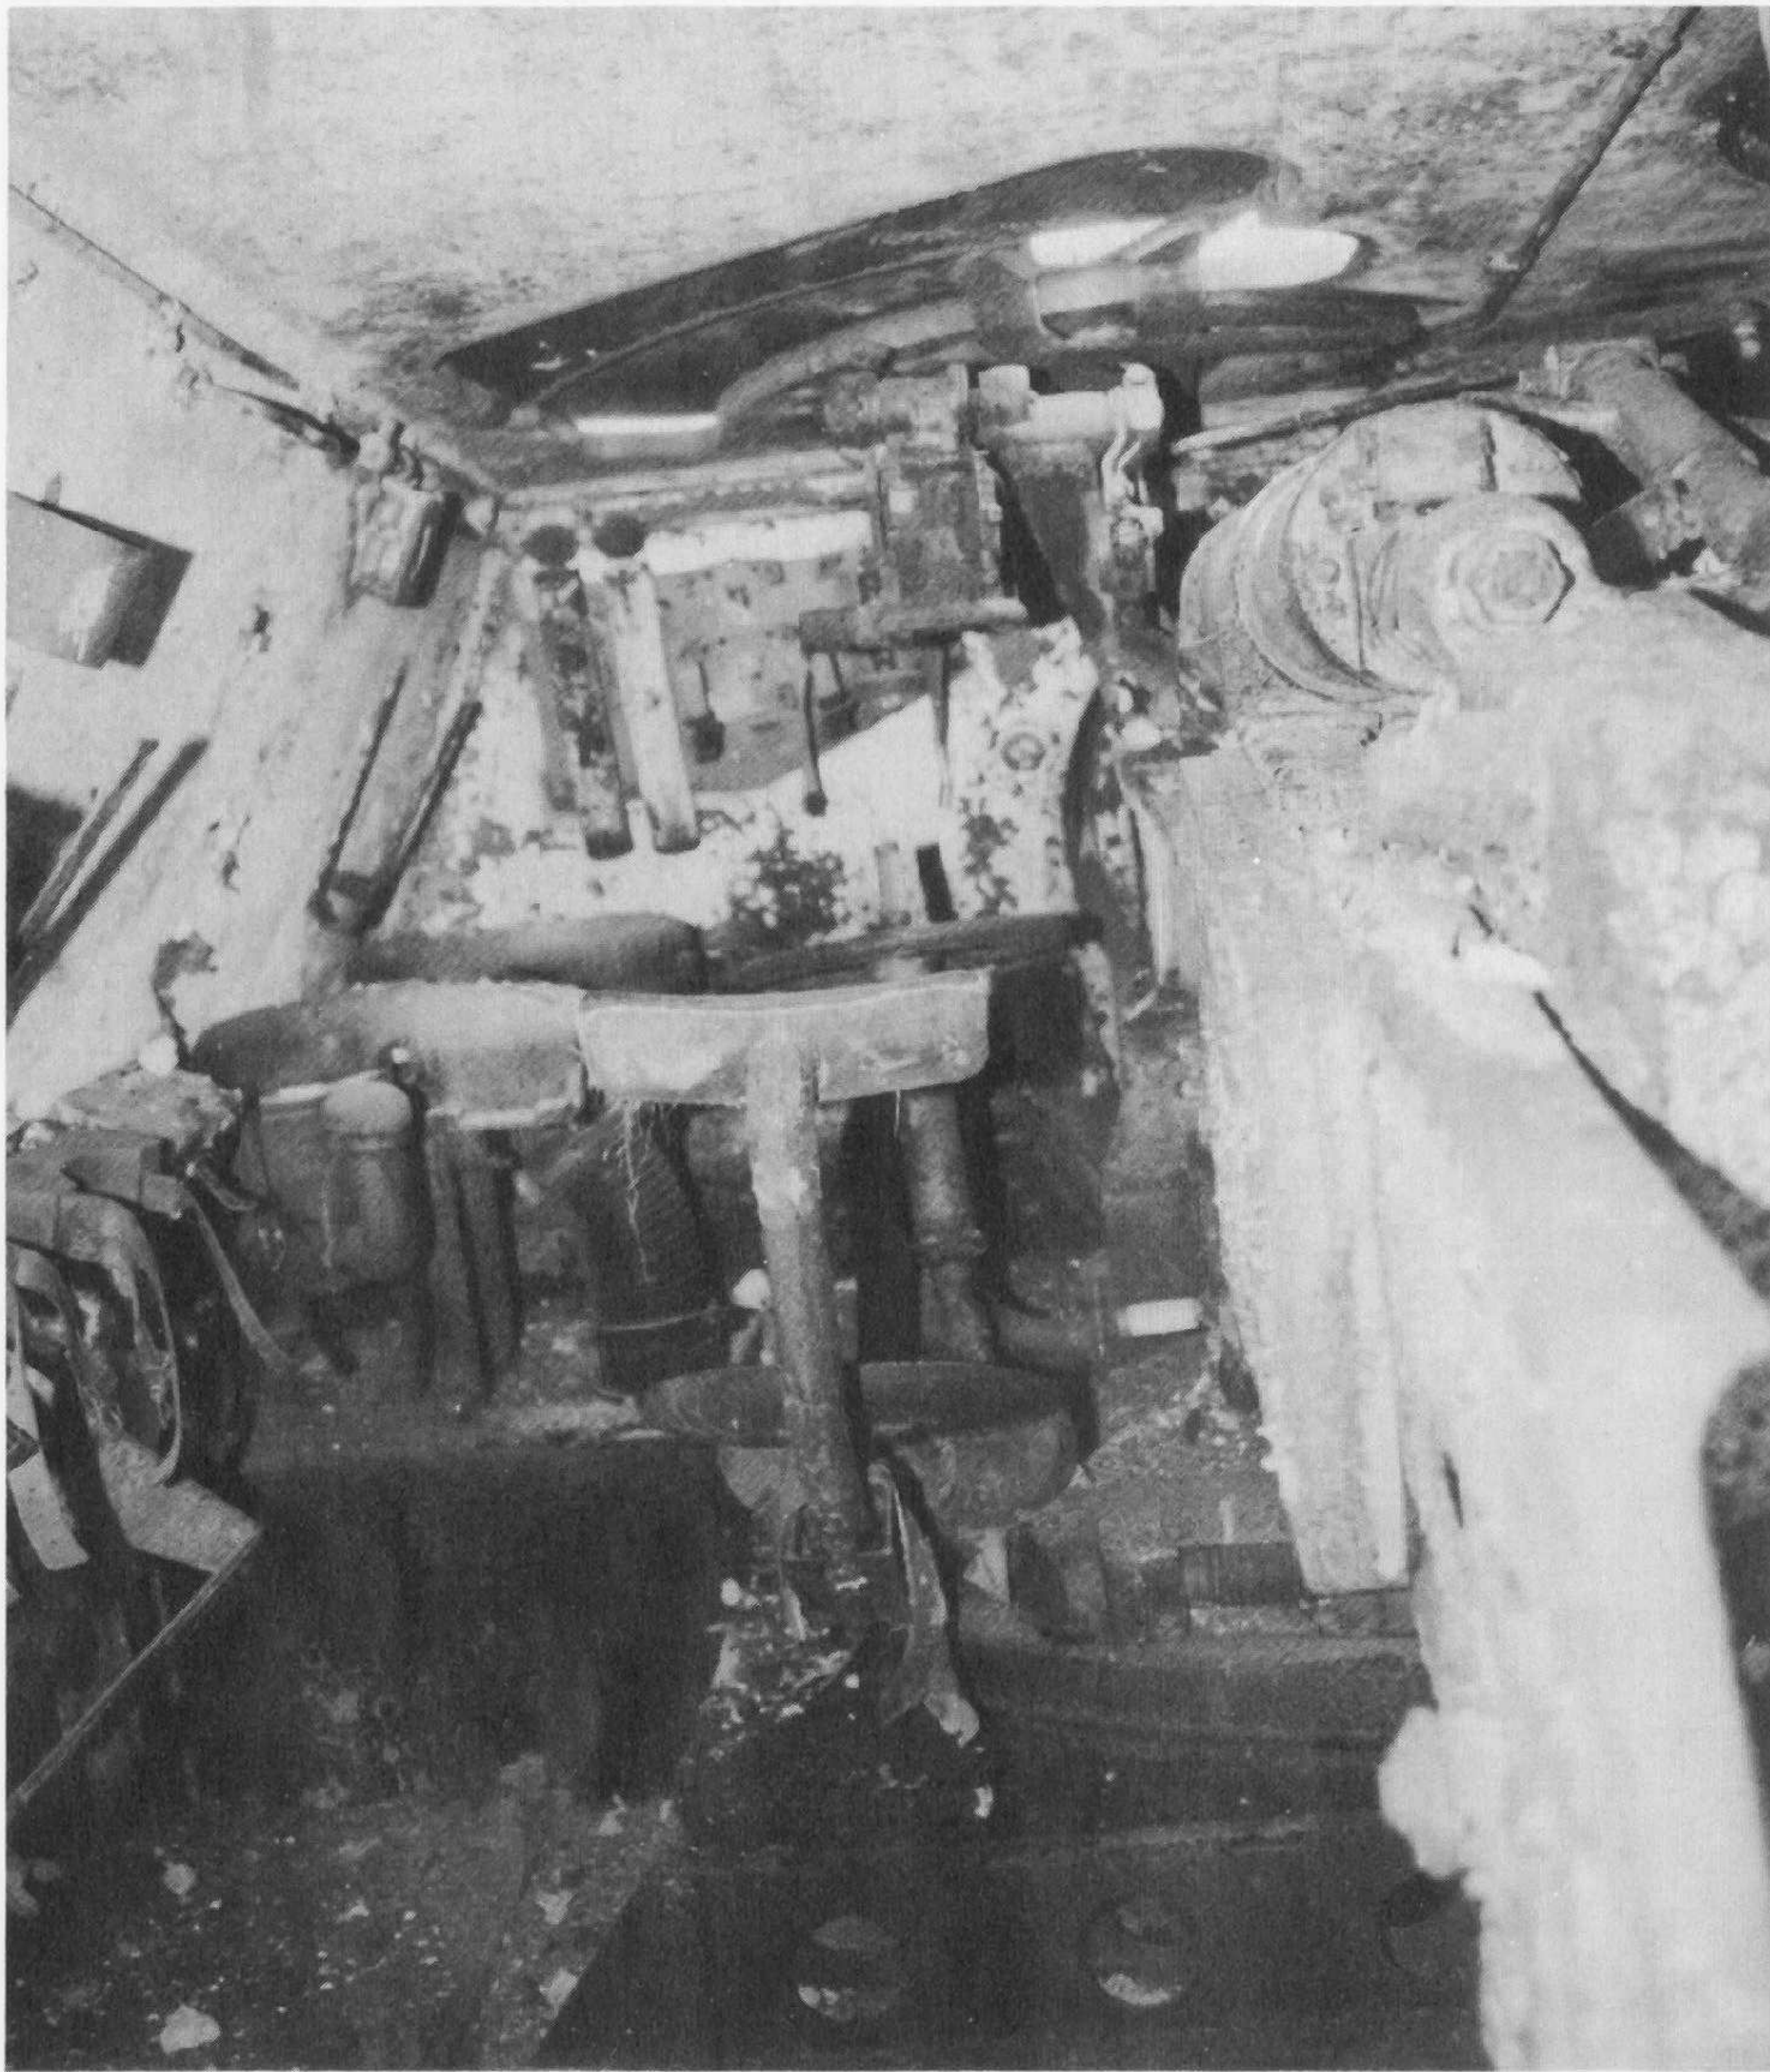
The breech guard has been locked in the firing position. Almost 50 years later, the breech guard still worked smoothly. Also note the angled and overlapping plate that covers the electric motors in the rear of the fighting compartment.

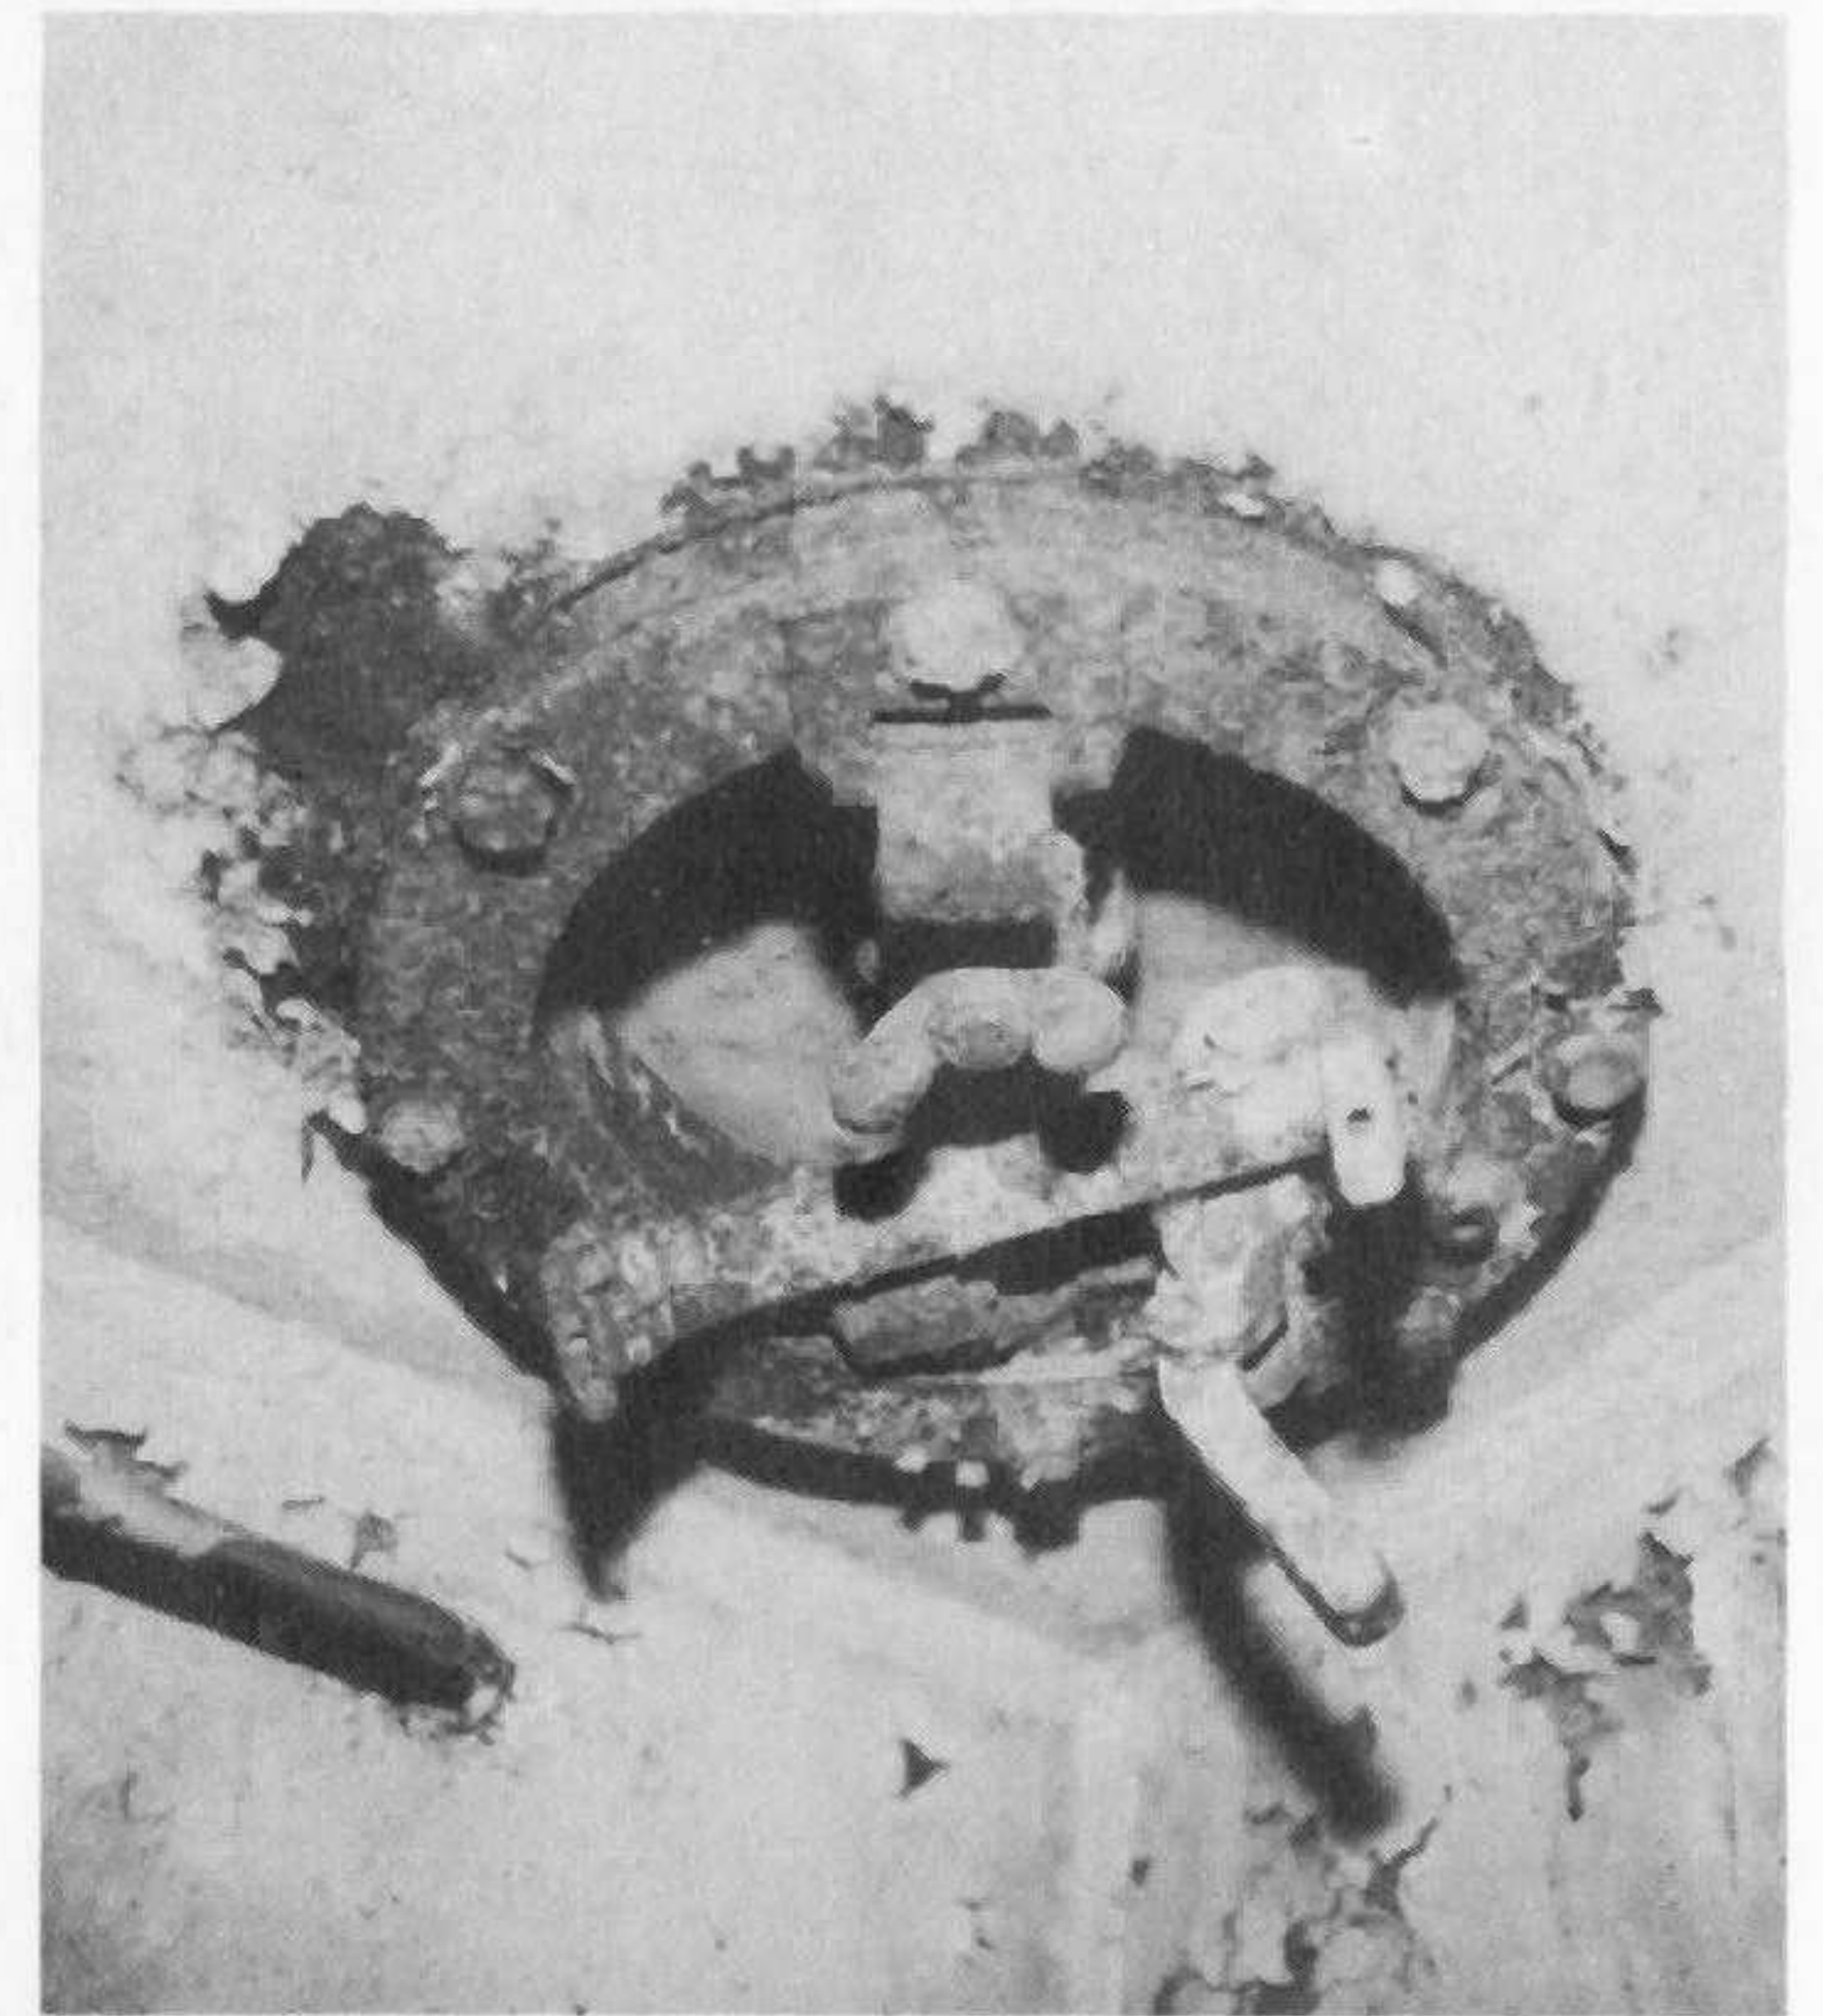
Looking down the left side of the main gun.

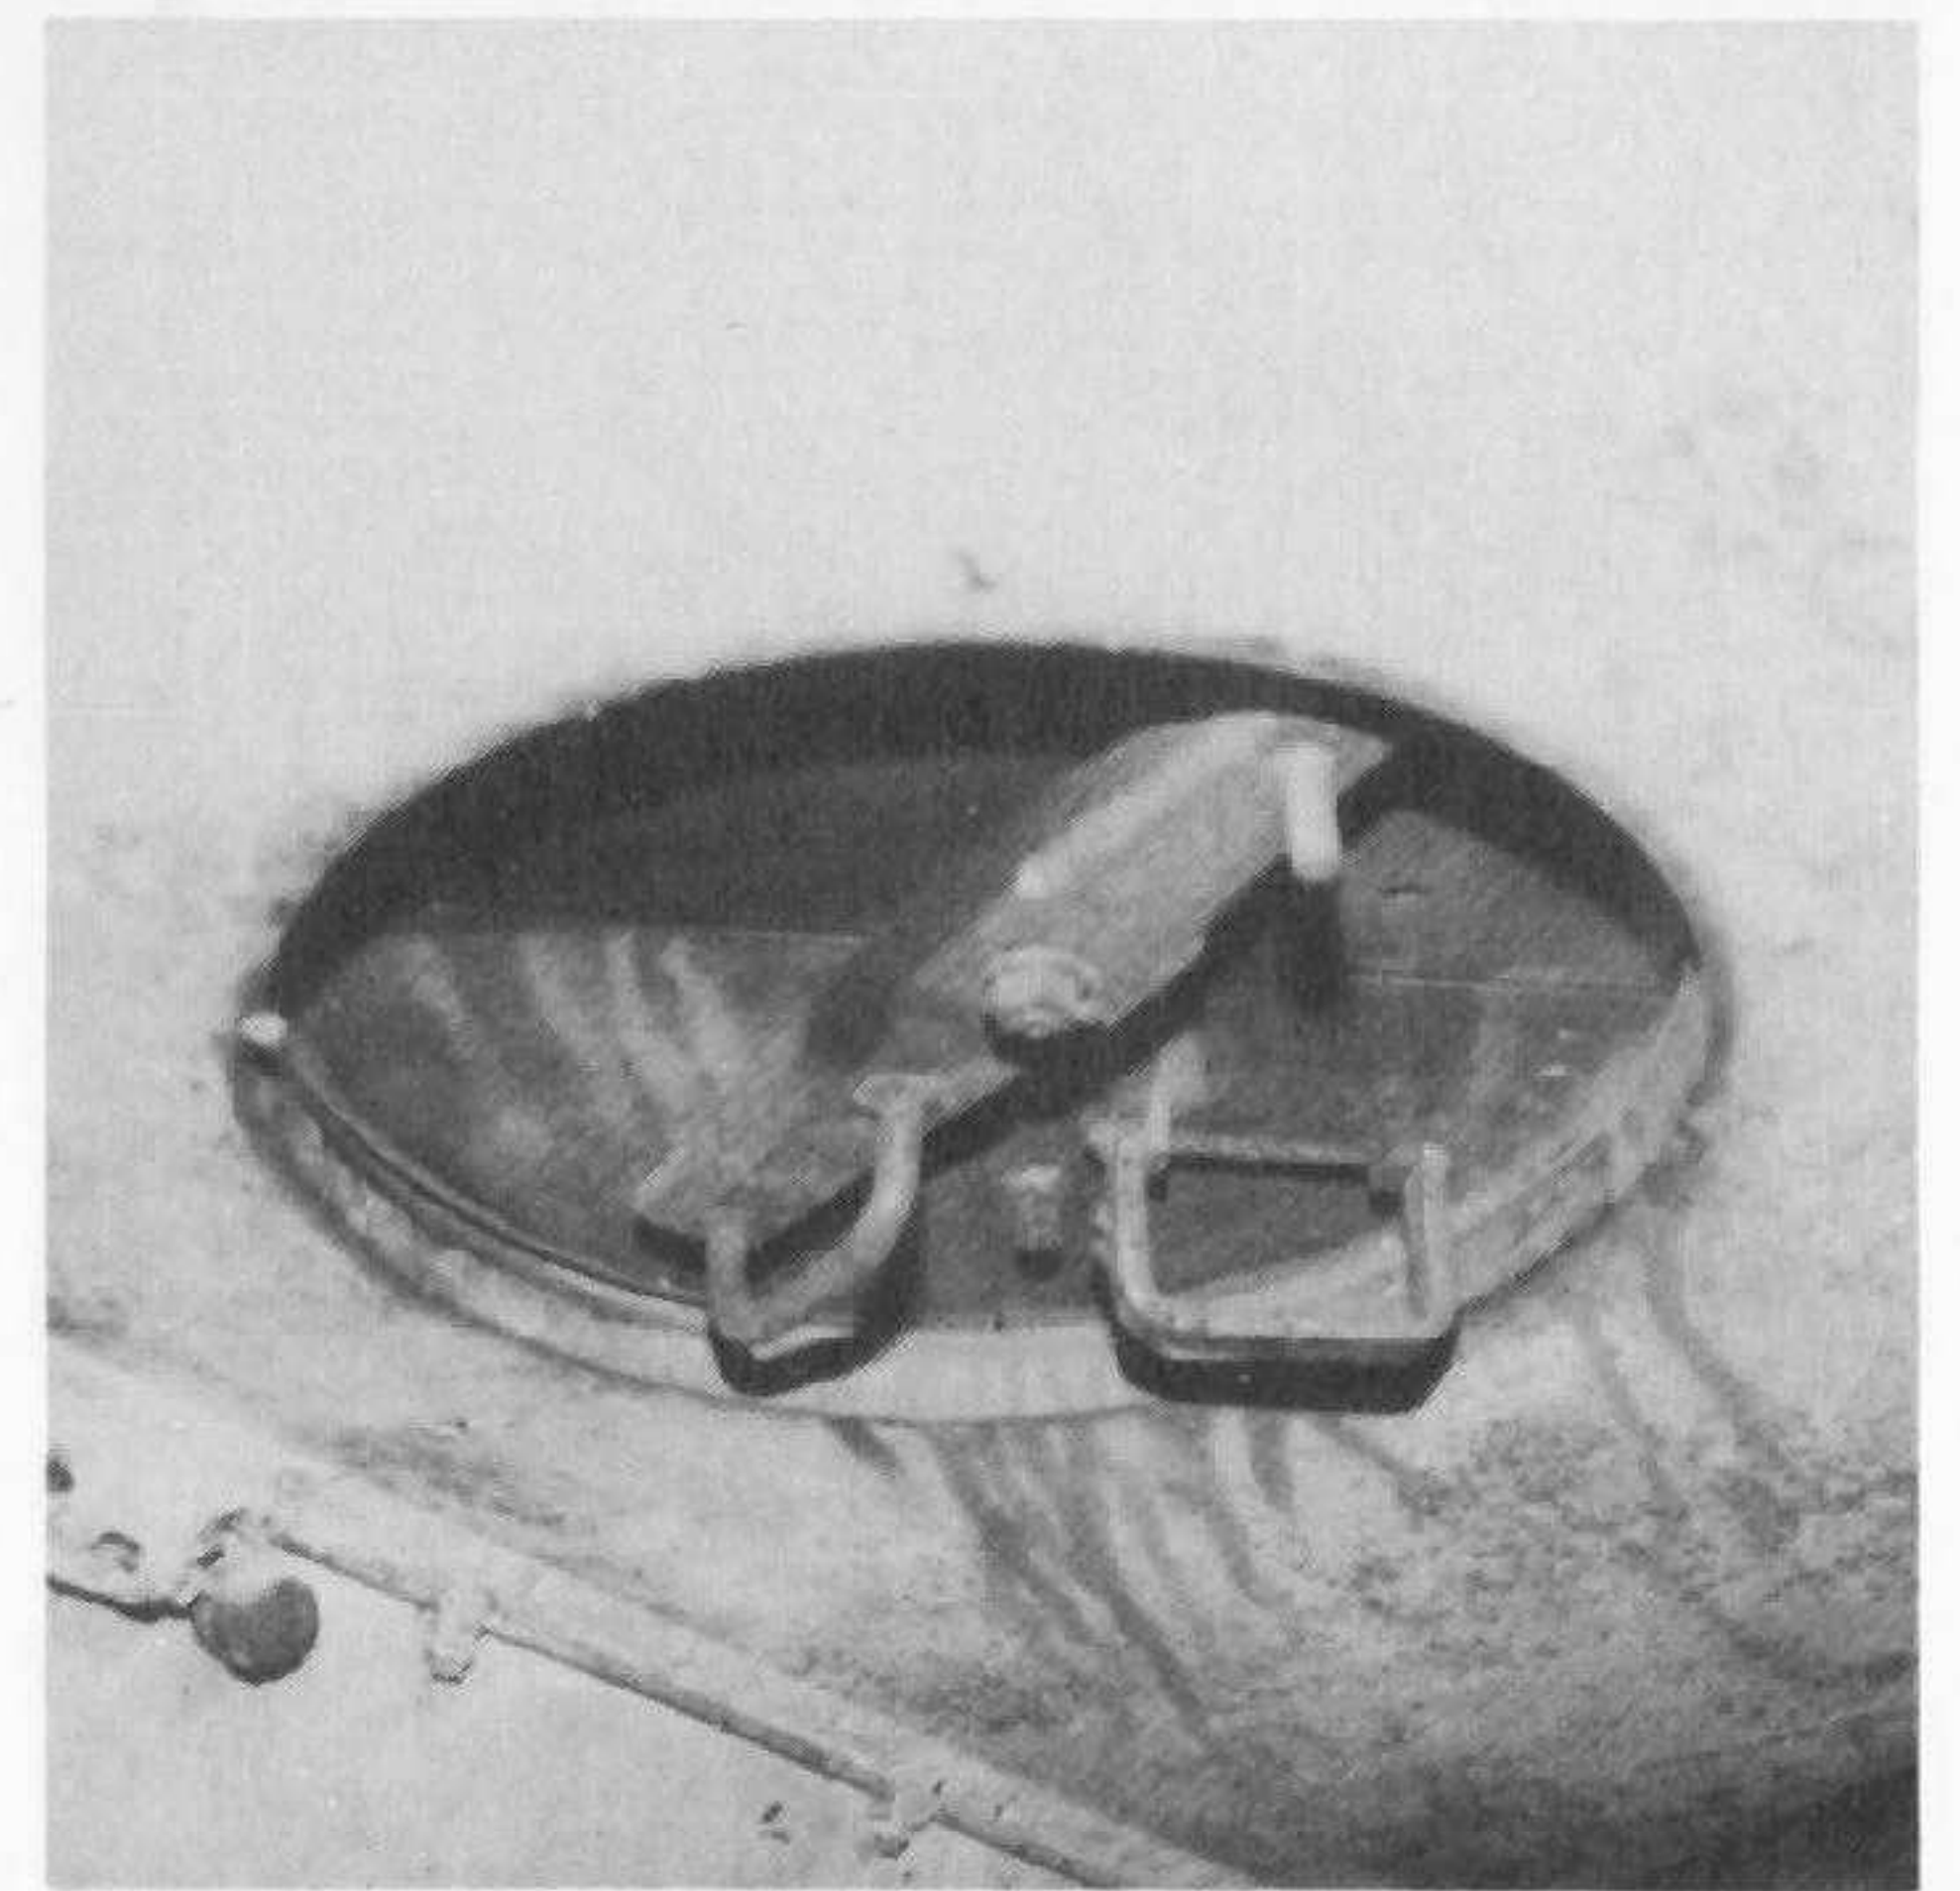
The small vision hatch (one per side) in the back corners of the fighting compartment roof.

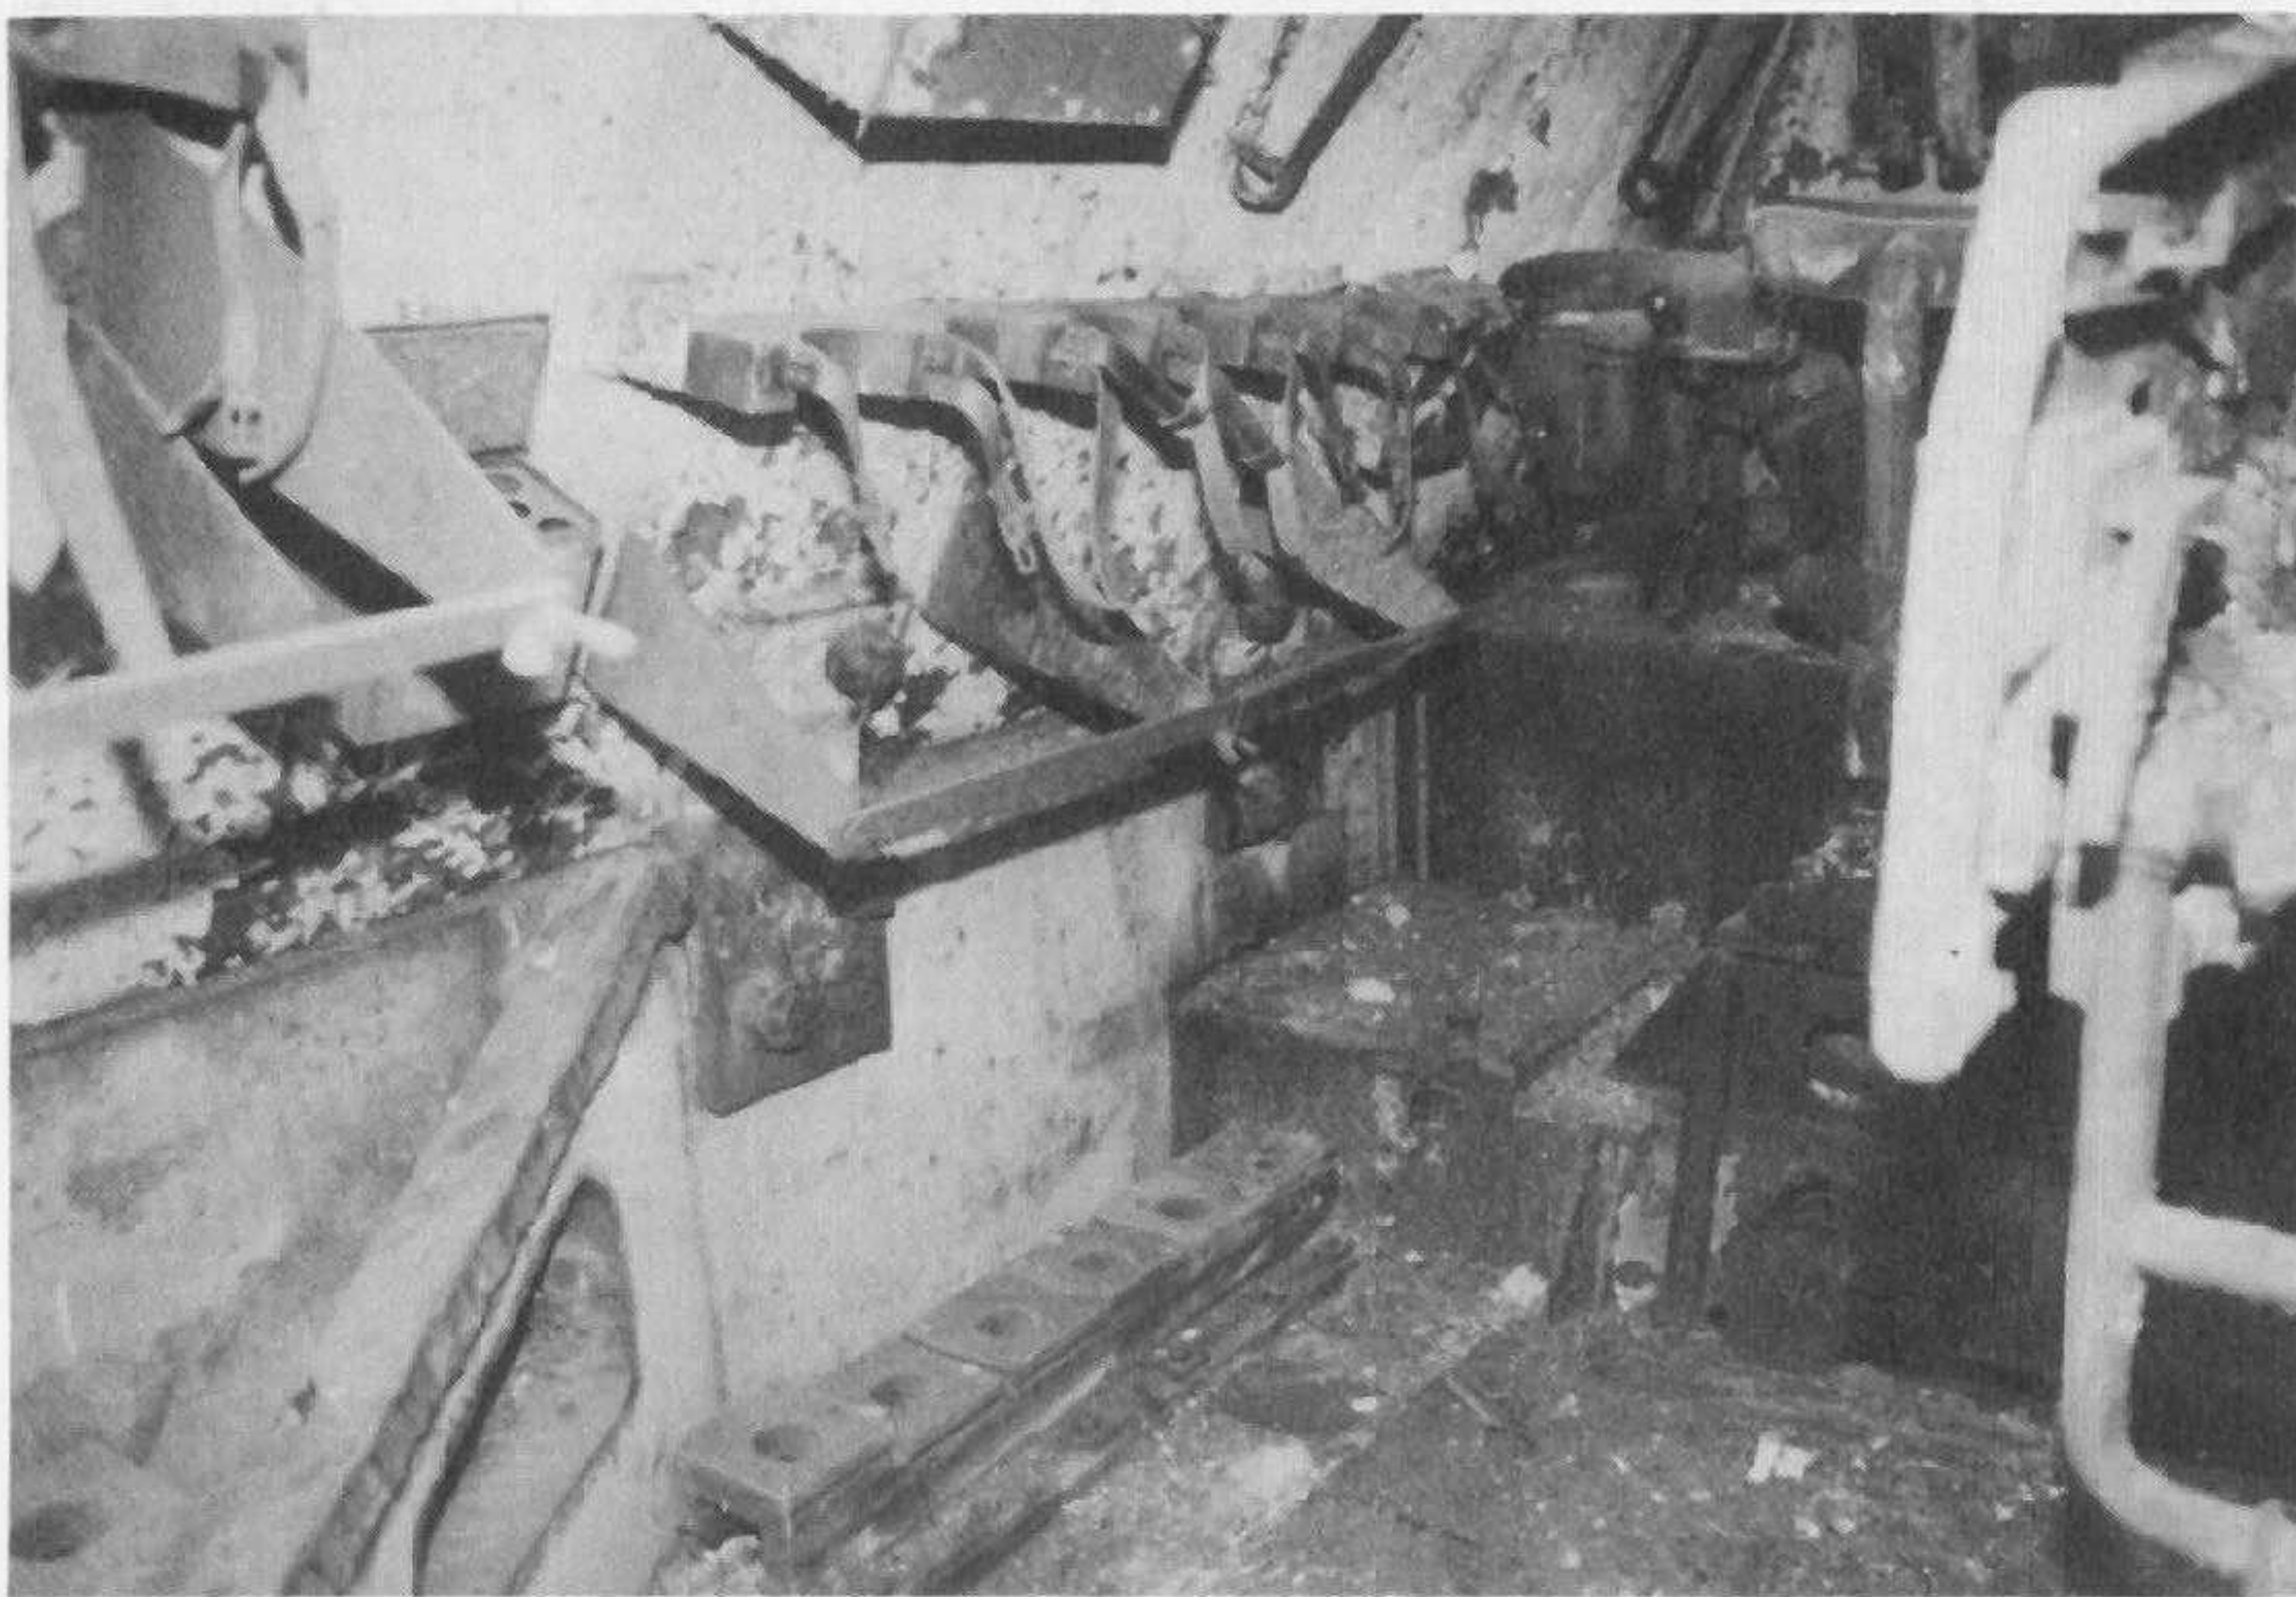
The circular hatch and its locking mechanism.
