MUSEUM ORDNANCE SPECIAL NUMBER 4

Elefant Panzerjäger Tiger (P)

Text by Thomas L. Jentz
Photos by Jeffrey D. McKaughan

THE "ELEFANT" AT ABERDEEN

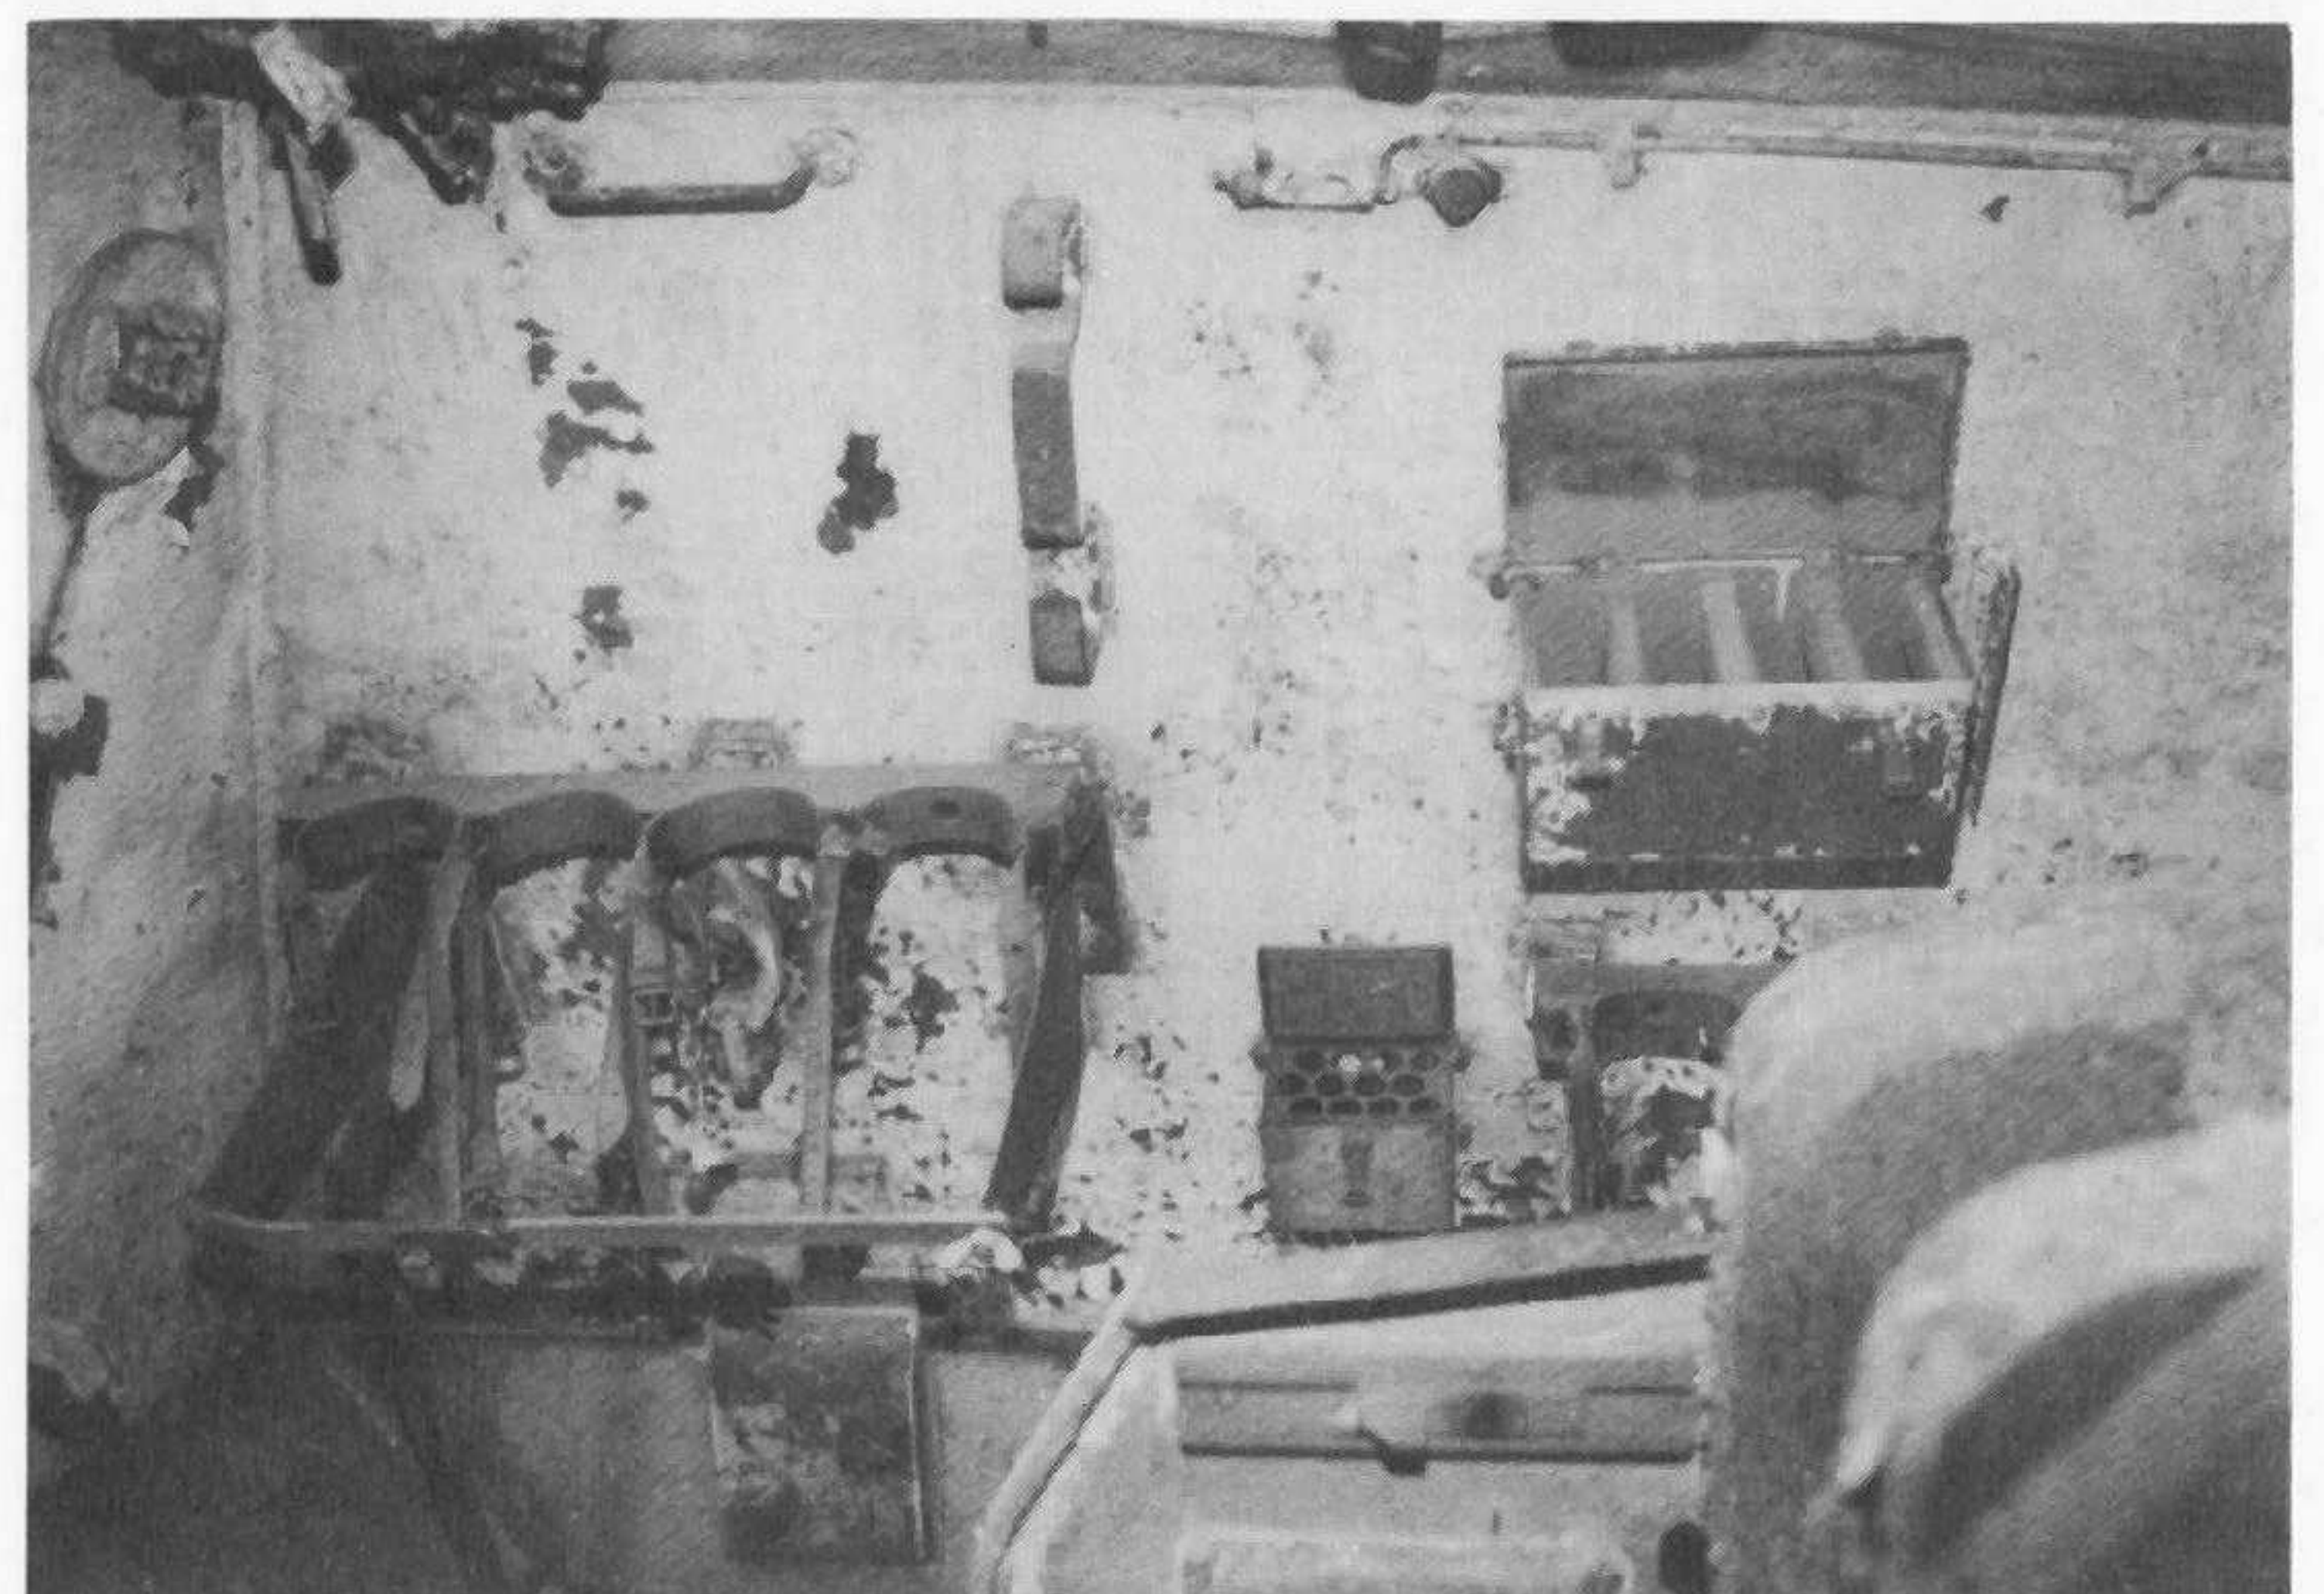
The ammunition in the Elephant was stowed nose down, with the projectile resting in a hole cut in a wooden block. A frame mounted on the wall had leather straps that secured the other end of the round. The differences in the two colors of the interior is very obvious here.

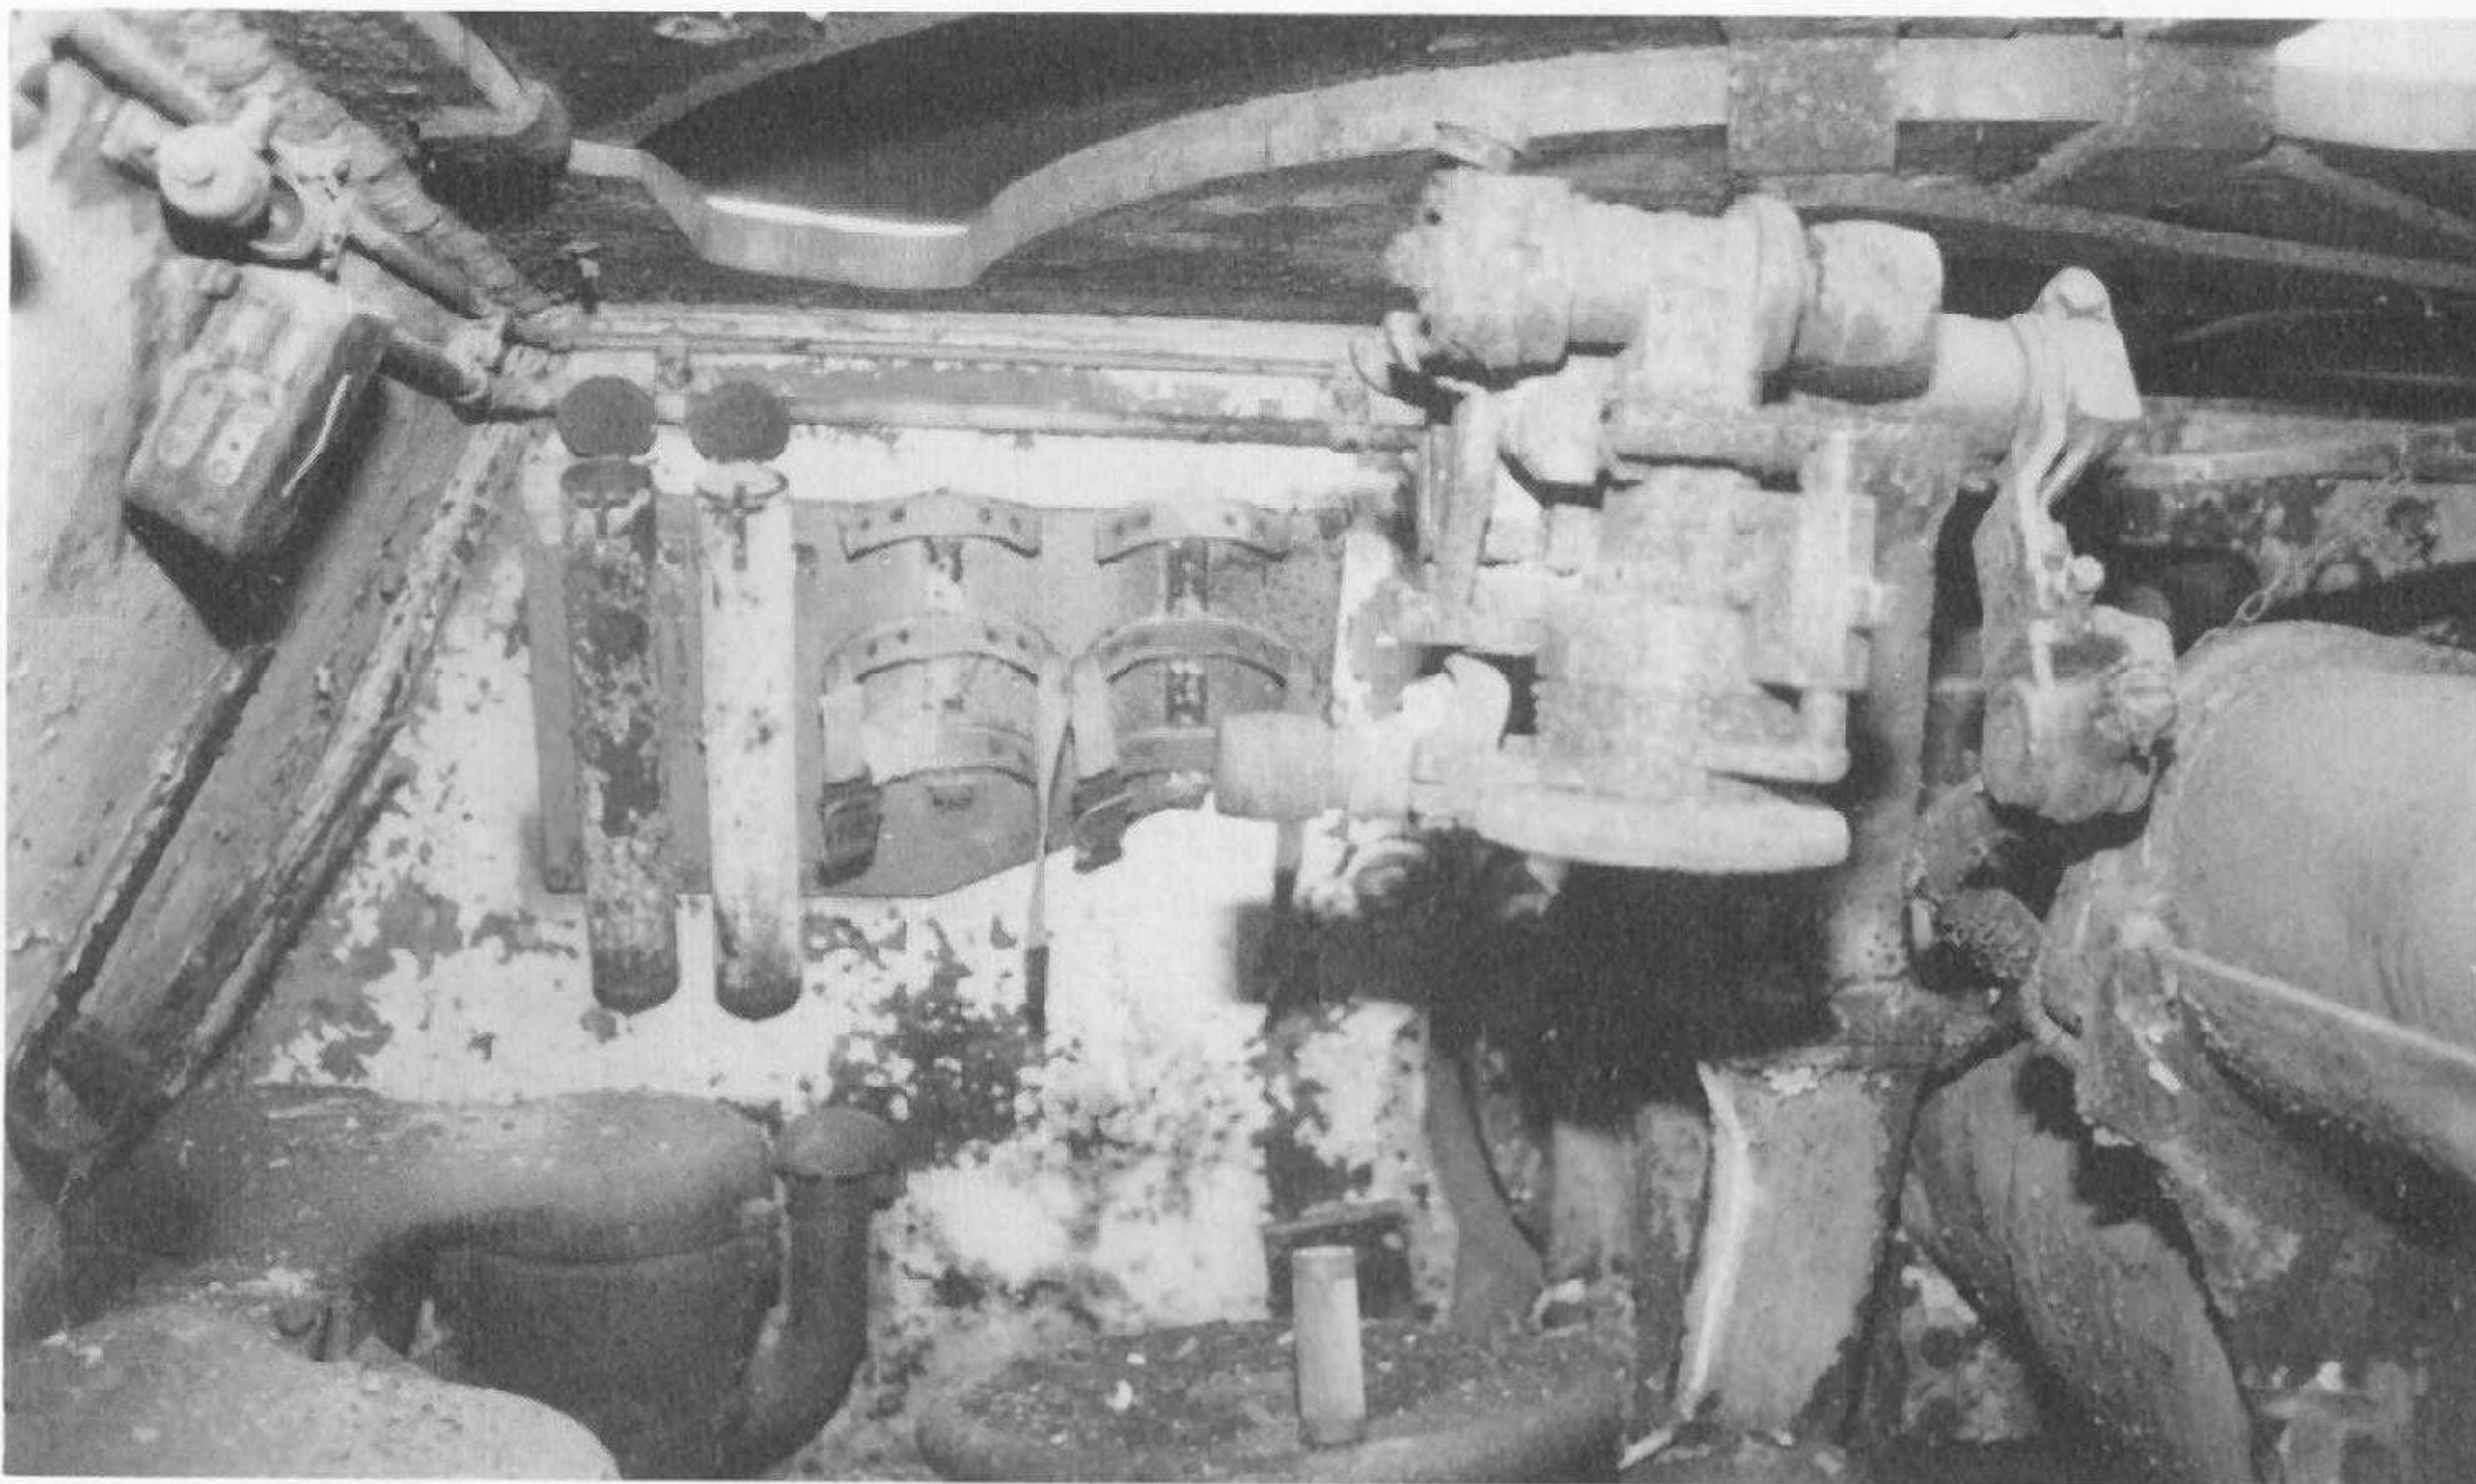
RIGHT: The left rear of the fighting compartment with another ammunition stowage rack, this one holds eight rounds. Also of interest is the locking mechanism for the pistol port in the left center and the support bracket just below that.

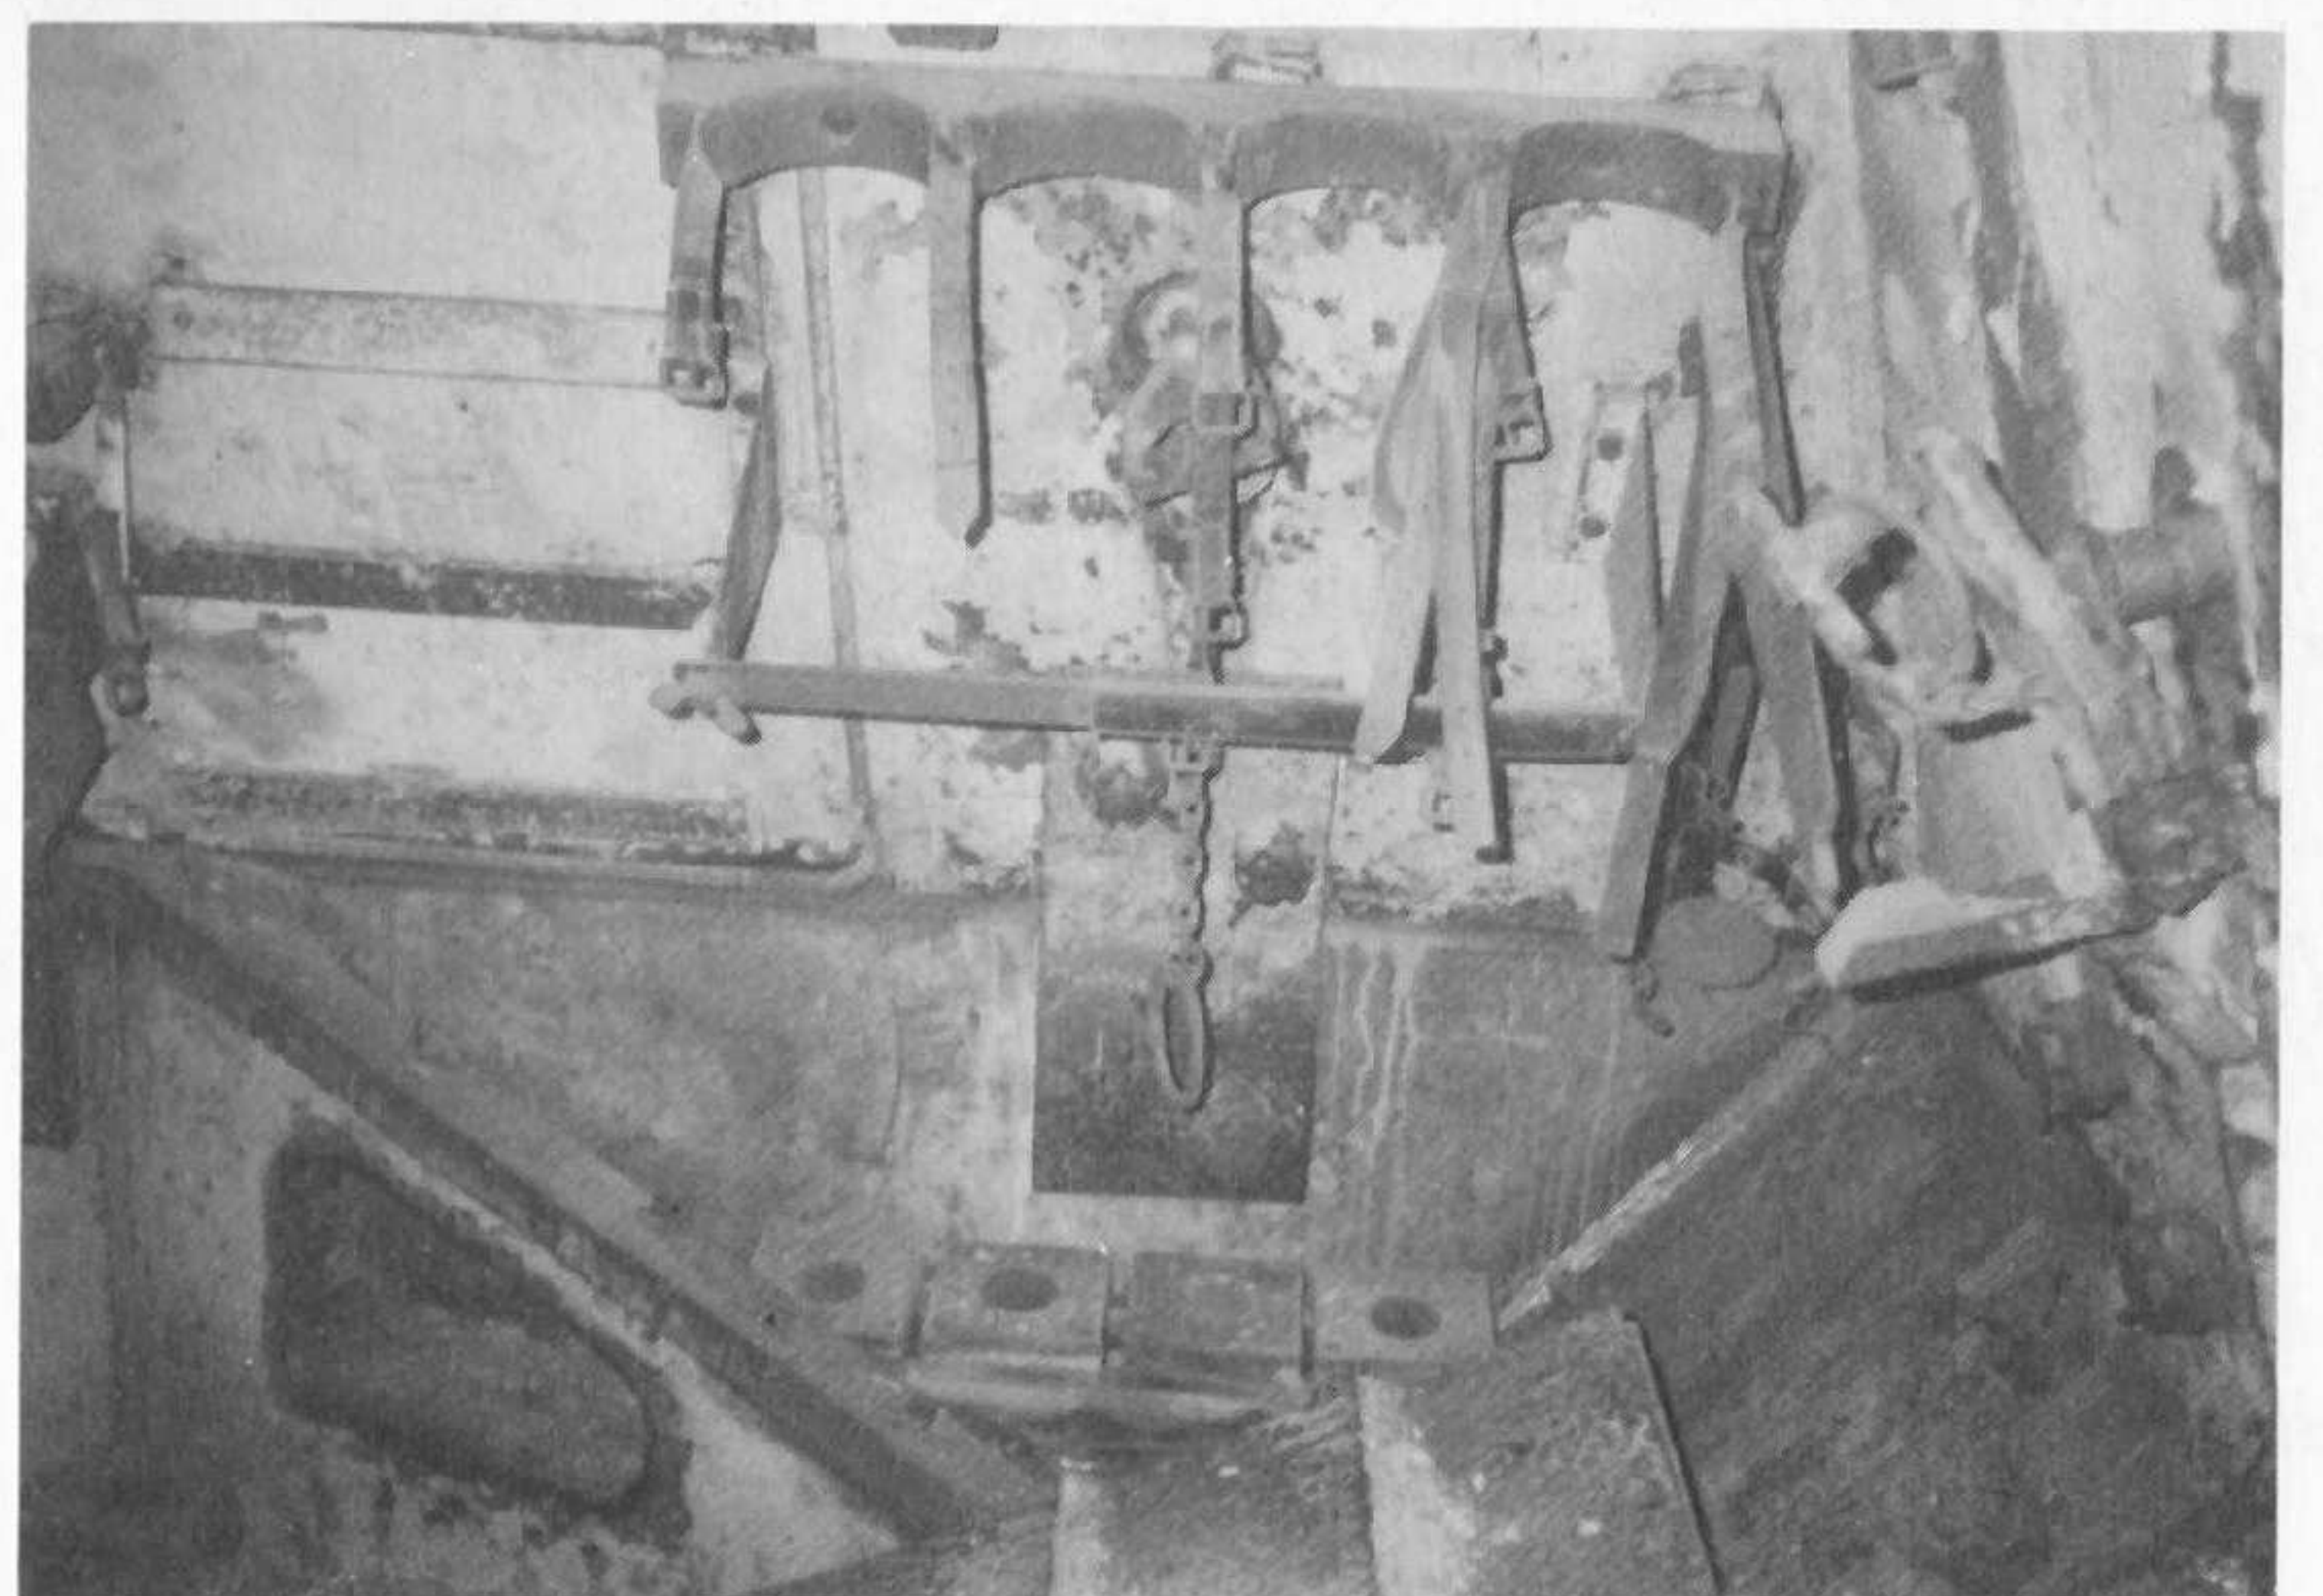
The left rear corner.

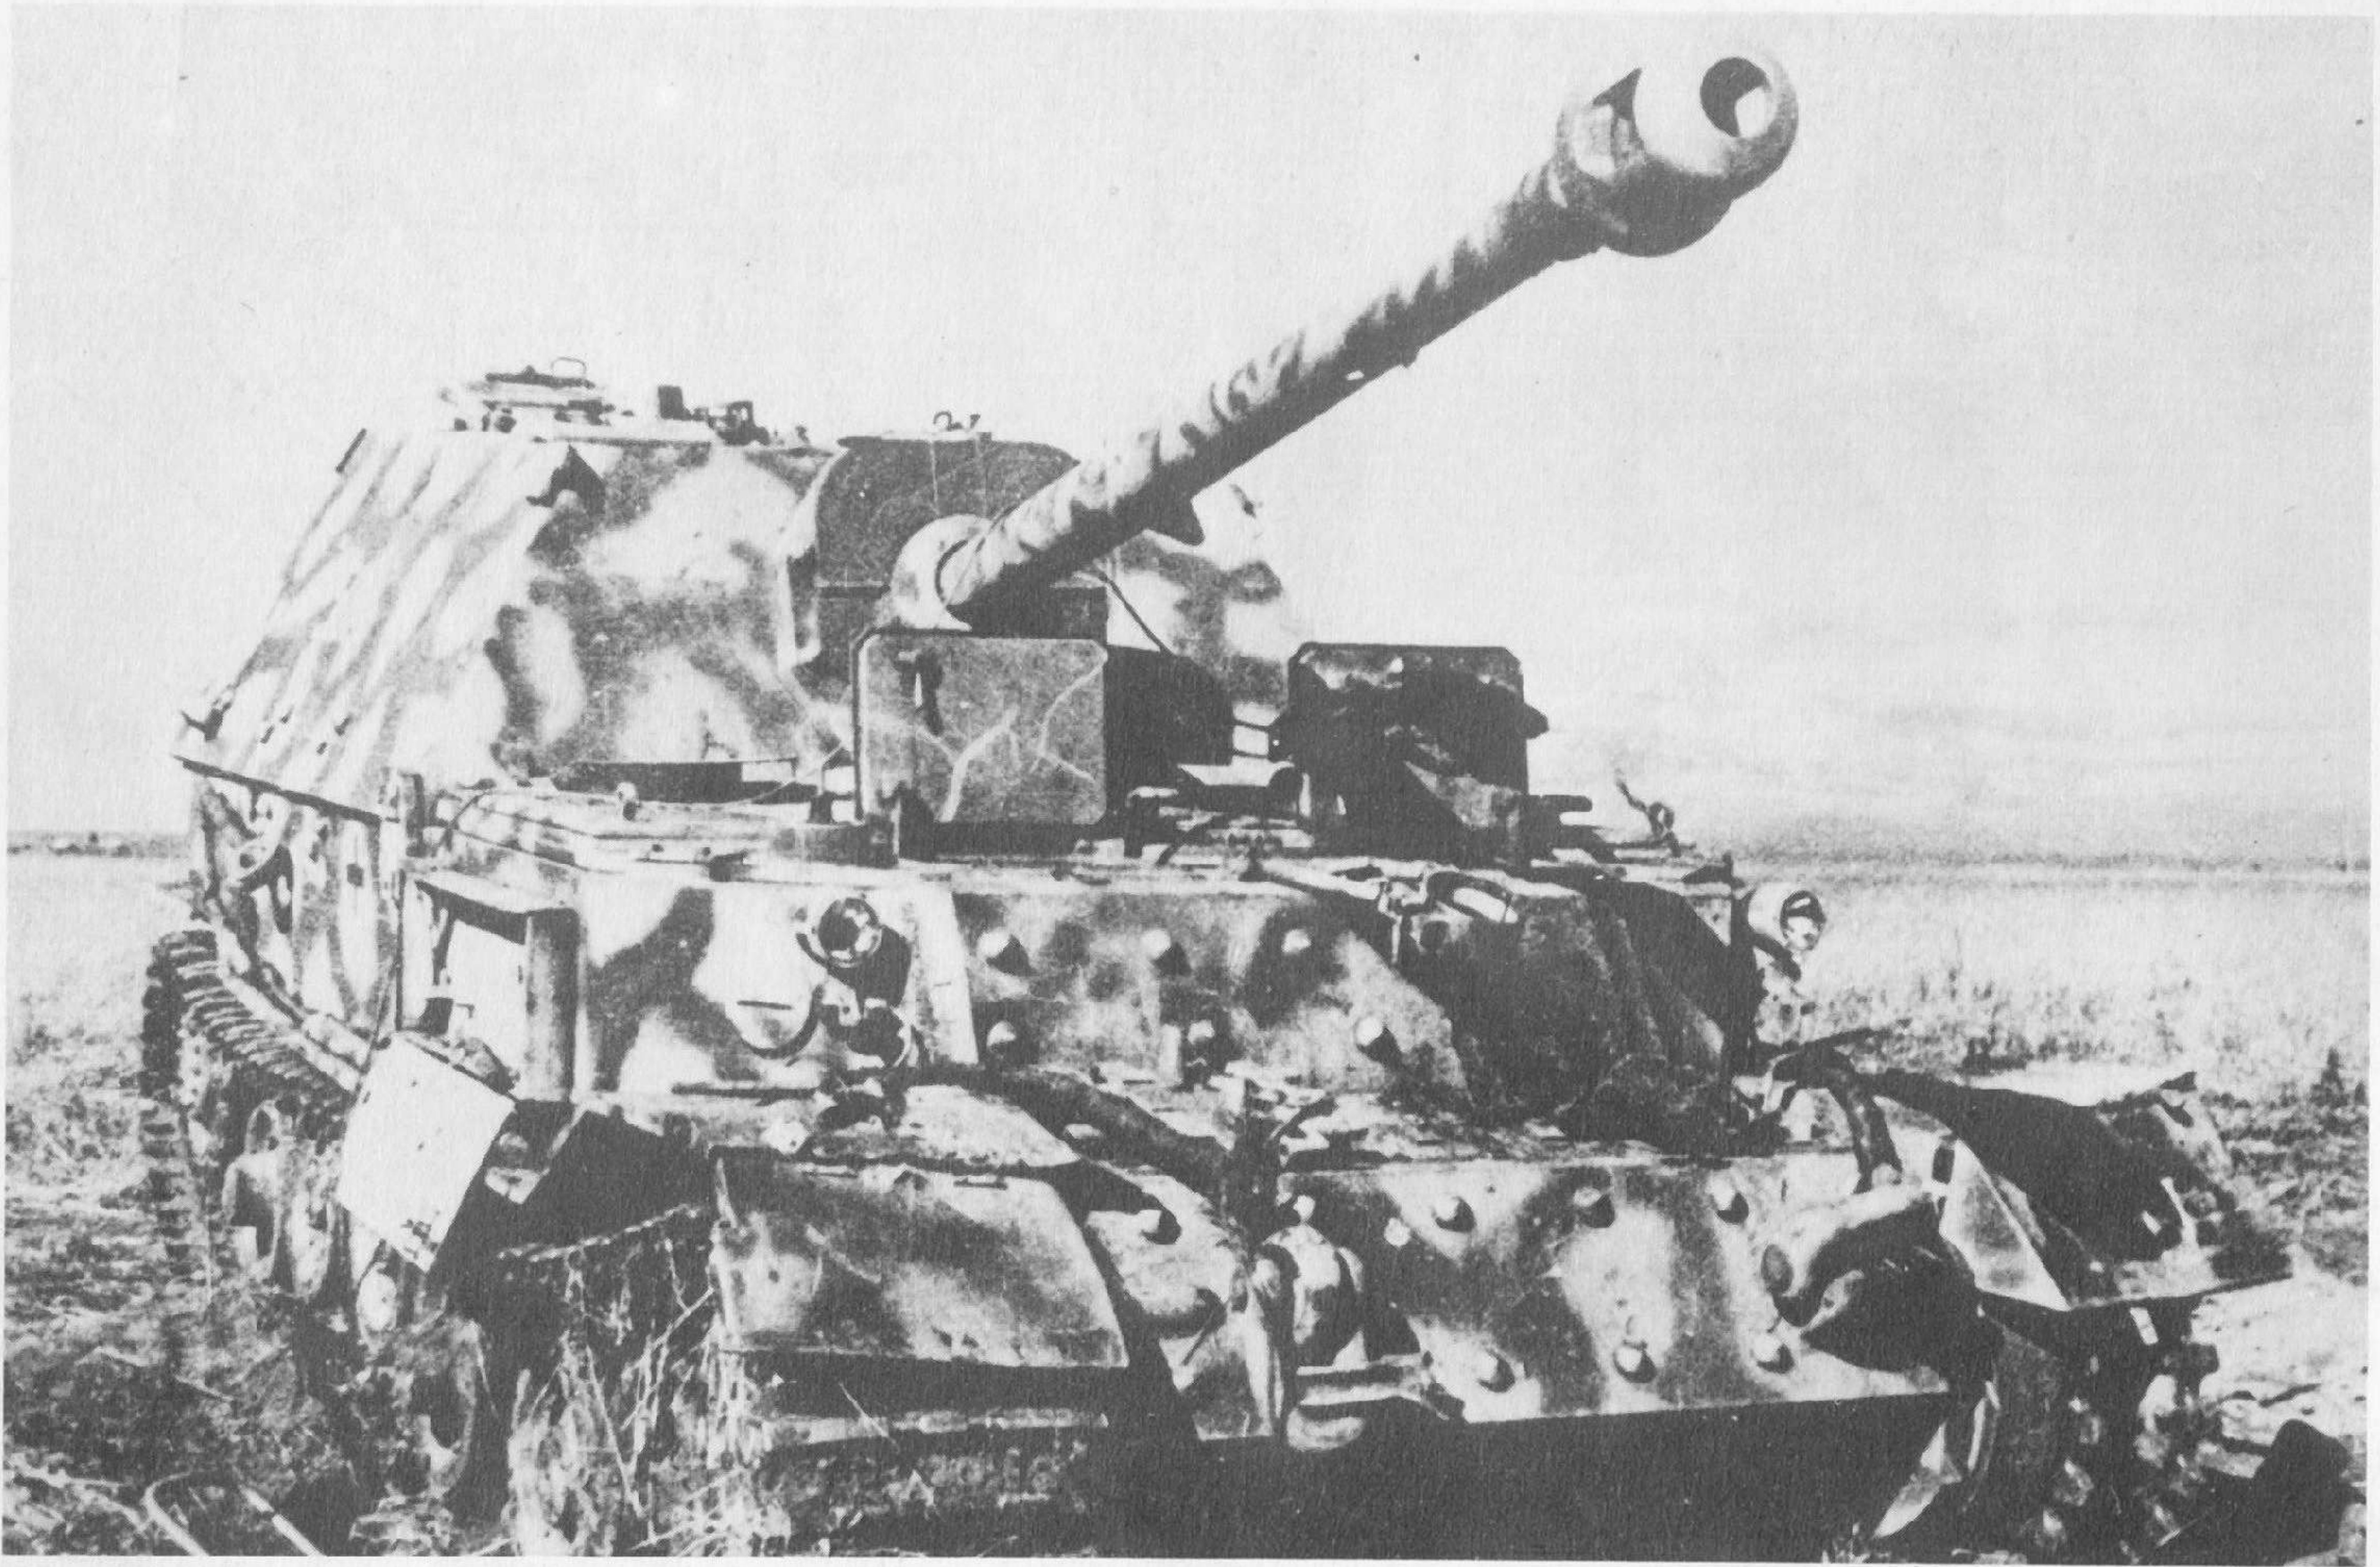
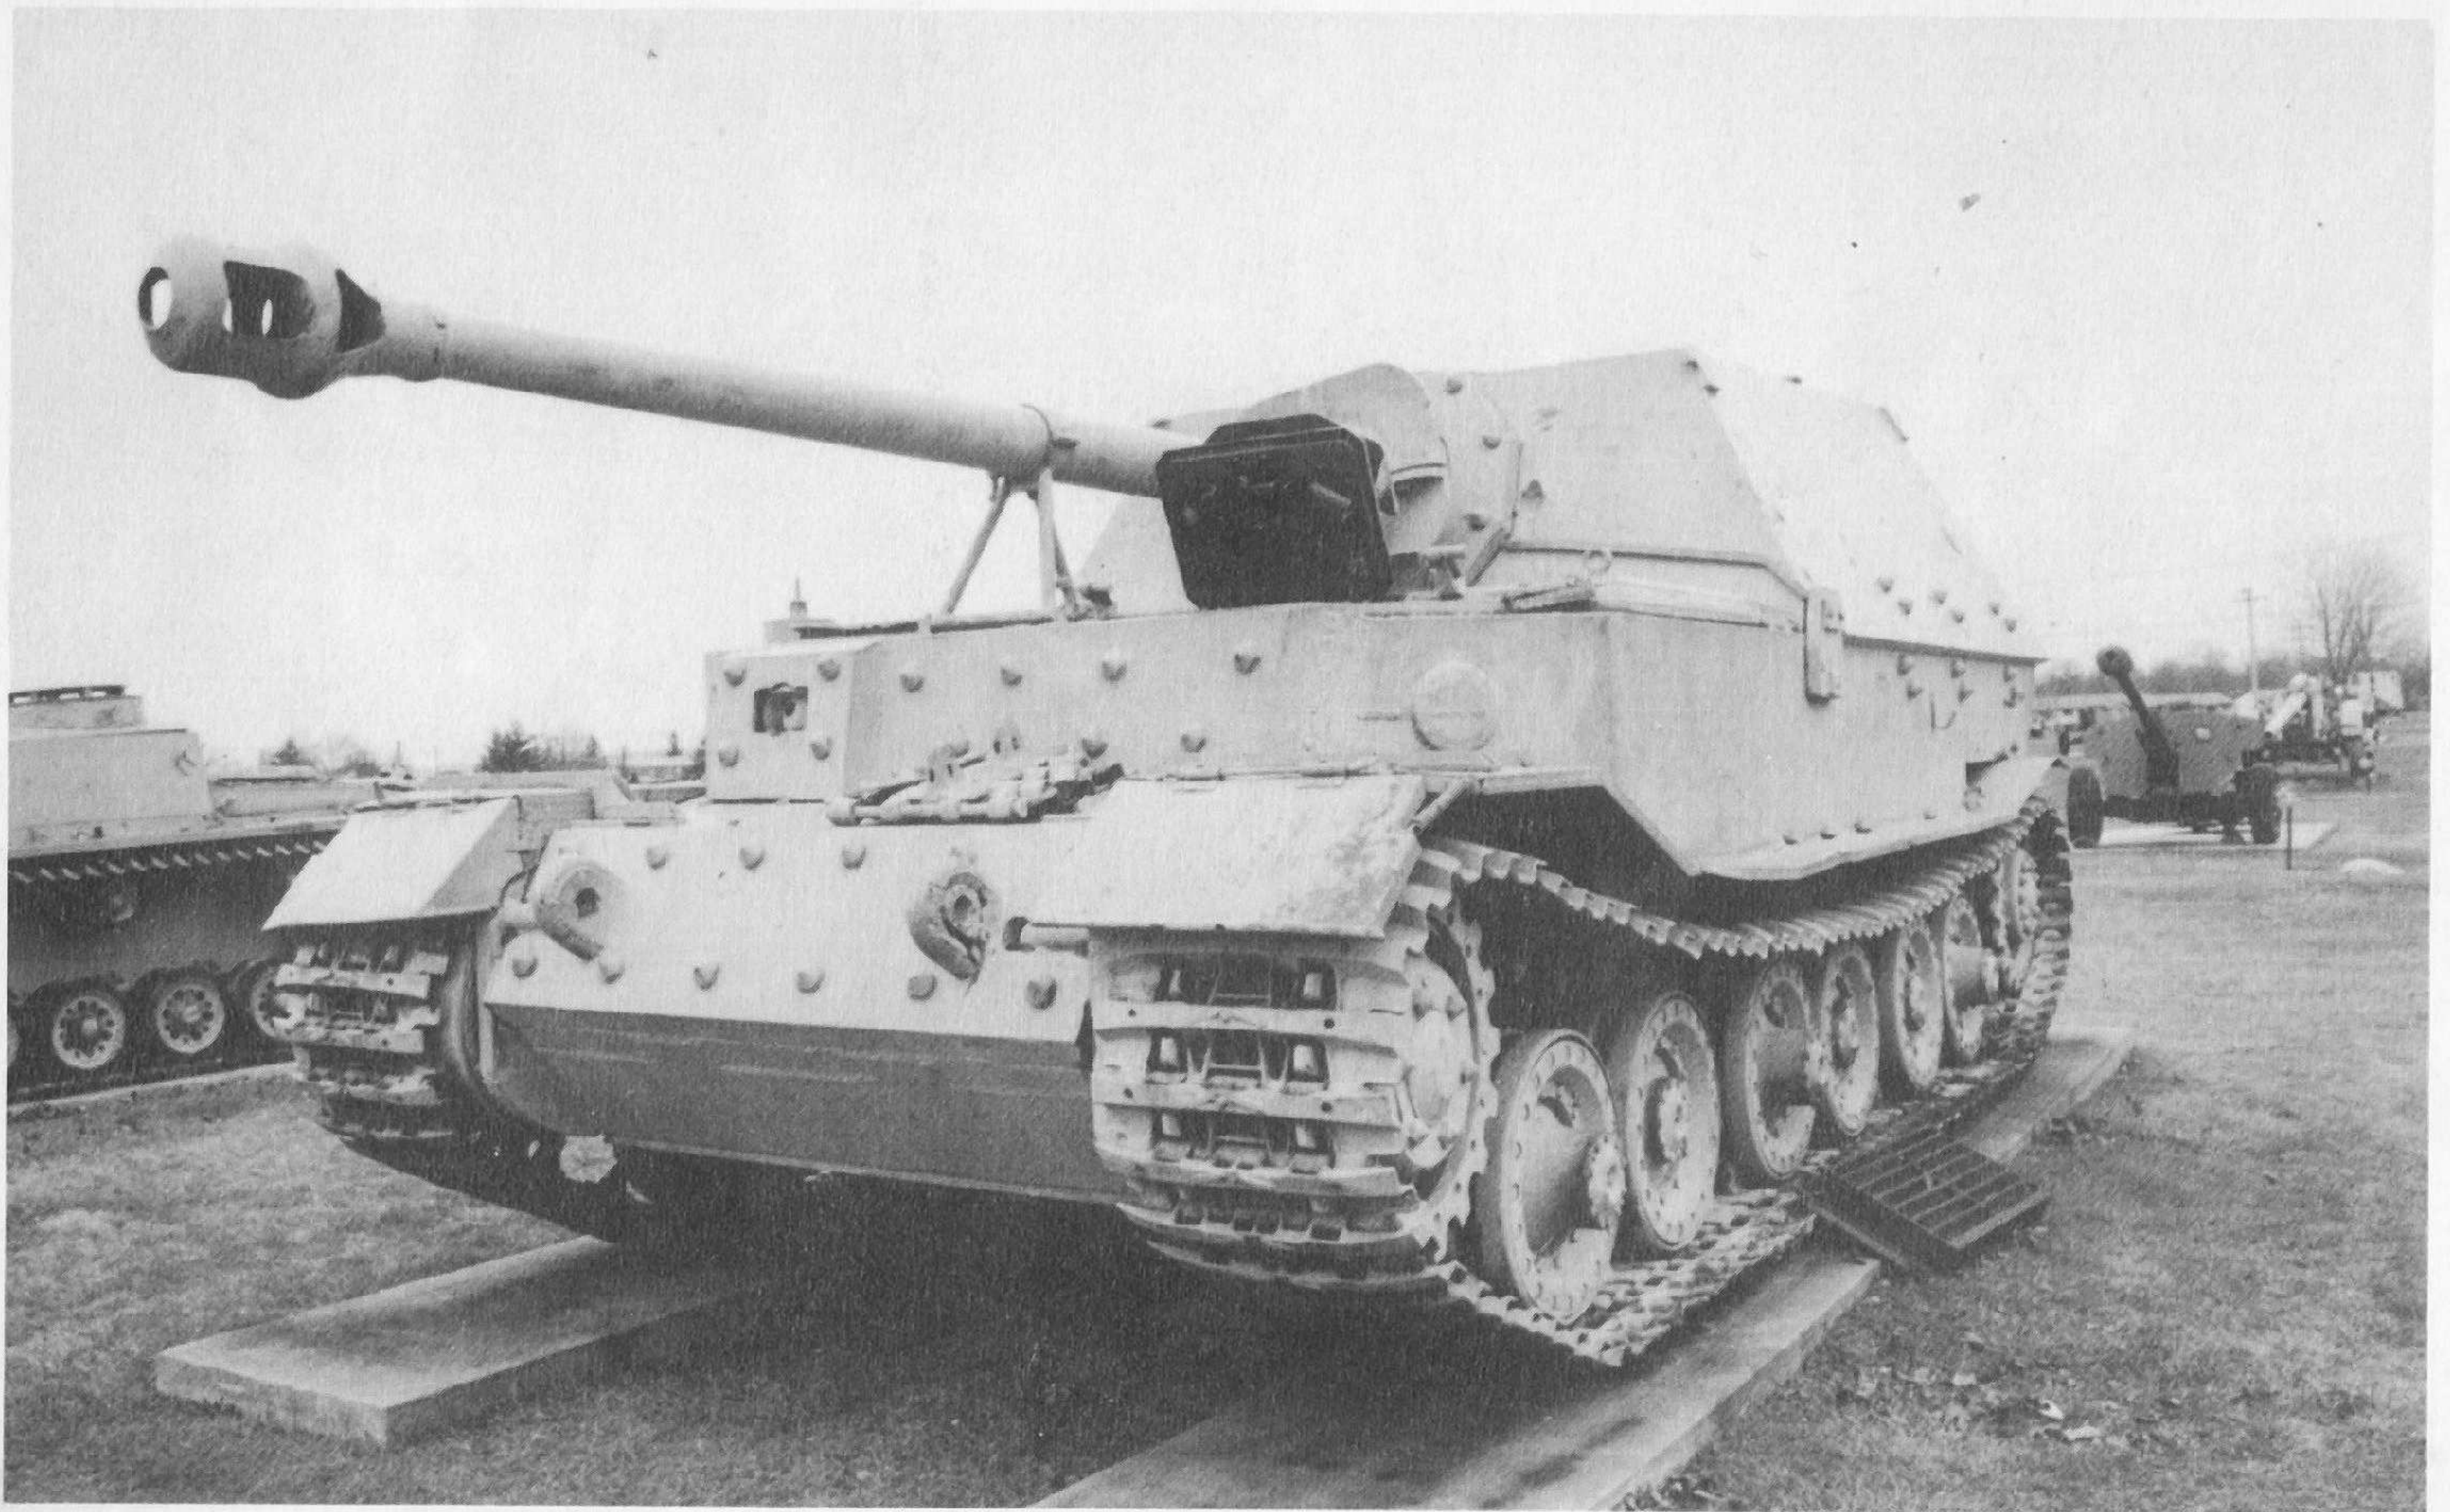
The right rear corner of the fighting compartment. The front of the metal frame that helps support the ammunition is held hold by one wing nut and a pivot pin.
